**Inspection Photos**  
**Location Name: Maylon Scow Pilcher #1**  
**API: 05-083-06418**

**Location ID #393155 with 200 bbl. AST.**

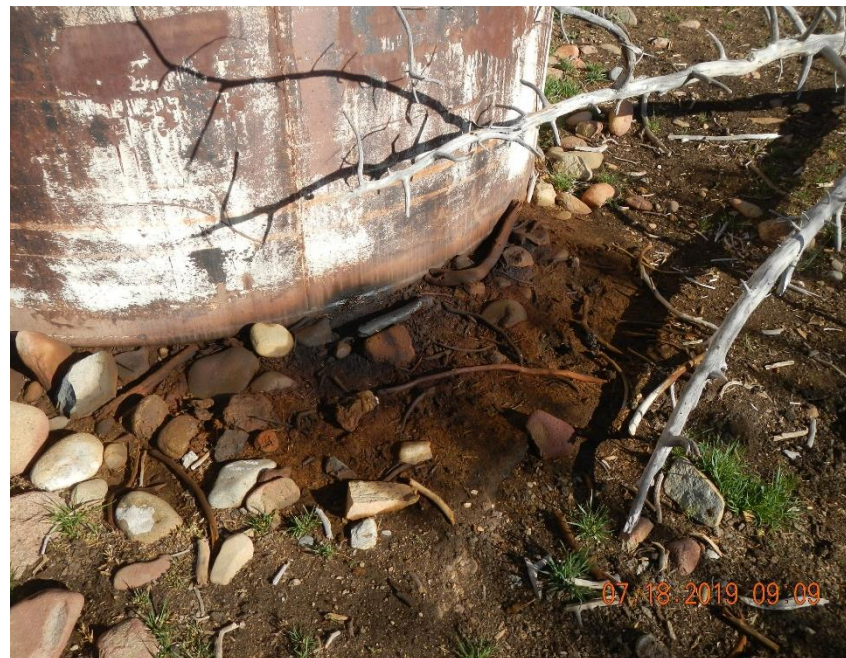
**Corroded bottom seam and stained soil.**

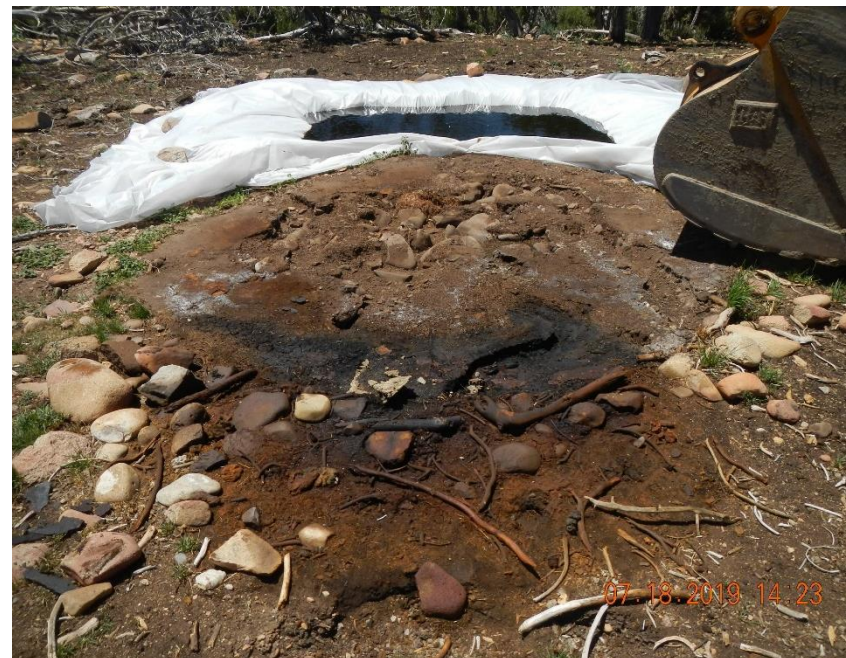
**Area where AST had been.**

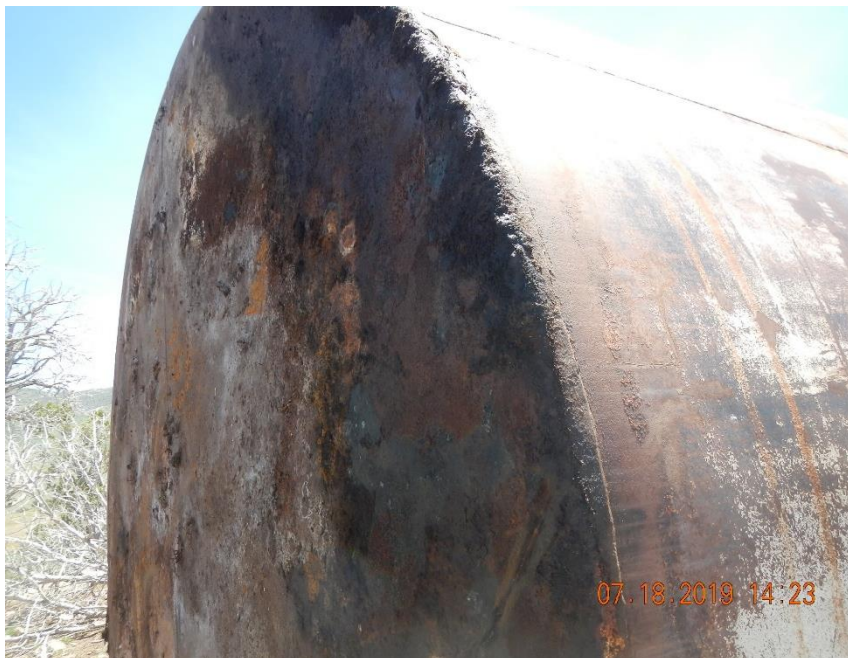
**Corrosion along bottom seam of AST.**

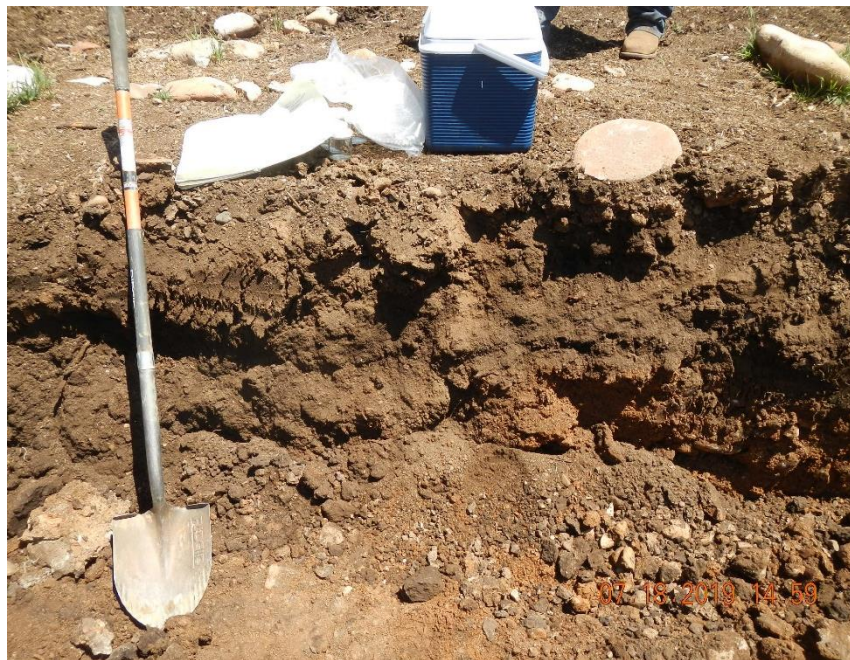
**Sample location from eastern portion of excavation.**

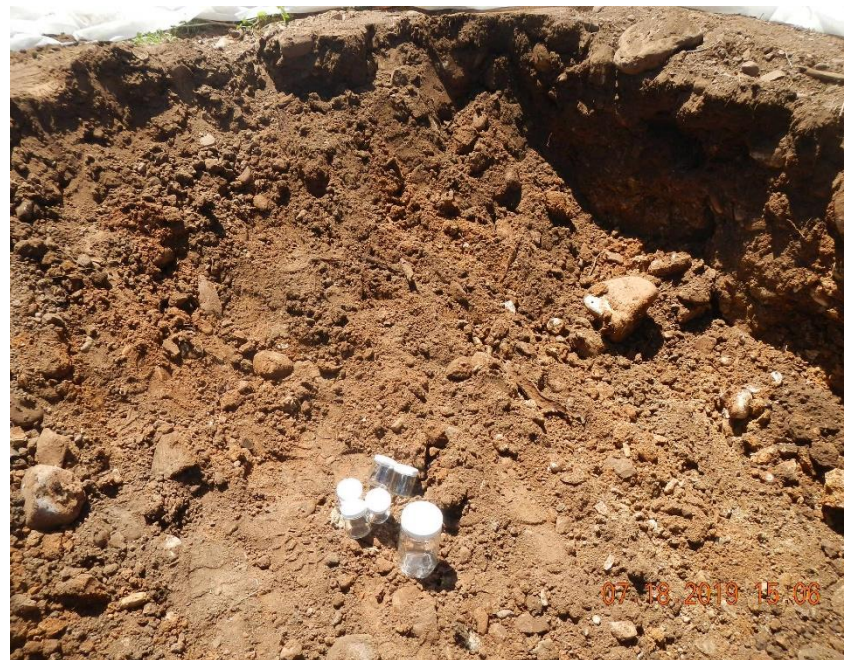
**Sample location from western portion of excavation.**
