Inspection Photos
Operator: BP America
Location #: 333708
Date: 1-31-2020

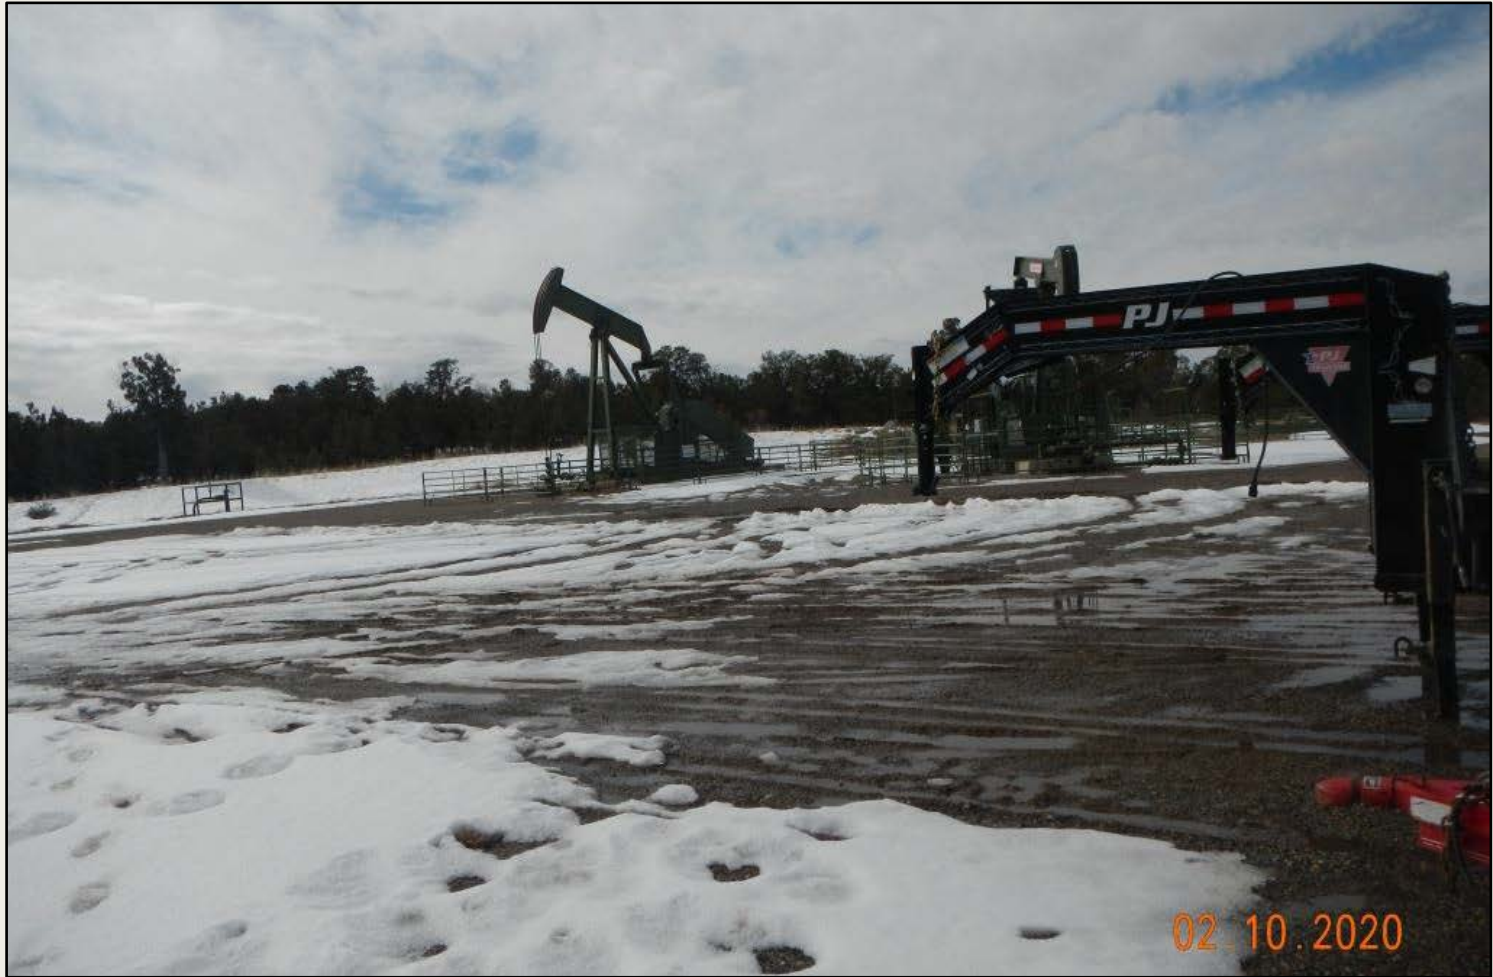
Photo 1. View of the project area from the northeastern corner facing center.

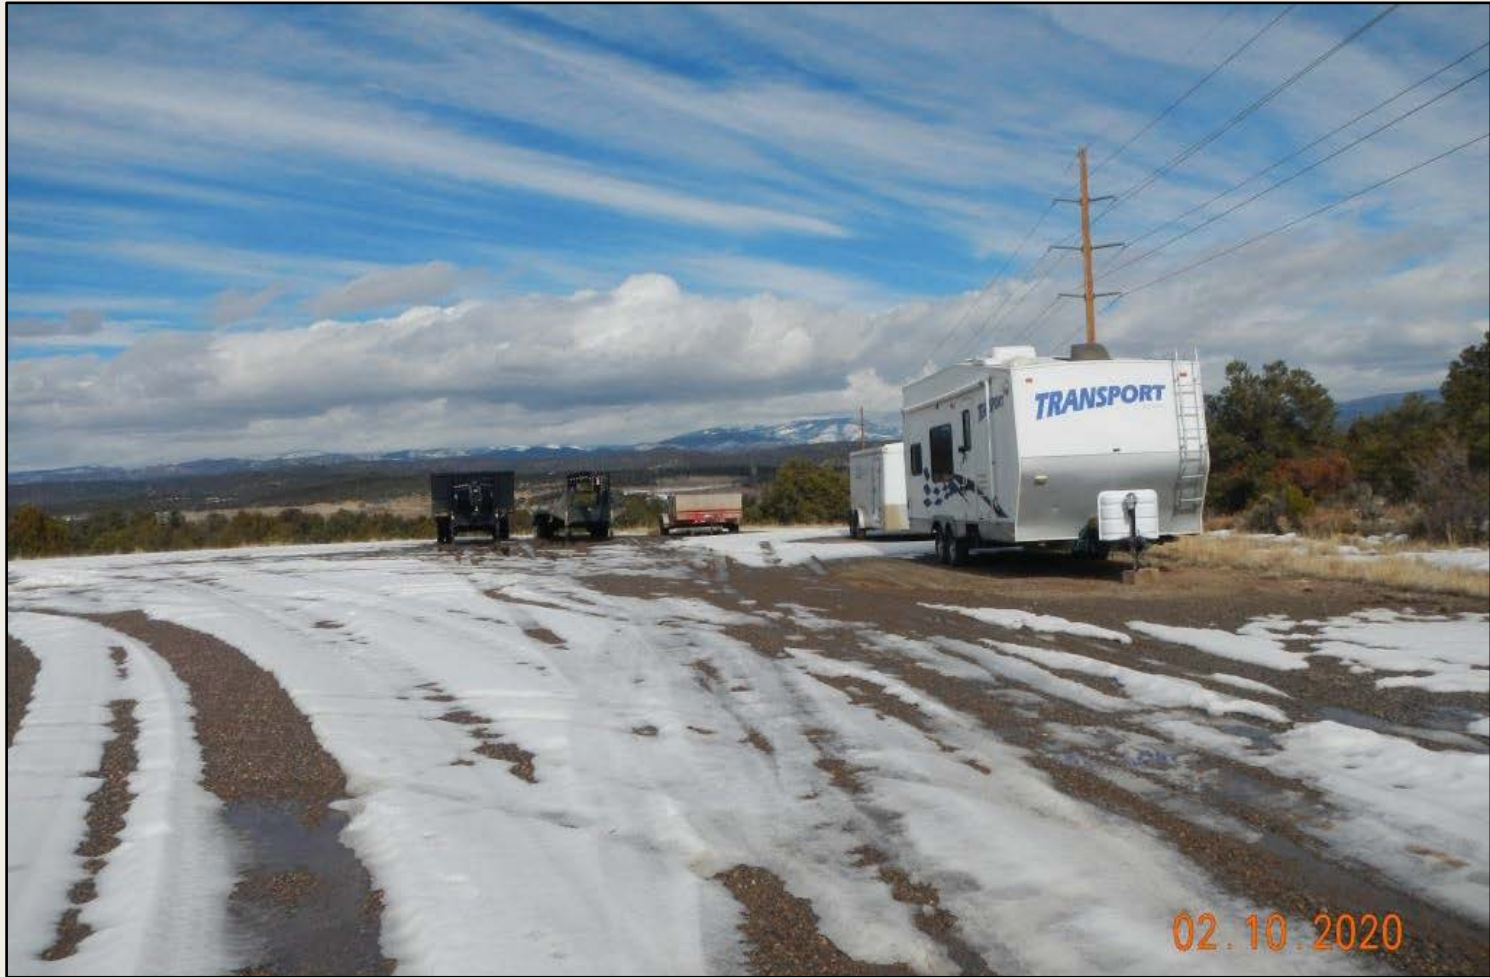
Photo 2. View of trailers stored within the northeastern working area. As this area is not needed for production operations it therefore needs be interim reclaimed.

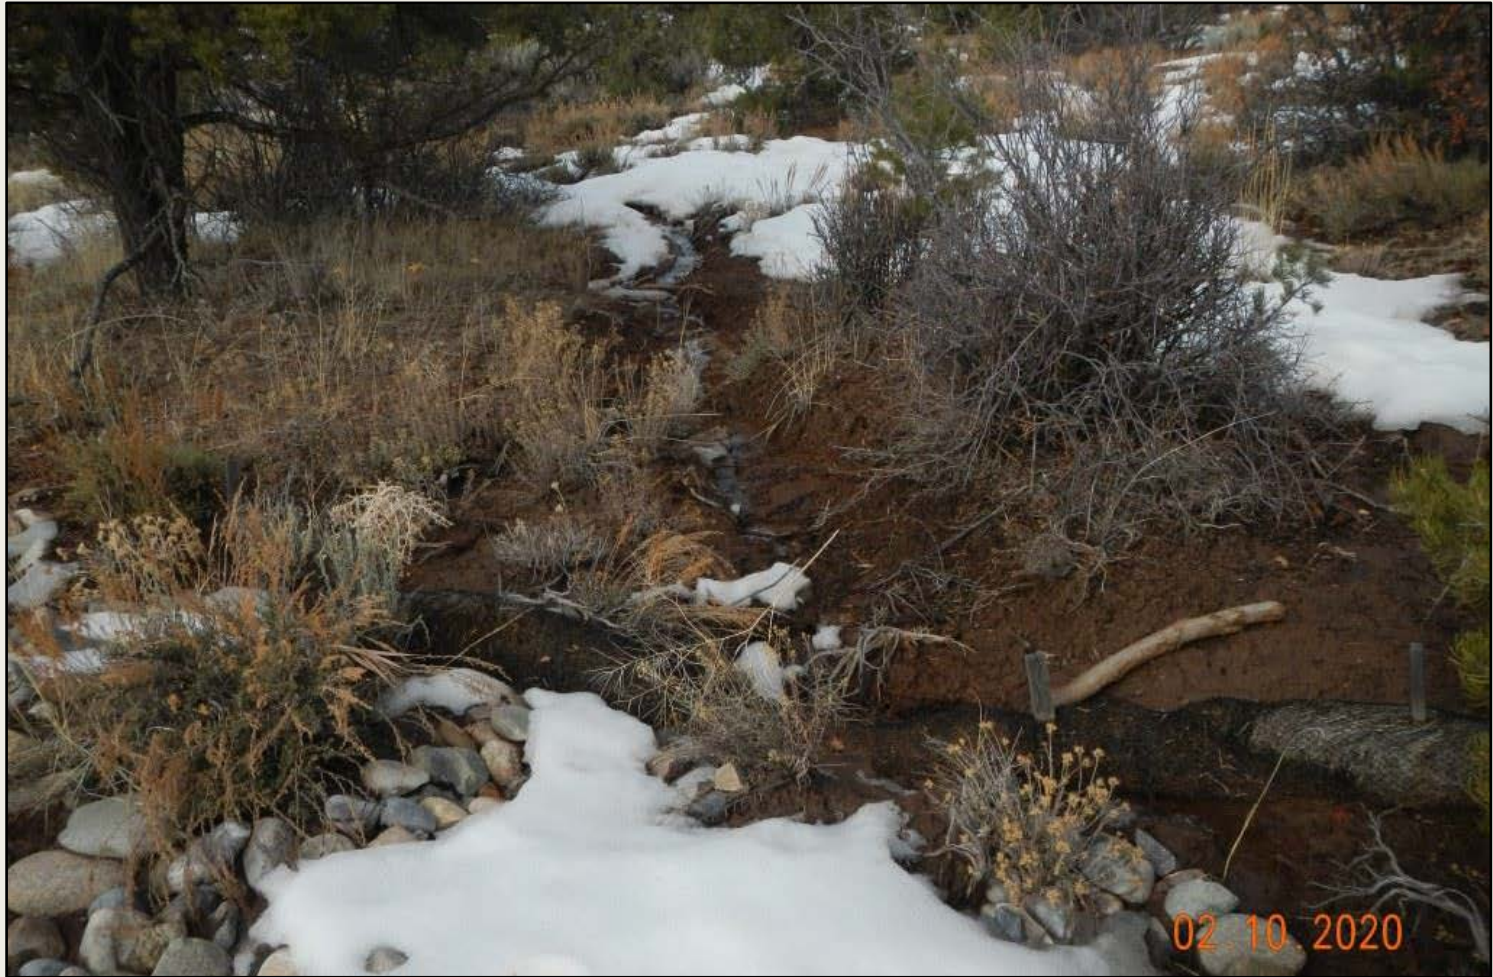
Photo 3. View of area at the northeastern edge of project area where snow melt is forming an erosional channel flowing off of the project area where stormwater controls are not sufficient to de-energize and filter flows.

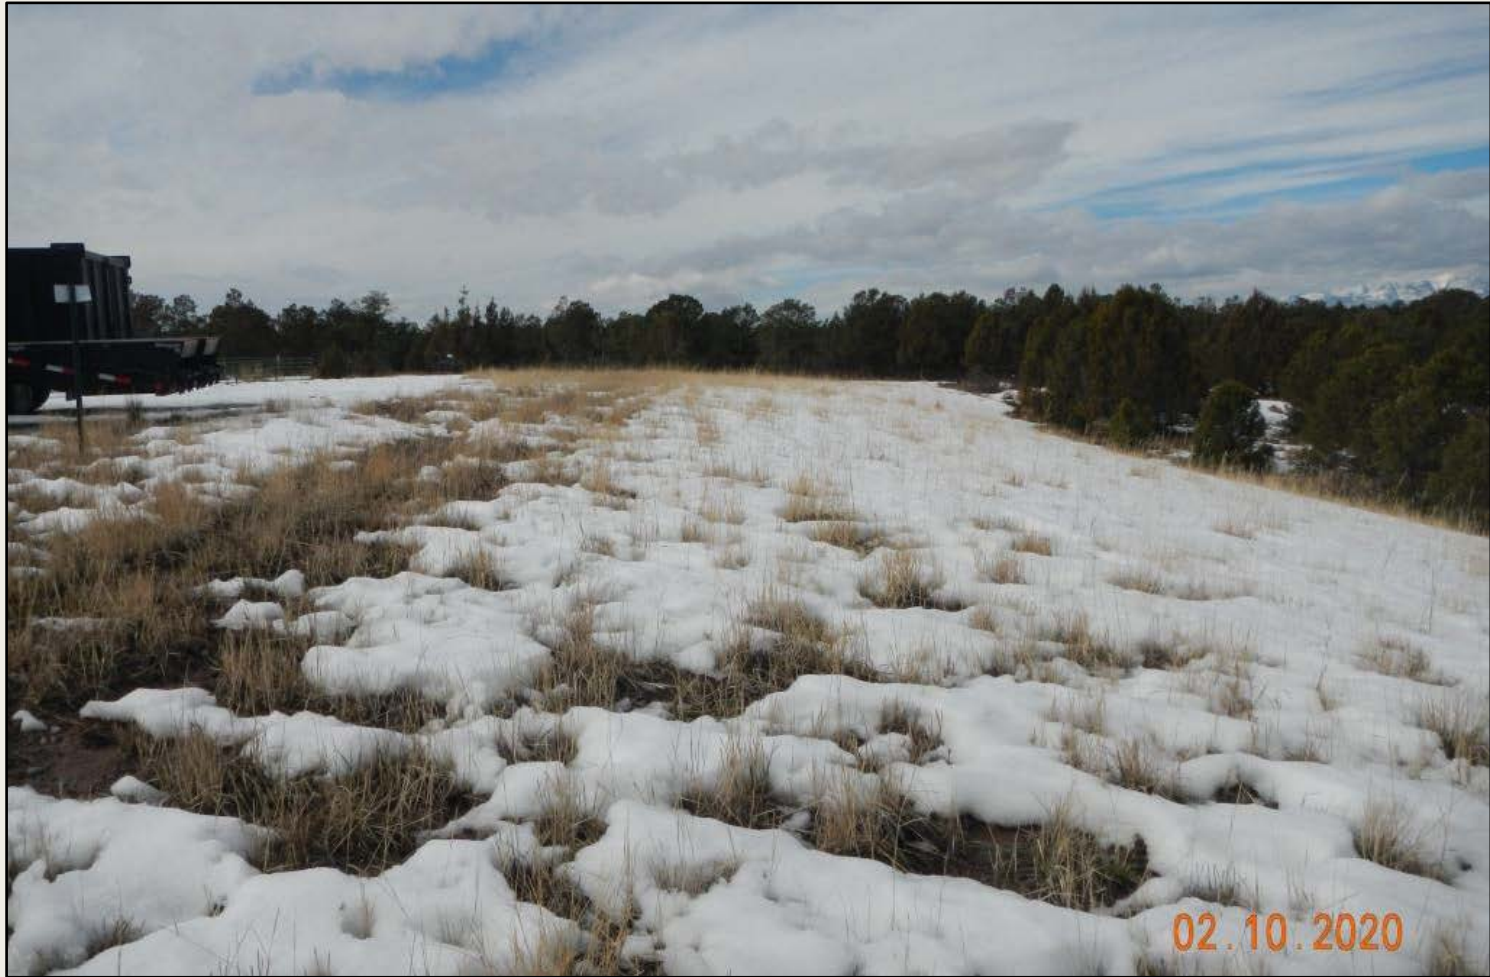
Photo 4. View of the northern project area from the northeastern corner facing westward. Revegetation appears to be progressing with grasses such as thickspike wheatgrass, western wheatgrass, and Indian ricegrass.
