# Inspection Photos

Operator: CHEVRON USA INC - 16700

Location ID: 397120

Rio Blanco County, CO

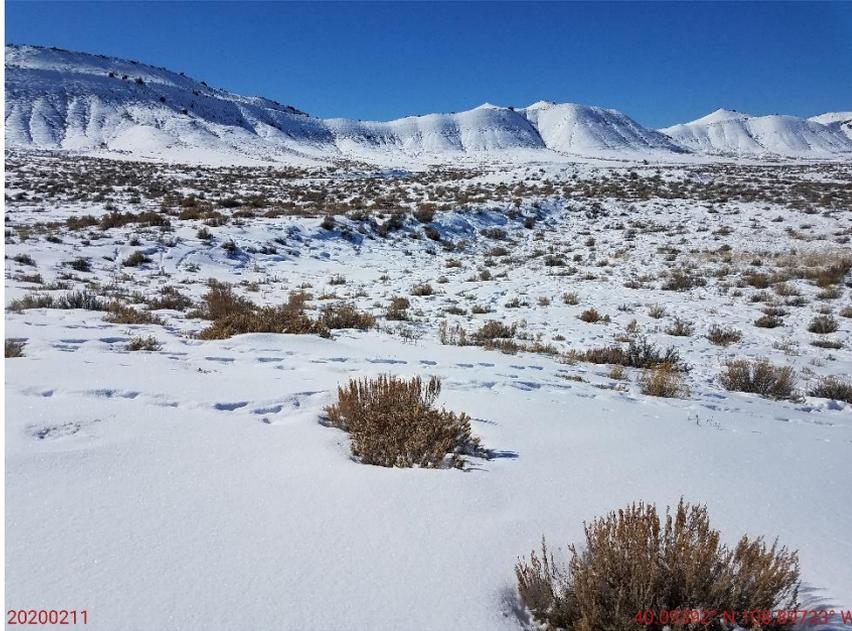
**Photo 1:** Photo taken from the east of the Location, facing southwest. Photos 1-4 provide an overview of the Location from southwest, west, northwest to North.

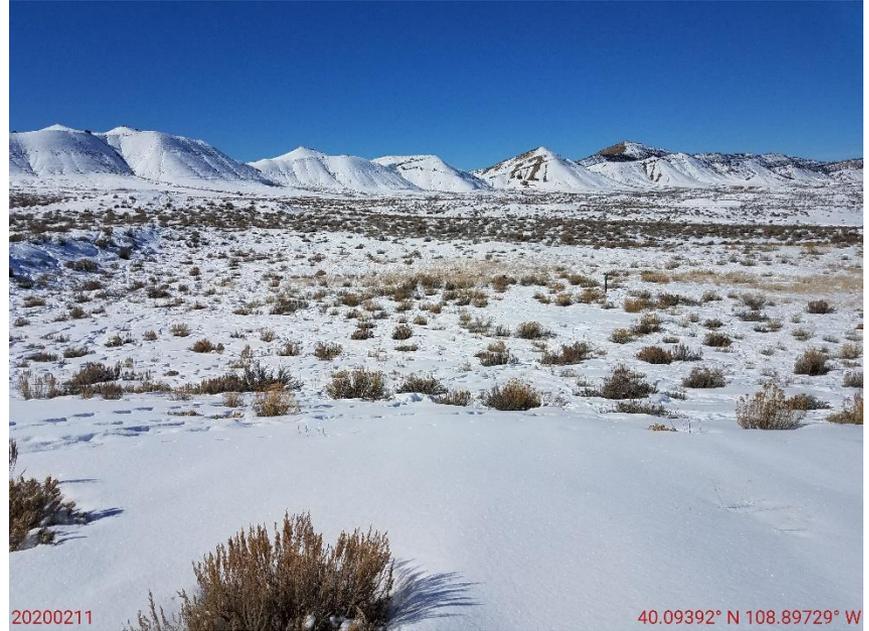
**Photo 2:** See comments under photo 1.

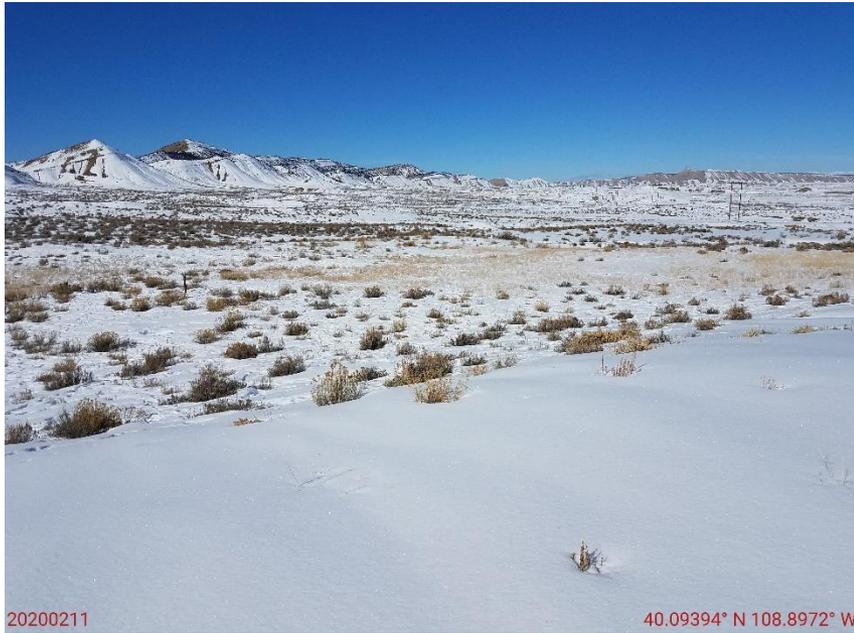
**Photo 3:** See comments under photo 1.

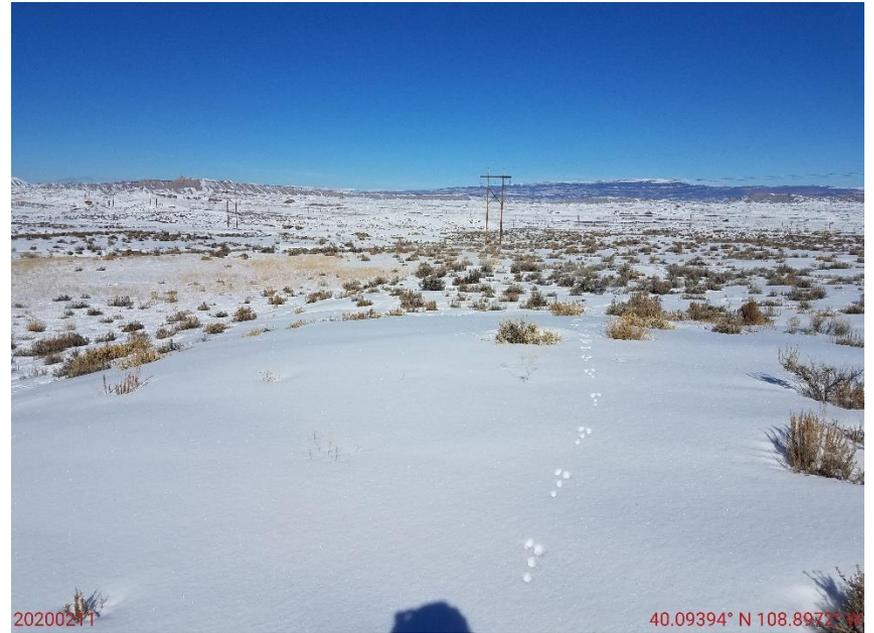
**Photo 4:** See comments under photo 1.

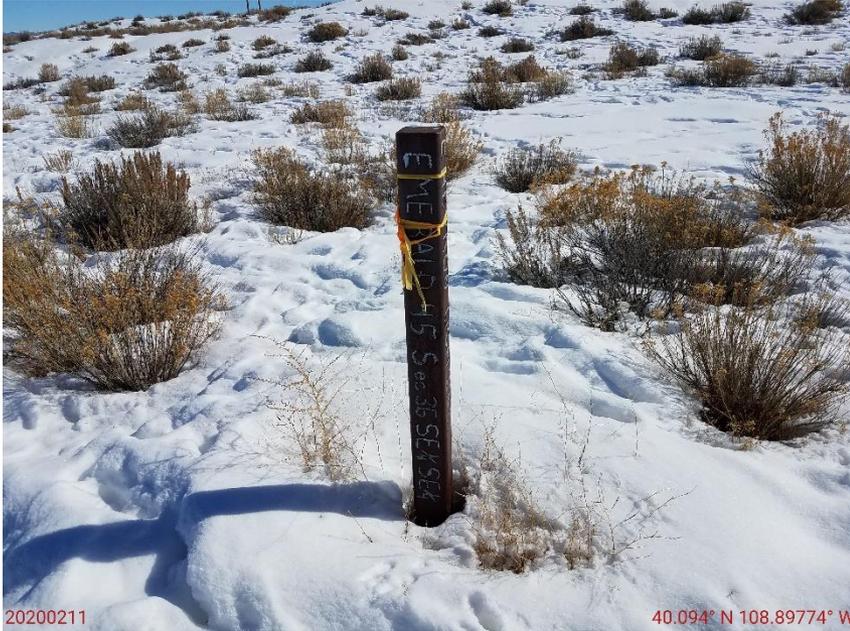
**Photo 5:** Photo of well marker.

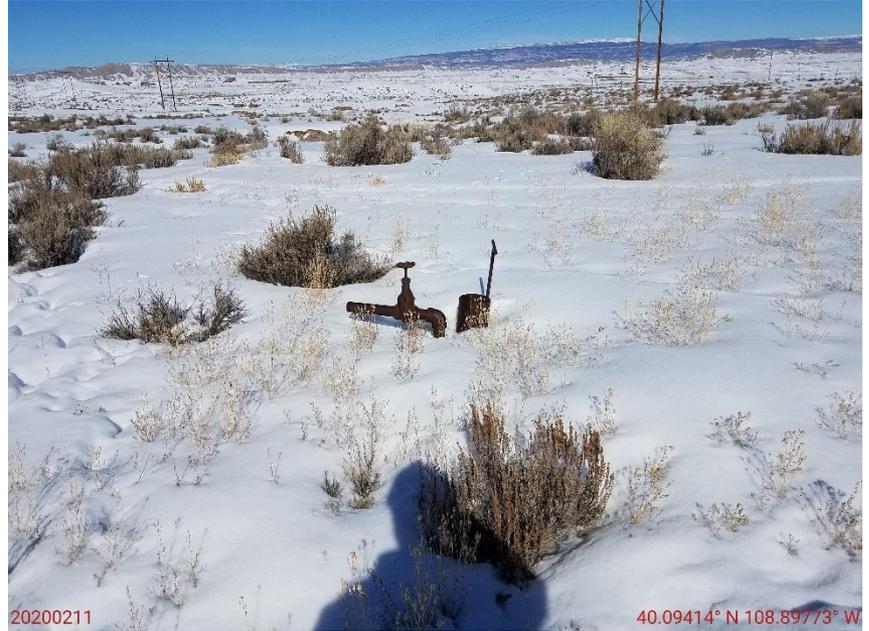
**Photo 6:** Photo taken from the north end of the Location, facing north. Photo shows risers/equipment remaining on the Location. Equipment requires removal.

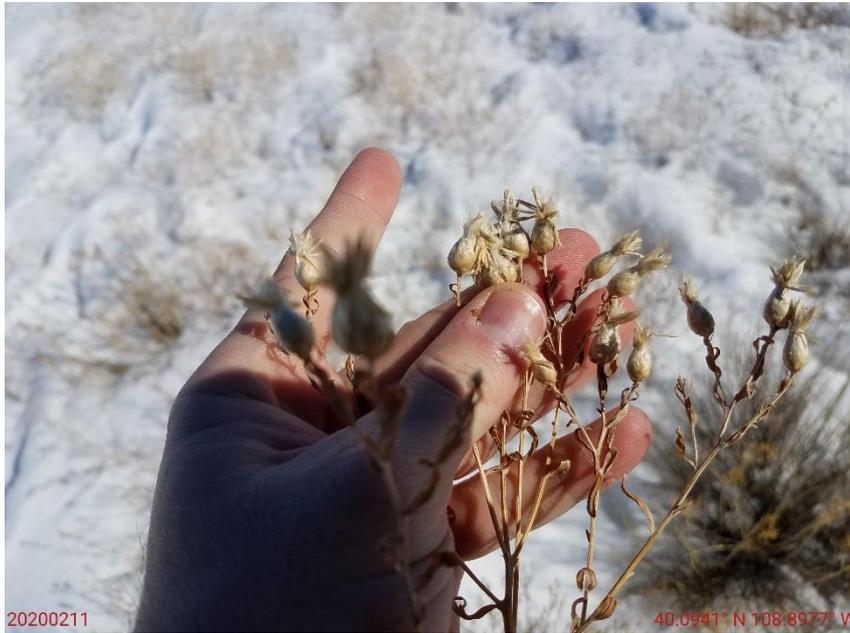
**Photo 7:** Photo taken from the Location. Photo shows what appears to be Russian Knapweed (*Rhaponticum repens*). This is a Colorado State listed noxious weed. *R. repens* observed throughout the Location, but is more dense within the center and northern areas of the Location.

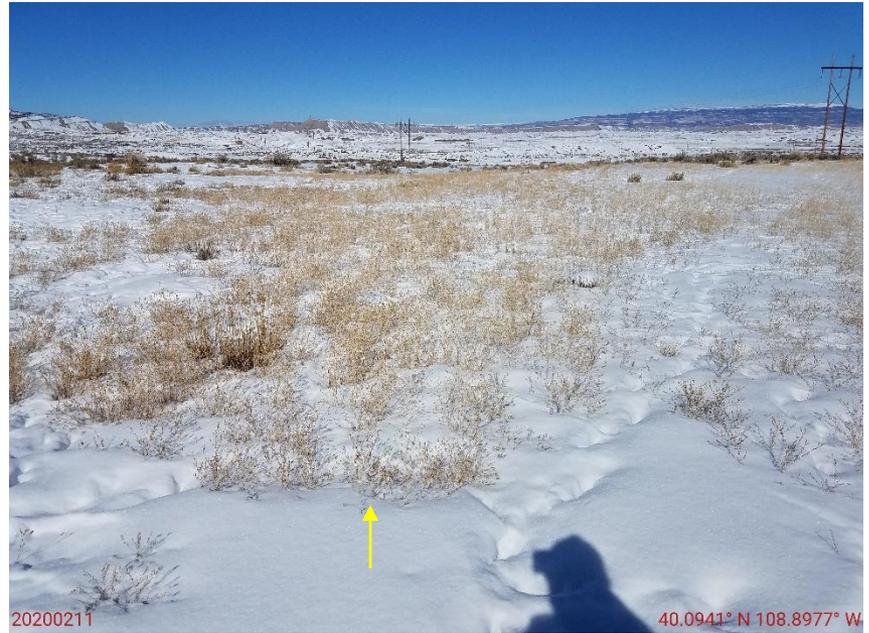
**Photo 8:** Photo taken from Location, facing north. Photo shows *R. repens* (light brown plants) is the dominant plant observed on the Location.

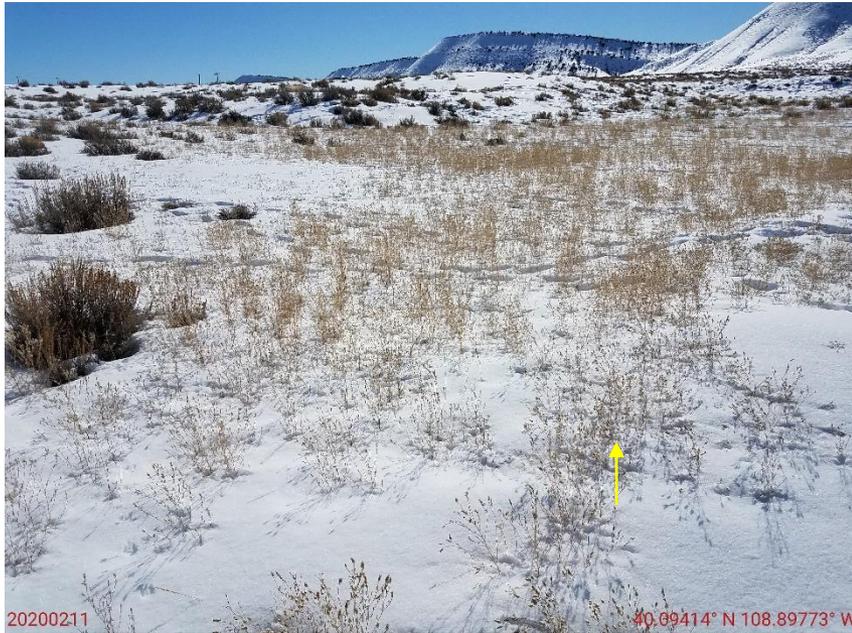
**Photo 9:** Photo taken from the North end of the Location, facing southeast. Photo shows *R. repens* has established throughout the location (dominant light brown plants, arrow for example).

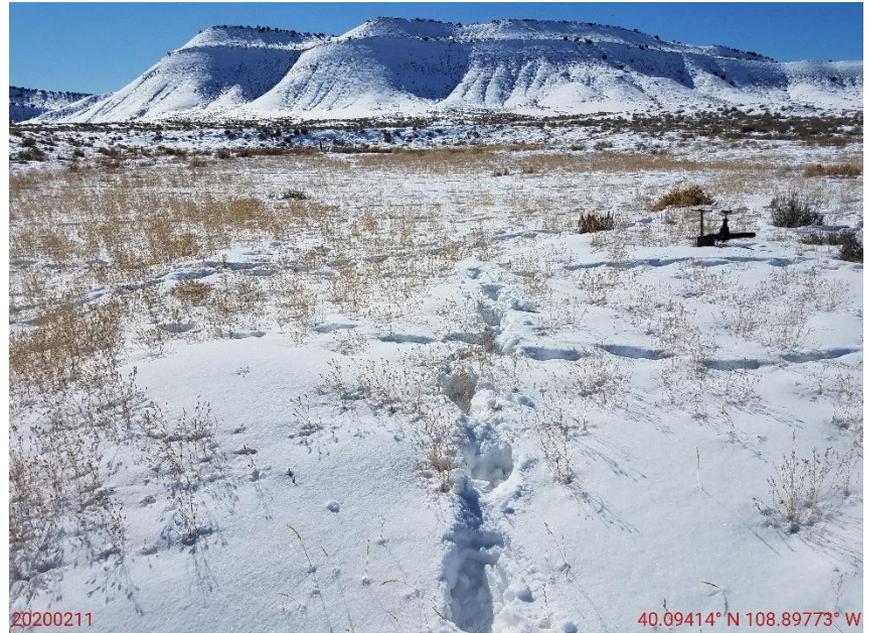
**Photo 10:** Photo taken from the North end of the Location, facing southwest. See comments under photo 9. Photo also shows pipe equipment remaining on Location, see photo 6.

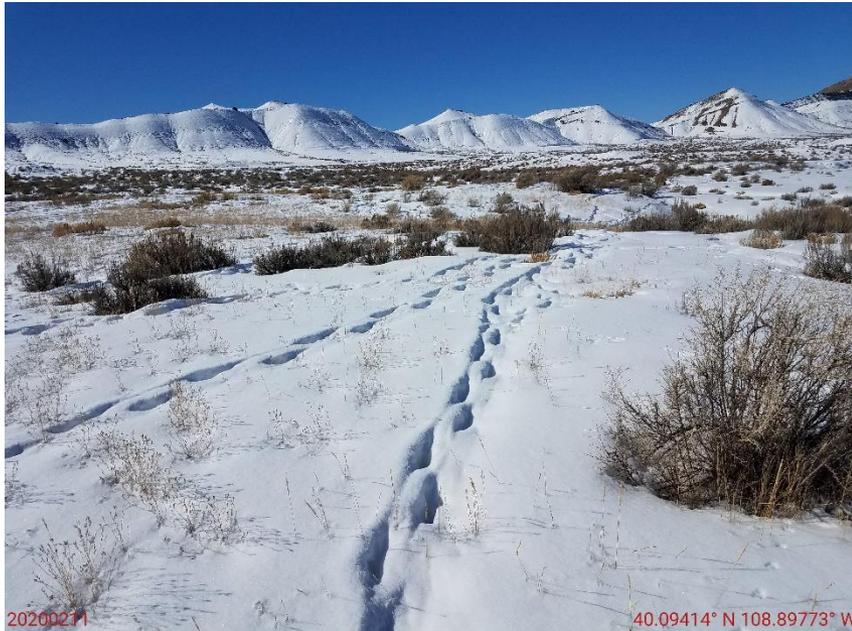
**Photo 11:** Photo taken from the North end of the Location, facing west. See comments under photo 9

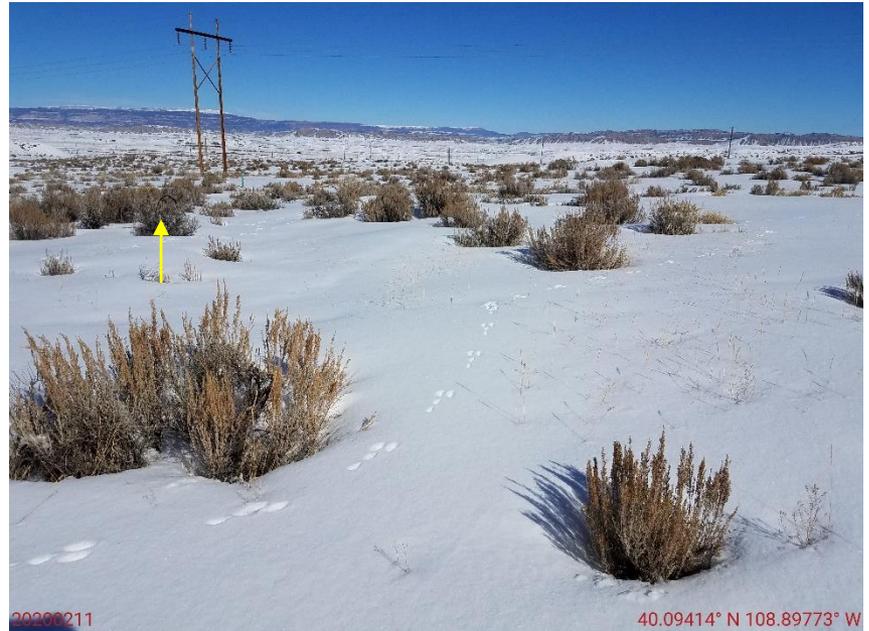
**Photo 12:** Photo taken from the North end of the Location, facing North. Photo shows populations/densities of *R. repens* significantly drops off once off the Location; Noxious weeds appear to be spreading from the Location to adjacent lands north. Photo also shows cable/wires observed on the northern areas adjacent to the Location.

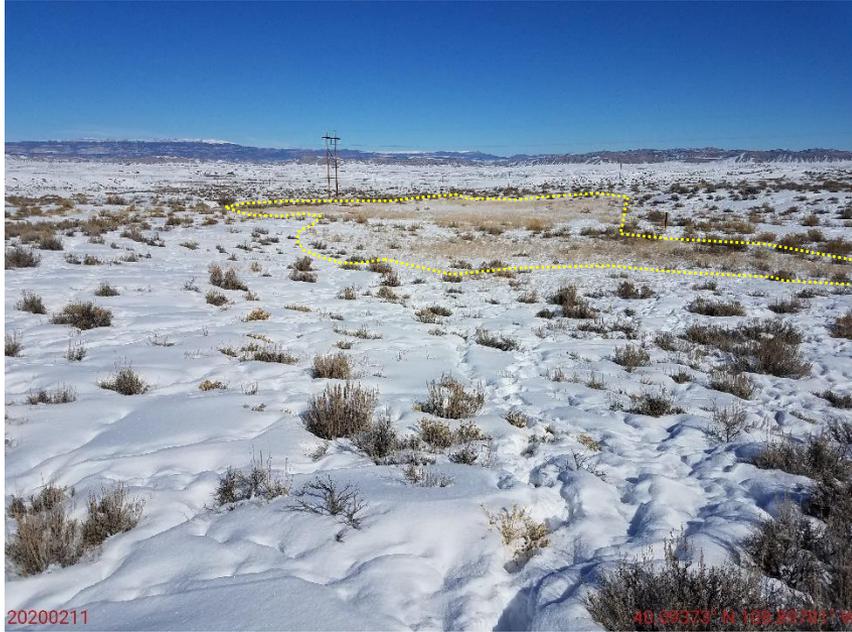
**Photo 13:** Photo taken from the southwest corner of the Location, facing northeast. Photo shows areas on the location where *R. repens* is dense (dominant light brown plants).

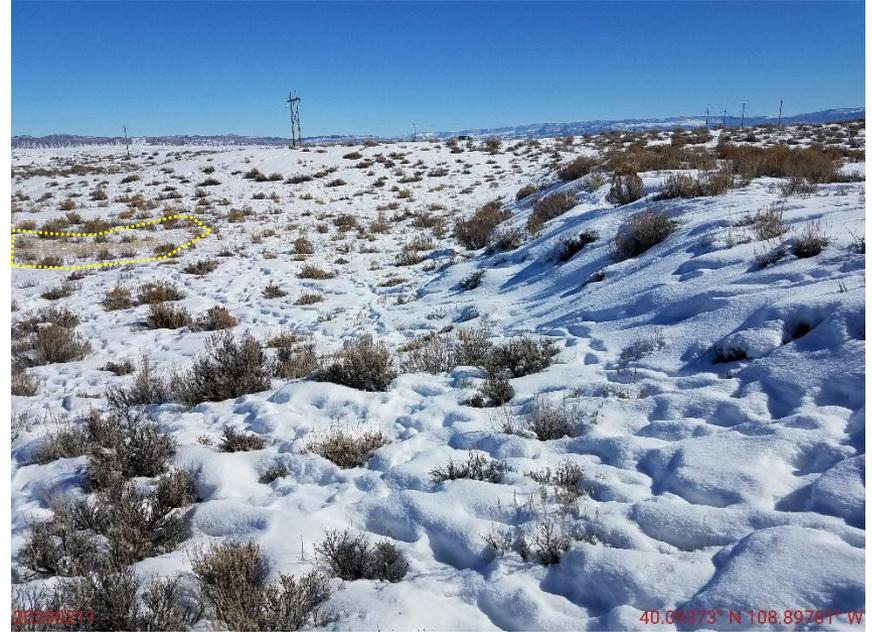
**Photo 14:** Photo taken from the southwest corner of the Location, facing northeast. See comments under photo 13.

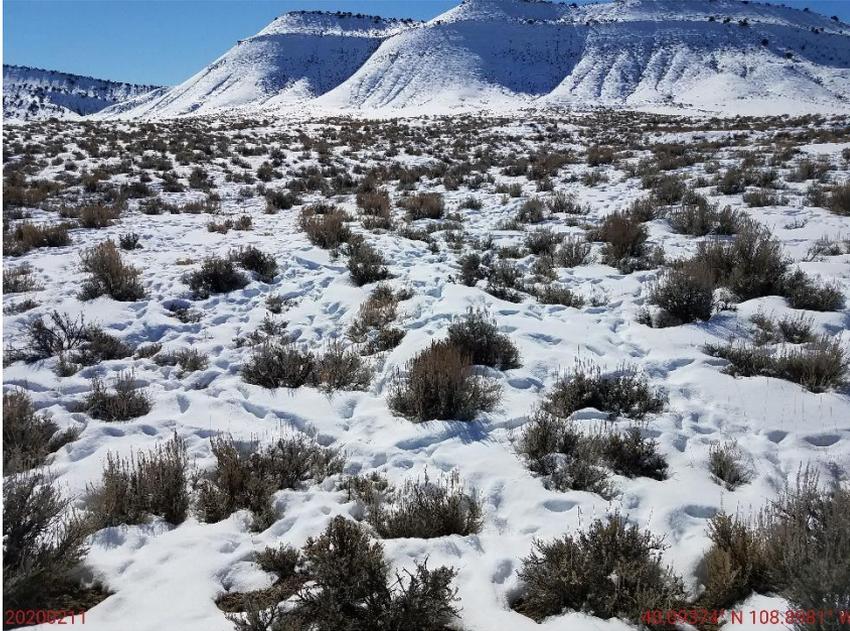
**Photo 15:** Photo taken from the south end of the Location, facing south. Photo shows *R. repens* was not observed within the reference areas to the south of the Location; Noxious weeds appear to be spreading from the Location to adjacent lands

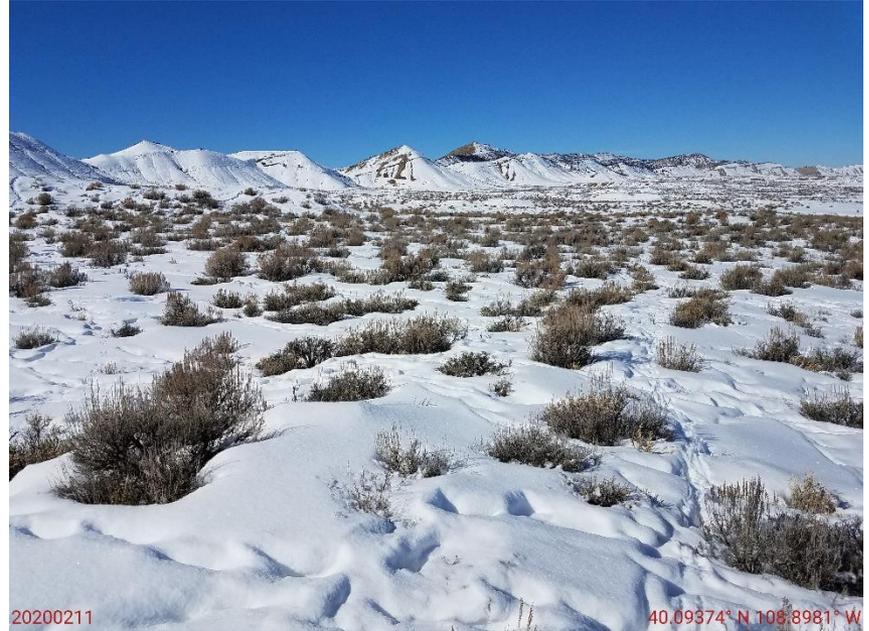
**Photo 16:** Photo taken from the west end of the Location, facing west. Photo shows *R. repens* was not observed within the reference areas to the south of the Location; Noxious weeds appear to be spreading from the Location to adjacent lands

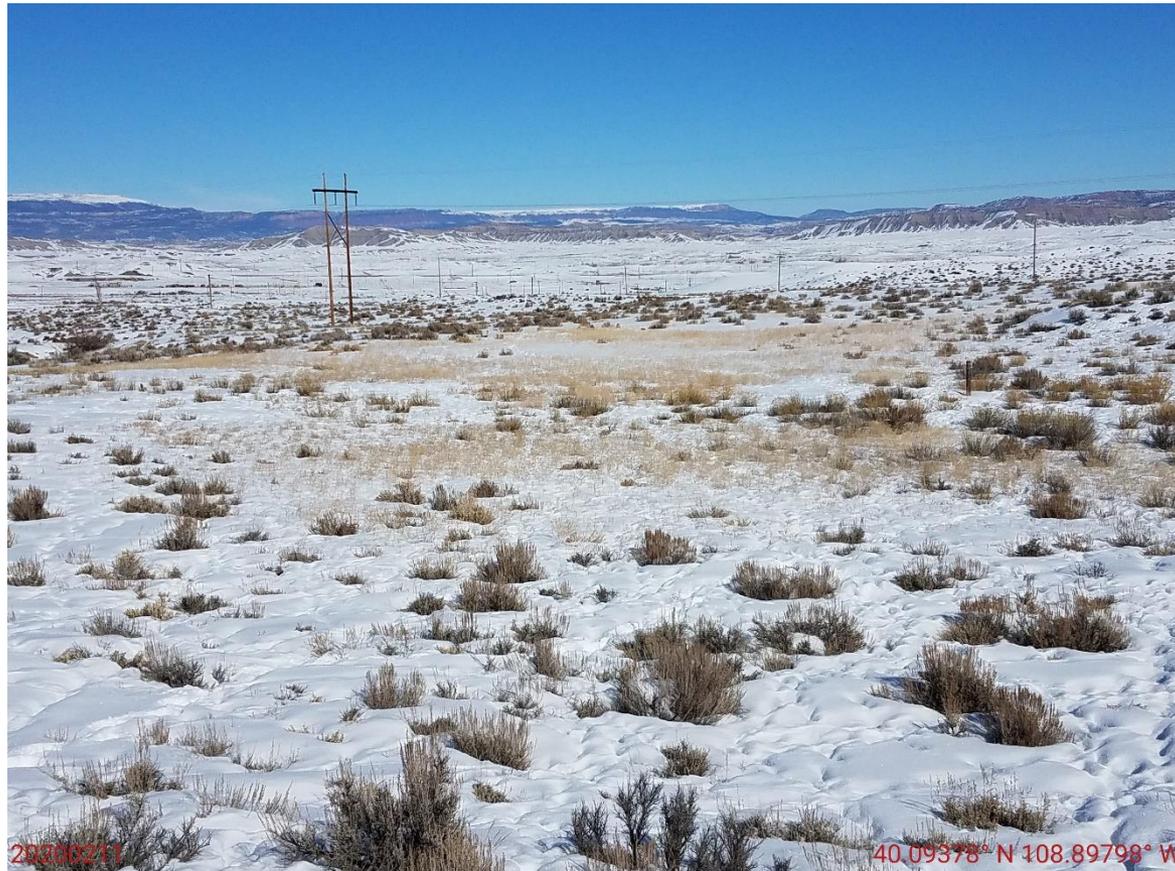
**Photo 17:** Photo taken from the south end of the Location, facing northeast. Photo shows areas on the location where *R. repens* is dense (dominant light brown plants).
