Inspection Photos  
Operator: BP America  
Location #: 326323  
Date: 1-31-2020

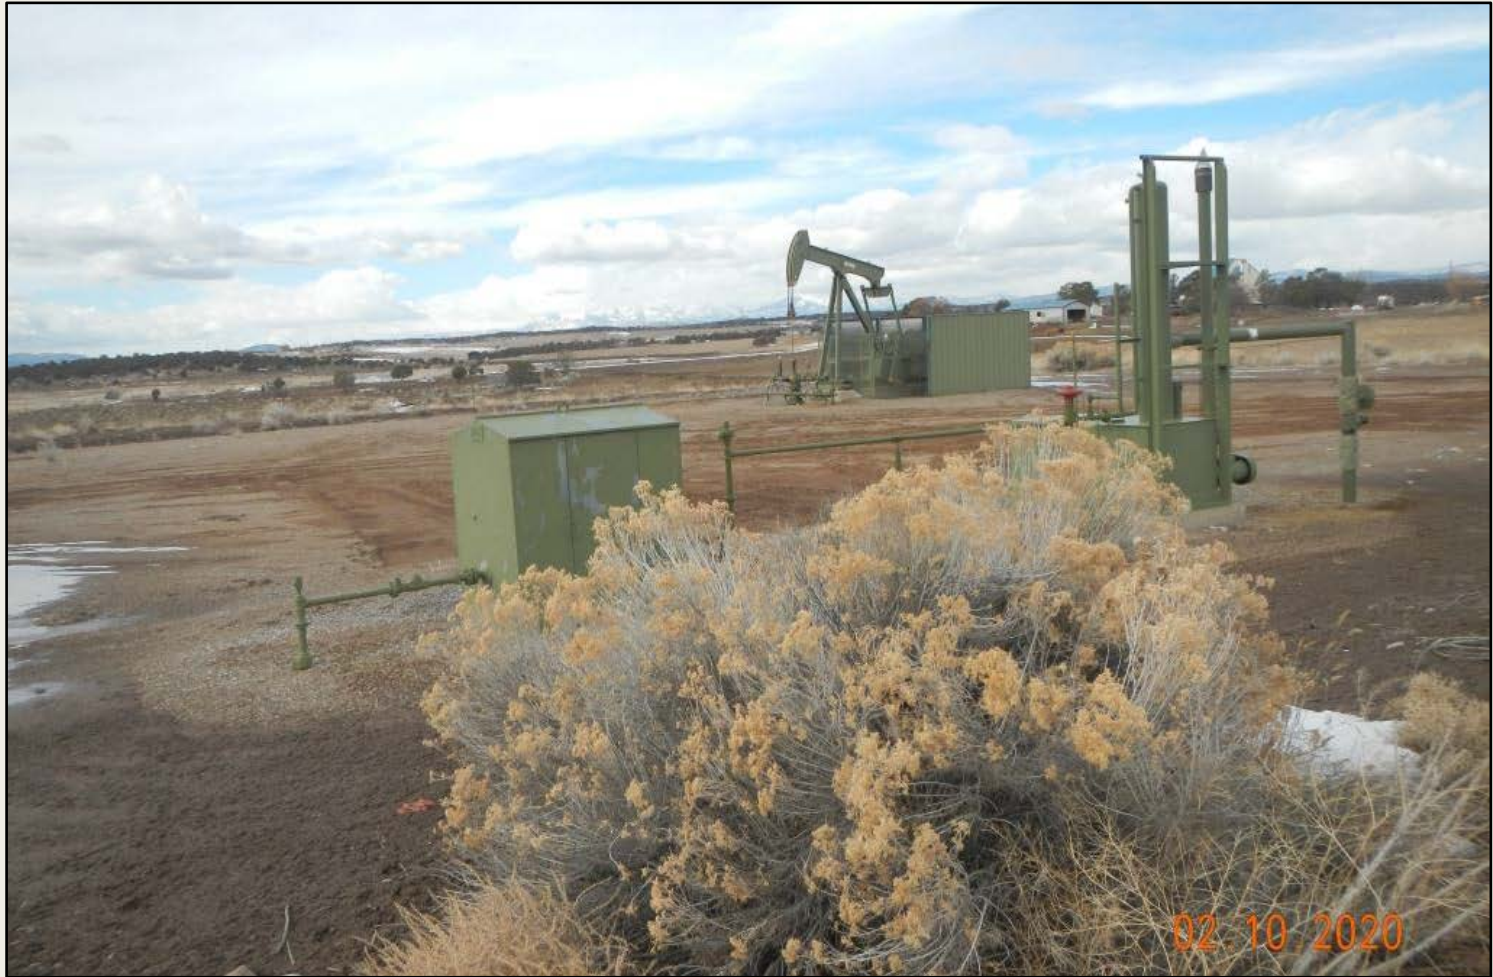
Photo 1. View of the project area from the southeastern corner facing center.

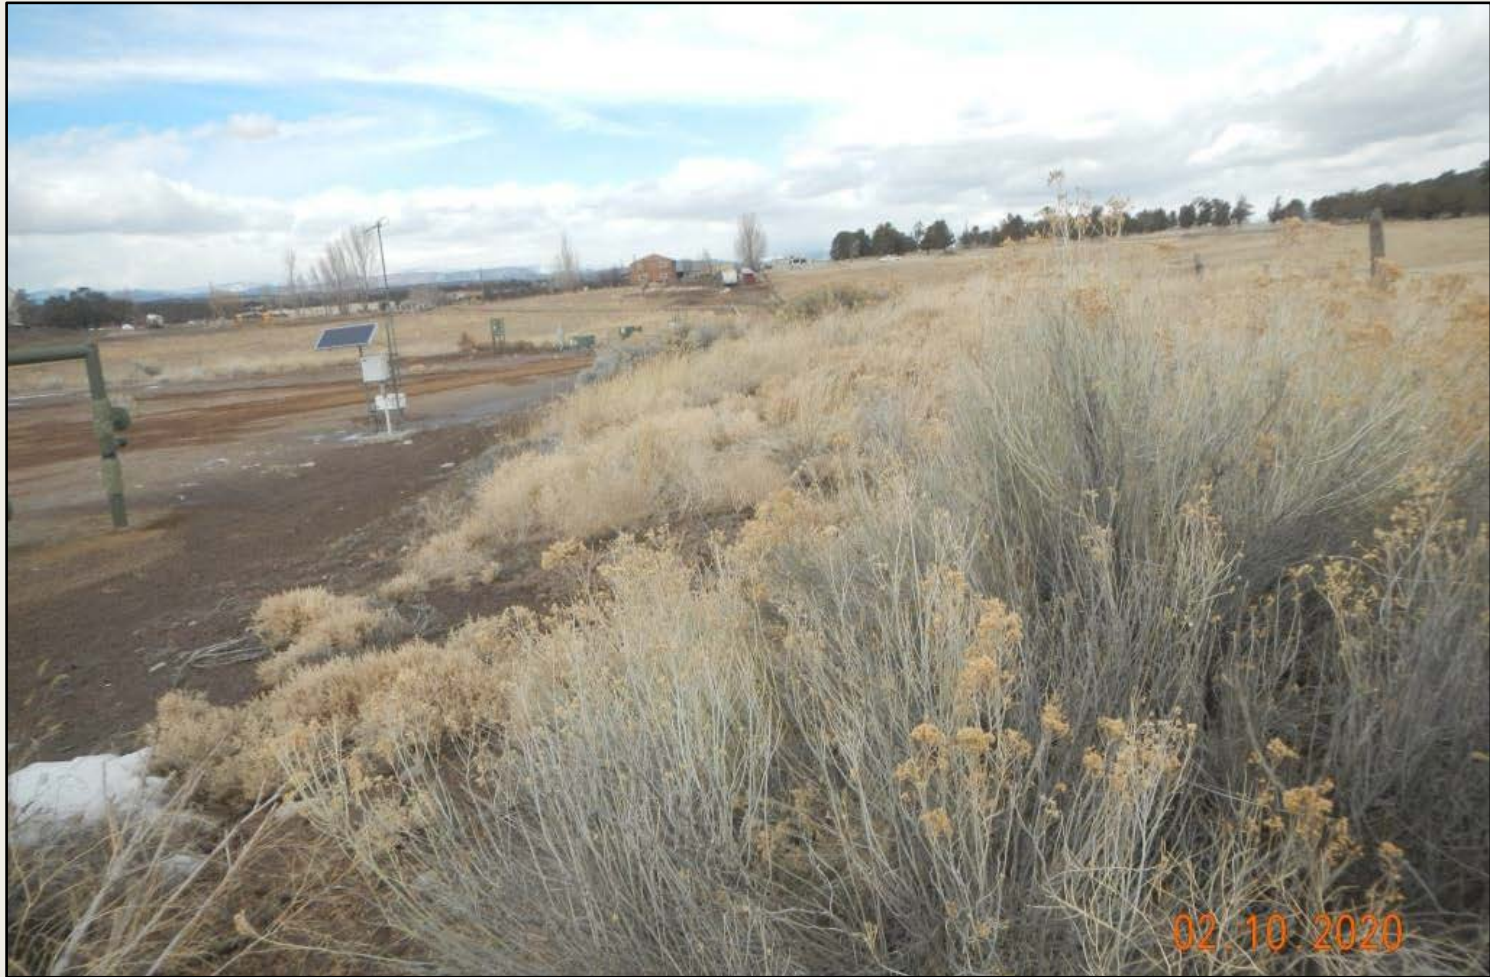
Photo 2. View of the eastern project area from the southeastern corner facing northward. Revegetation is progressing in portions of the outer revegetation areas with rubber rabbitbrush and western wheatgrass. However, portions of the project area remain with poor revegetation and require spot seeding.

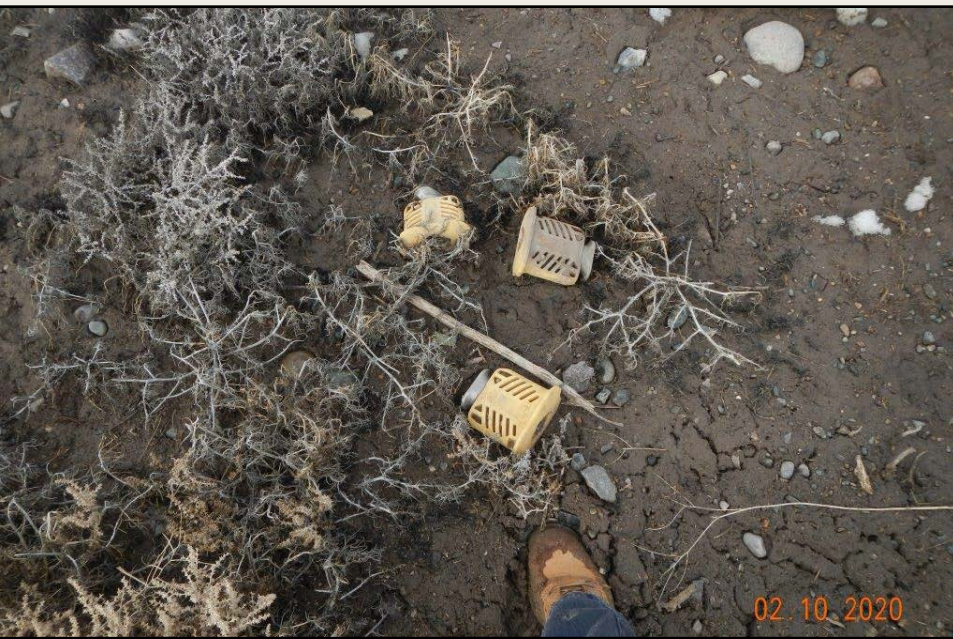
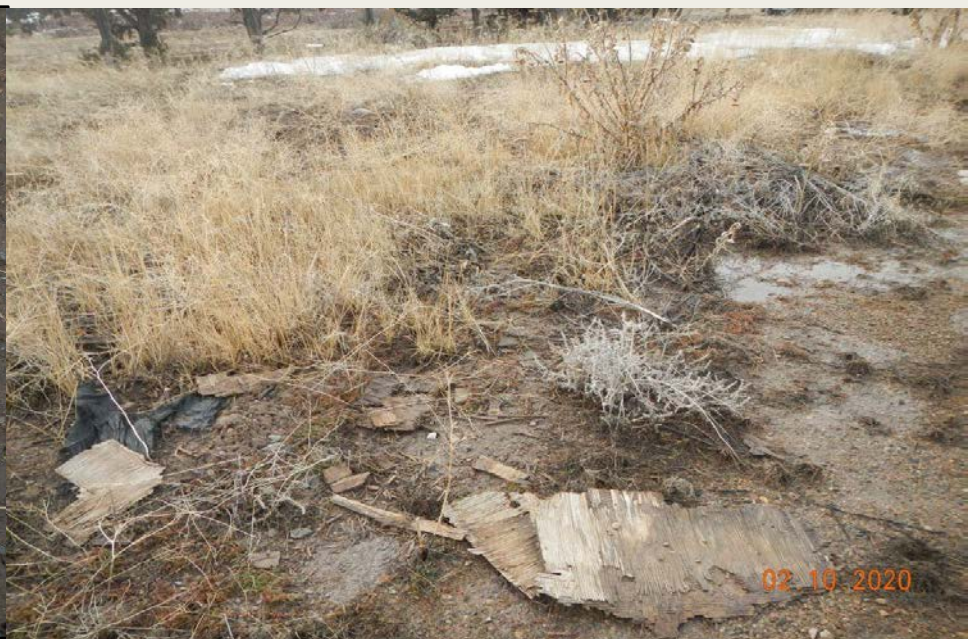
Photo 3. View of wood and other debris identified within the project area.

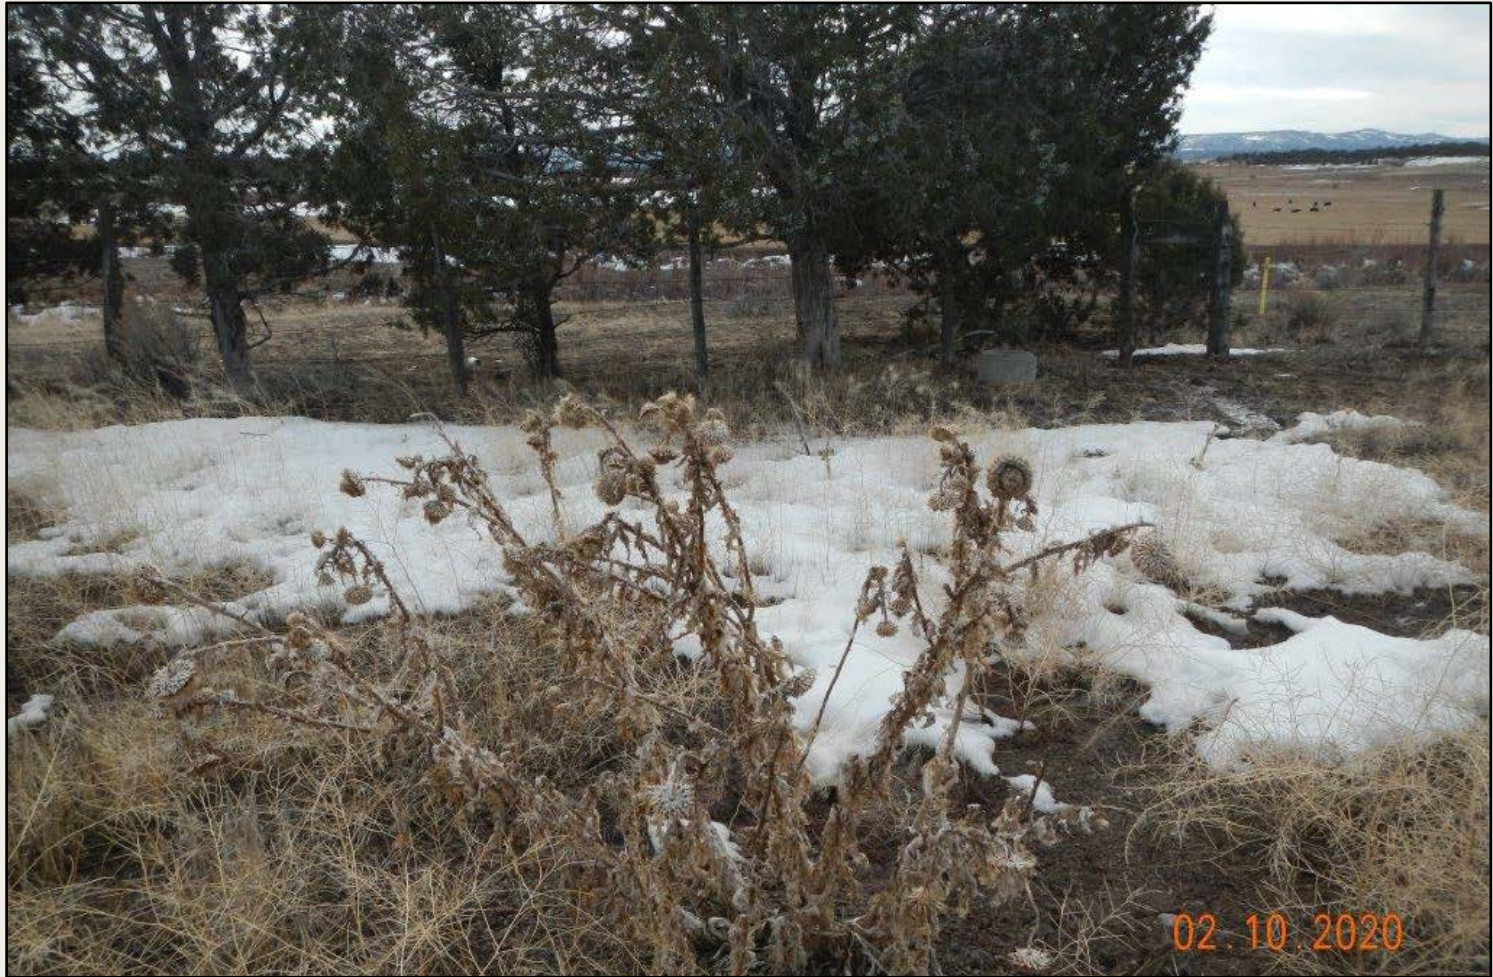
Photo 4. View of musk thistles within the southern project area.

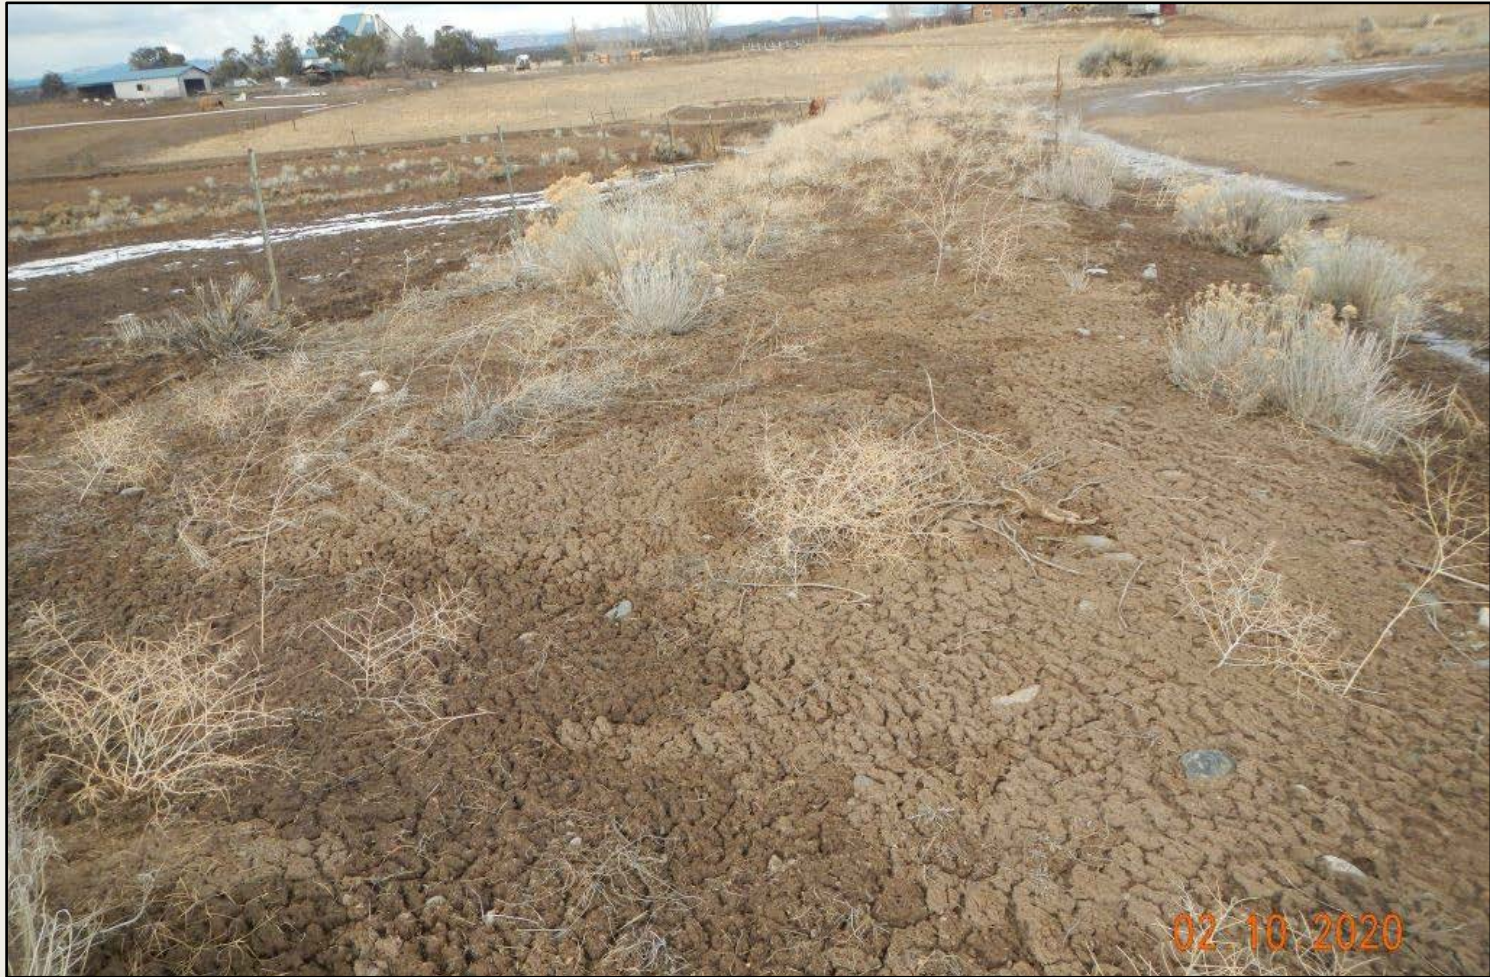
Photo 5. View of the western project area from the southwestern corner facing northward. Significant areas of bare soil remain and need to be stabilized with perennial vegetation.

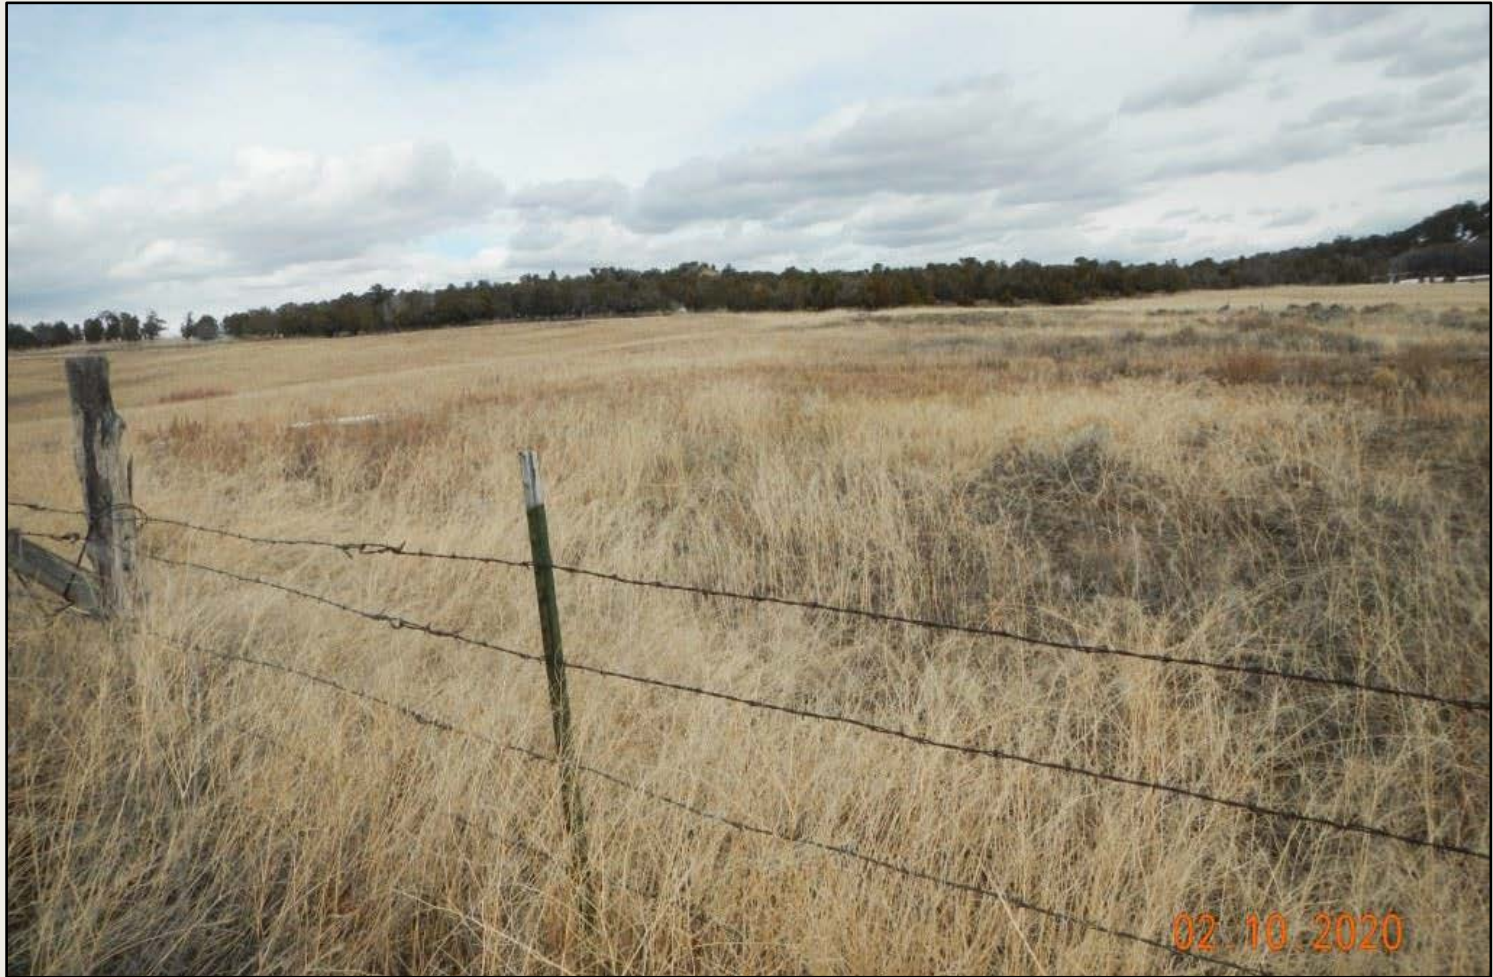
Photo 6. View of the reference area, comprised of pasture in grazed/dormant vegetative condition.
