Final Reclamation and Stormwater Inspection

Operator: J W OPERATING COMPANY - 44350

Location ID: 312247

Inspection Document #: 697501084

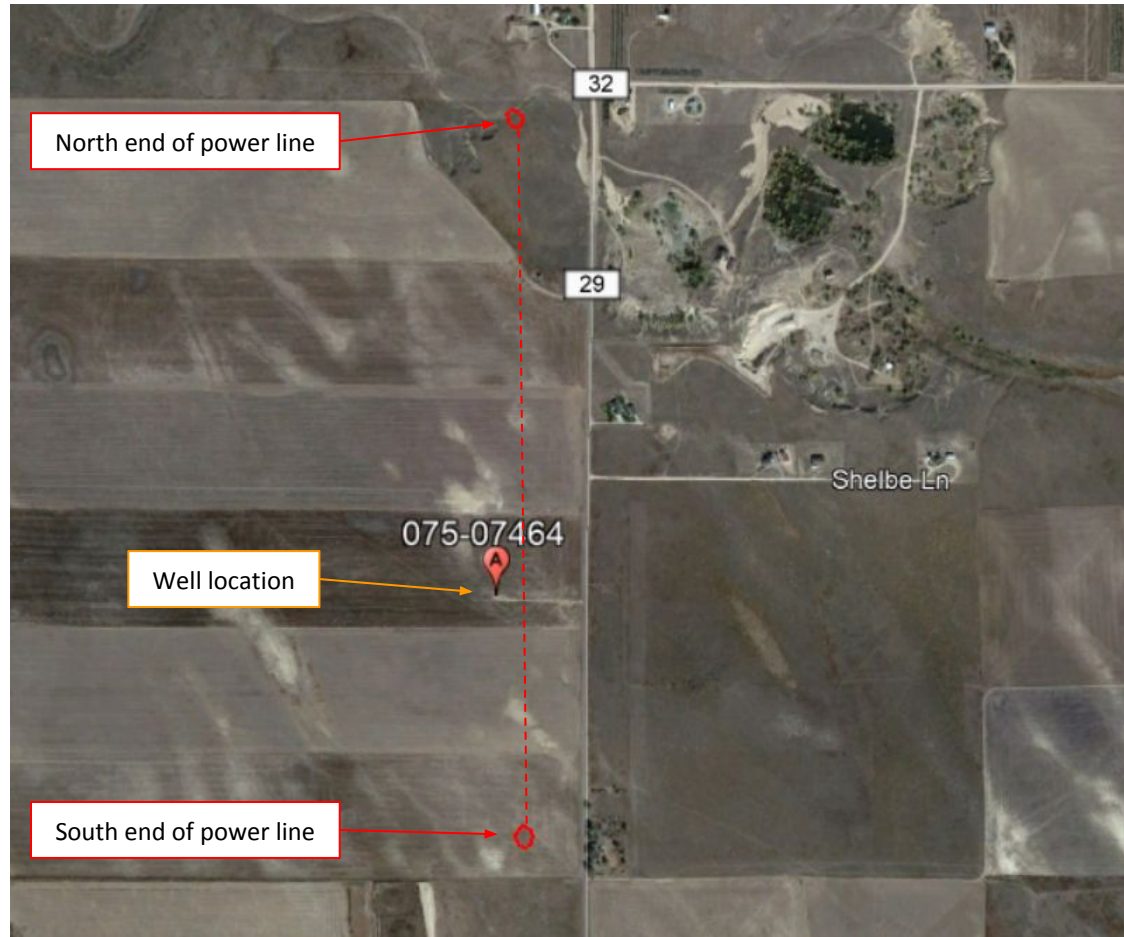
Photo 1. Google Earth aerial imagery taken 10/15/2015 illustrating a power line within Township 8 North, Range 53 West, Section 20. Photo illustrates the power line does not terminate at the well location. See Photo 2 for a close up of the well location.

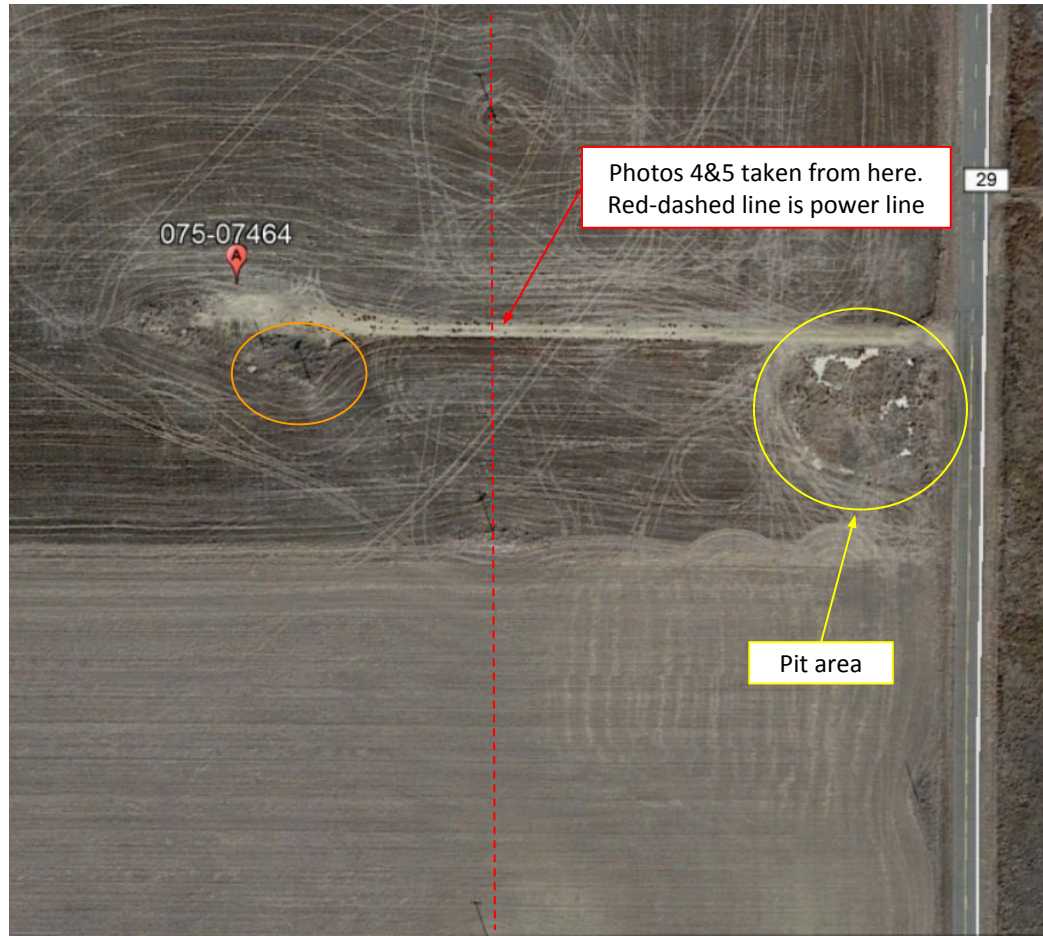
Photo 2. Google Earth aerial imagery illustrates the power line does not terminate at the well location. Also, there appeared to be one electrical power pole at the well location (orange circle) which has been removed.

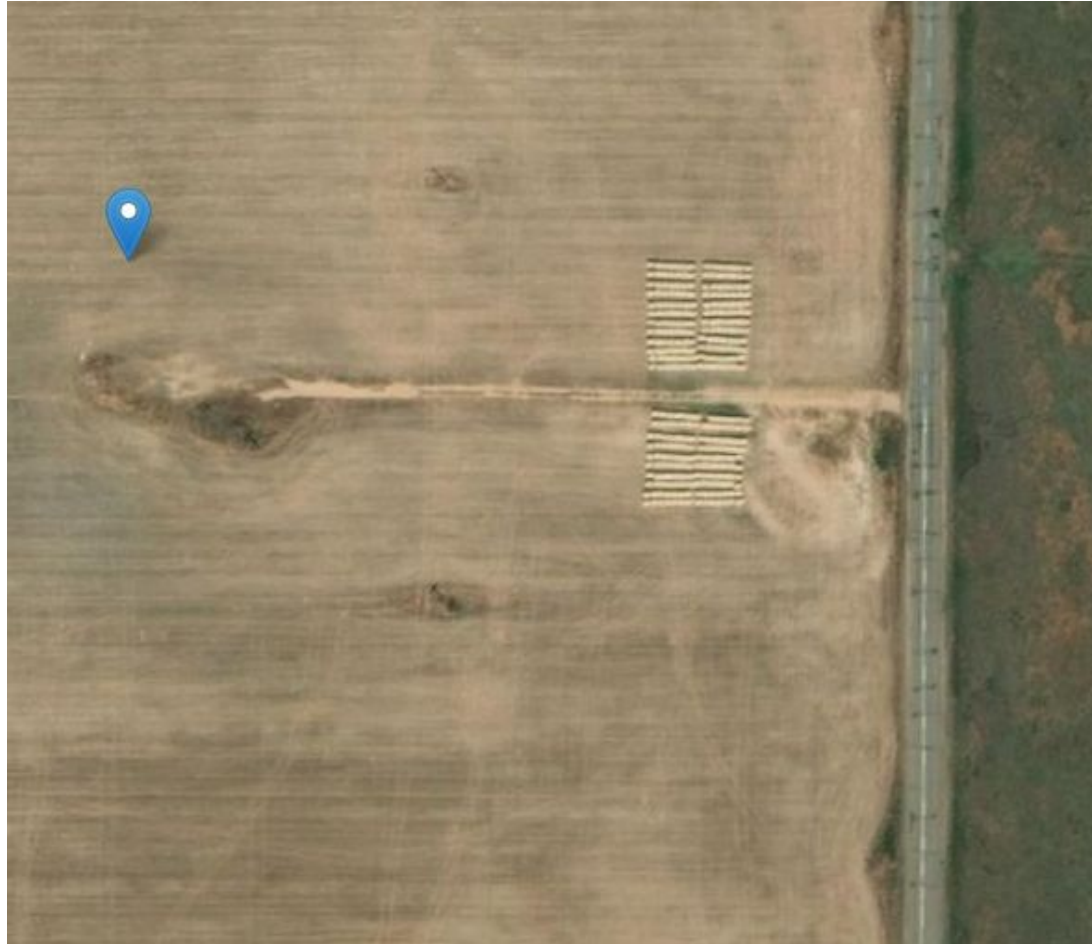
Photo 3. Earth Explorer aerial imagery from 2019 further illustrates the pit area/tank battery, well location access road and well location do not meet Rule 1004 standards which do not appear to be reflective of reference crop areas.

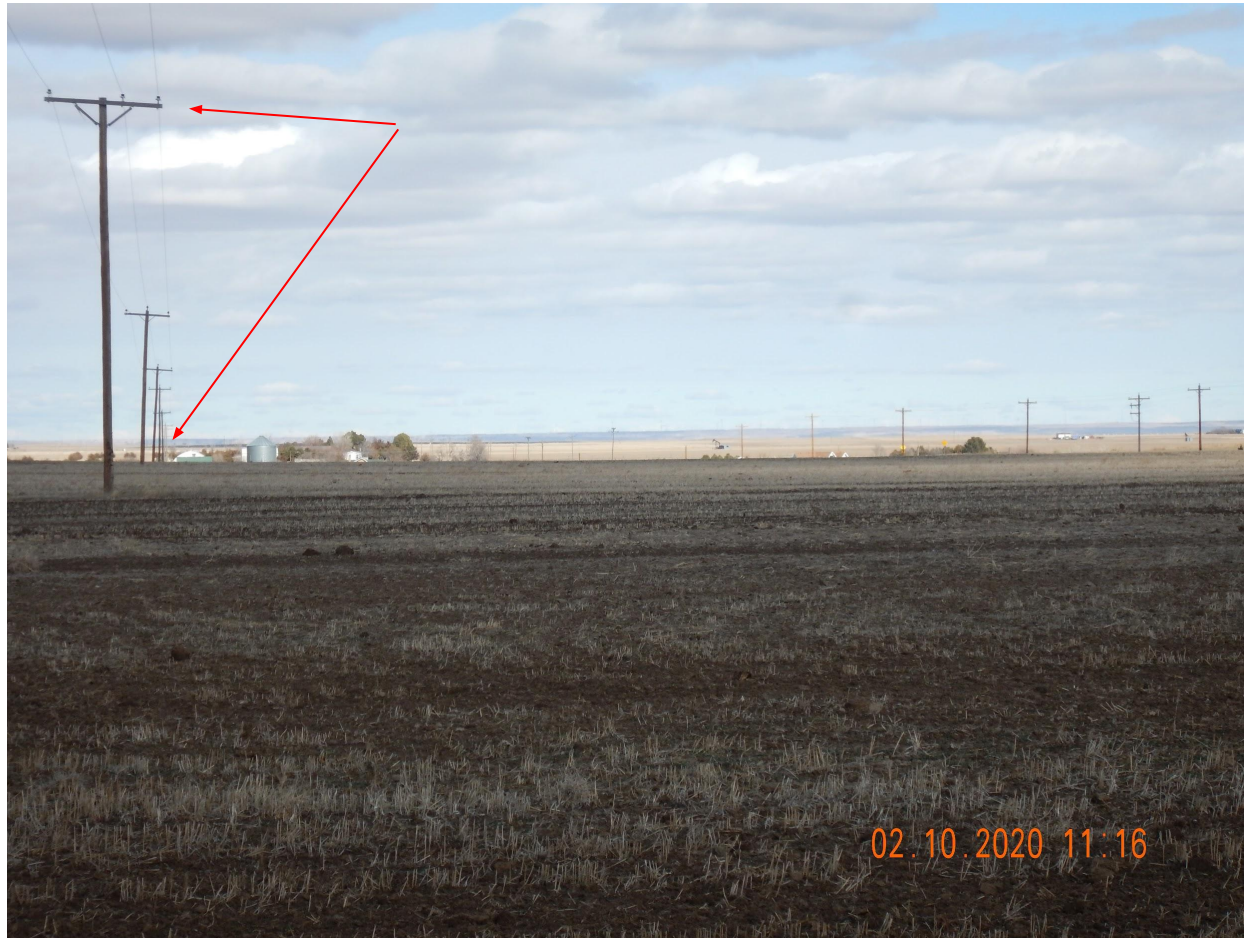
Photo 4. Photo taken from a portion of the former well location access road, facing North. Photo illustrates the power line continuing to the north, not terminating at the well location.

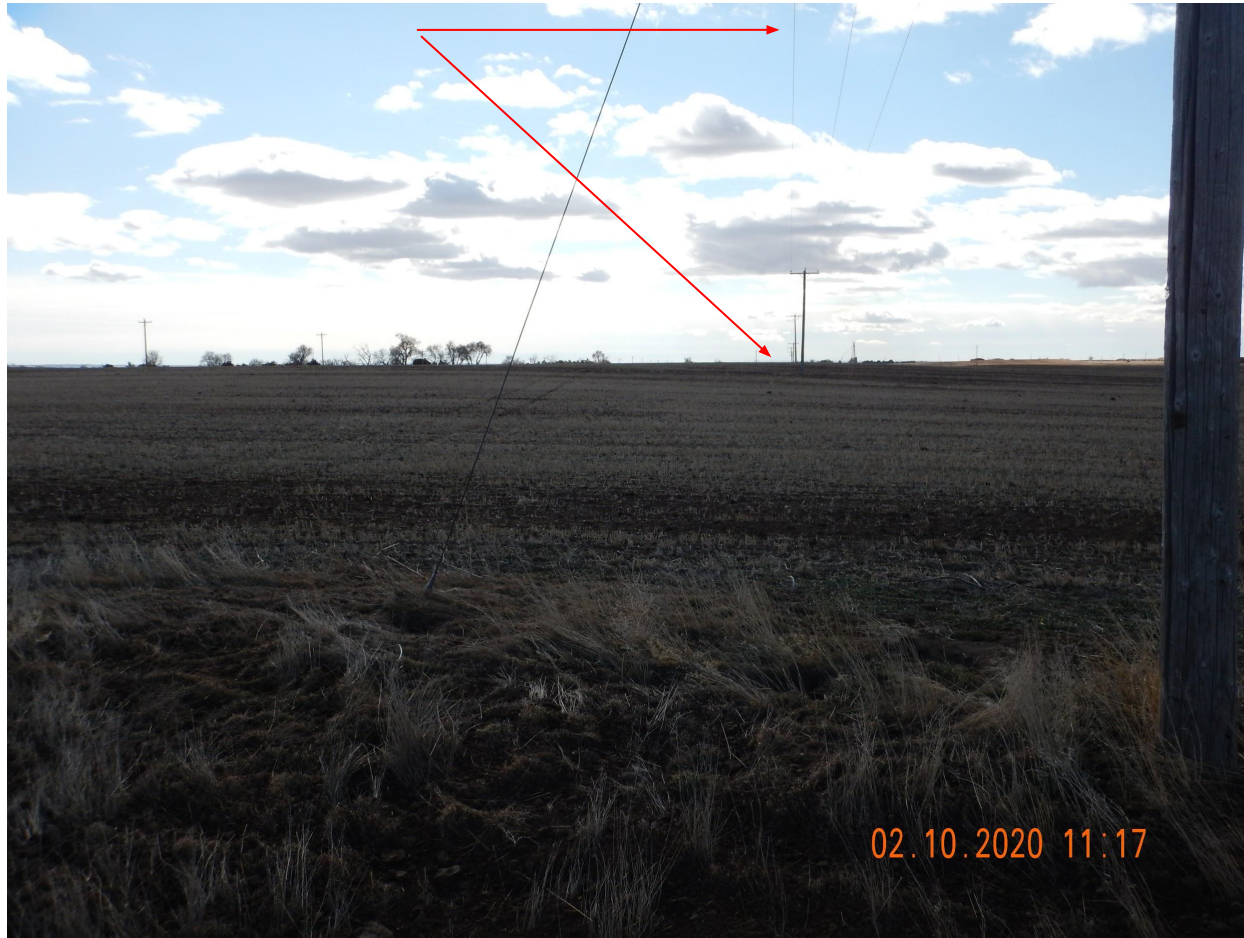
Photo 5. Photo taken from a portion of the former well location access road, facing South. Photo illustrates the power line continuing to the south, not terminating at the well location.

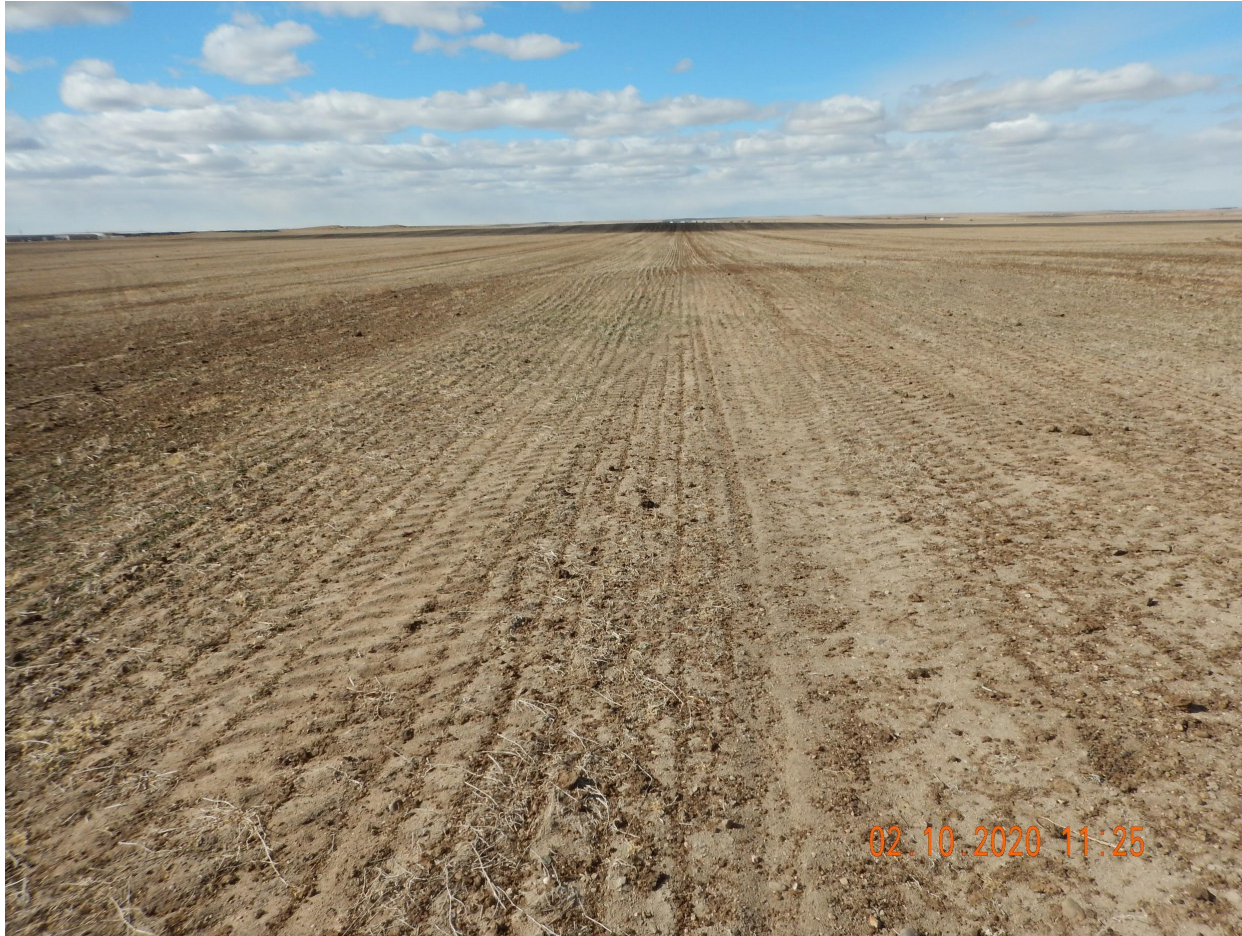
Photo 6. Photo taken from the former well location, facing West. Photo illustrates the one electrical power pole shown in Photo 2 (orange circle) has been removed.

Note: Reference crop areas appear to be planted in winter wheat. Germination of winter wheat was not observed within portions of the tank battery, pit area, portions of the well location access road and well location.

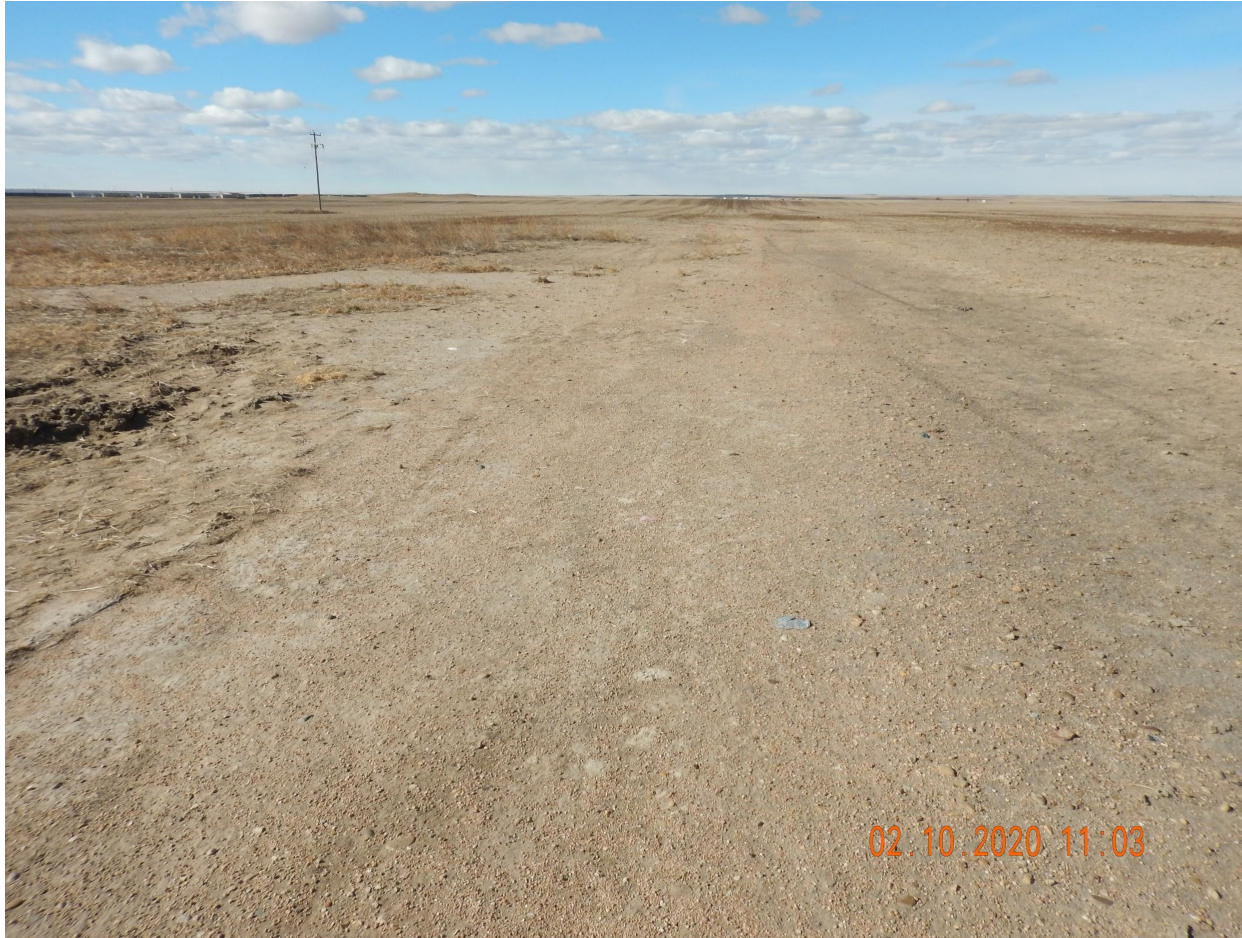
Photo 7. Photo taken from the former tank battery, facing West. Photo illustrates gravel remains along portions of the tank battery location and portions of the well location access road.

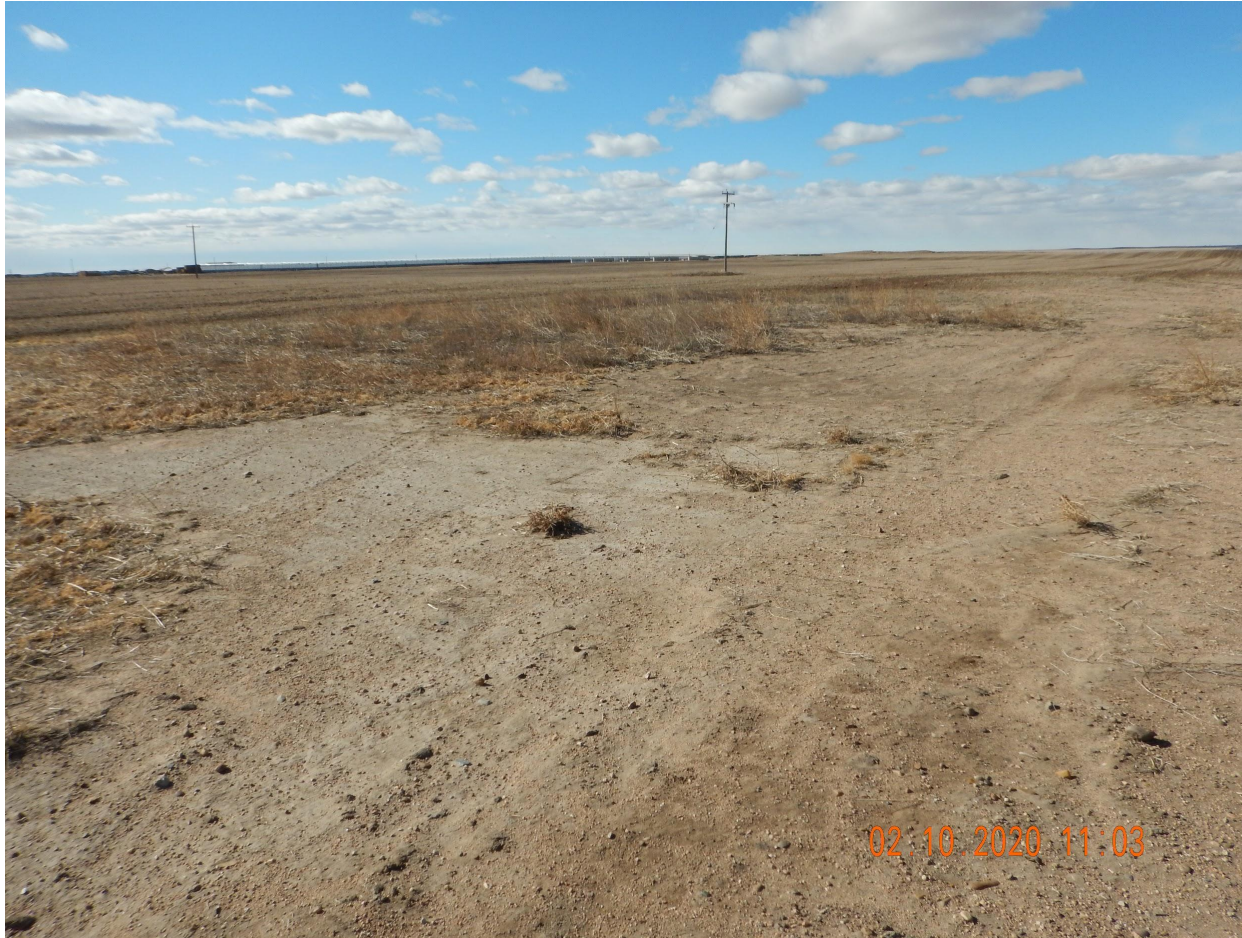
Photo 8. Photo taken from the former tank battery, facing Southwest. This appears to be where a former pit (#116196) was located- see Photo 2. Germination of winter wheat was not observed within this portion.

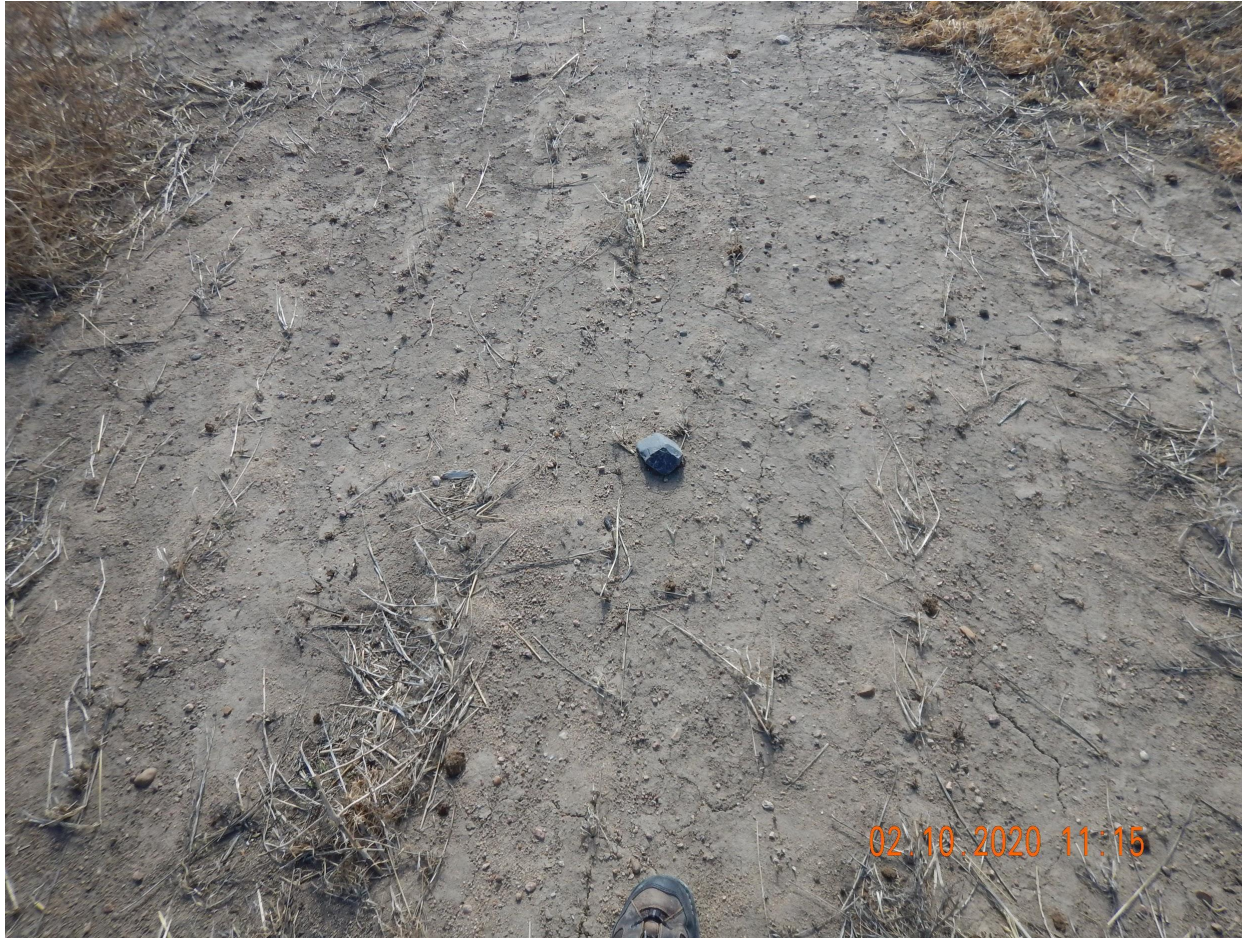
Photo 9. Photo taken from the former tank battery/pit area. Photo illustrates drill rows attempting to seed into a portion of the former tank battery/pit area with no germination success.

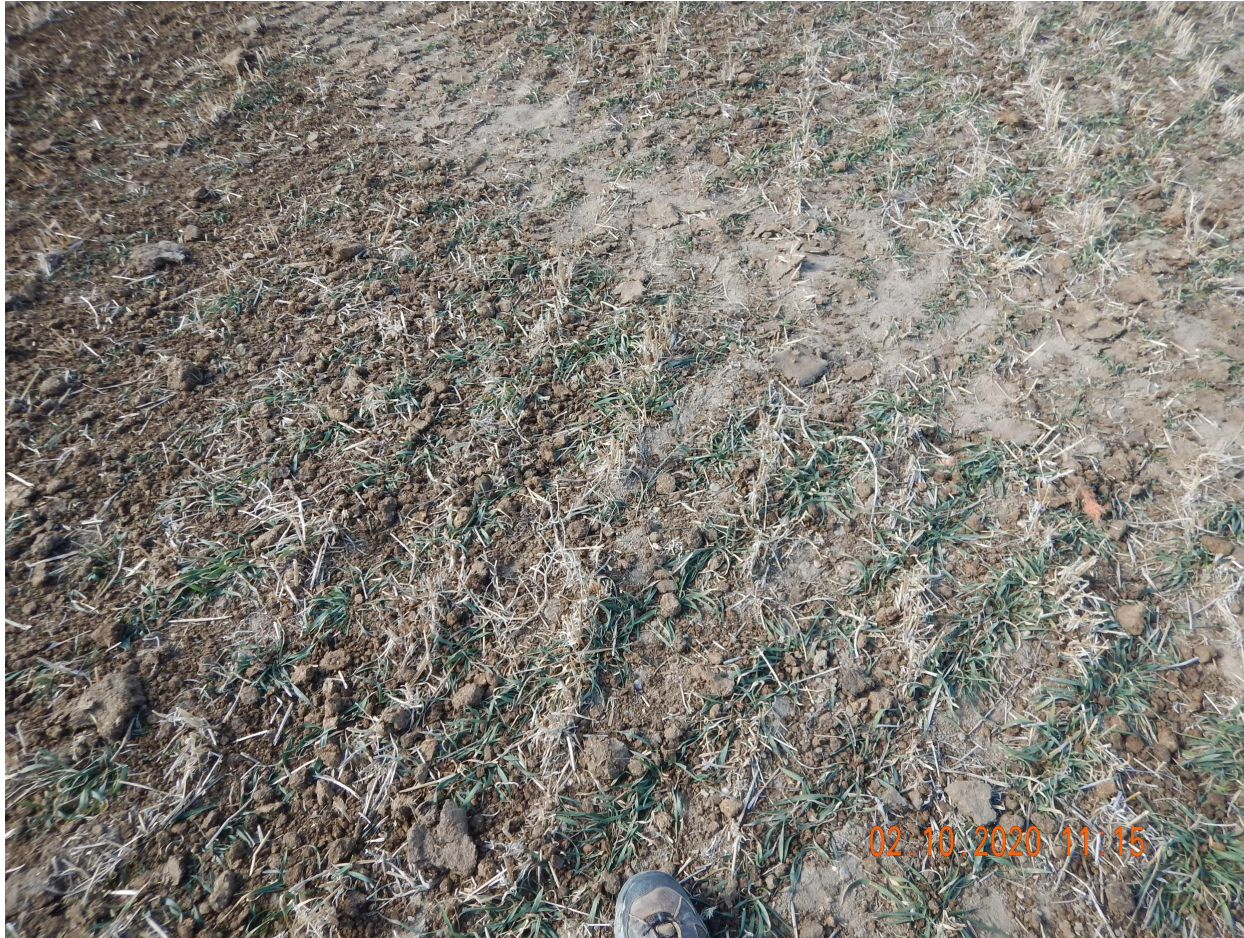
Photo 10. Reference crop photo taken south of the former tank battery. Photo illustrates drill rows with successful germination of winter wheat.

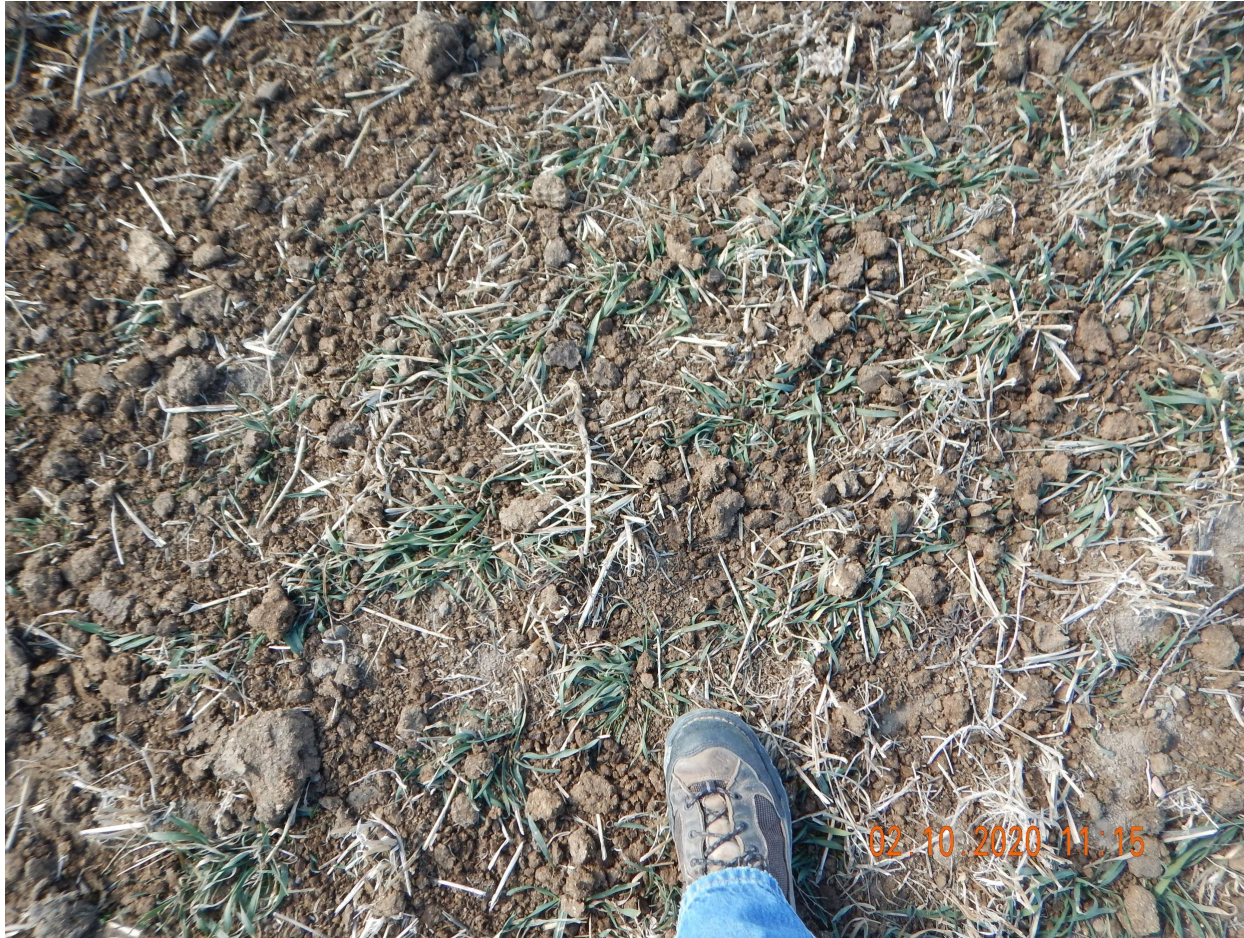
Photo 11. Close up reference crop photo taken south of the former tank battery.
