Inspection Photos

API: 071-07593

Operator: EVERGREEN NATURAL RESOURCES

Inspection Date: 2/14/2020

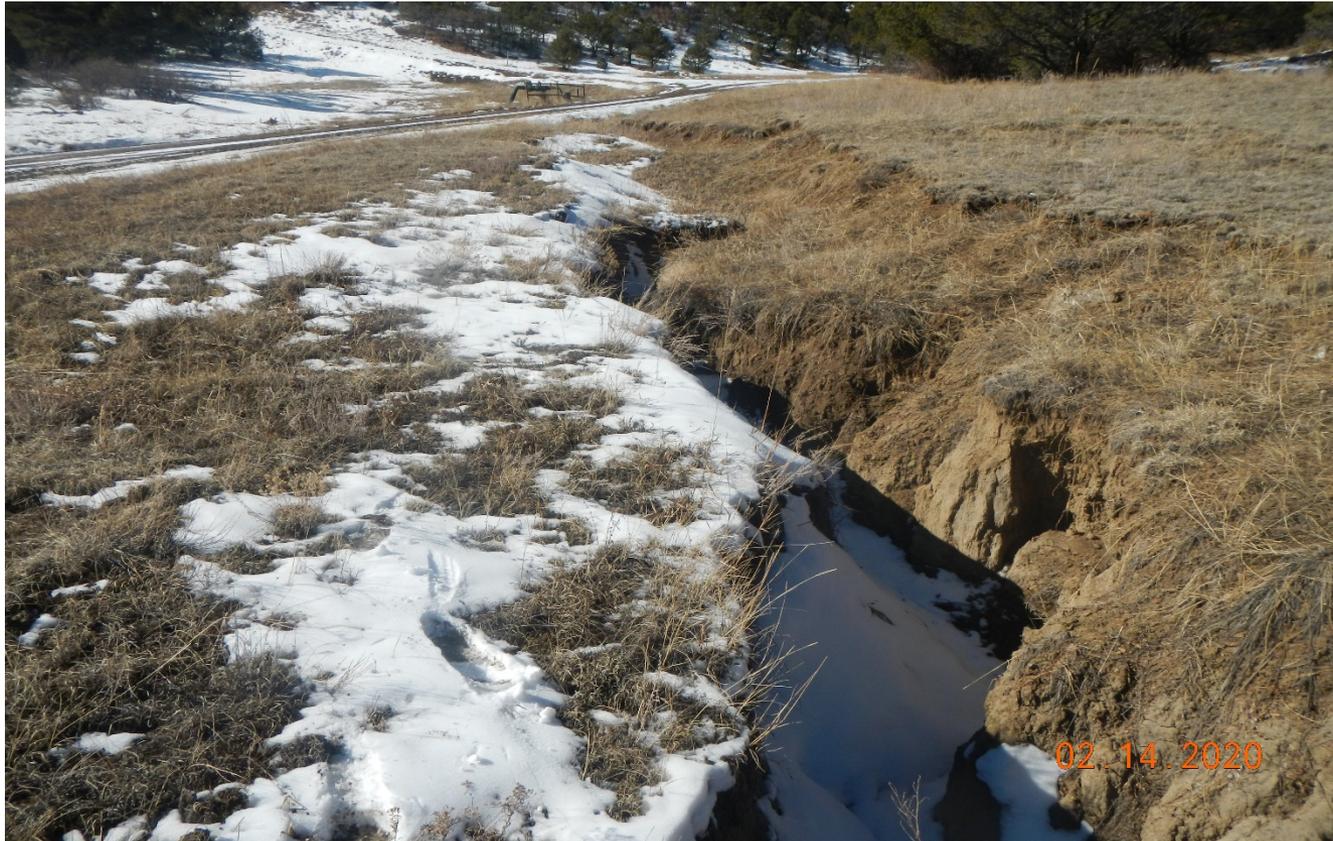
Photo 1. There a deep erosion channel along the main access road from stormwater runoff from the road at Lat/Long:37.14482,-104.86800. This area needs to be repaired and reclaimed.

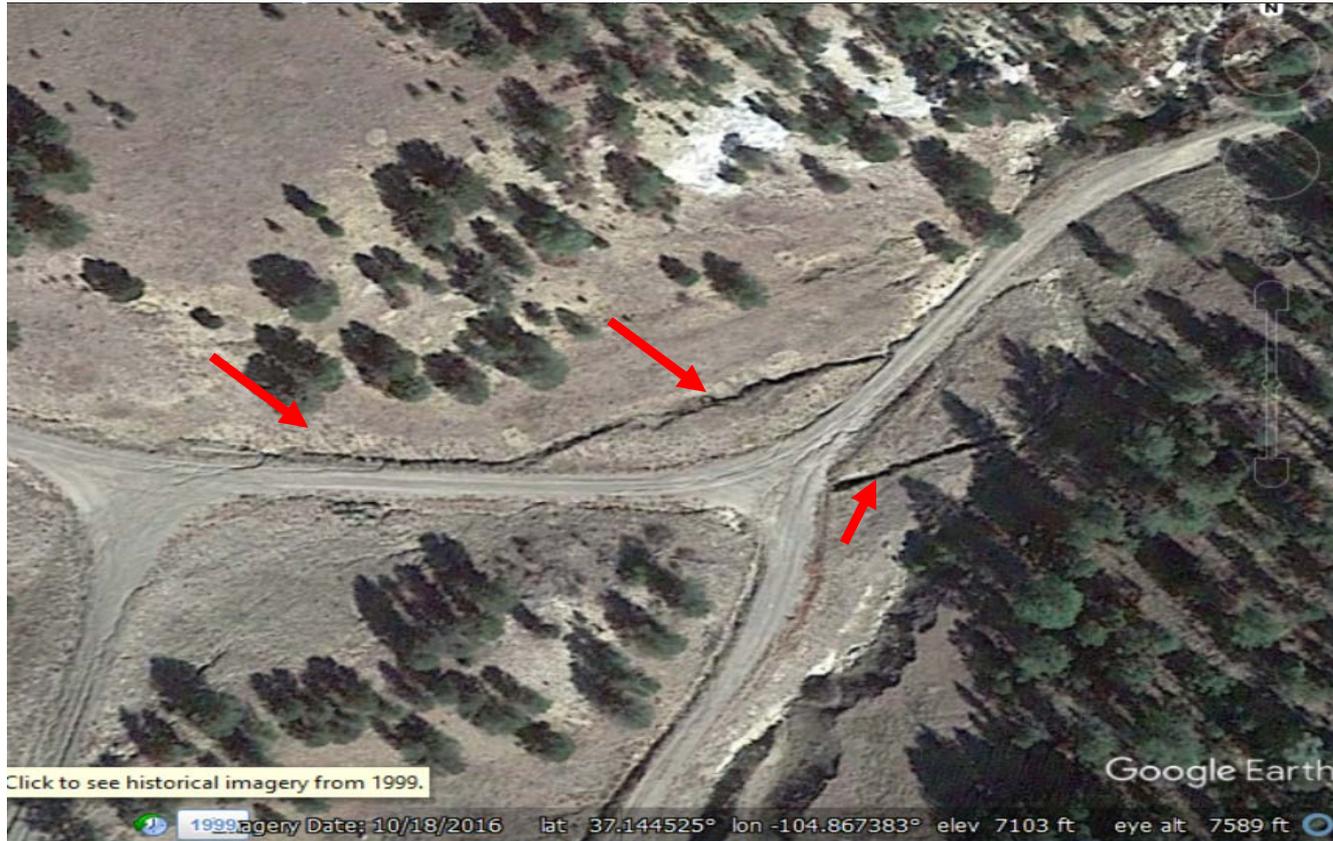
Photo 2. Aerial image shows erosion along the road identified in the previous photo.

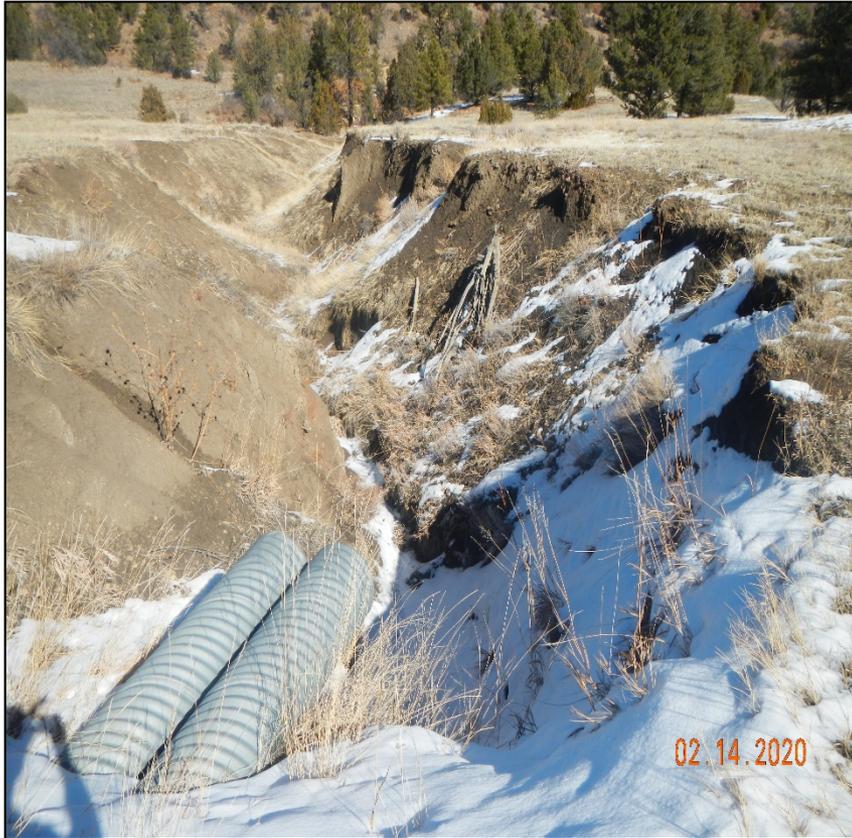
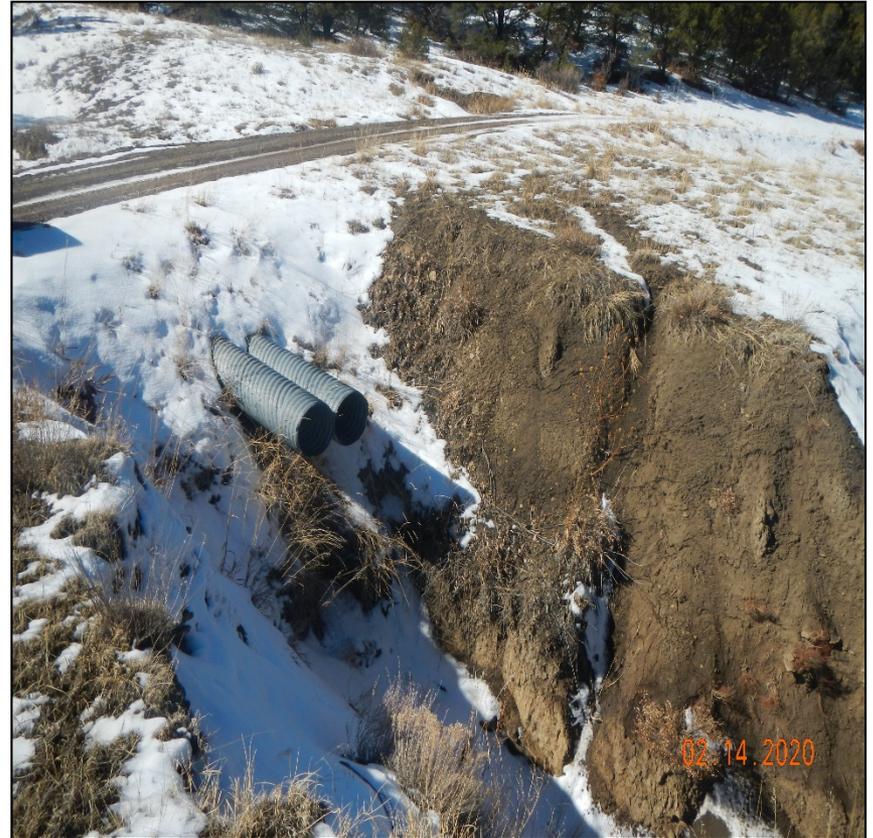
Photo 3. The stormwater outlet from this culvert is contributing to erosion of this gully.
Lat/Long:37.14492,-104.86948.

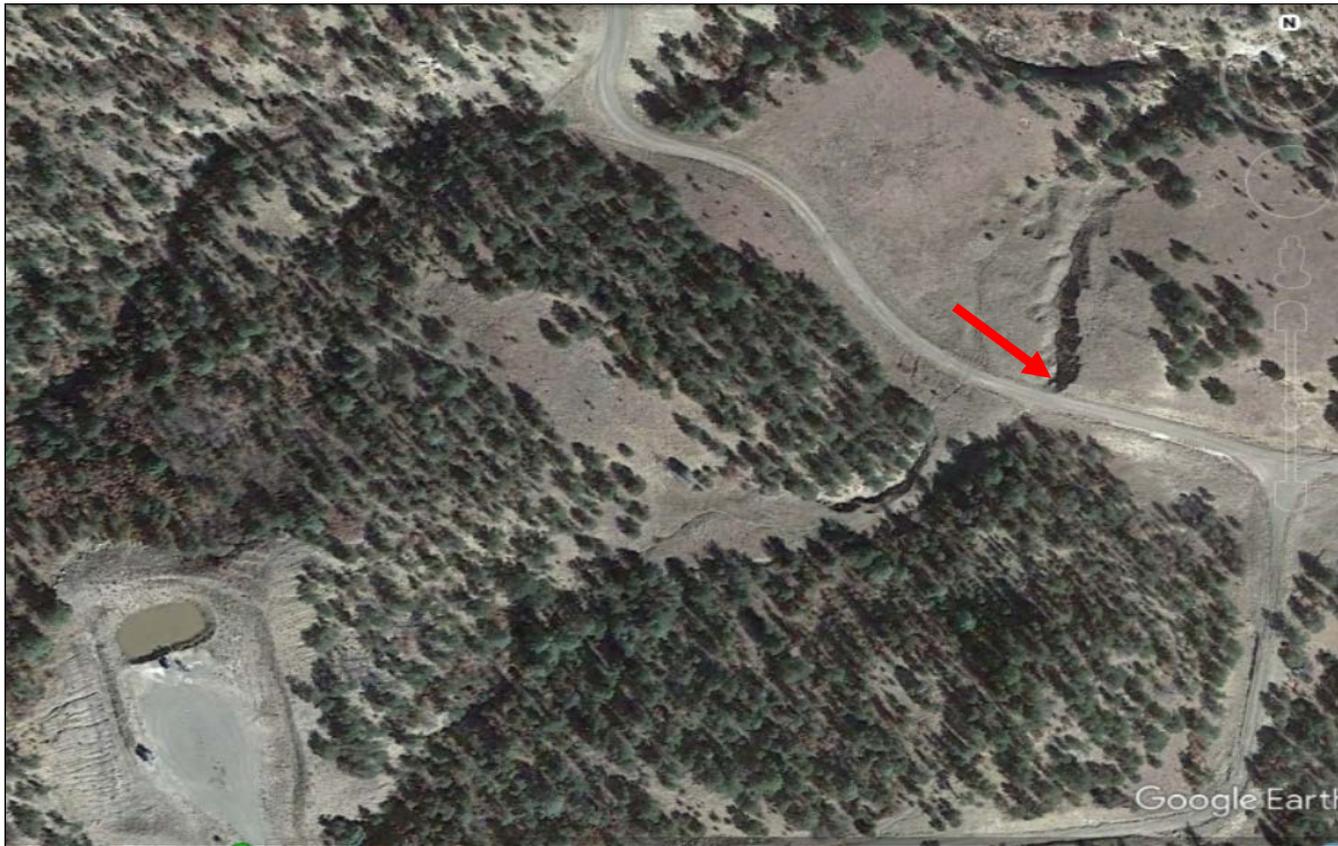
Photo 4. Aerial image shows erosion identified in the previous photo at red arrow. It appears there is stormwater runoff from the Crazy Woman 32-27 location contributing to erosion.

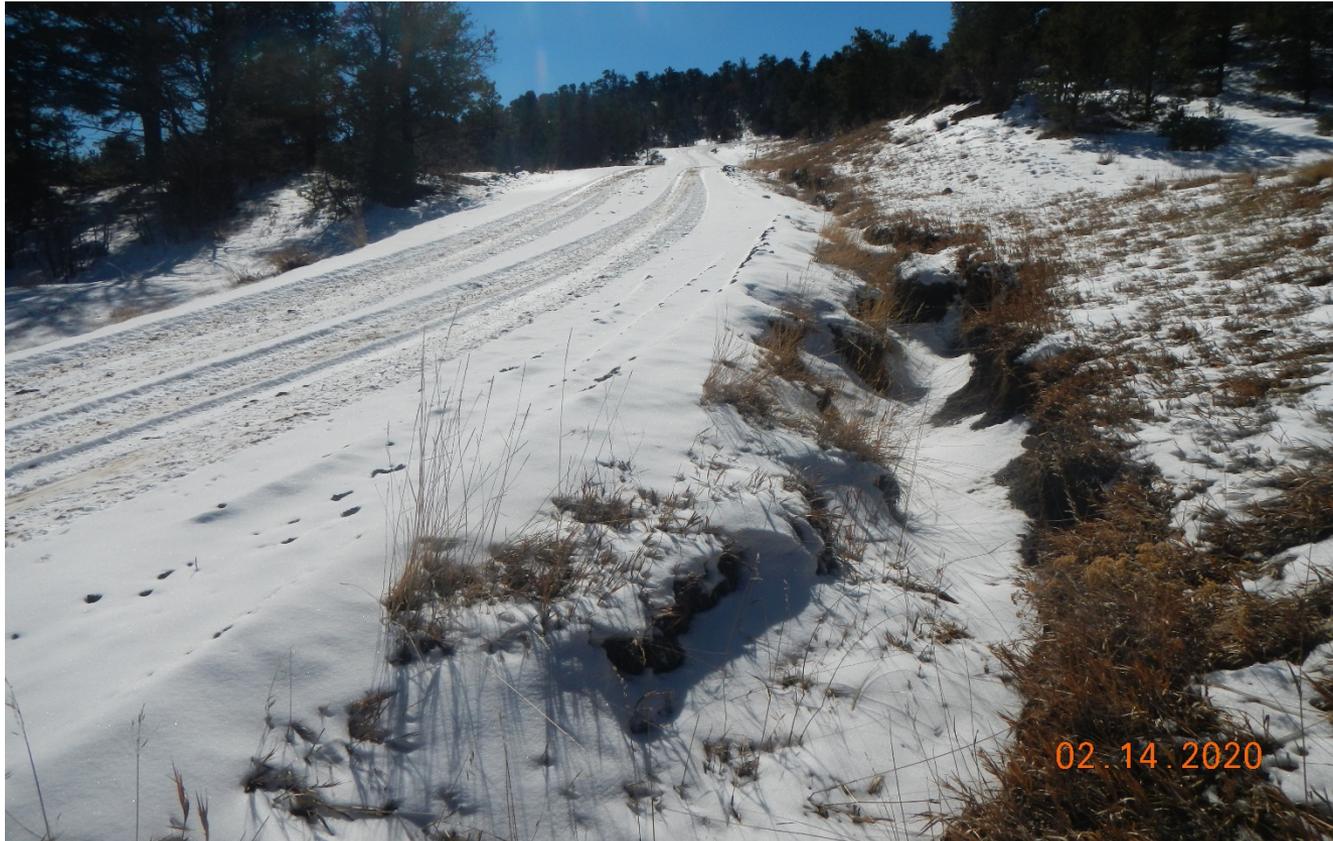
Photo 5. There a deep erosion channel along the access road at Lat/Long:37.14899,-104.87705.

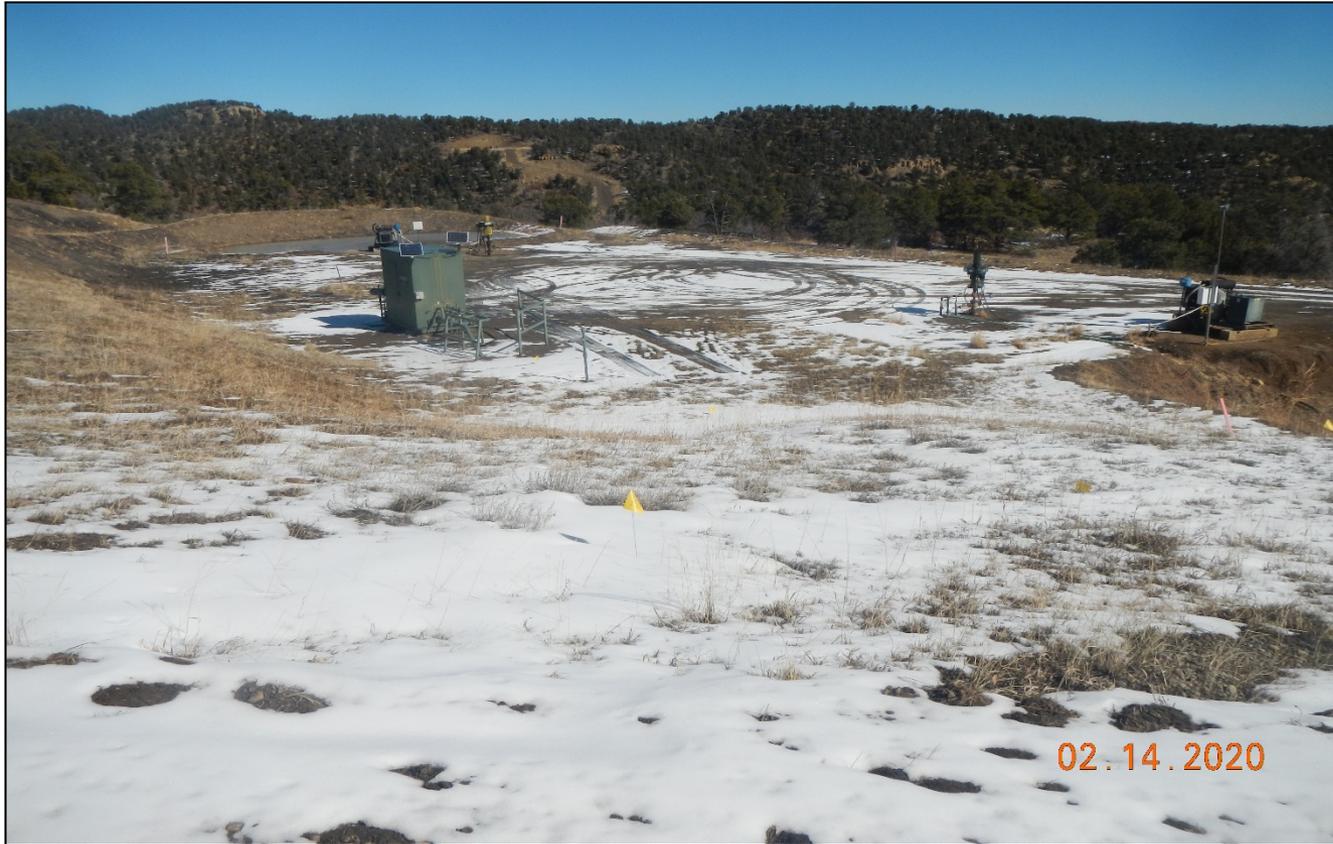
Photo 6. Facing toward the location.

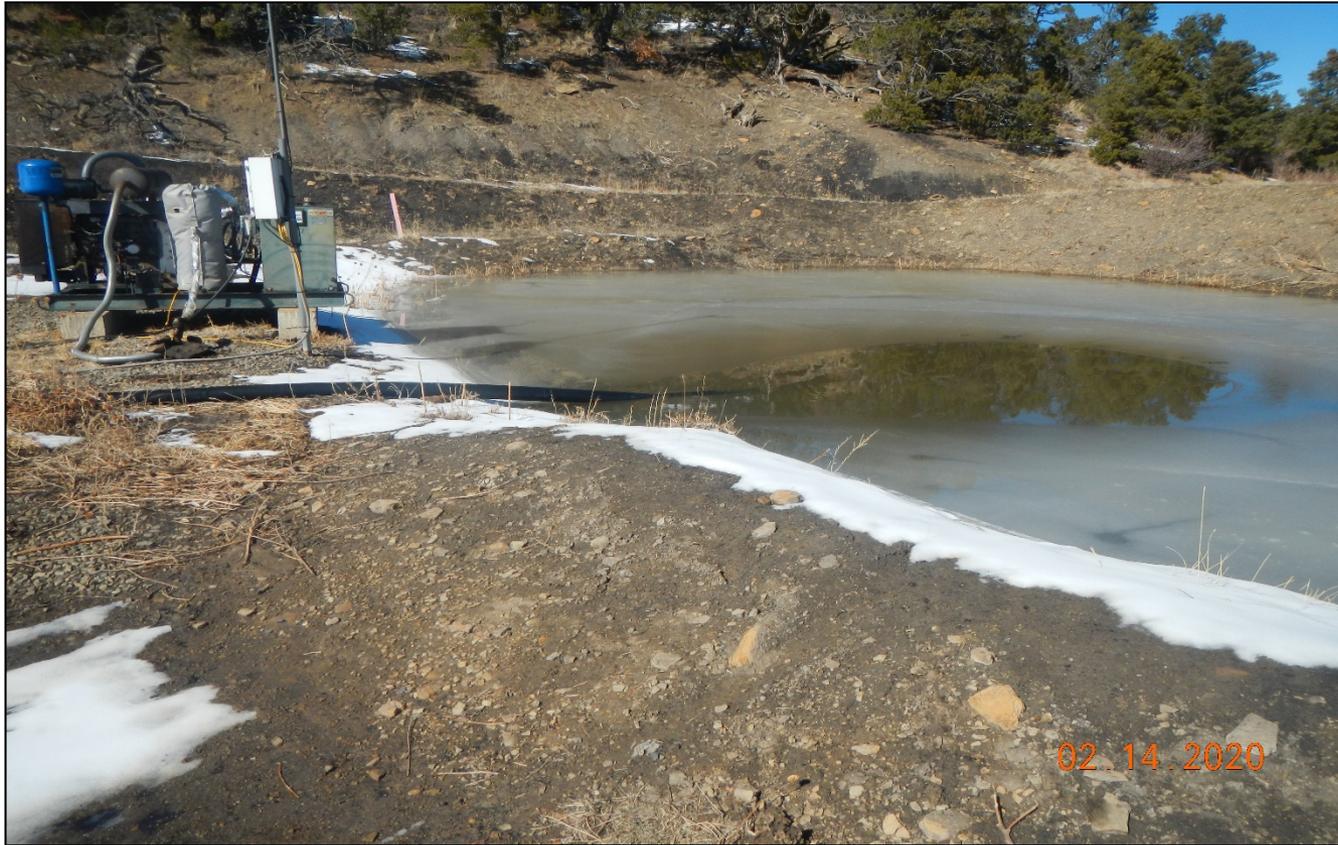
Photo 7. The water level at the pit is approaching 2 ft. freeboard and needs to be lowered.
