# Inspection Photos

Operator: EAGLE OPERATING INC - 26155

Location ID: 311824

Rio Blanco County, CO

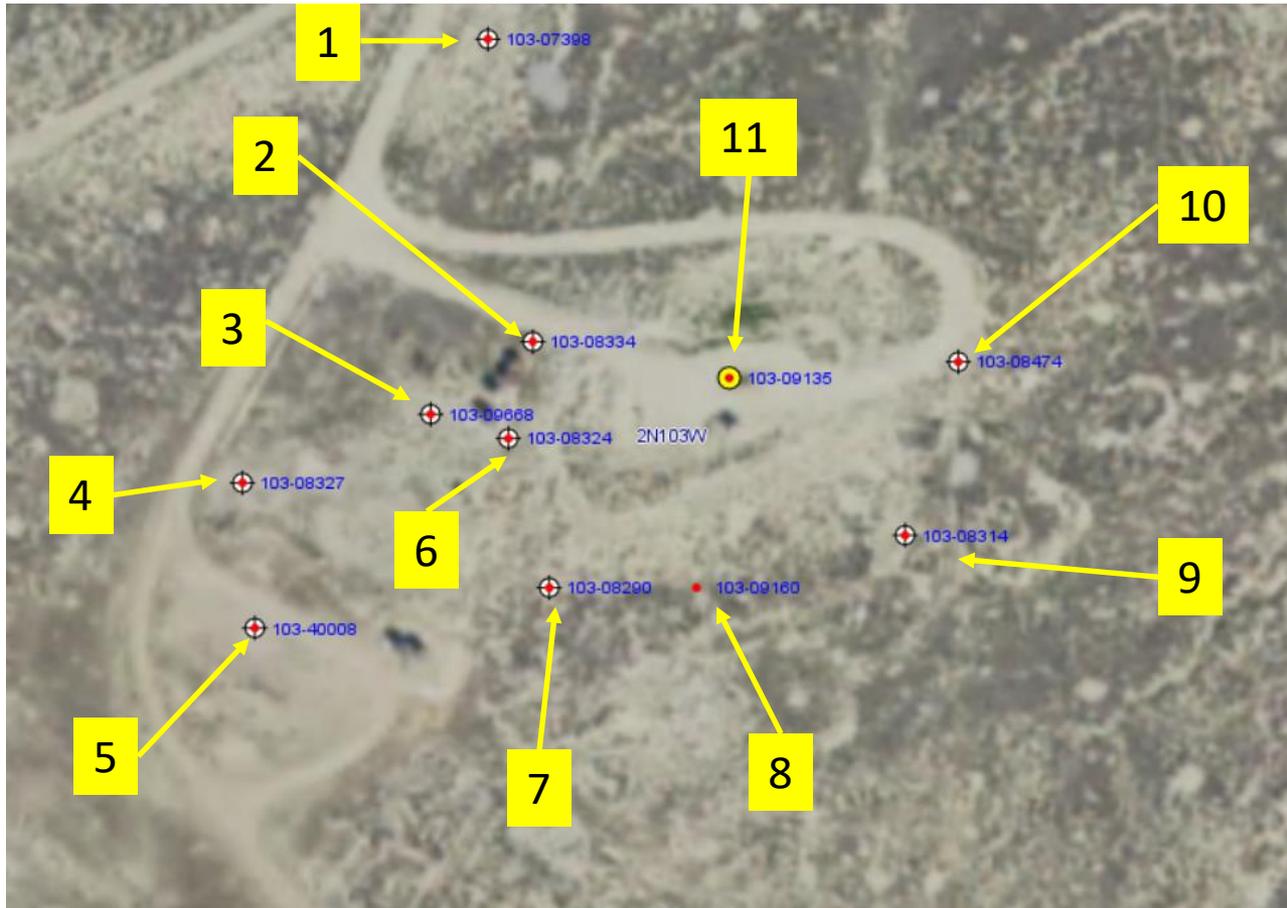
**Photo 1:** Photo shows all wells within the disturbance area. **1)** Equity Oil, PA 1972. **2)** Diamond Back, PA 1979. **3)** D&D, PA 1998. **4)** Diamond Back, PA 1979. **5)** Eagle Operating, PA 2015. **6)** D&D, PA 1979. **7)** Diamond Back, PA 1979. **8)** D&D, DA 1984. **9)** Diamond Back, PA 1979. **10)** Diamond Back, PA 1980. **11)** Eagle Operating, Active well.

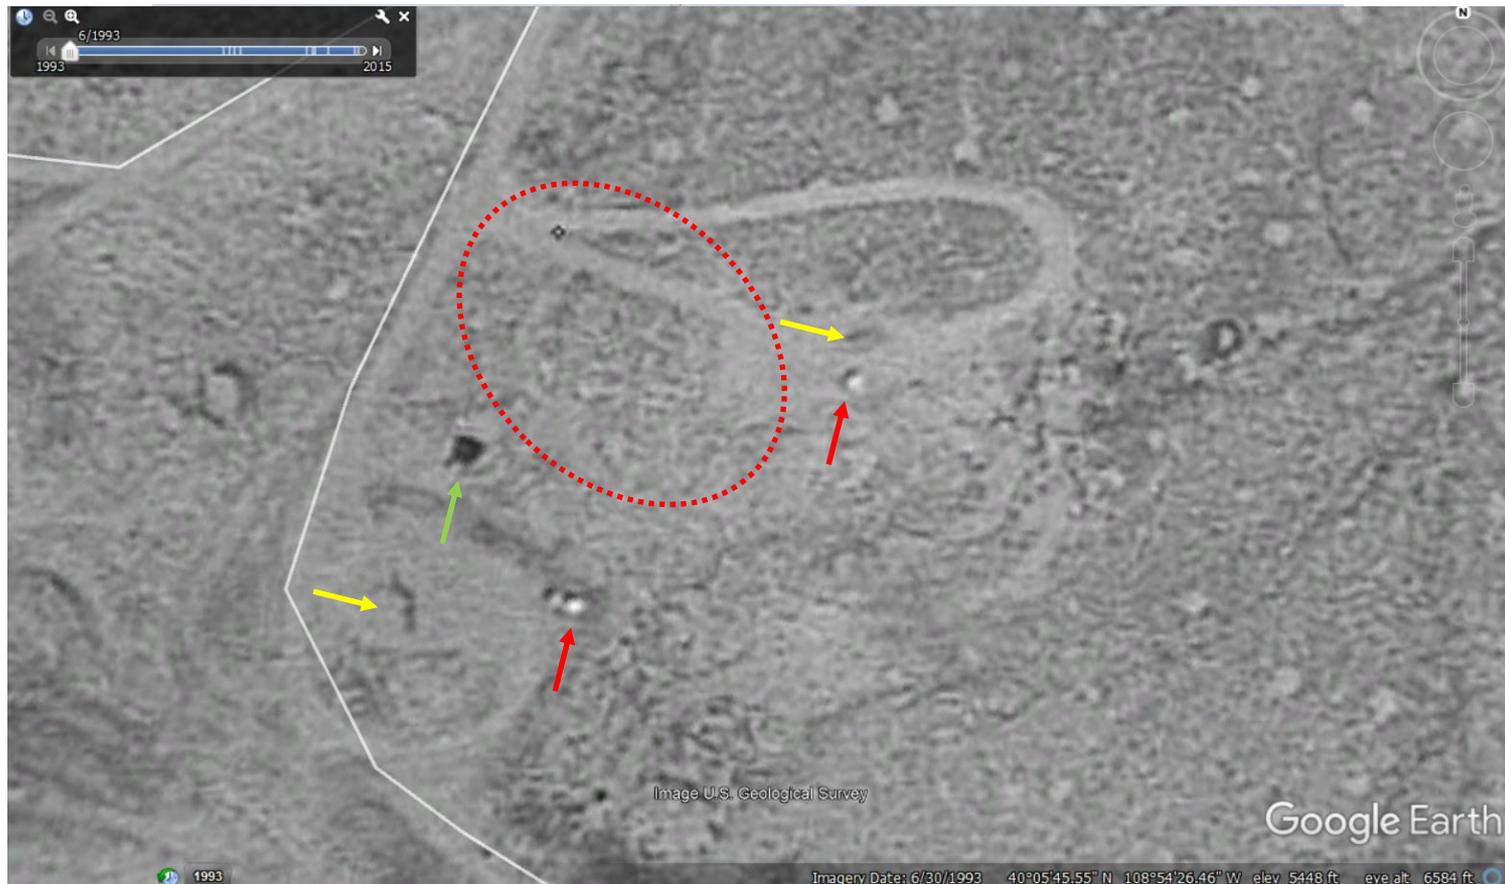
**Photo 2:** Google Earth Aerial Imagery dated 6/1993. The only active wells at this point are the Emerald C 125 (103-4008) and the Emerald 275 (103-09135). Arrows (yellow) show well locations (yellow), pit (green), and tank batteries (red). Note no equipment is evident within circle at this time

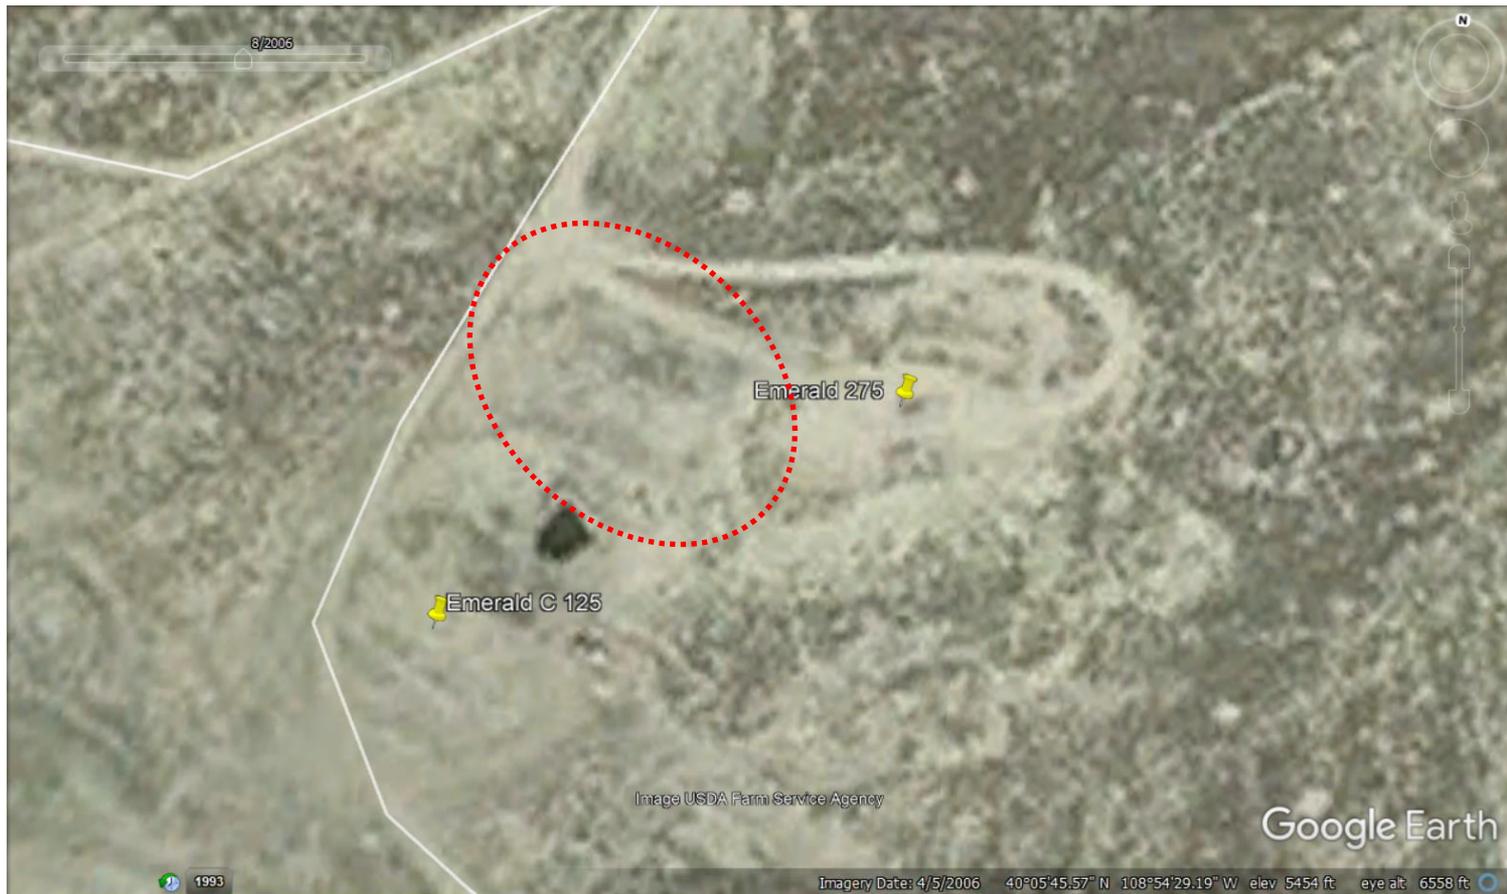
**Photo 3:** Google Earth Aerial Imagery dated 8/2006. Photo shows no equipment is evident within circle at this time. Note: Form 10 #1097855 shows Eagle Operating Inc. as the Operator of the Locations effective 8/29/2002. Previously Equity Oil Co.

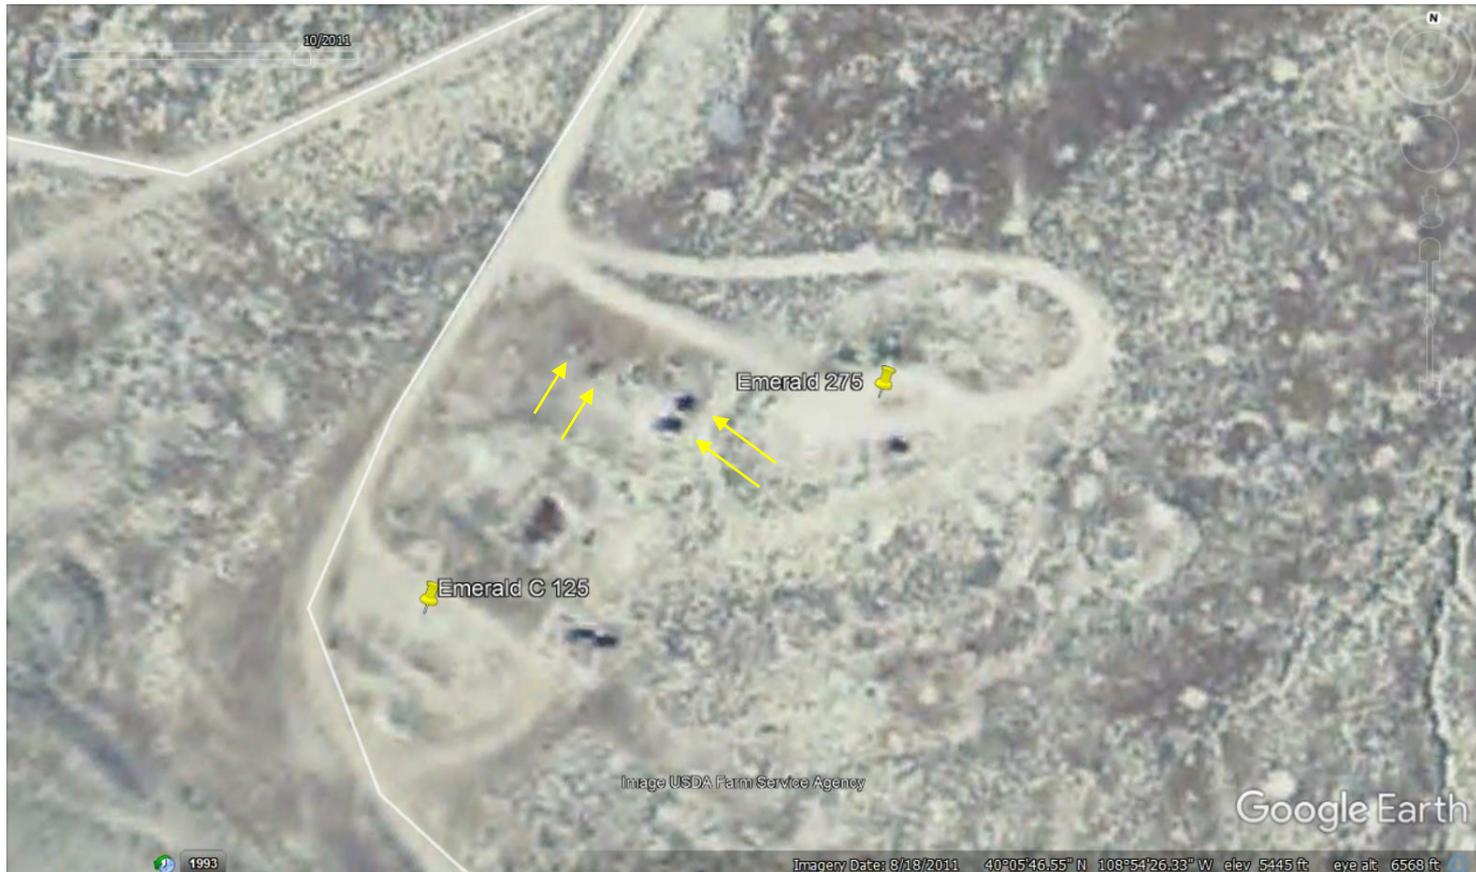
**Photo 4:** Google Earth Aerial Imagery dated 10/2011. First Google Earth aerial imagery that shows two tank batteries and two (2) pump units evident on the areas west of the Emerald 275

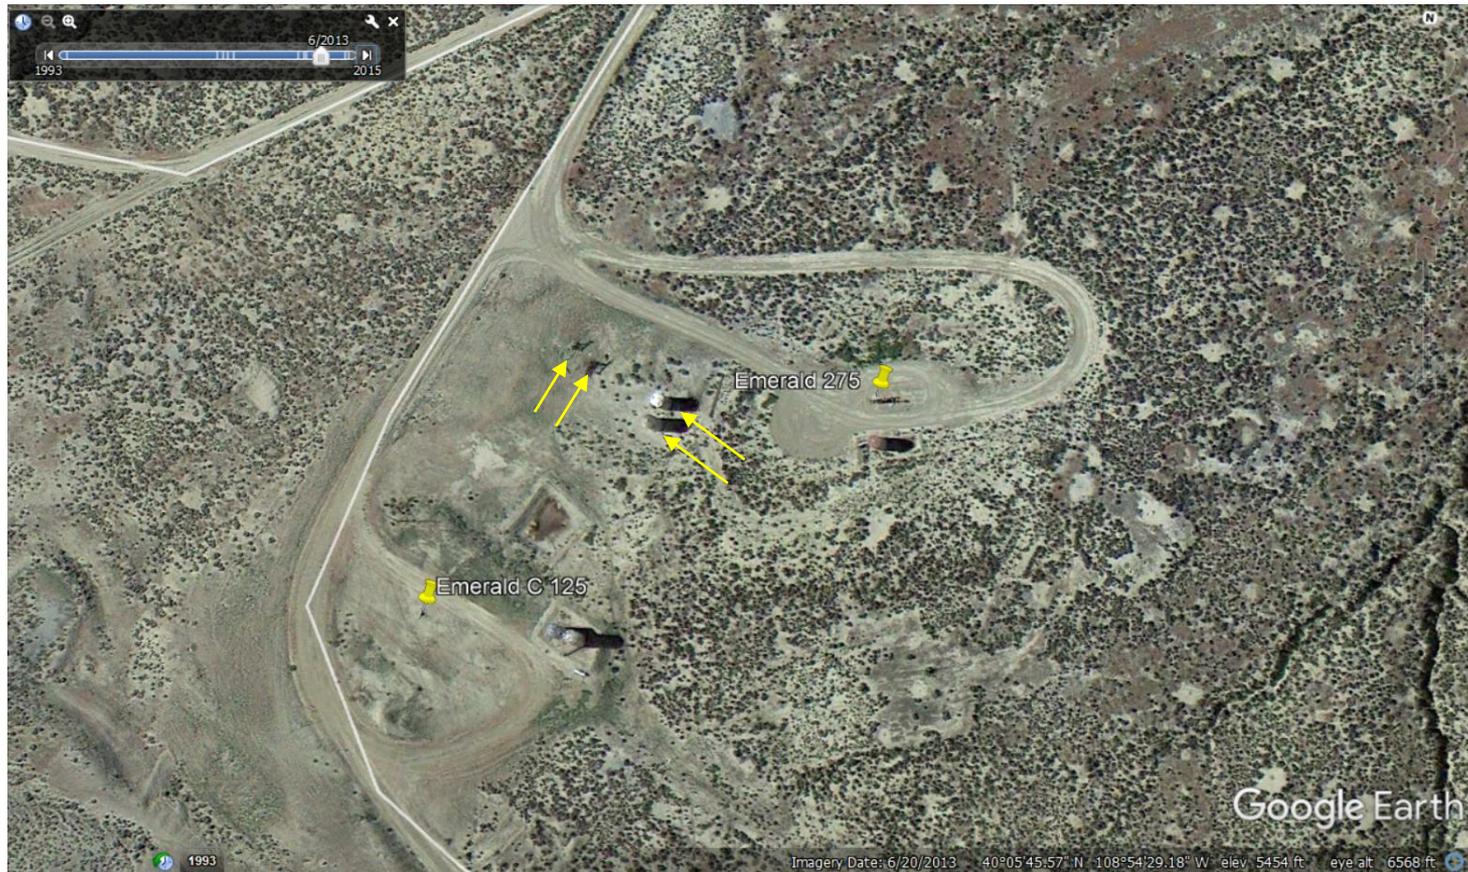
**Photo 5:** Google Earth Aerial Imagery dated 6/20/2013. More clear image showing the two tank batteries and two (2) pump units outlined in photo 4.

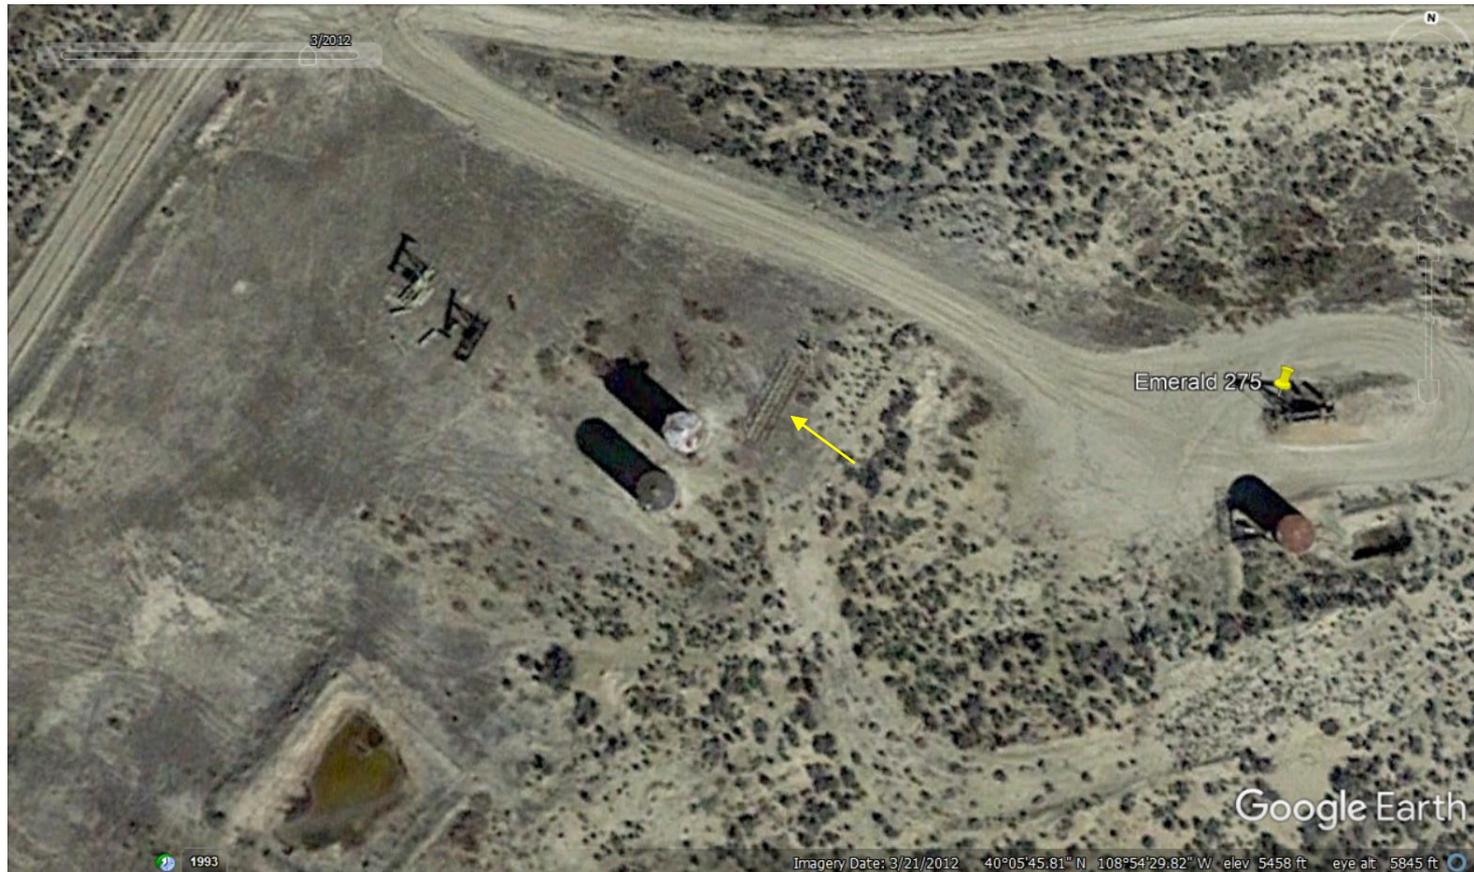
**Photo 6:** Continued from photo 5 zoomed in to show better image of the two (2) pump units, and two (2) tanks observed. Photo also shows additional equipment being stored east of the tanks.

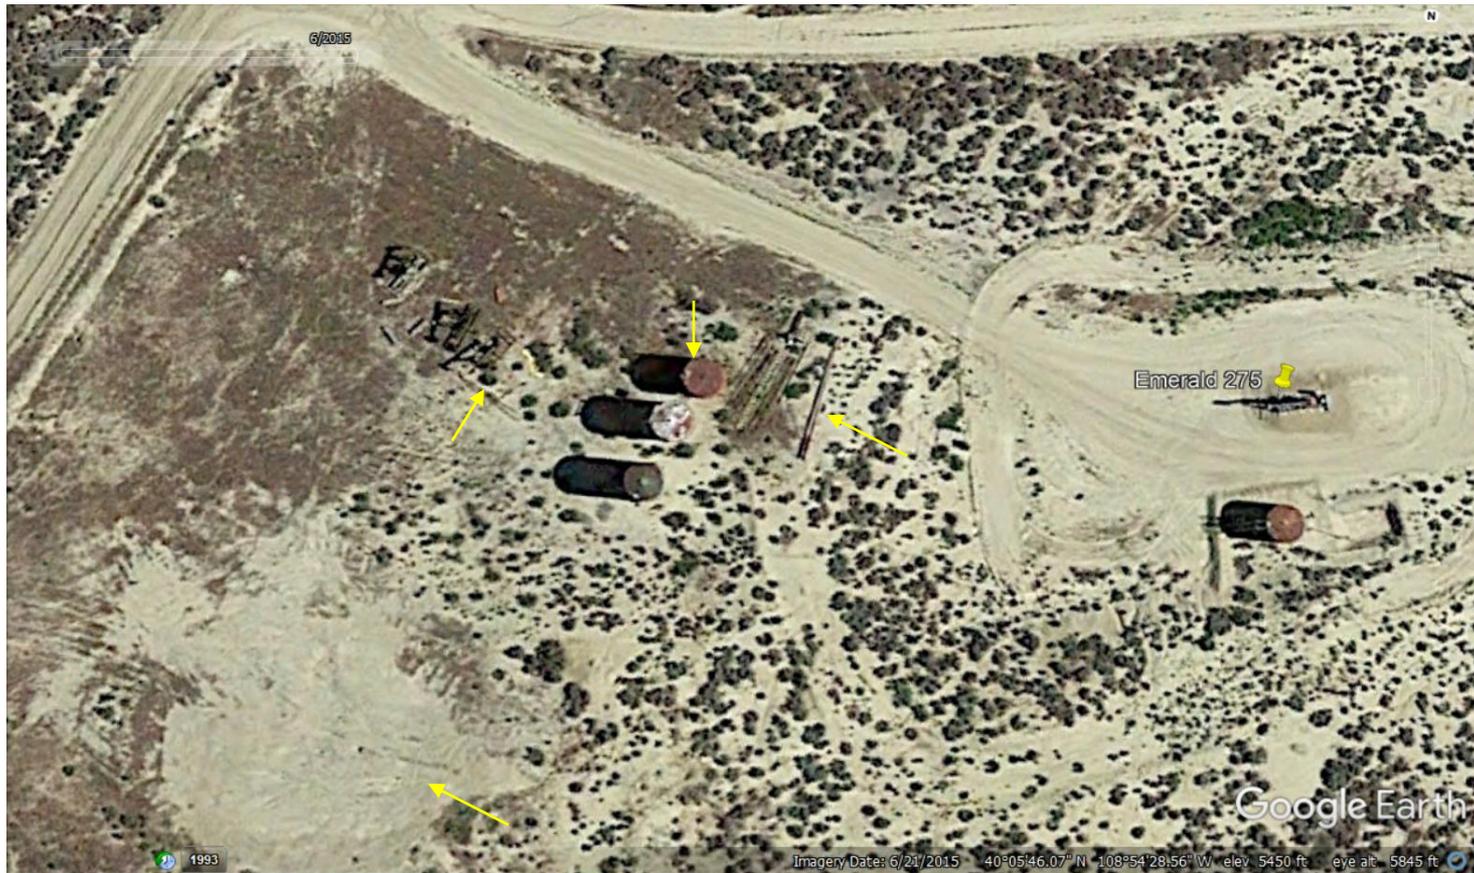
**Photo 7:** Google Earth Aerial imagery dated 6/2015. Photo shows a third (3<sup>rd</sup>) pump jack, and a third (3<sup>rd</sup>) tank is now evident on the site. Photo also shows additional equipment evident east of the tanks, and pit has been closed. Unable to find pit closure records per Rule 905.b

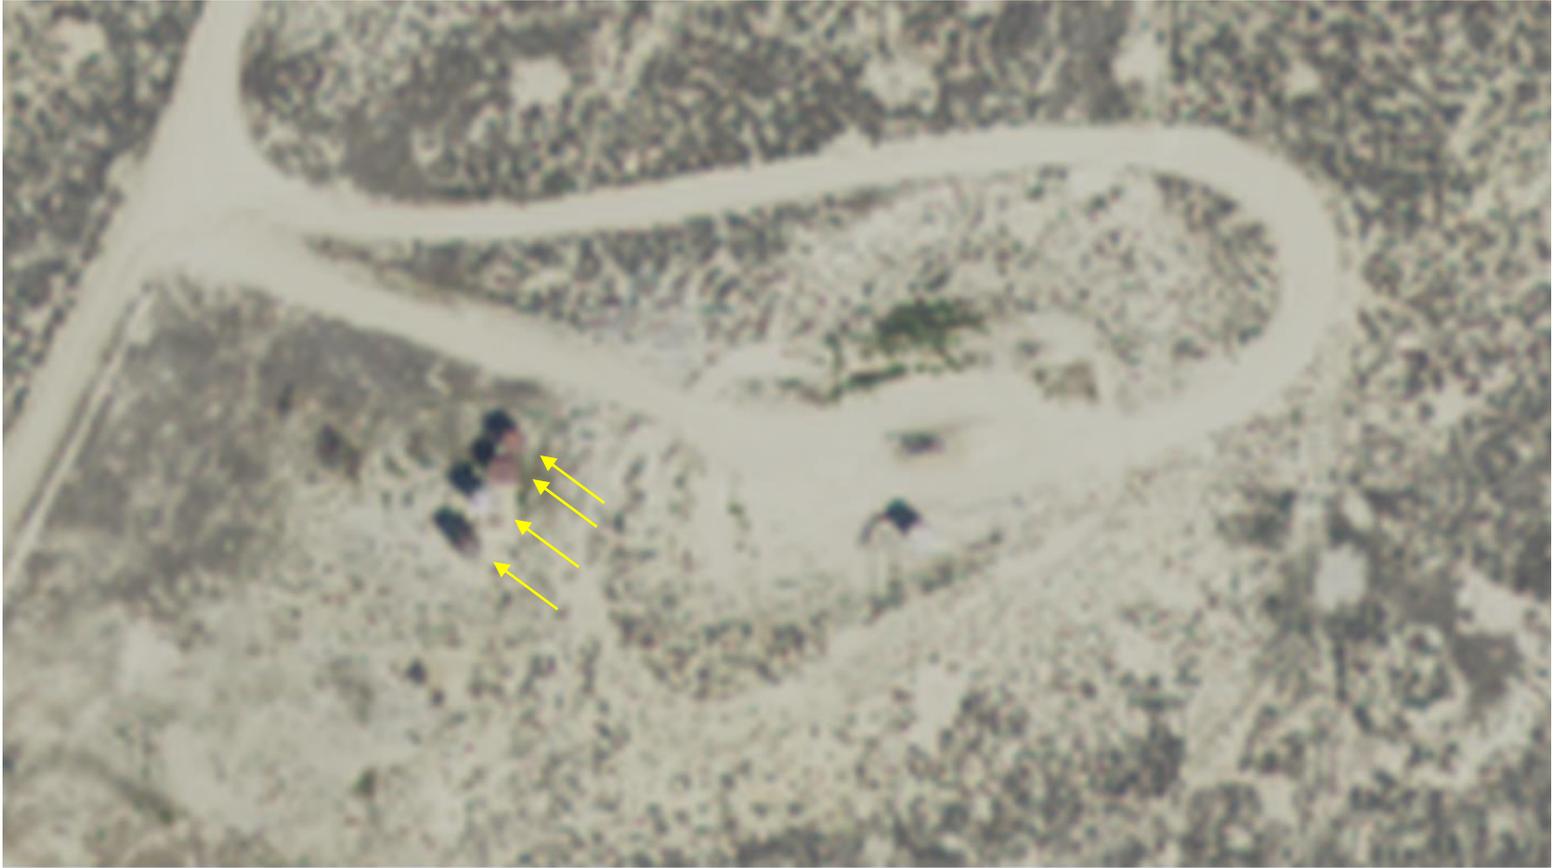
**Photo 8:** 2017 USDA-FSA-APFO NAIP aerial image (ID No: M\_4010857\_NE\_12\_1\_20170901). Imagery shows a fourth (4<sup>th</sup>) tank is now evident.

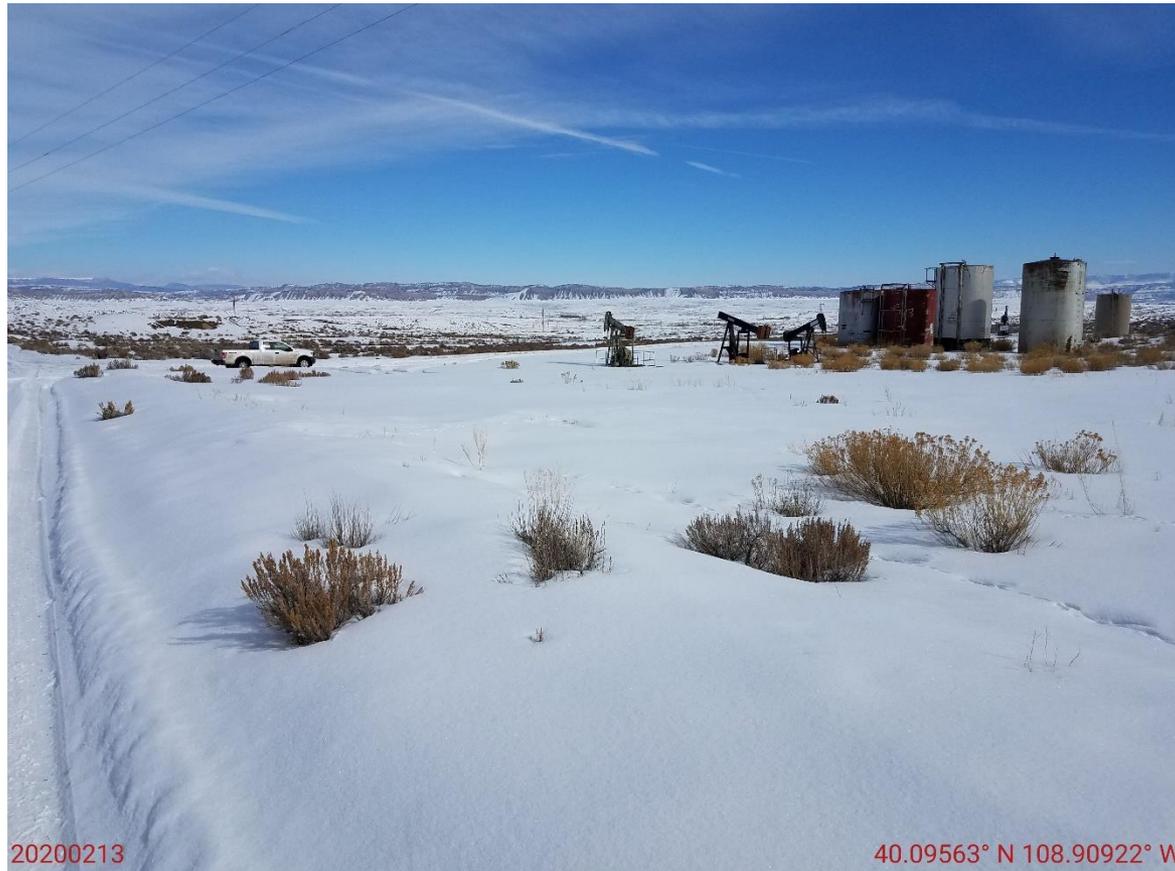
**Photo 9:** Photo taken from the access road, west of the location, facing North. Photos 9-11 provides an overview of the Location. Photos show the three (3) pump jacks, and four (4) tank batteries stored on areas west of the Emerald 275.

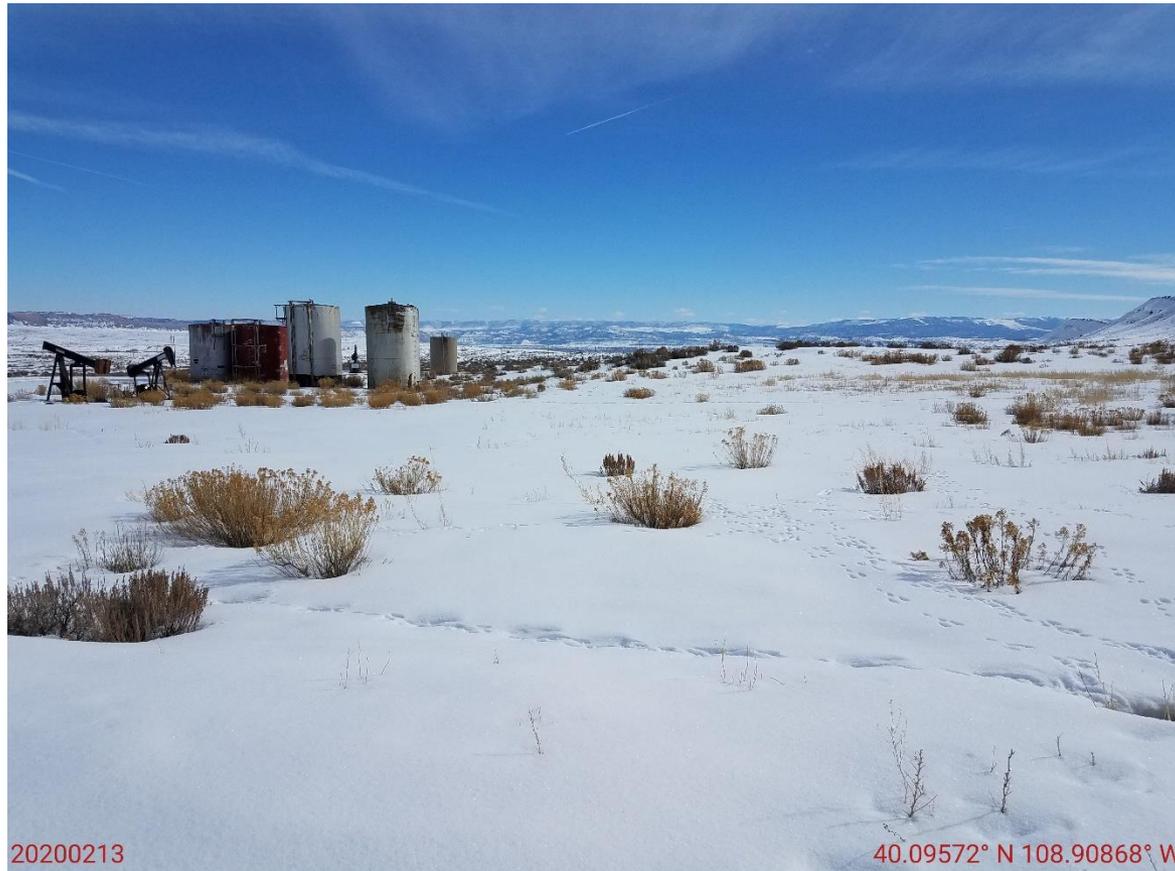
**Photo 10:** See comments under photo 9.

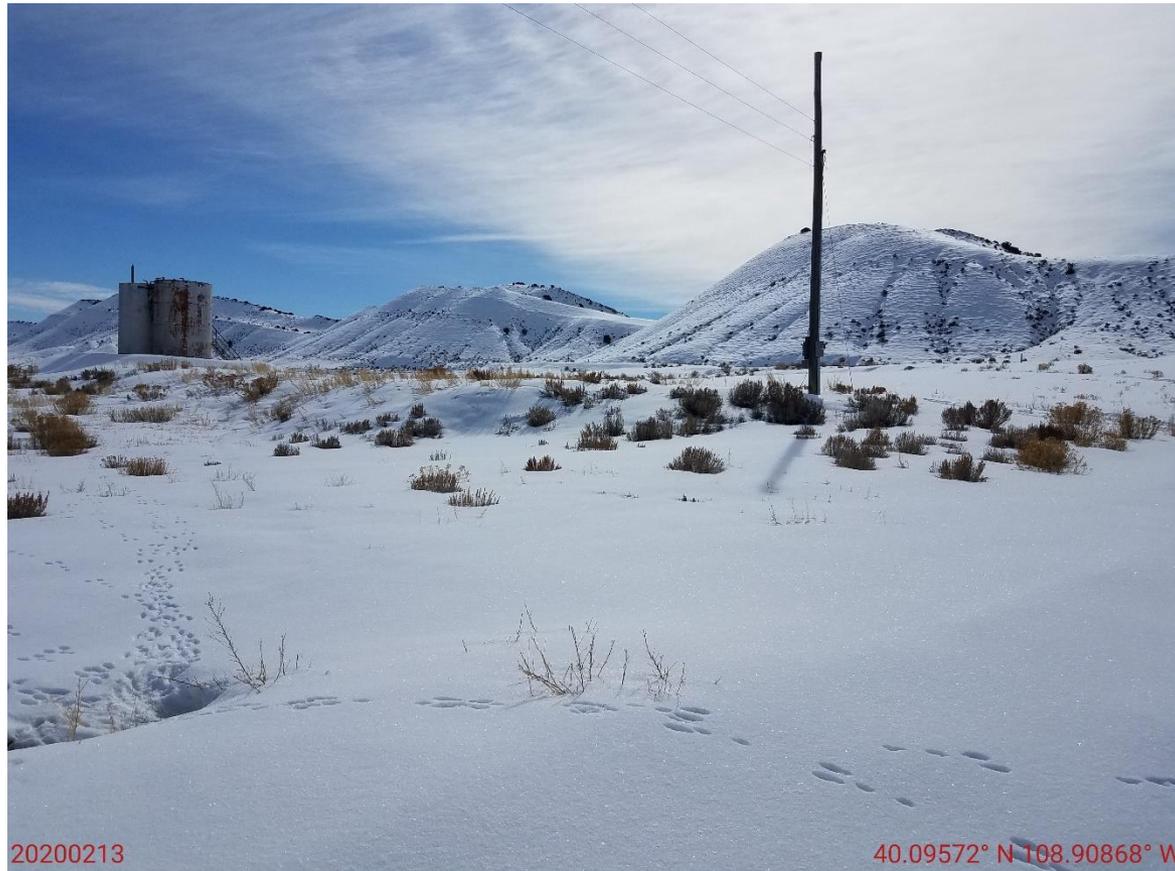
**Photo 11:** See comments under photo 9. Photo also shows the active tank battery facility (E-M Emerald C-1 HZ) with two (2) Crude Oil ASTs

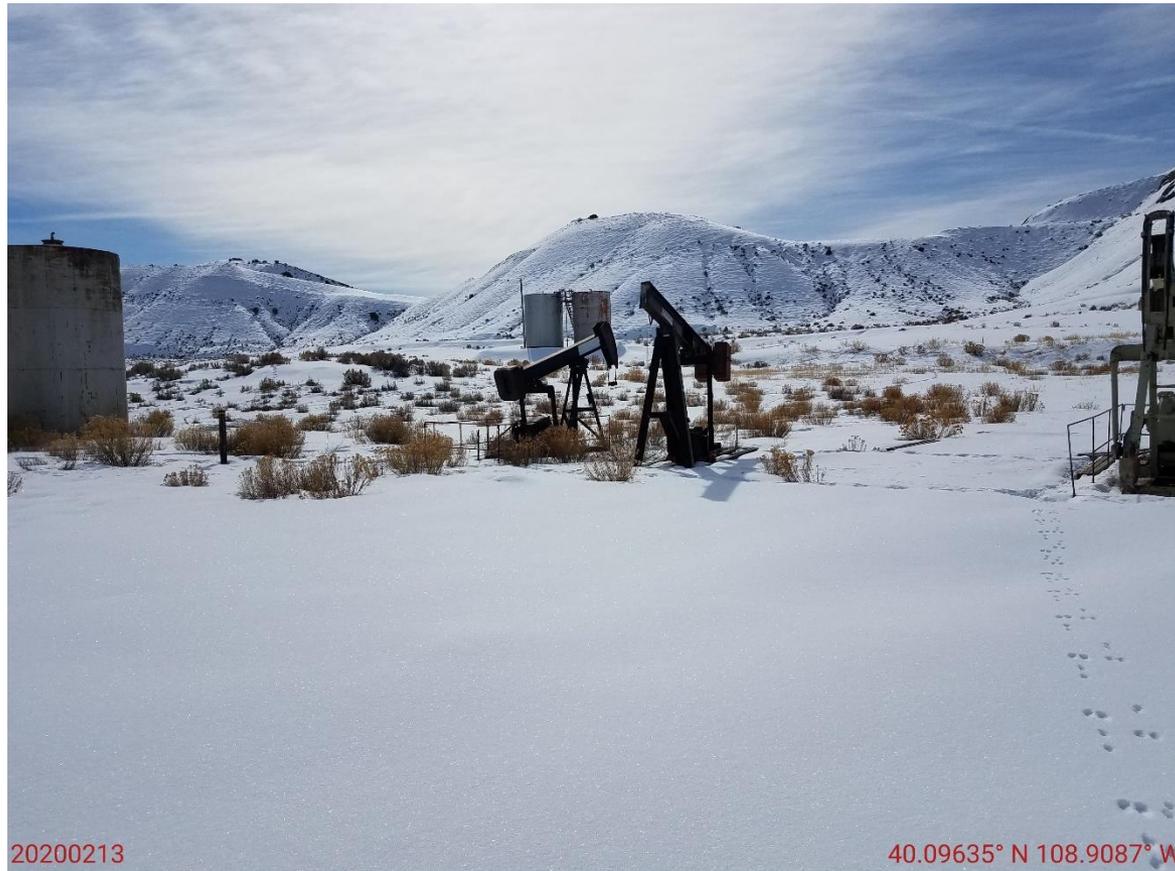
**Photo 12:** Photo shows the three (3) pump units stored west of the Emerald 275.

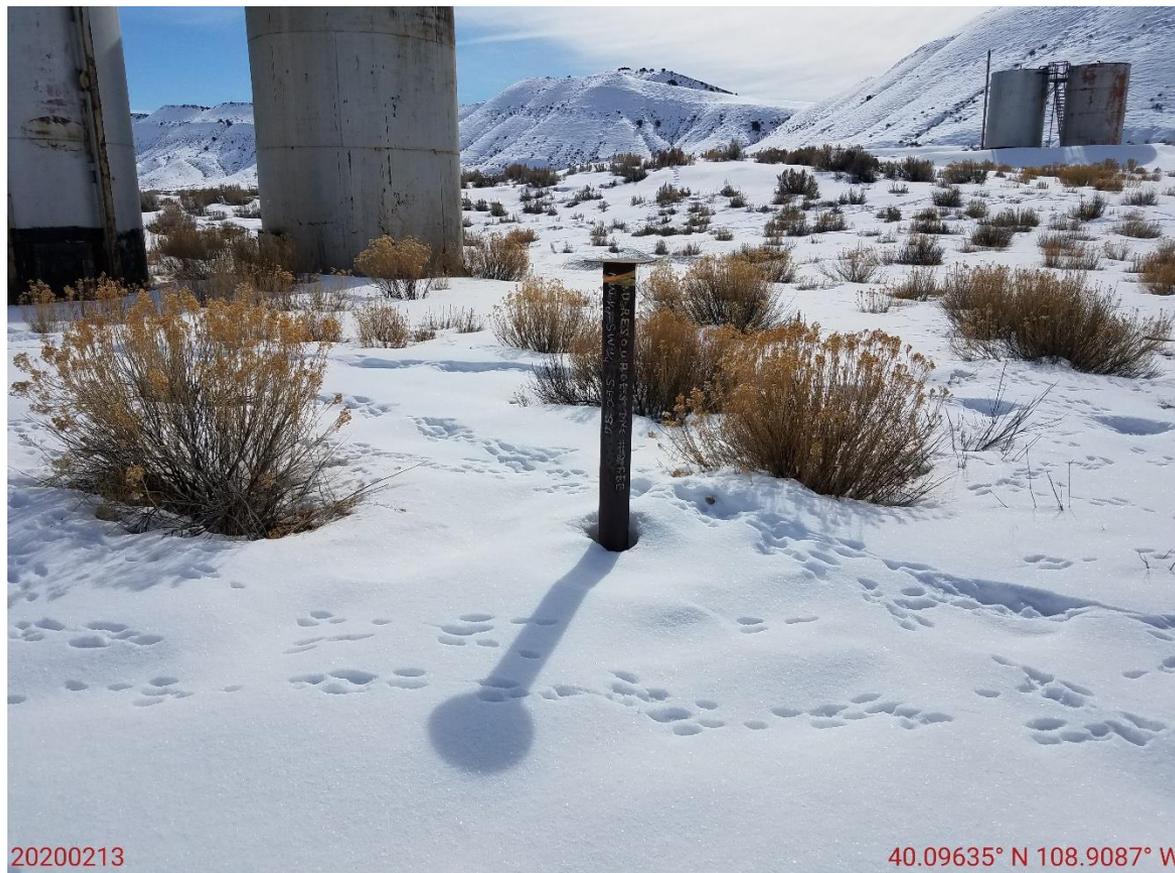
**Photo 13:** Photo of a dry well marker for the D&D Resources Inc's "Emerald C DCD #2" well. Well was SPUD 7/14/1994 and did not produce. Inspection dated 11/20/98 documents a dry hole marker on the Location with comments "No tank battery equipment", "General Housekeeping-OK", "OK to release"; No surface equipment appears to have been documented.

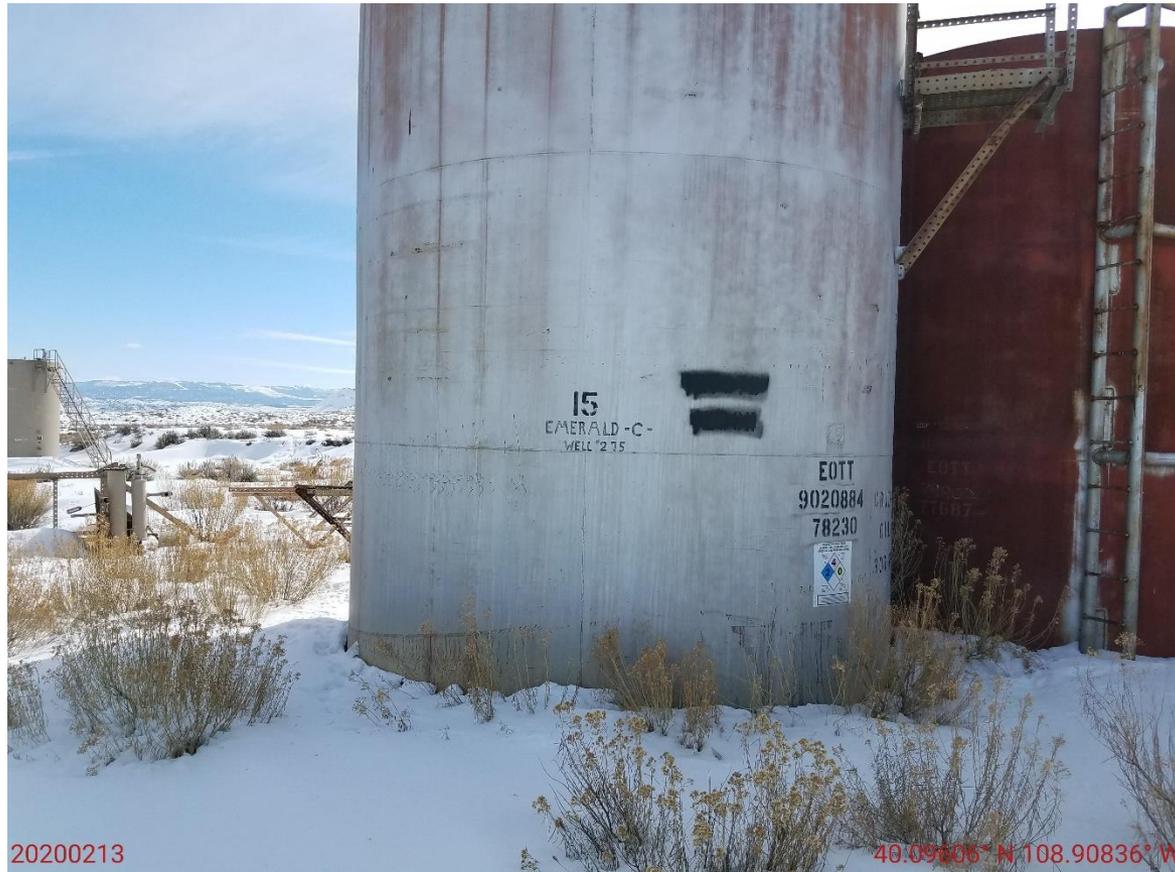
**Photo 14:** Photo of the northernmost tank observed stored on site. Tank labeled "Emerald-C-Well 275".

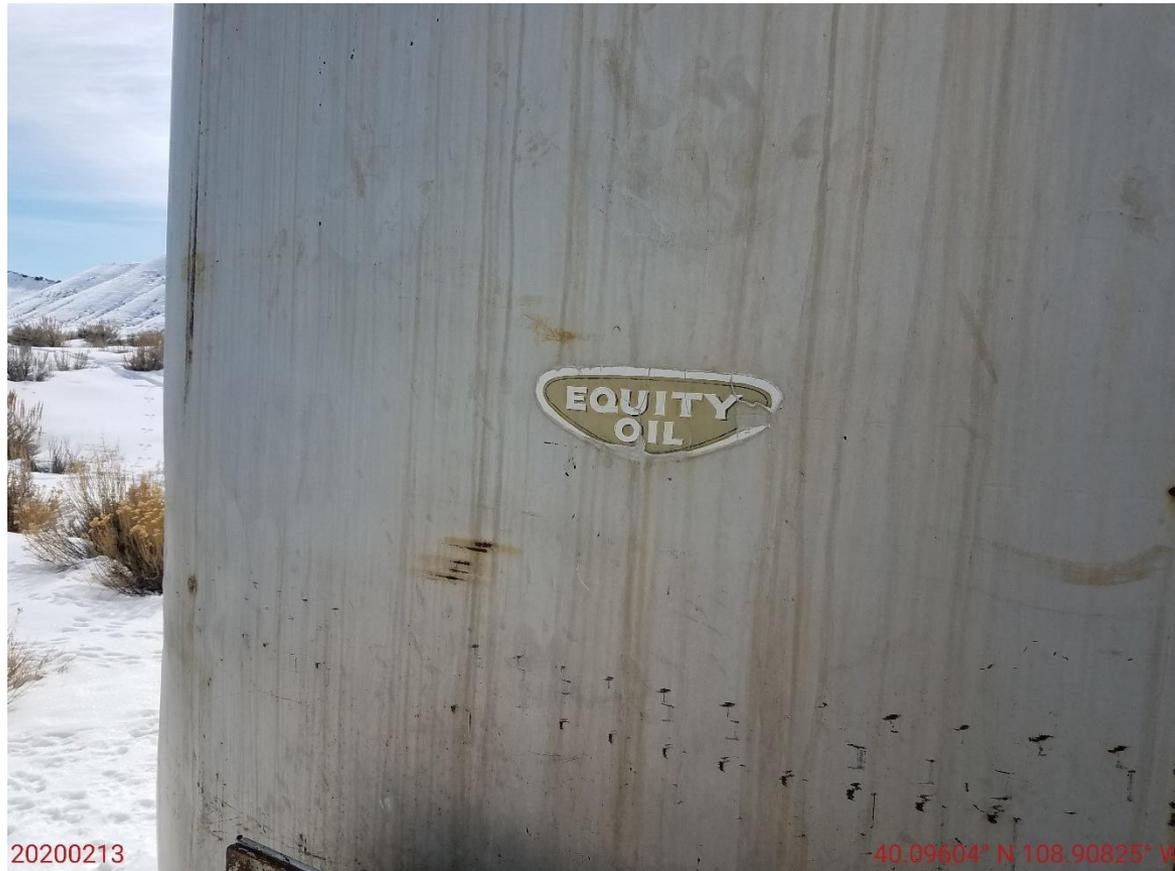
**Photo 15:** "Equity Oil" sign on other tank. Locations previously owned by Equity; Eagle Operating took ownership of the Equity Locations in 2002.

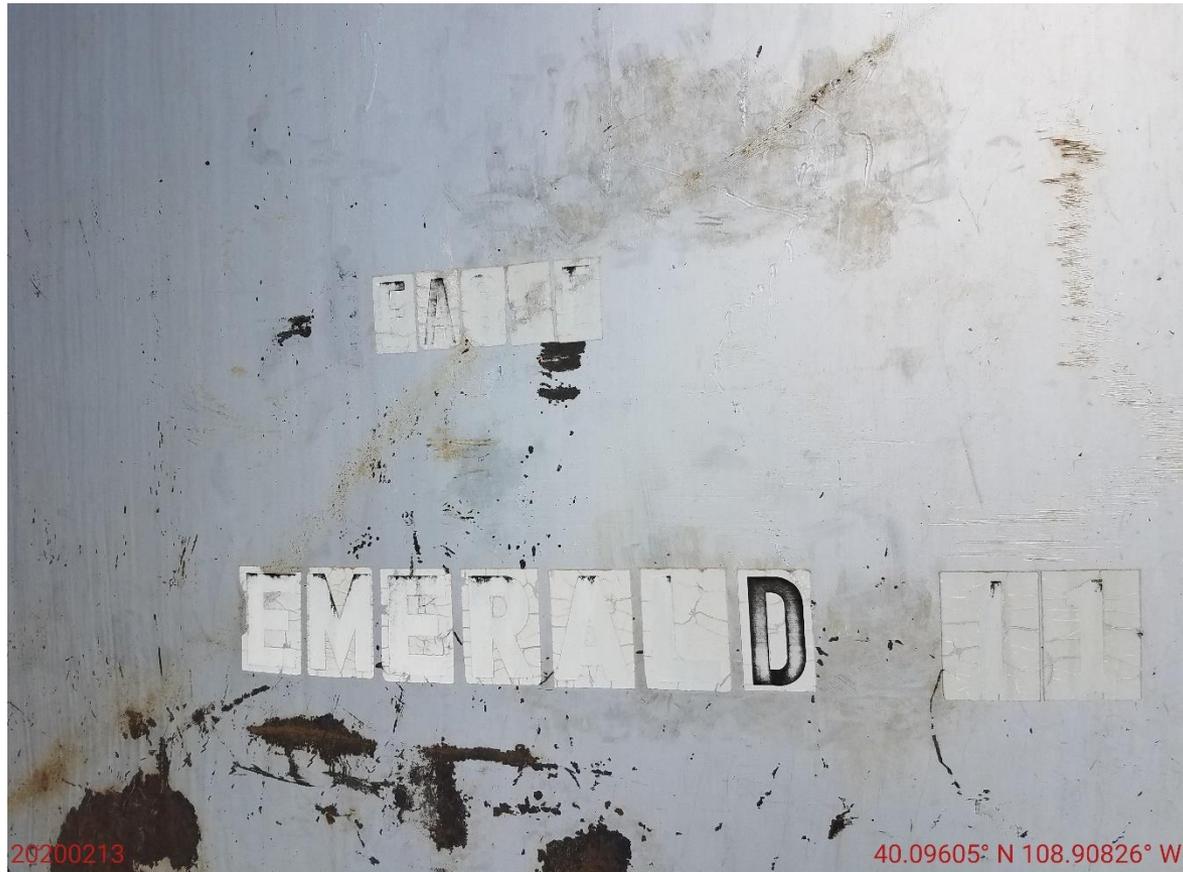
**Photo 16:** Label on one of the tanks observed on site stating “Eagle” and “Emerald 11”. The Emerald 11, API 103-05508, is approximately 1.2 miles northwest and was PAD by Eagle Operating in 2005.

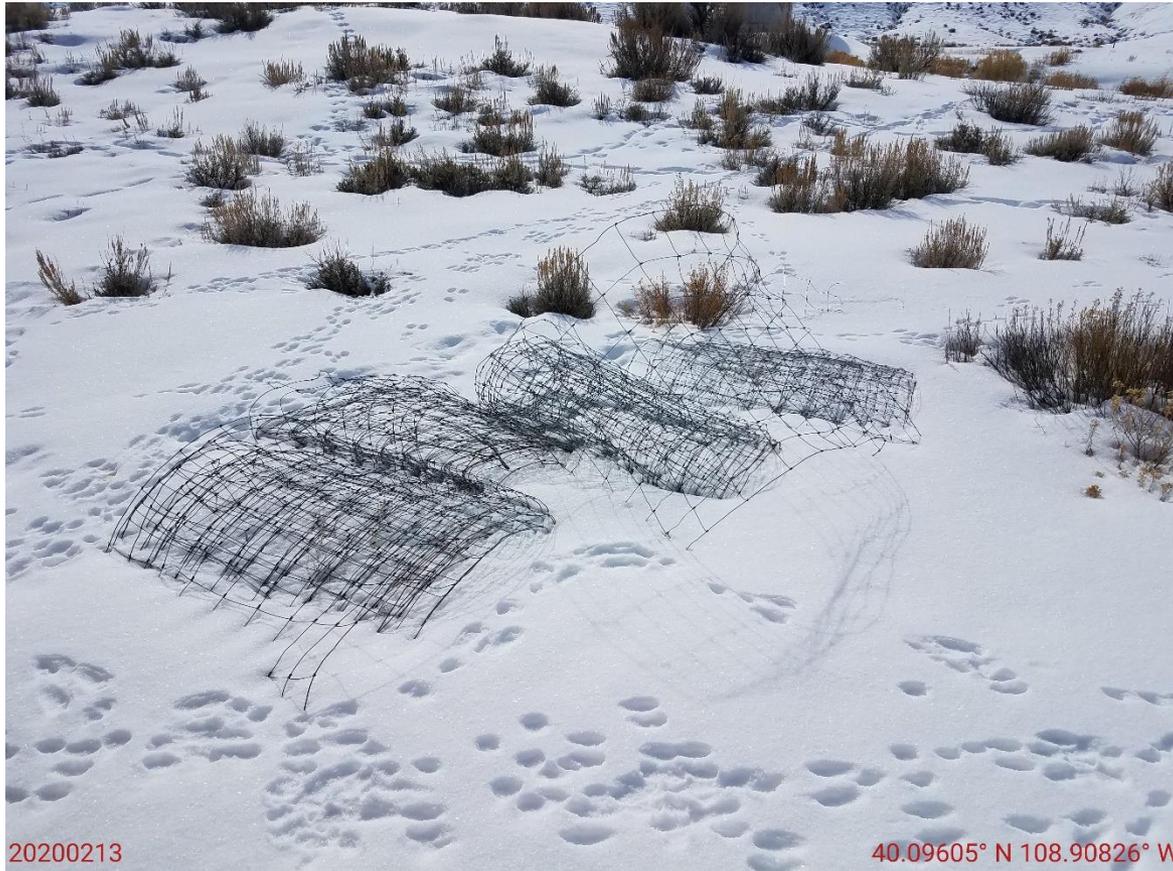
**Photo 17:** Photo of trash debris observed just to the south of the southernmost tank.

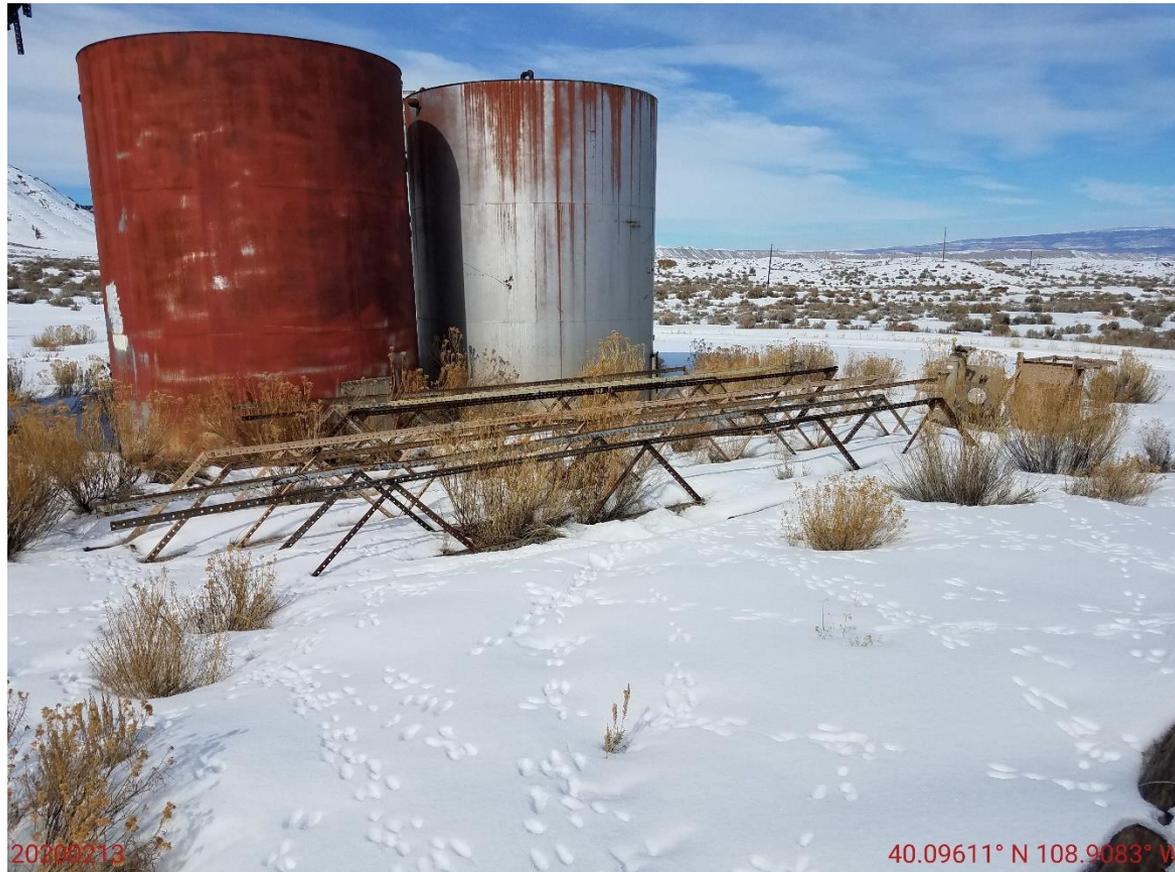
**Photo 18:** Photo taken from the east of the stored tanks. Photo shows additional equipment being stored on Location.

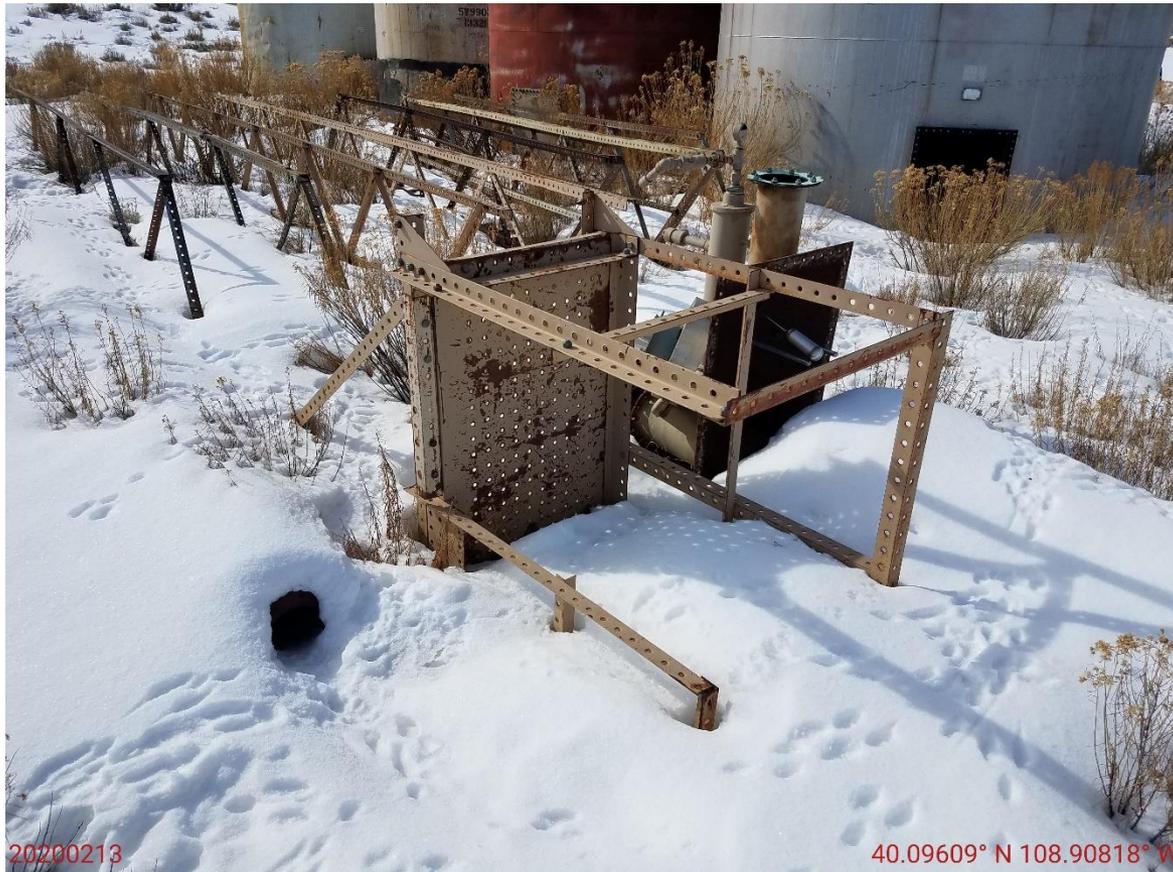
**Photo 19:** Continued from photo 18. Photo shows additional equipment stored on the Location.
