# Inspection Photos

Operator: EAGLE OPERATING INC - 26155

Location ID: 311824

Rio Blanco County, CO

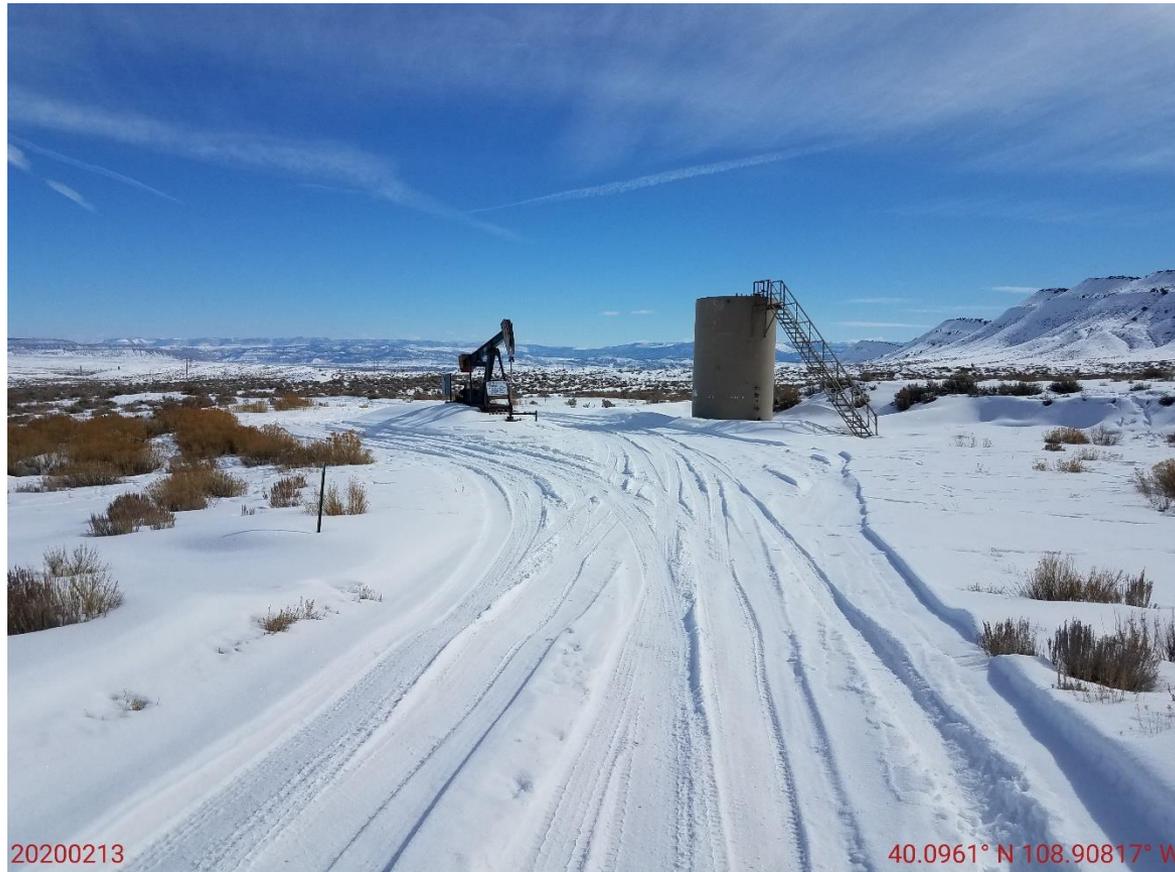
**Photo 20:** Photo taken from the west of Eagle Operating's Emerald #275 well, facing east

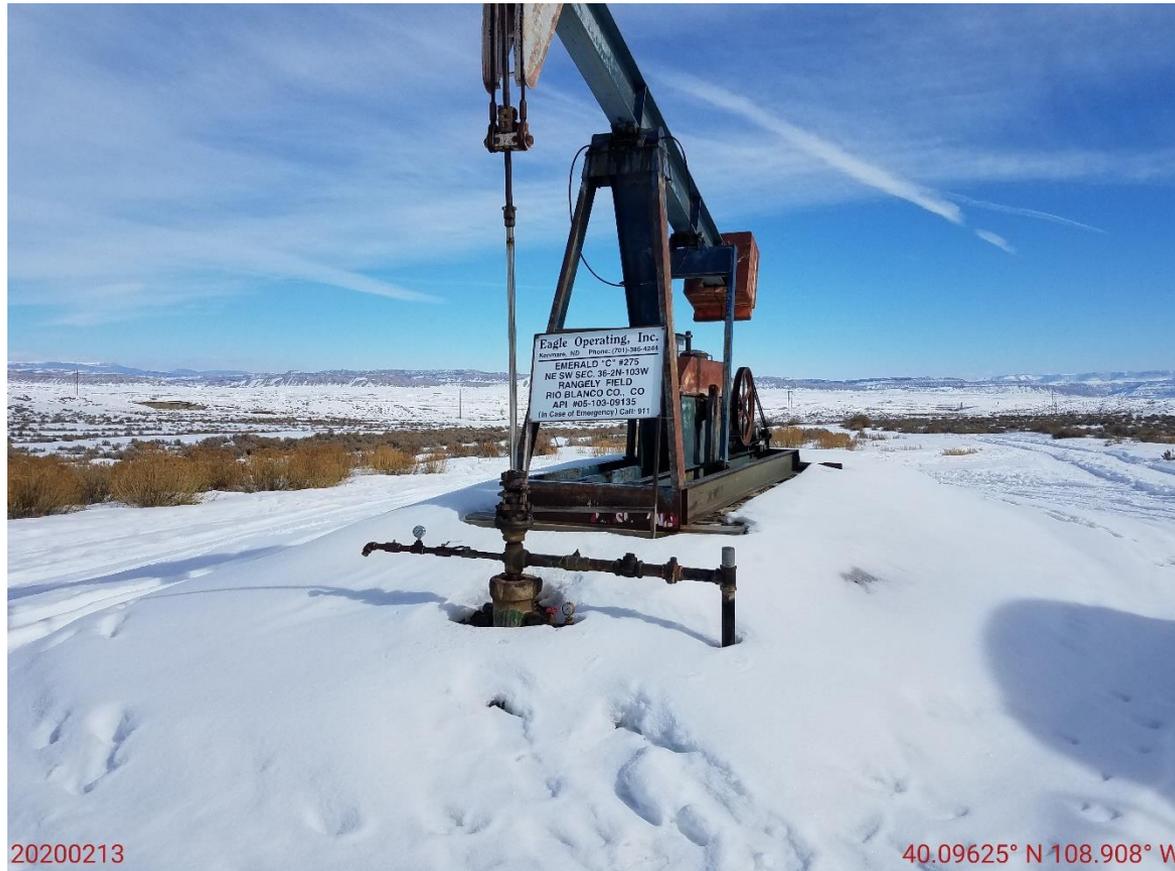
**Photo 21:** Photo of the Emerald #275 Well. Photo shows signage at well matches with tank observed in photo #14

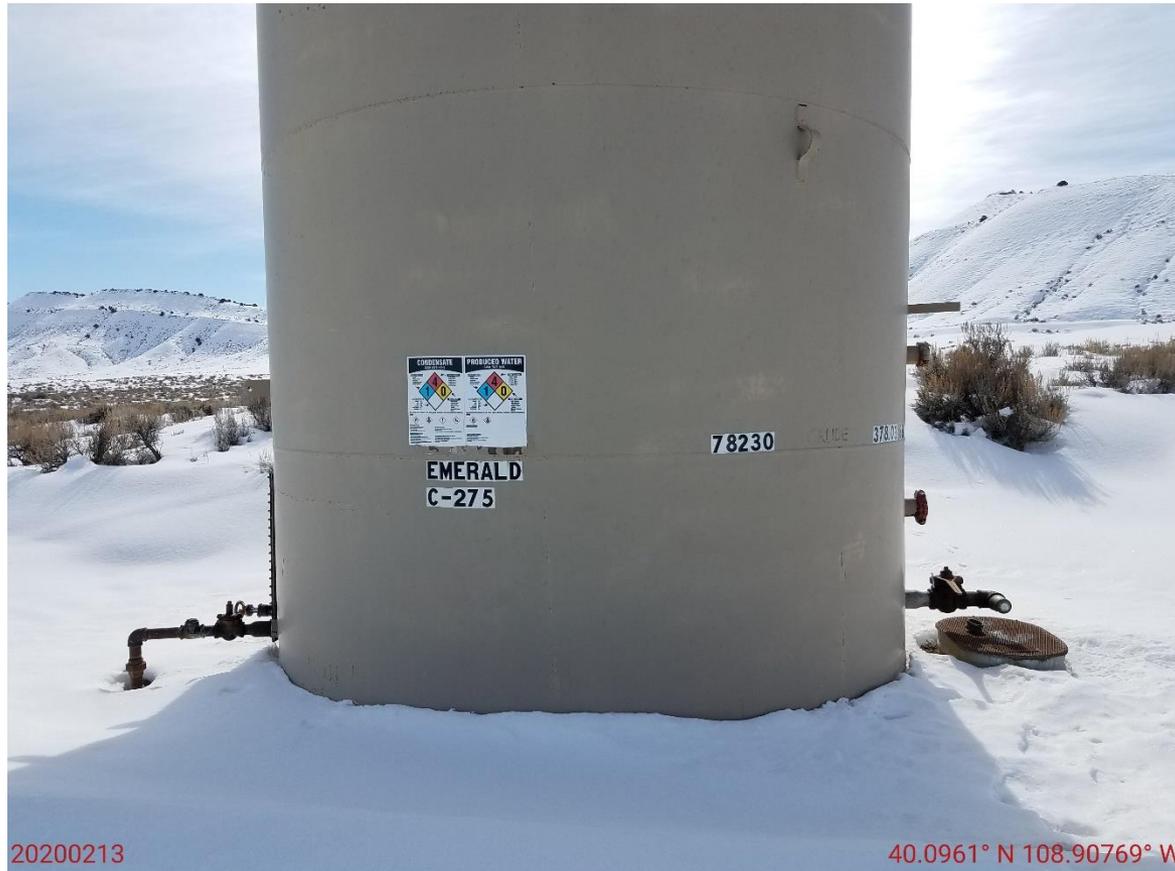
**Photo 22:** Photo taken from that south end of the Emerald #275 well Location, facing south. Photo shows current active produced water tank on the Location. Label indicates capacity @378.03 bbl. Signage on tank matches with signage on stored tank in photo #14; It appears the tank in photo 14 was replaced with this tank, was then stored on site rather than removed.

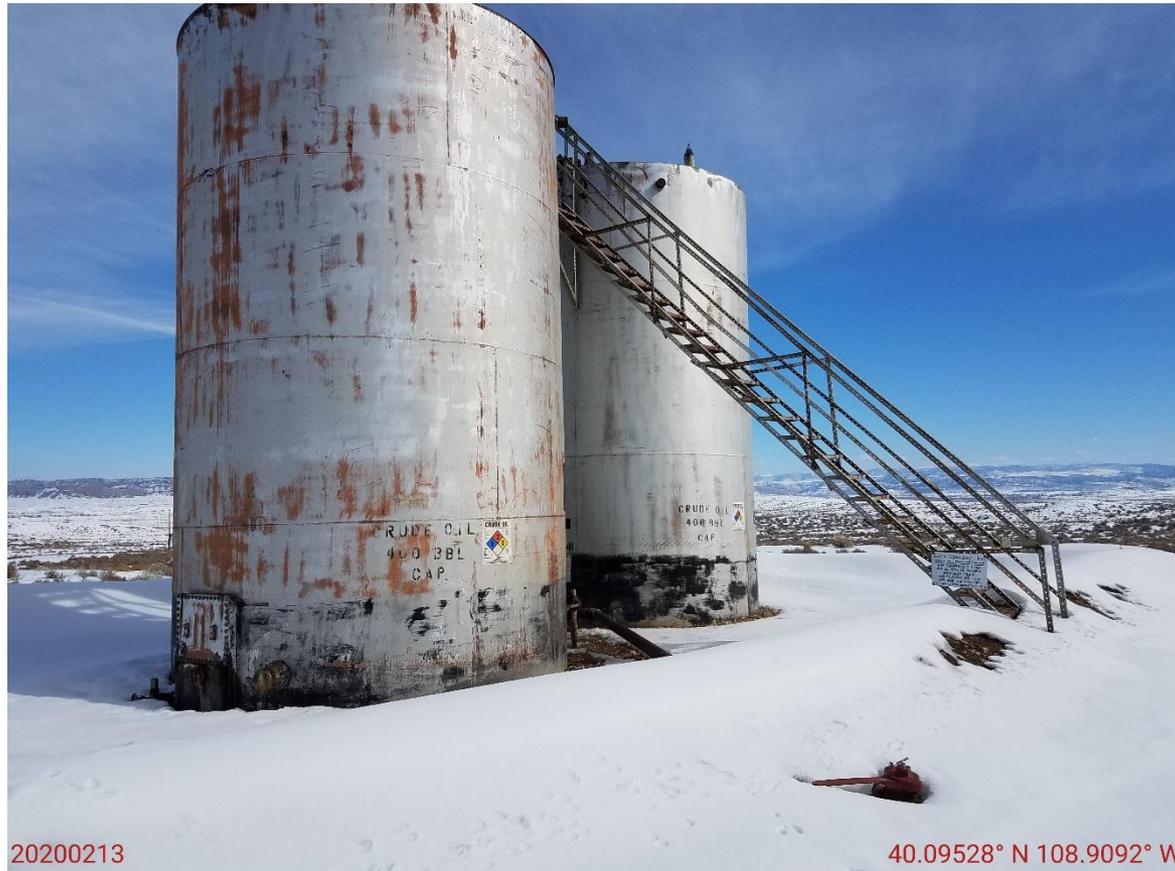
**Photo 23:** Photo taken from the two (2) 400 bbl Crude Oil ASTs to the south of the Emerald #275.

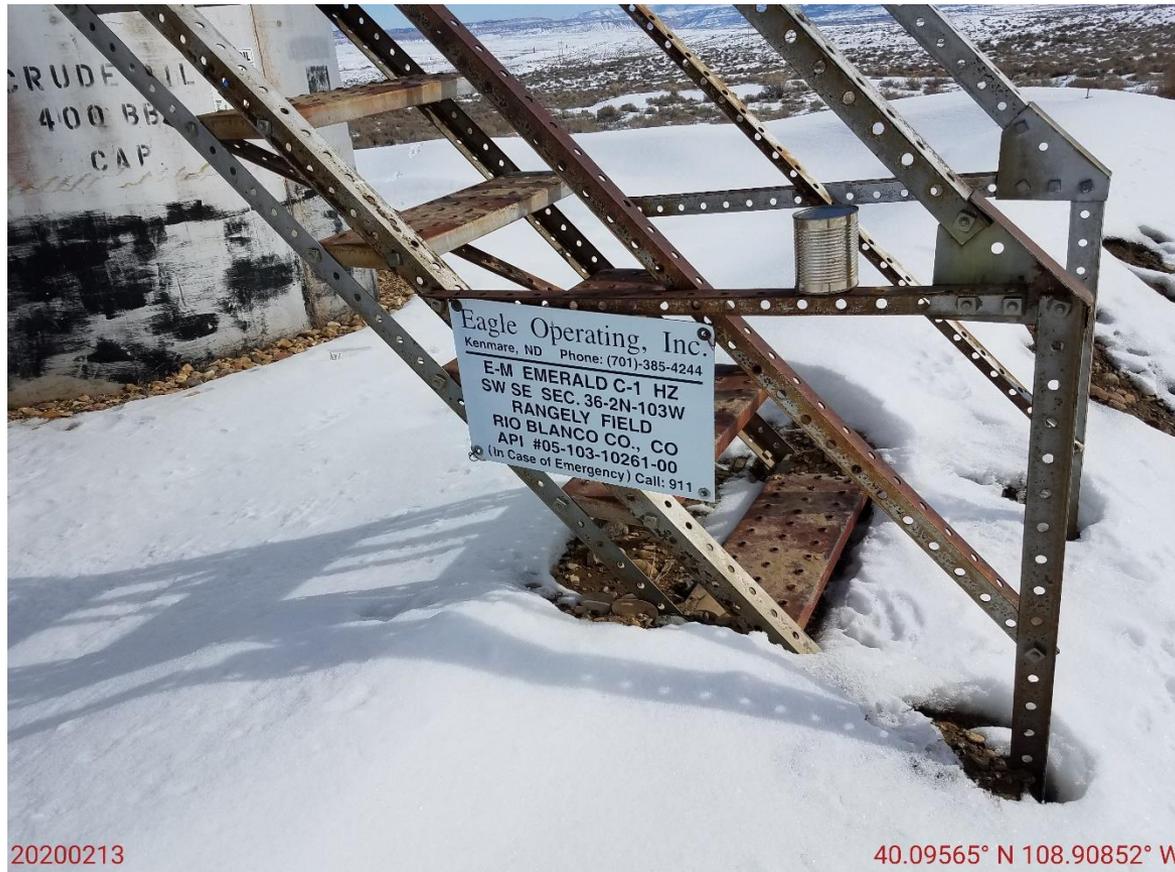
**Photo 24:** Signage at Crude Oil ASTs. Signage indicates tank battery is associated with the E-M Emerald #C-1HZ well (103-10261) ~1/3 mile to the east.
