# Construction and Stormwater Inspection

February 13, 2020

Operator: BONANZA CREEK ENERGY OPERATING COMPANY LLC - #8960

Location ID: 462951

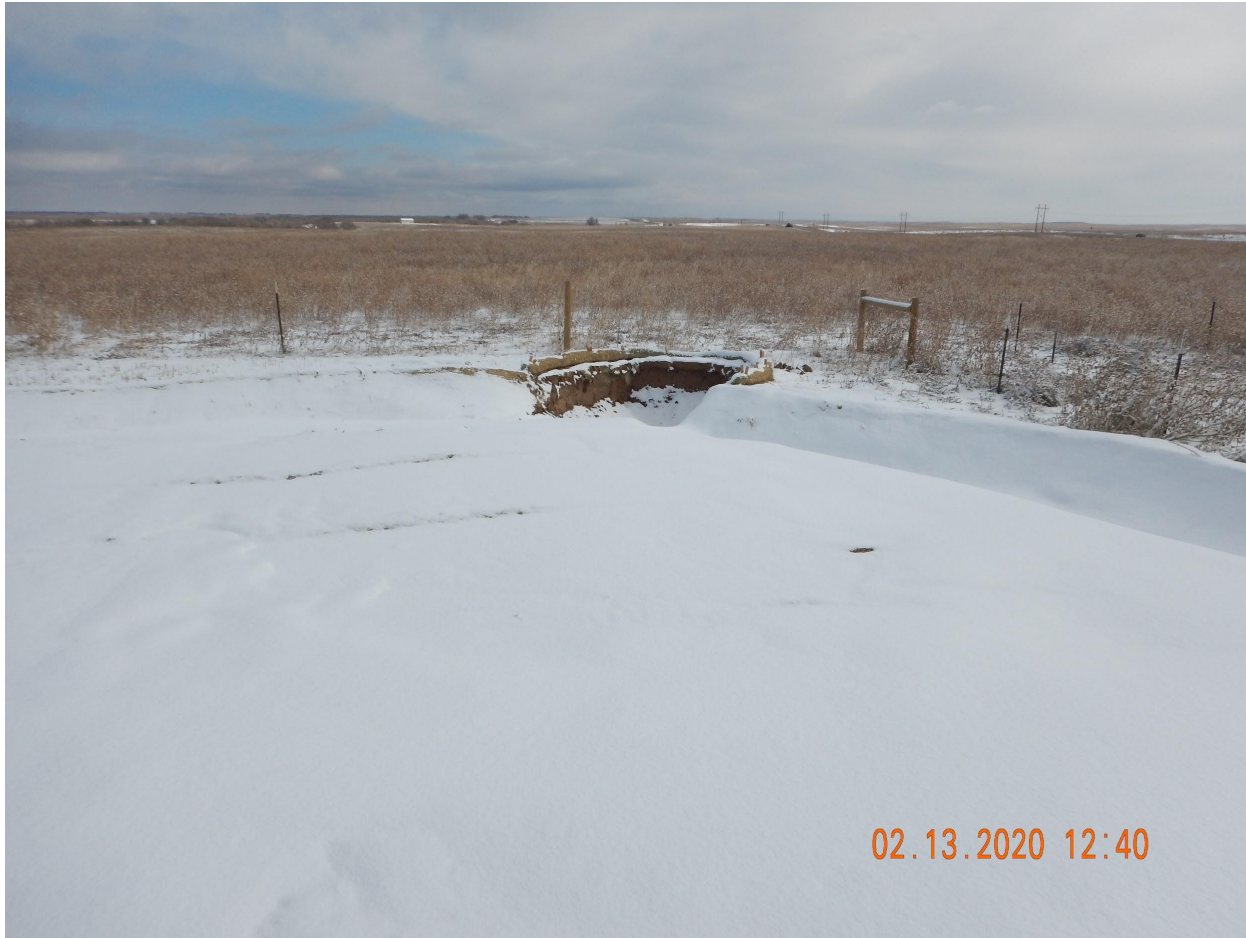
**Photo 1.** Photo taken from the southeastern perimeter of location, facing East. Photo illustrates Operator appears to have installed a sediment trap. Per good engineering practices, a sediment trap should have side slopes of 2:1 or flatter and should have a stabilized outlet. The above sediment trap has vertical side slopes that are susceptible to sloughing and no stabilized outlet. Wattles are not intended to filter stormwater but rather pool stormwater.

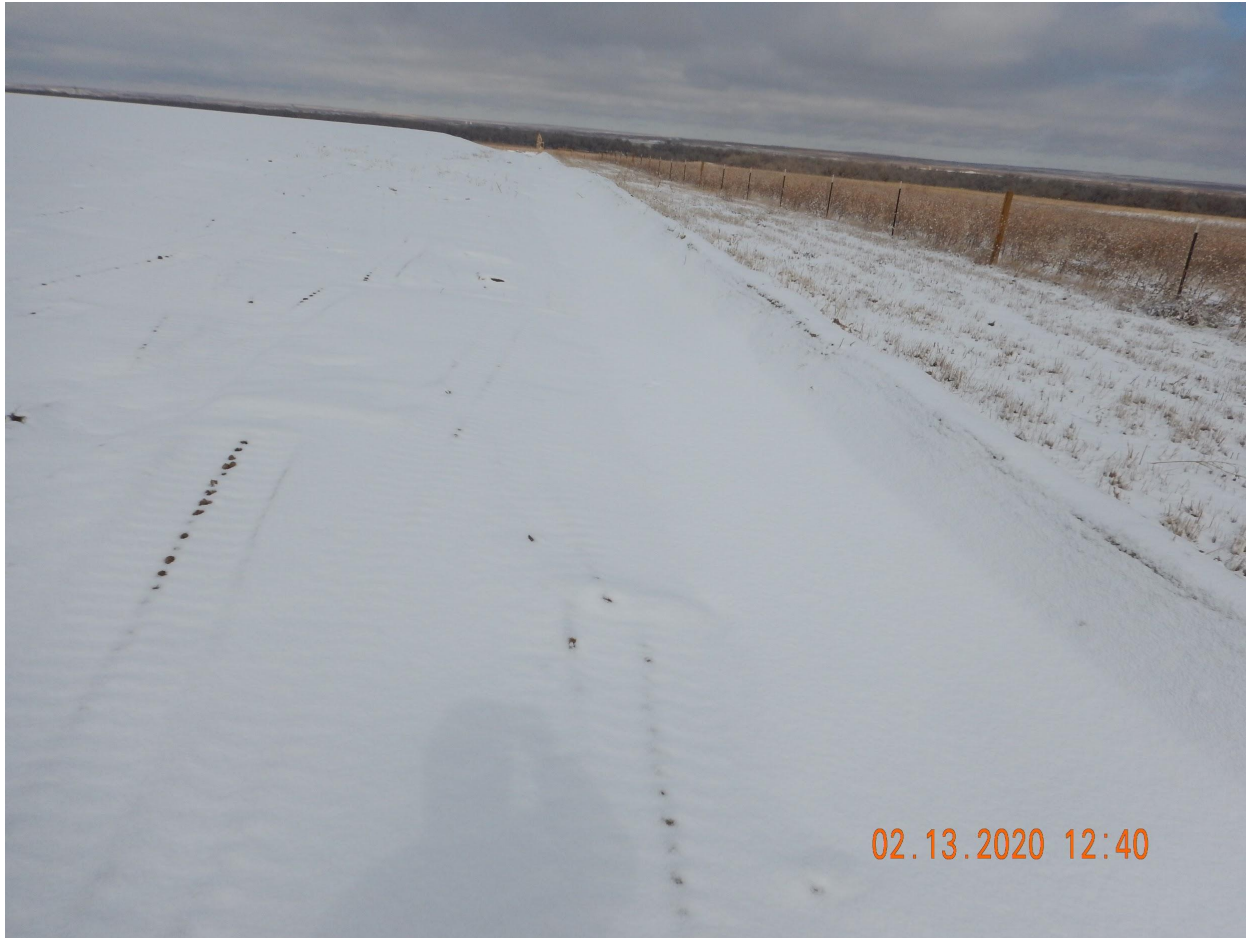
**Photo 2.** Photo taken from the eastern perimeter of location, facing North. Photo illustrates Operator appears to have made improvements to the ditch BMP and installed a ditch and berm BMP.

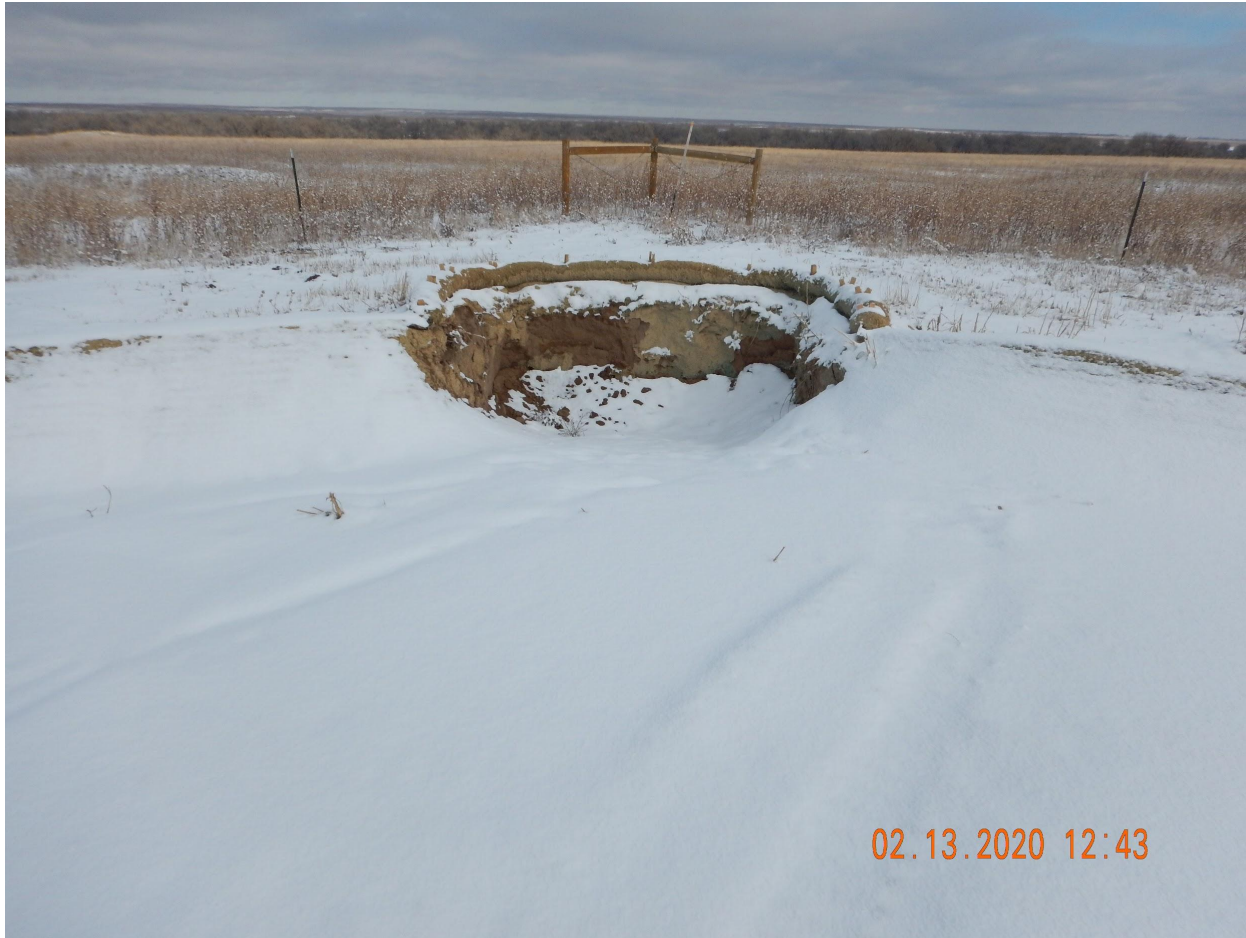
**Photo 3.** Photo taken from the northeastern perimeter of location, facing East. See comments under Photo 1. Note, with the vertical side slopes, it appears sloughing is already evident. It appears the Operator has also applied hydromulch but that did not prevent sloughing.

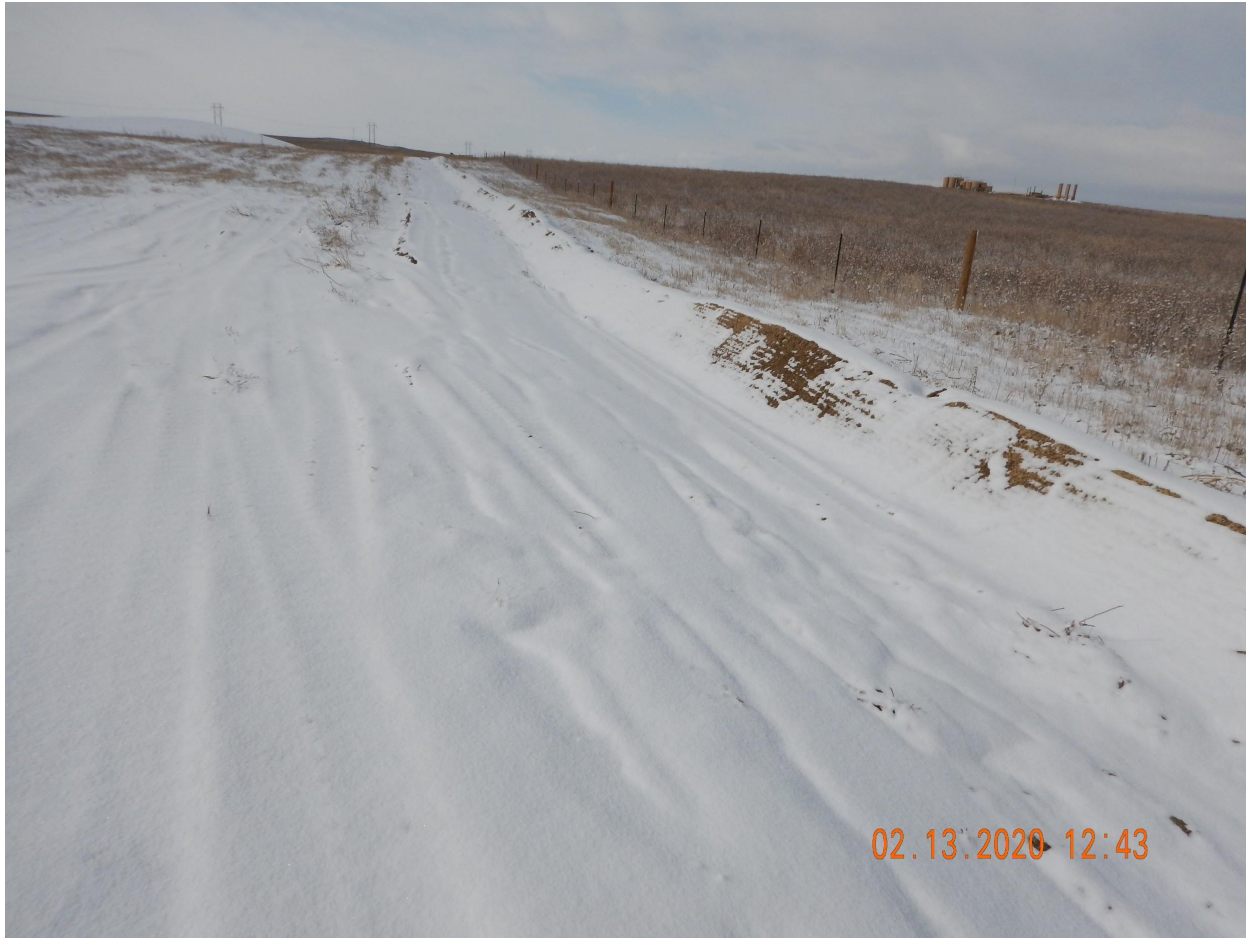
**Photo 4.** Photo taken from the northeastern perimeter of location, facing West. See comments under Photo 2.

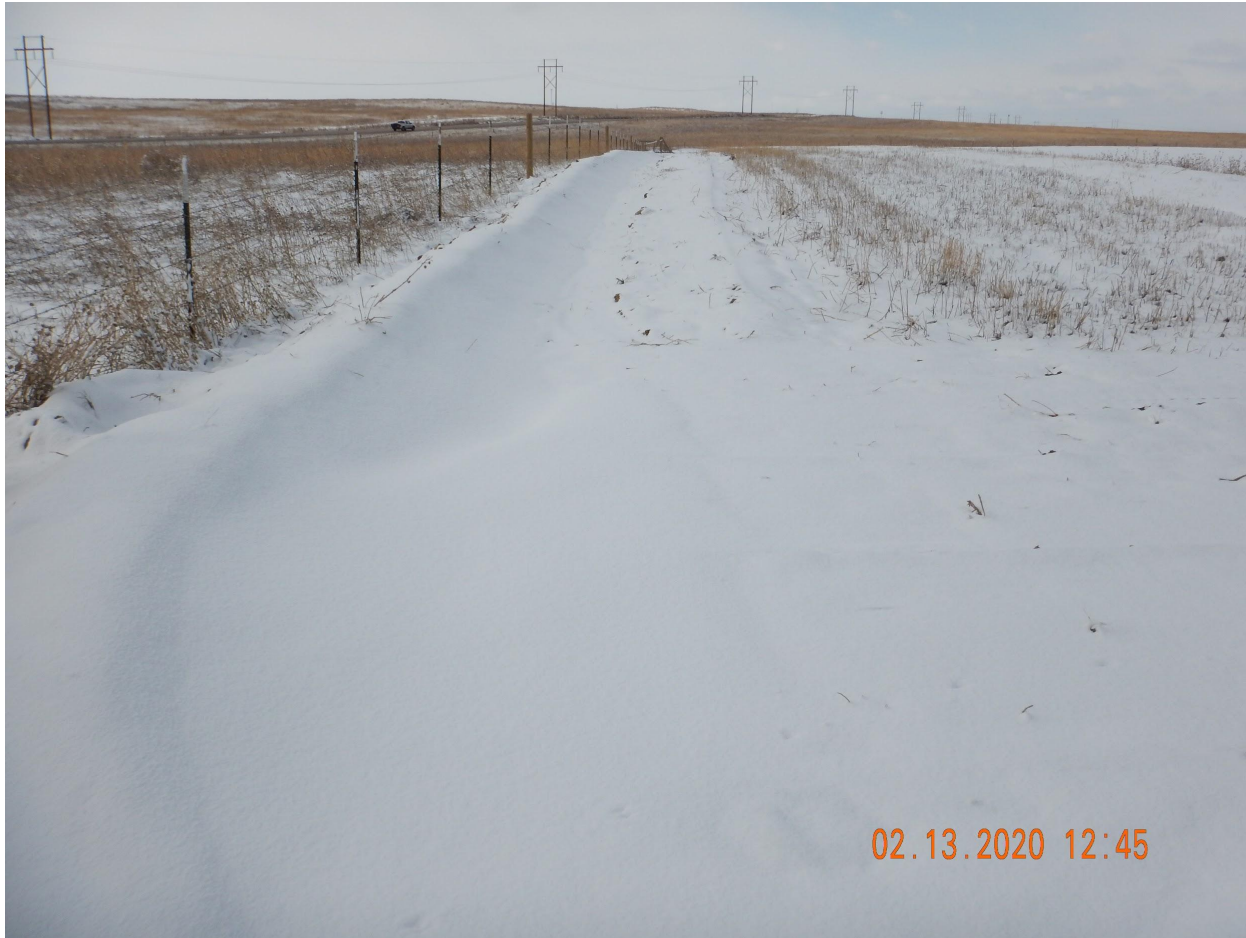
**Photo 5.** Photo taken from the southern perimeter of location, facing West. See comments under Photo 2.
