Inspection Photos

Facility Name: North Parachute Ranch EP Waste Mgmt

Facility ID: #120803 & #470699

Inspection Date: February 20, 2020

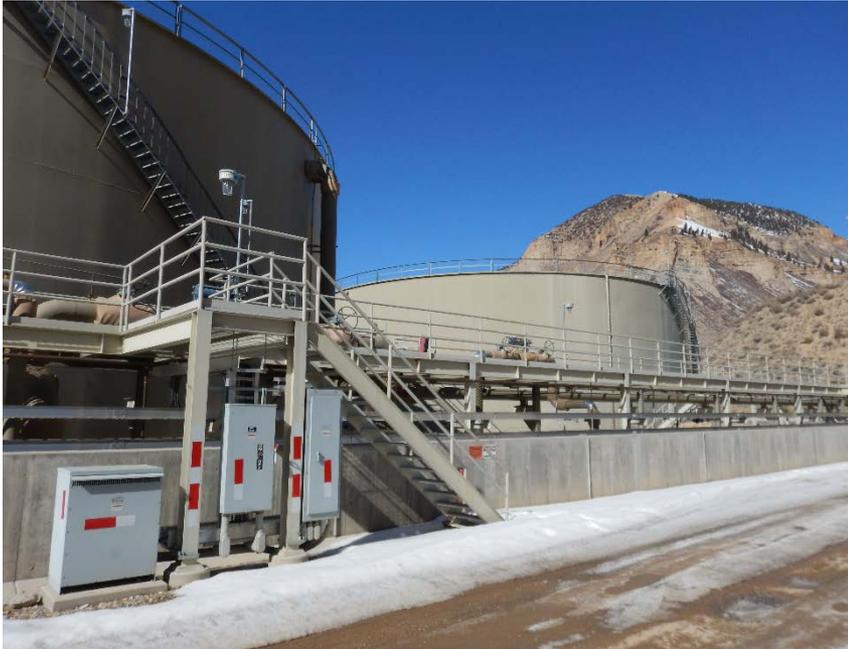
Photo #1 – View of west tank battery, looking northwest.

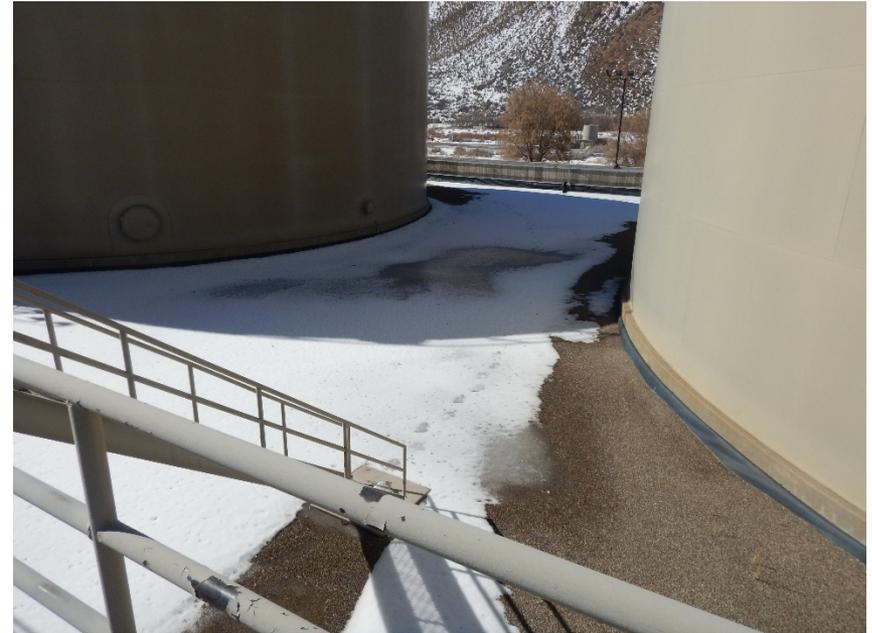
Photo #2 – West tank battery contained localized snow and ice on inspection date.

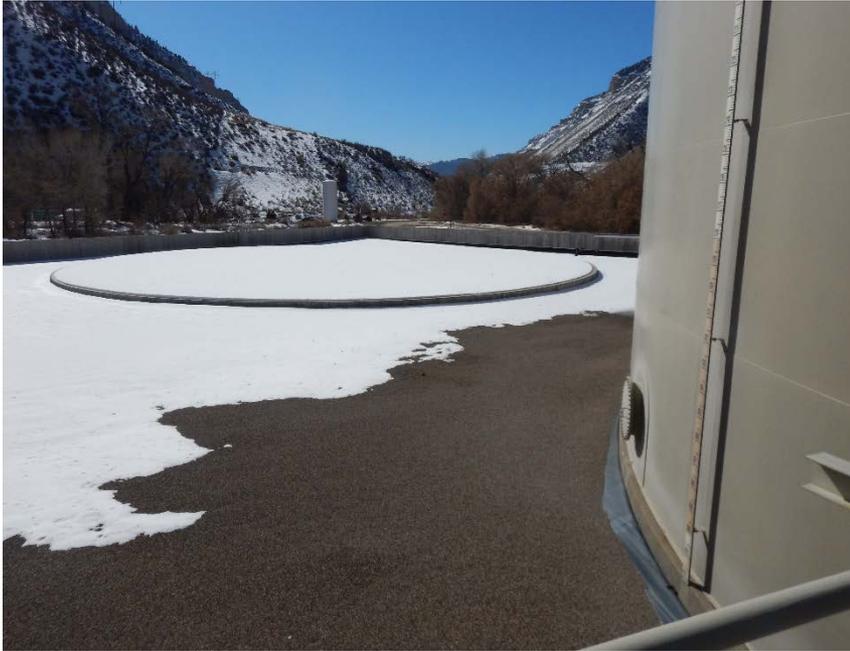
Photo #3 – Snow inside of south end of secondary containment for west tank battery, looking south.

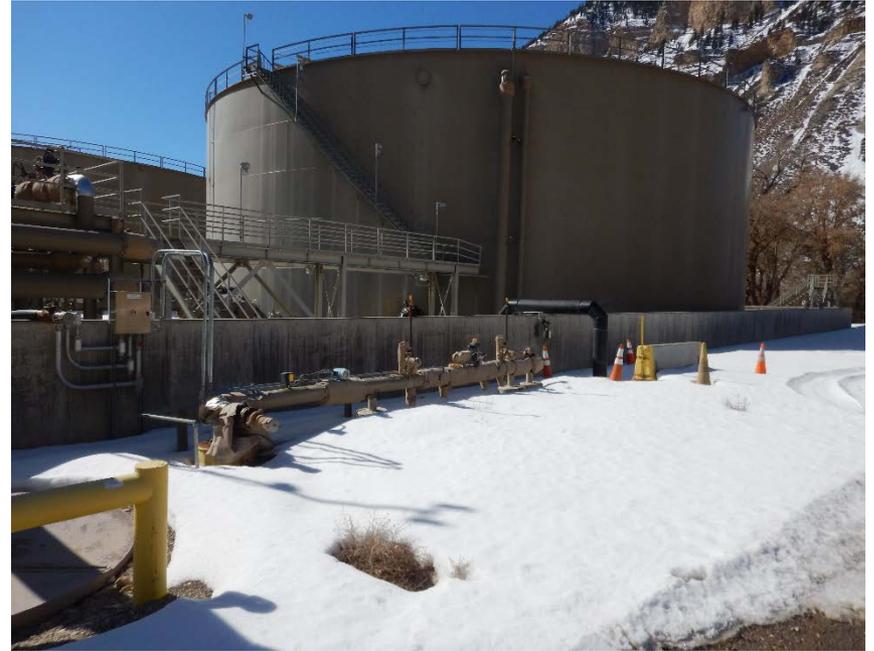
Photo #4 – Loadout on north side of west tank battery.

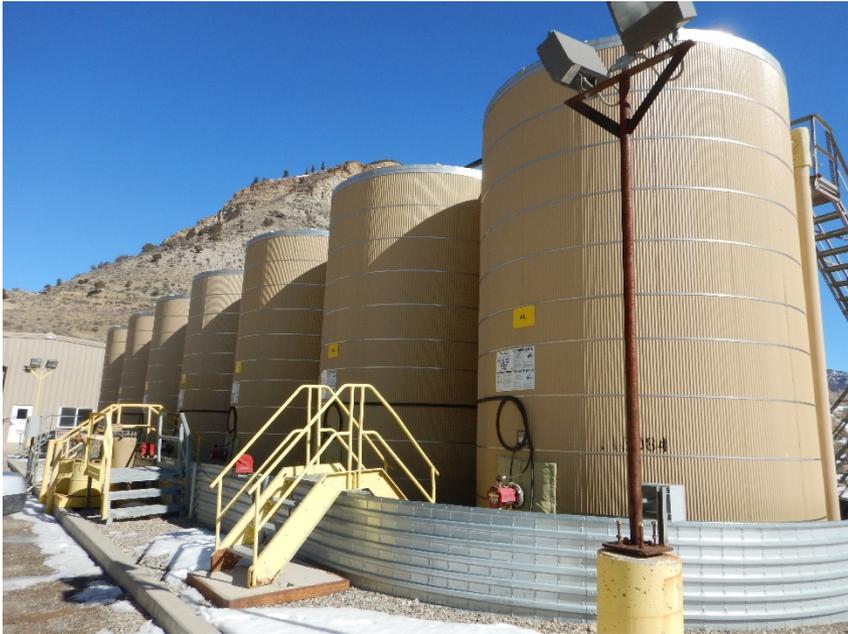
Photo #5 – View of tank battery located south of DAF building, looking northeast.

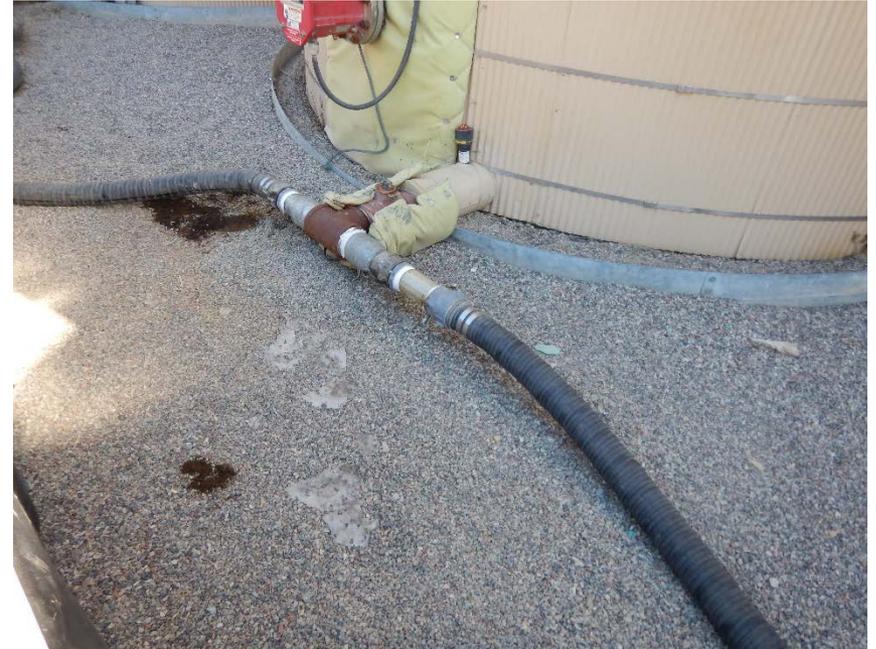
Photo #6 – Localized accumulation of oily waste beneath hose fittings on west side of tank battery.

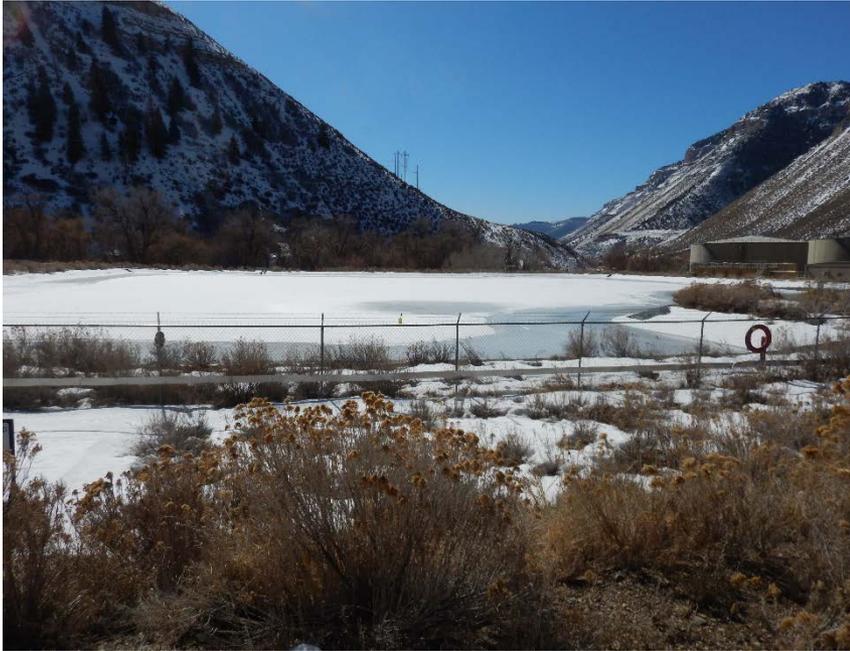
Photo #7 – Overview of fresh water pit located east of tank batteries, looking south.

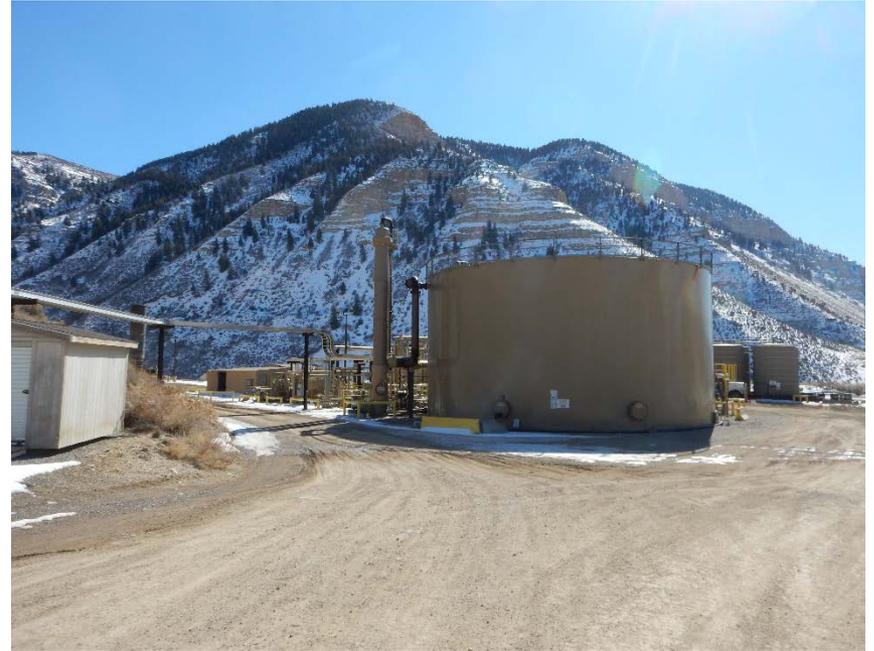
Photo #8 – Overview of "white tank" area and upper condensate tank battery, located ~560' north of DAF building.

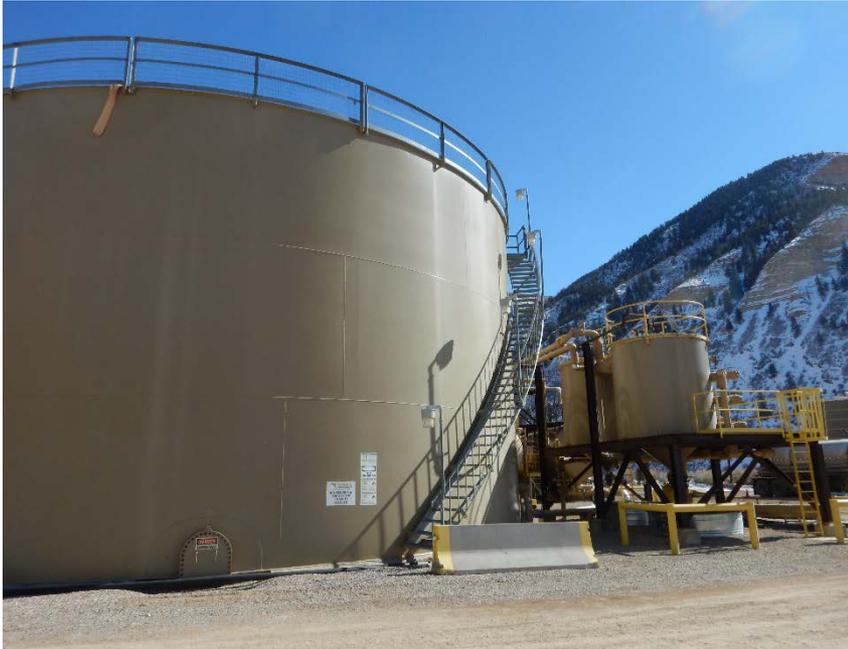
Photo #9 – View of 15,000 bbl produced water/condensate AST and two 110 bbl ASTs in “white tank” area, looking east.

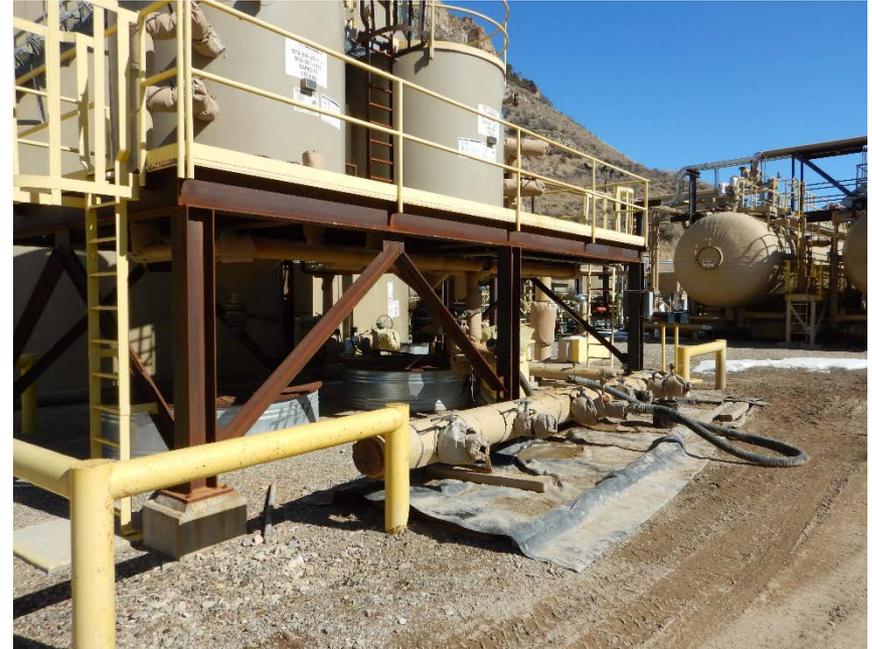
Photo #10 – Truck loadout manifold with hose located on south side of 15,000 bbl produced water/condensate AST.

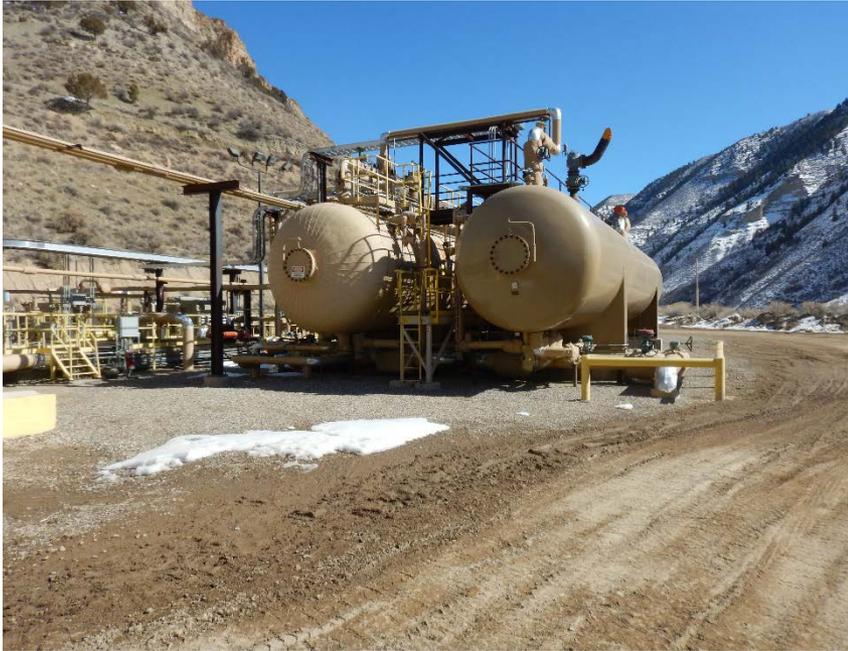
Photo #11 – Horizontal separators located east of 15,000 bbl produced water/condensate AST.

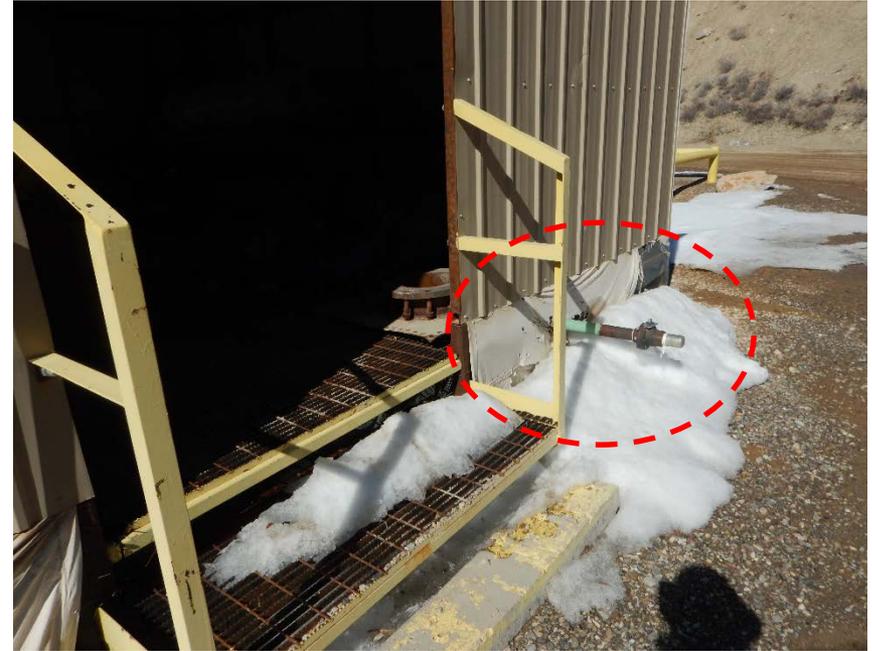
Photo #12 – Unmarked, 2" pipe with valve and bullplug located on east side of shed.

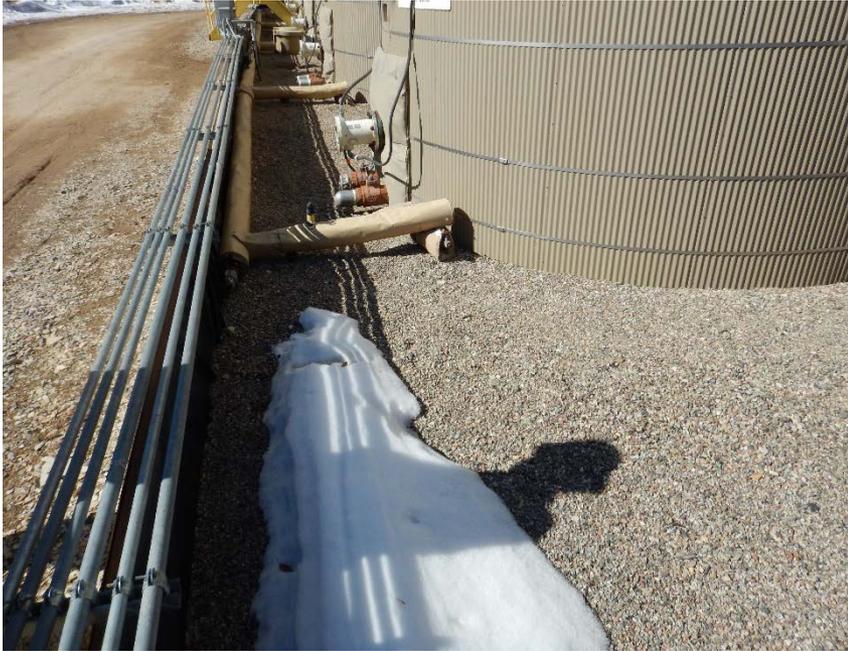
Photo #13 – View into south side of secondary containment for upper condensate tank battery in “white tank” area.

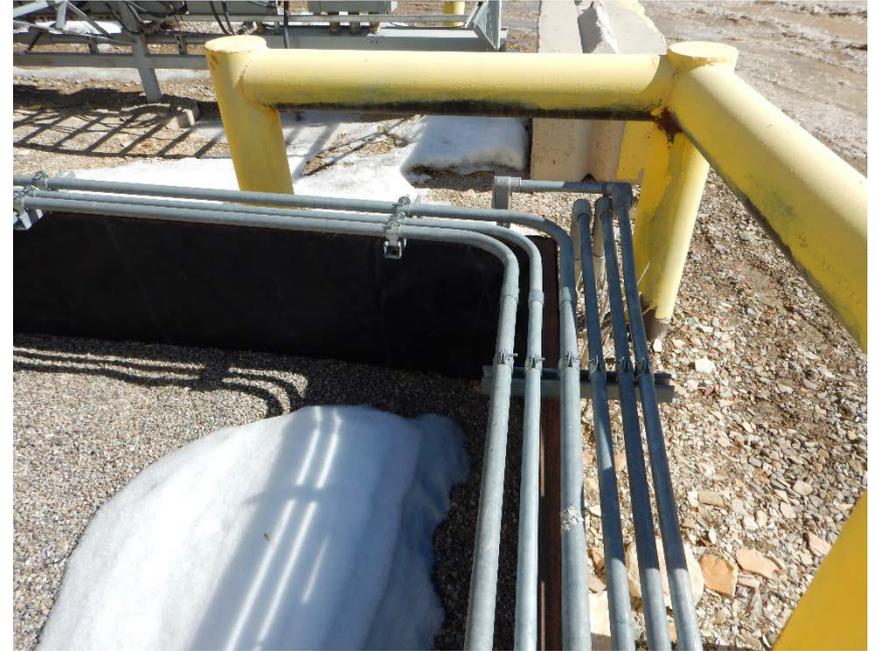
Photo #14 – View of southeast corner of secondary containment for upper condensate tank battery in “white tank” area. The secondary containment liner in this area had been repaired in response to previous FIR #69810063.

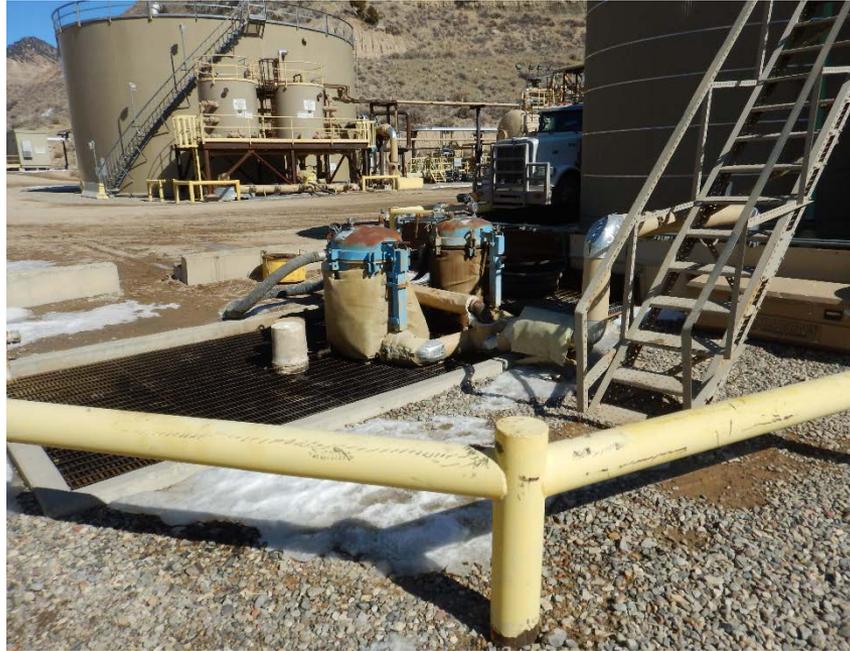
Photo #15 – View of truck loadout area of upper condensate tank battery, looking north.
