Location Name: – Ward and Son Operating – Rem #8069, 14588
Inspection Date: 02/18/2020

COLORADO
Oil & Gas Conservation
Commission
Department of Natural Resources

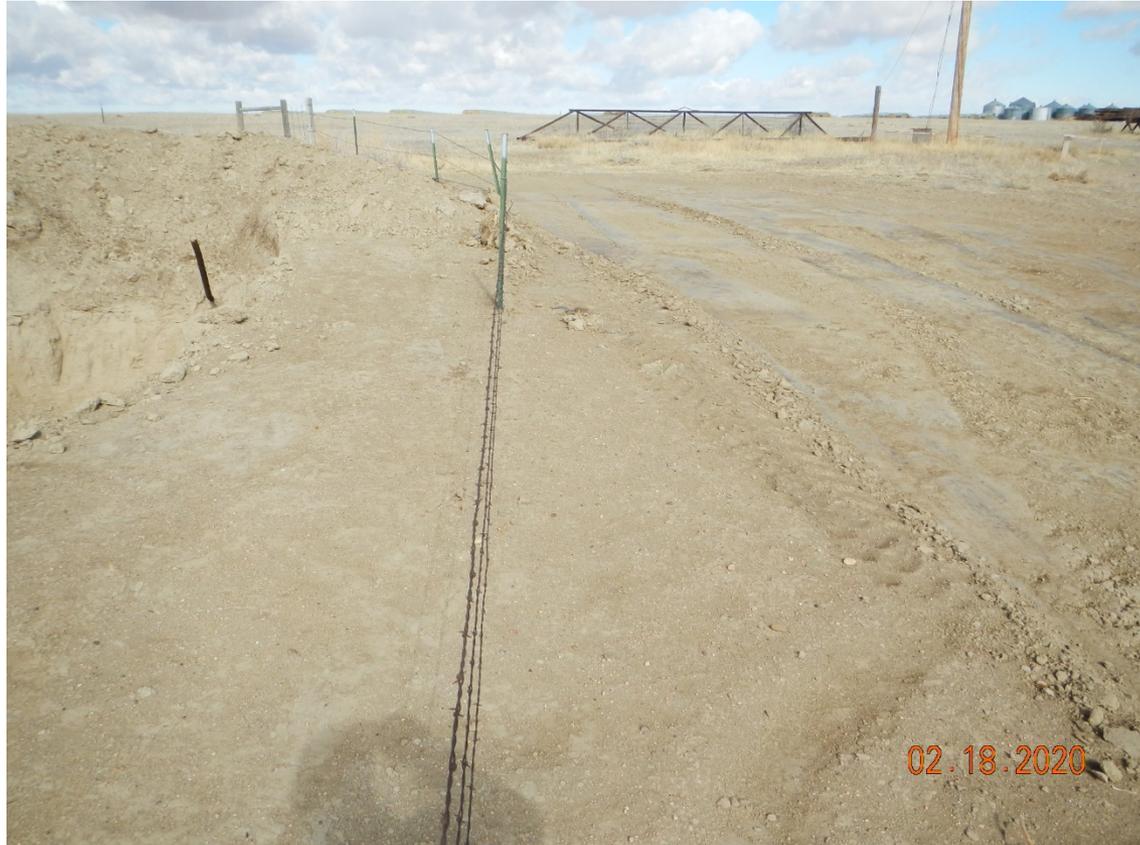
Photo # 2 – Oily soil stockpile has been removed, former oil skim pit cage remains on location

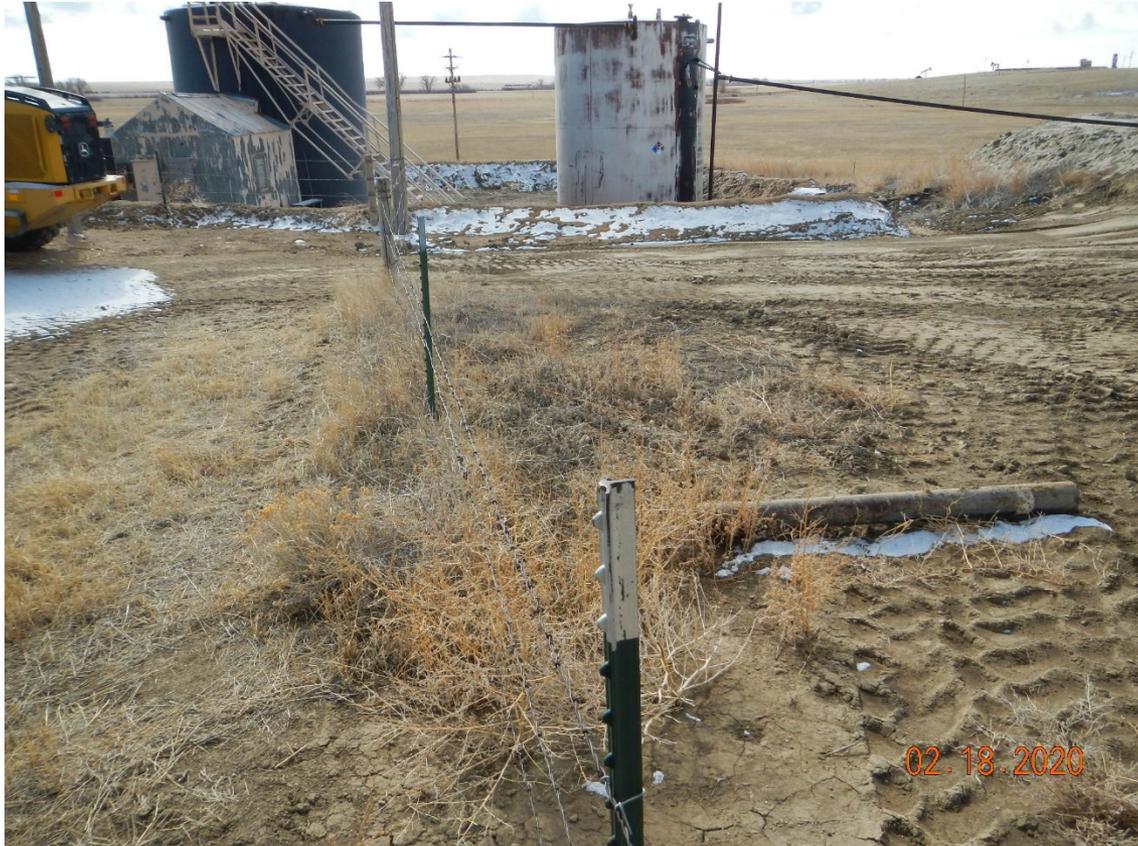
Photo # 3 – Oily soil stockpile has been removed

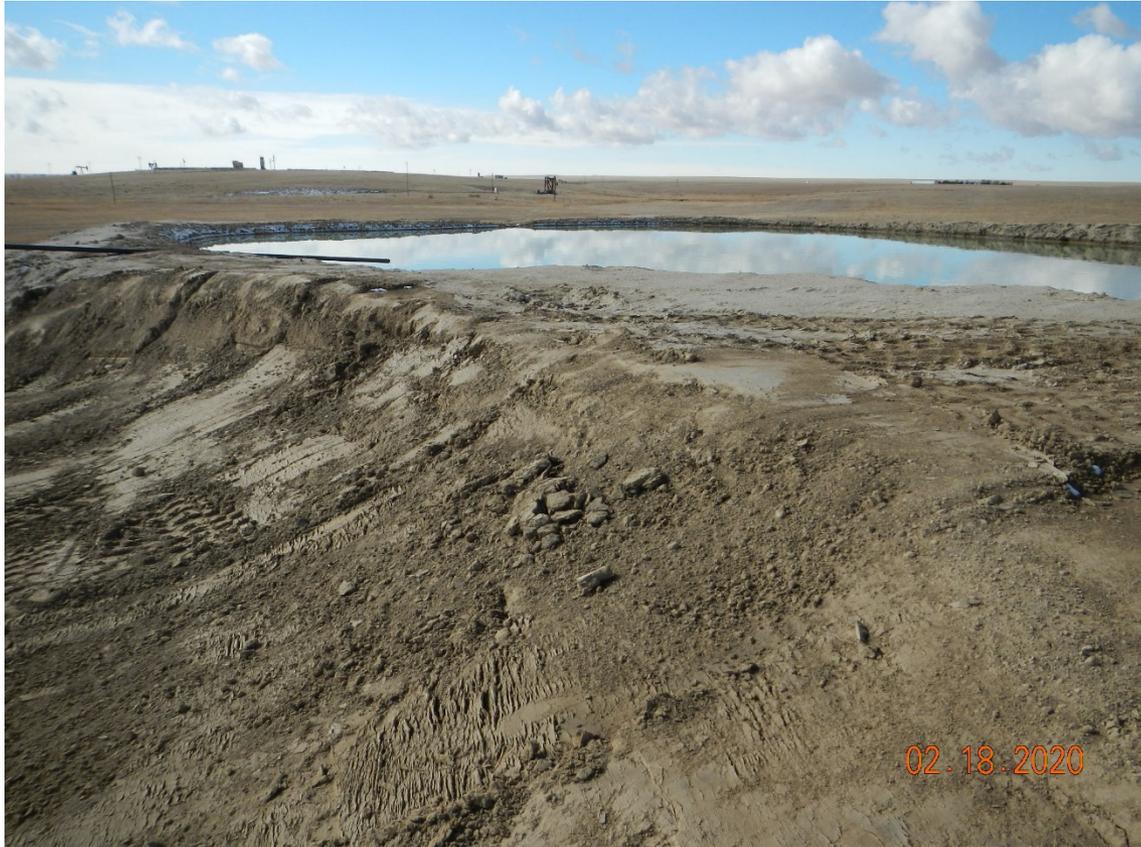
Photo # 4 – Pit 117462 not maintaining 2 feet of freeboard, probably 4” of freeboard. Spill 465823 and Rem 14588 related to this pit

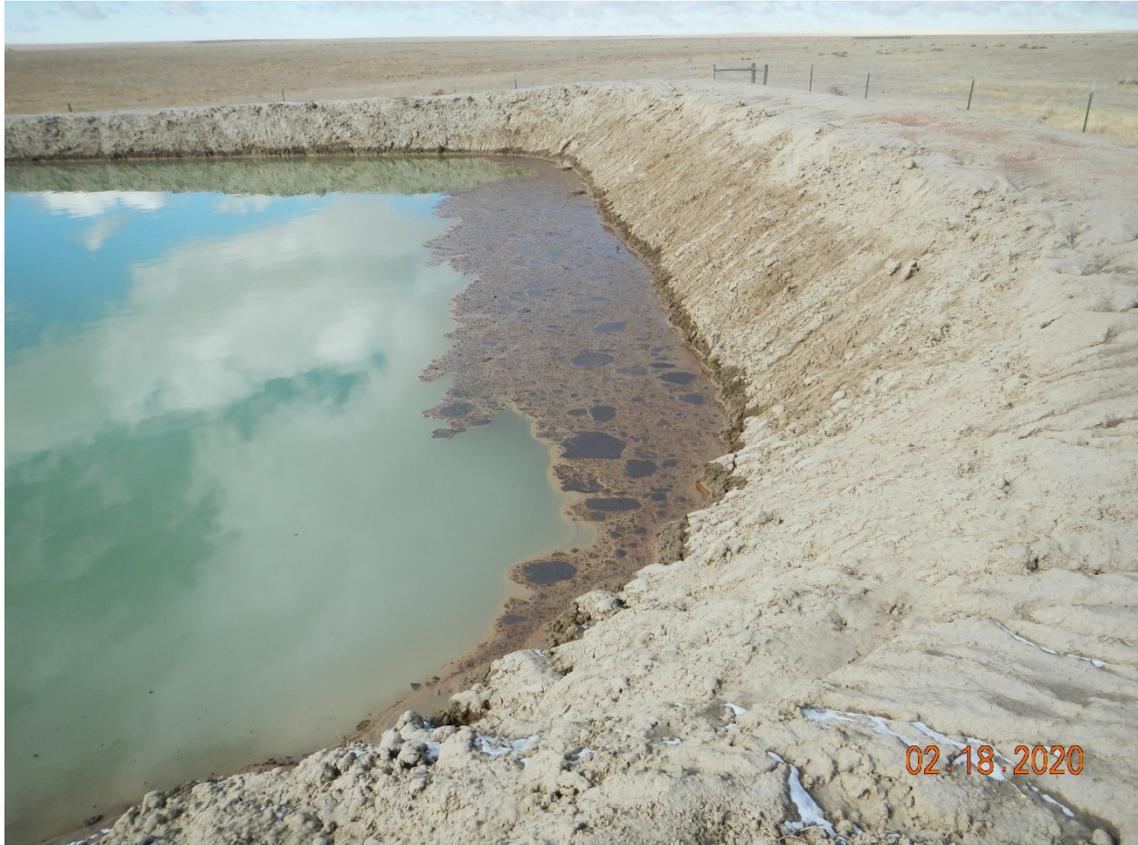
Photo # 5 – Pit 117462 not maintaining 2 feet of freeboard, oil accumulation on surface at north end due to wind direction

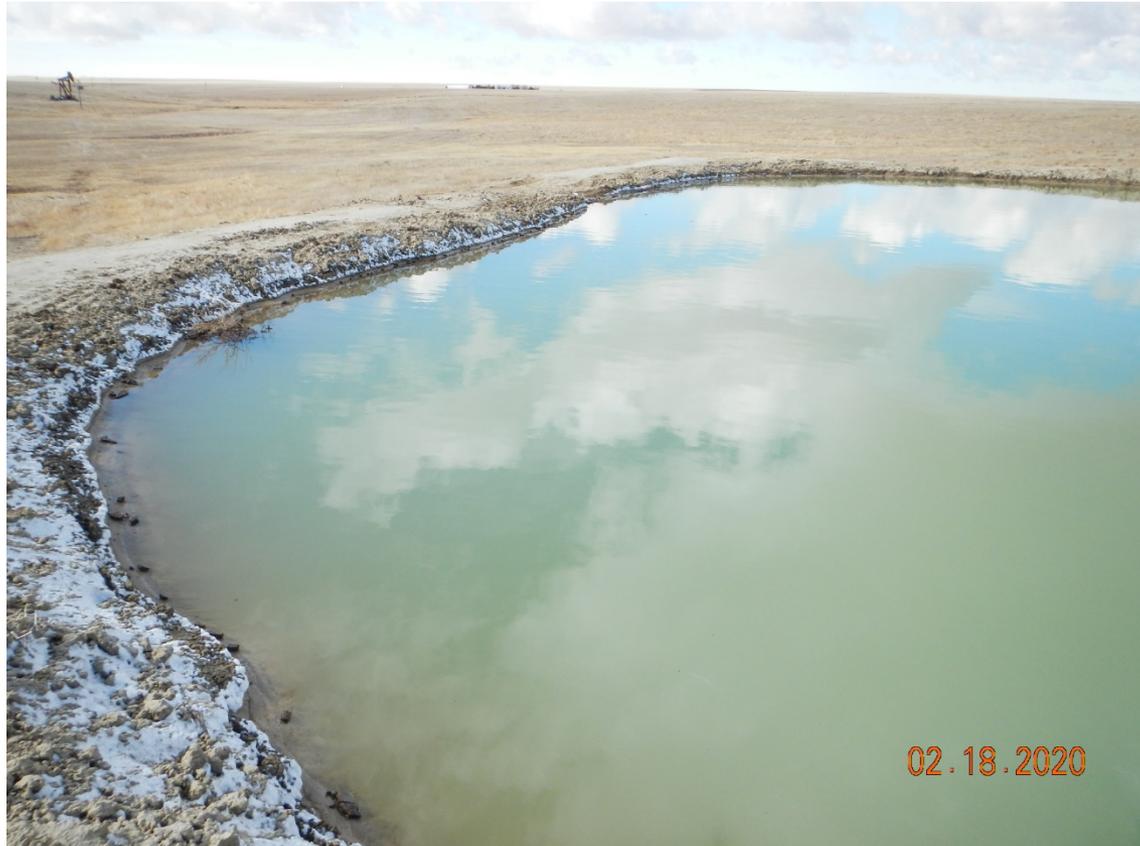
Photo # 6 – Pit 117462 not maintaining 2 feet of freeboard, view southwest

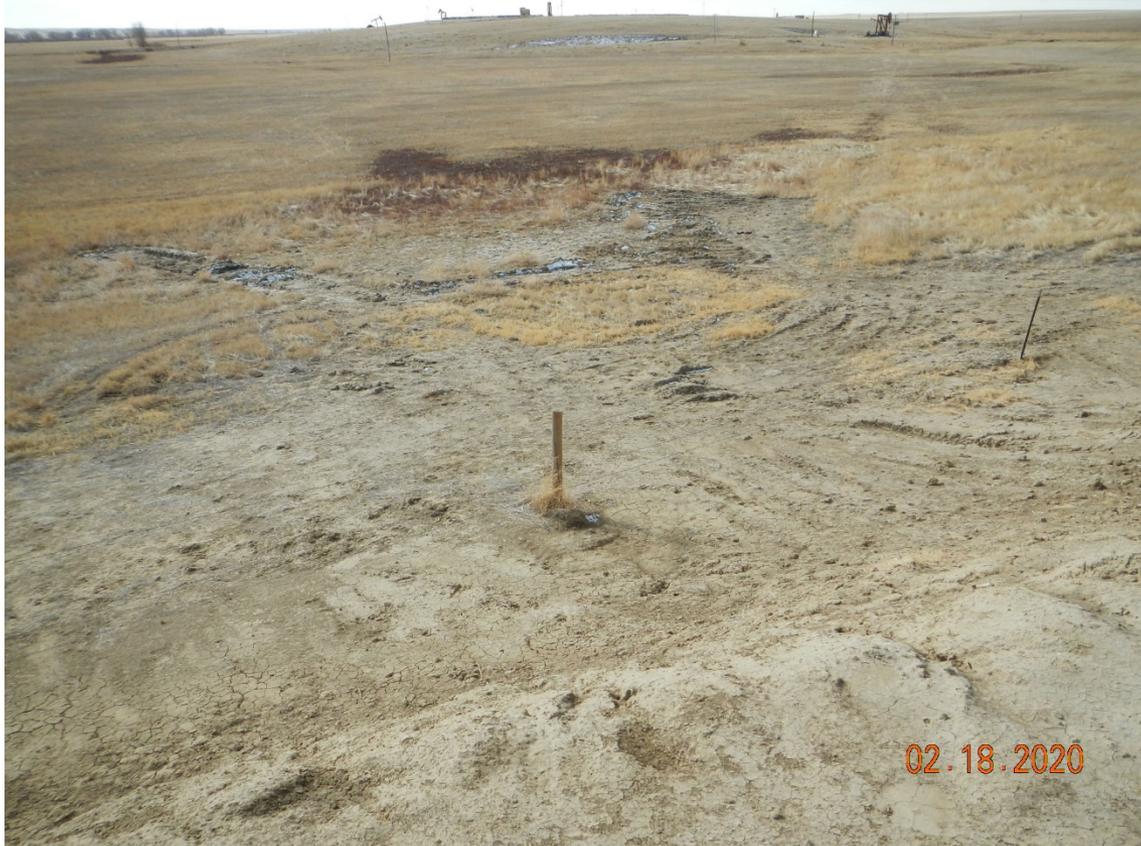
Photo # 7 – Pit 117462 spill area south of pit (Spill 465823, Rem 14588)

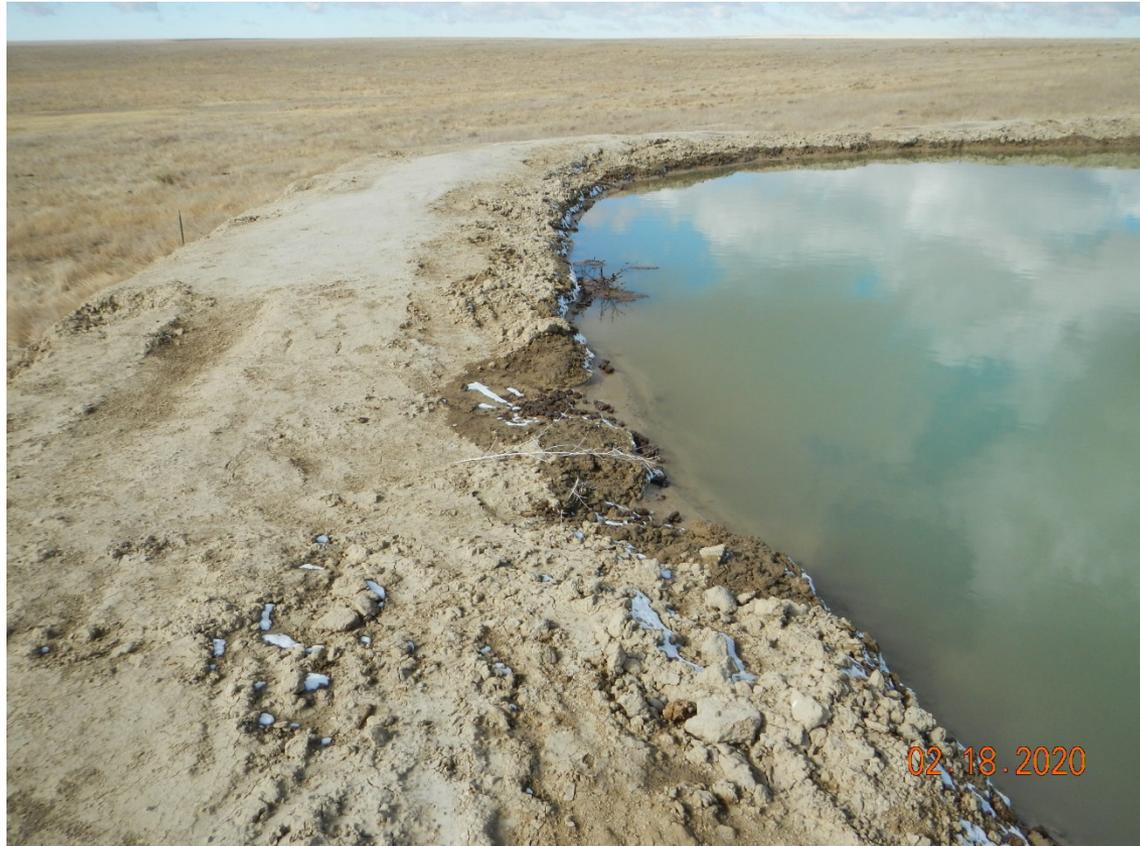
Photo # 8 – Pit 117462 not maintaining 2' of freeboard, wind caused waves could erode and breach pit berm

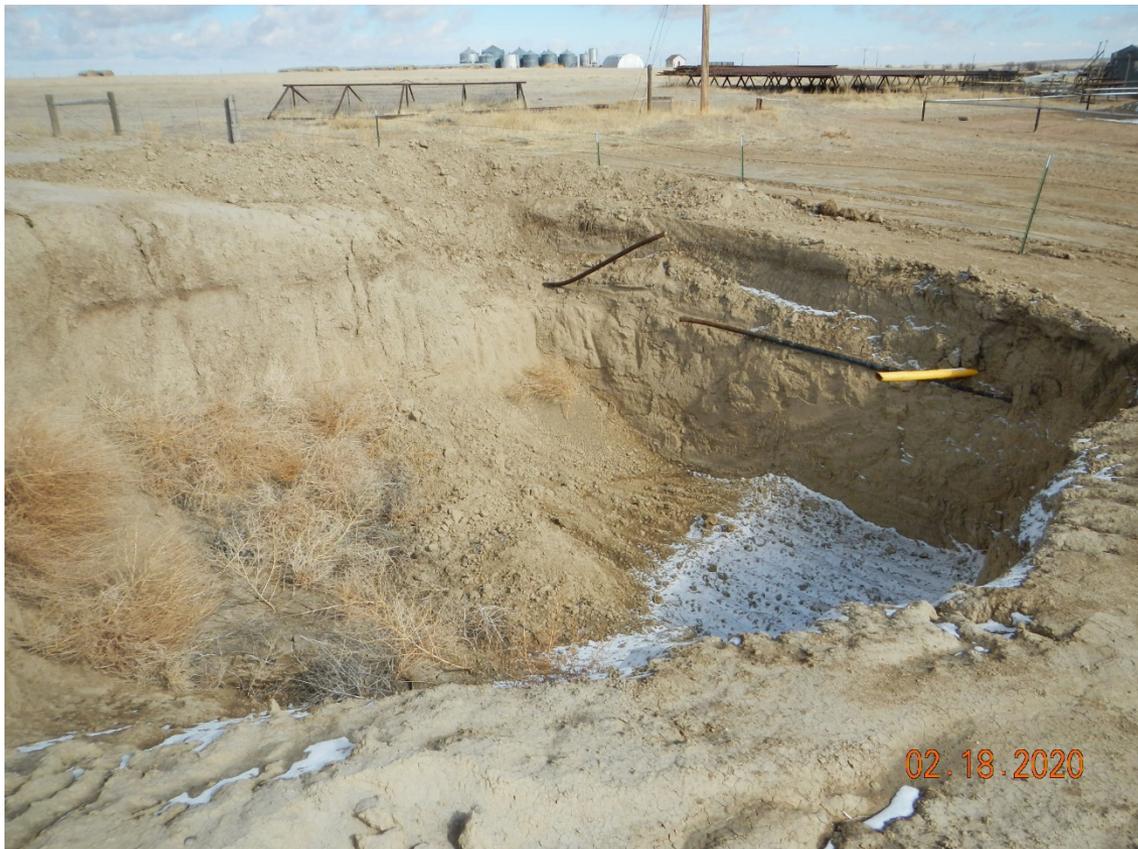
Photo # 10 – Pit 117790 Former oil skim pit, view northeast (Rem #8069)
