Banta Ridge 10-18-1-103

API: 05-103-10410

Inspection: 700400146

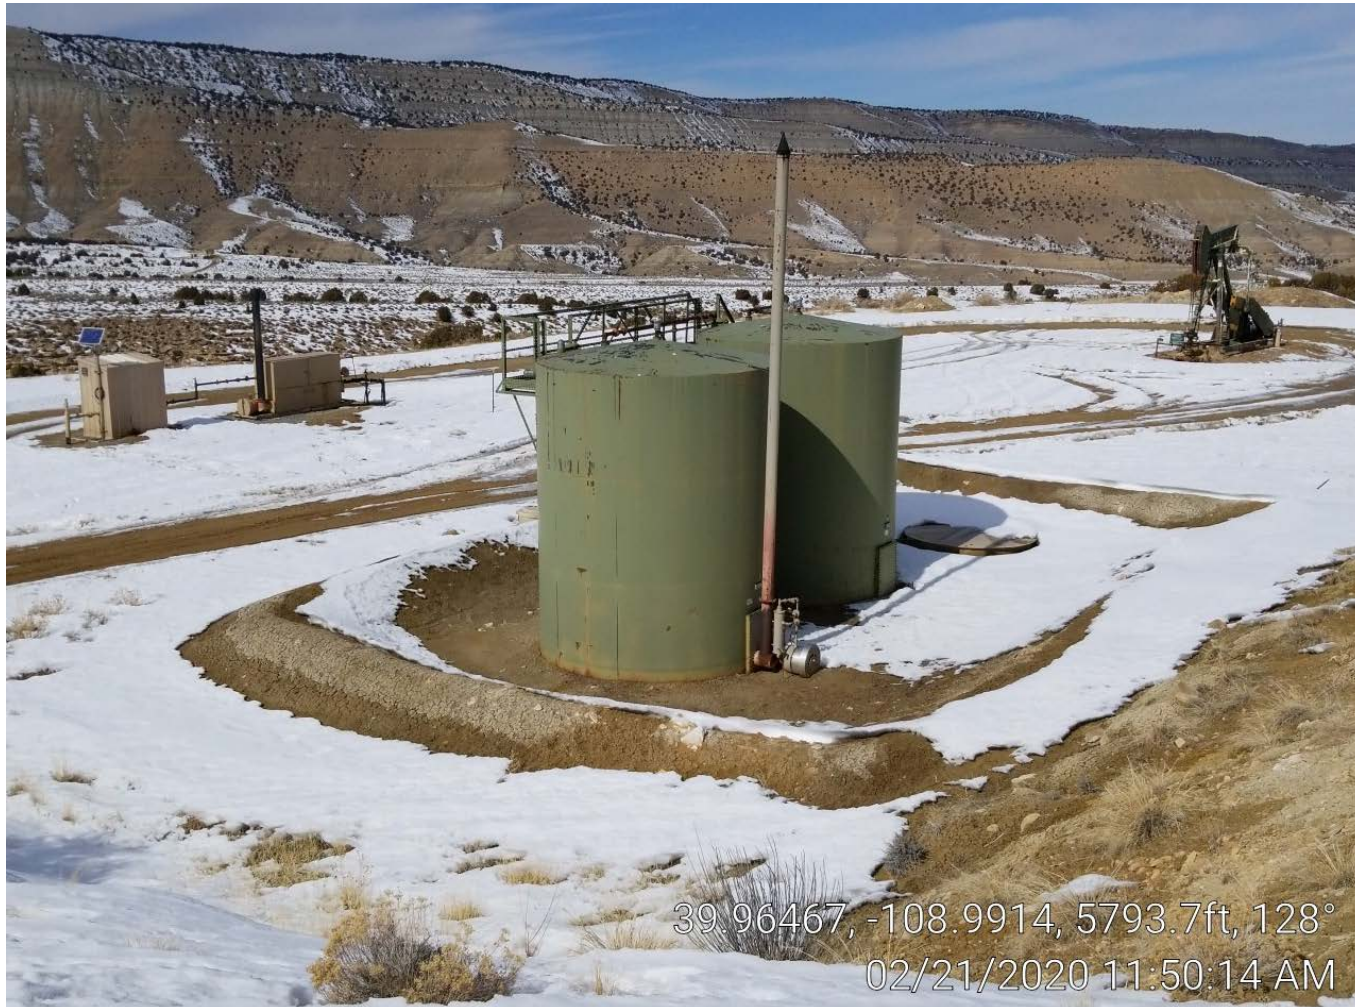
**Photo 1. Location.**

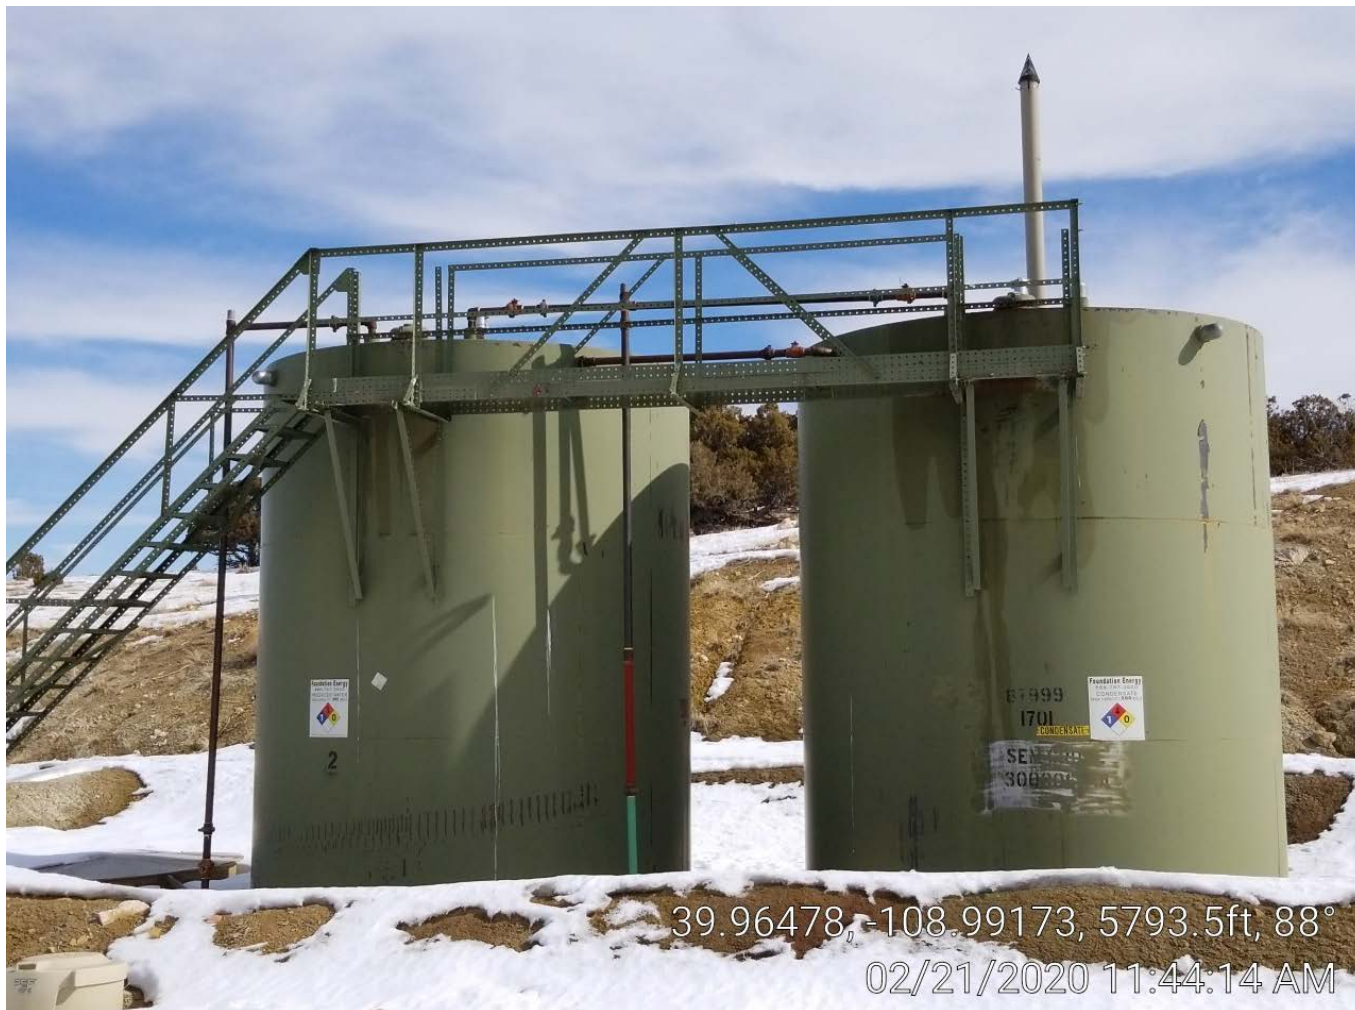
Photo 2. Tanks.

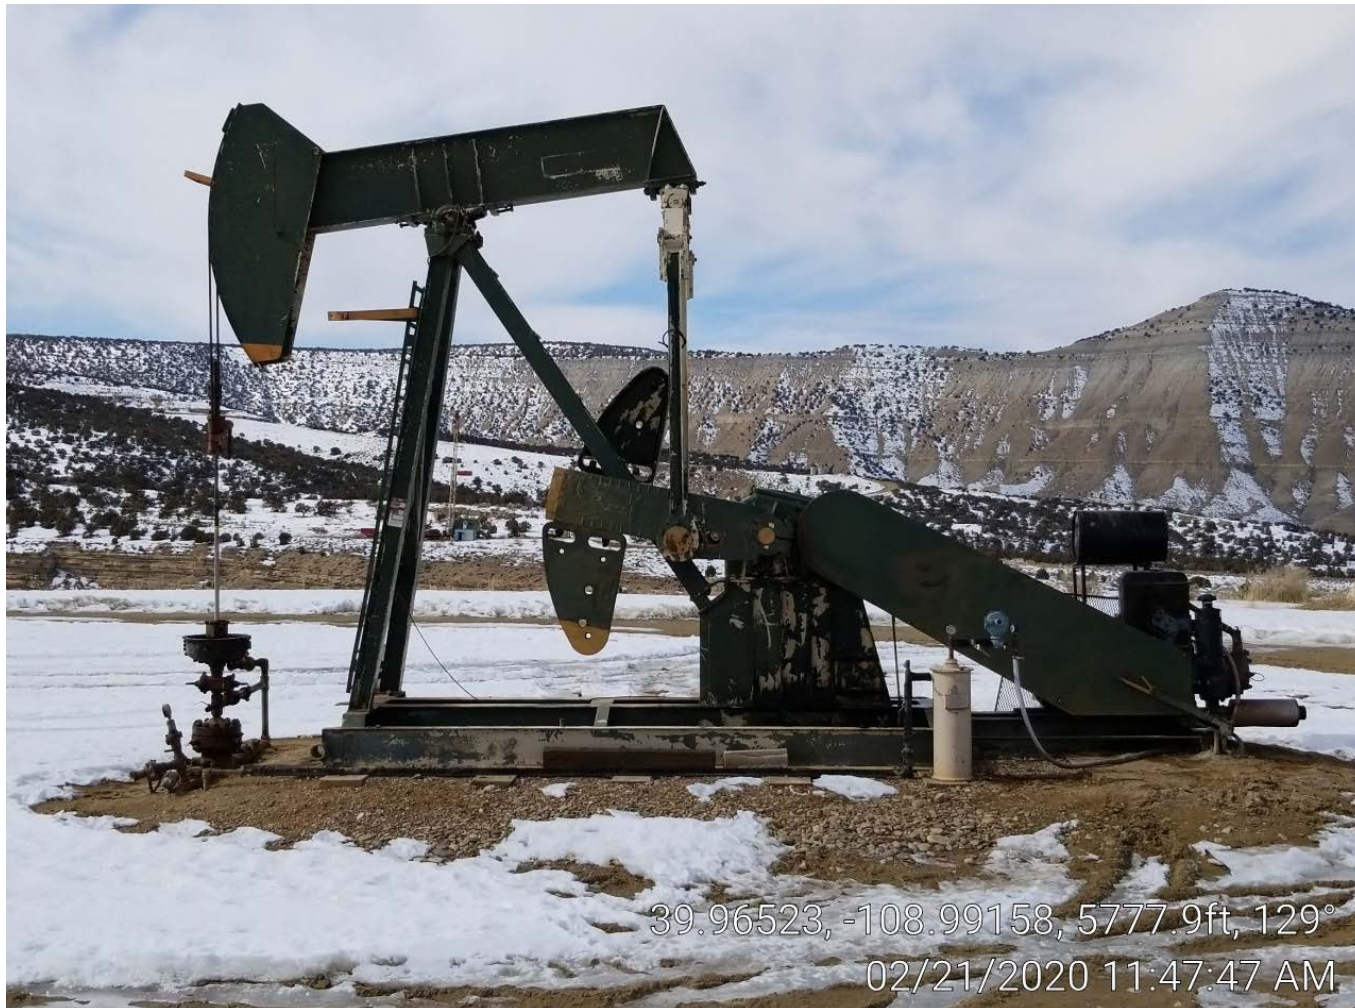
**Photo 3. Pump jack.**

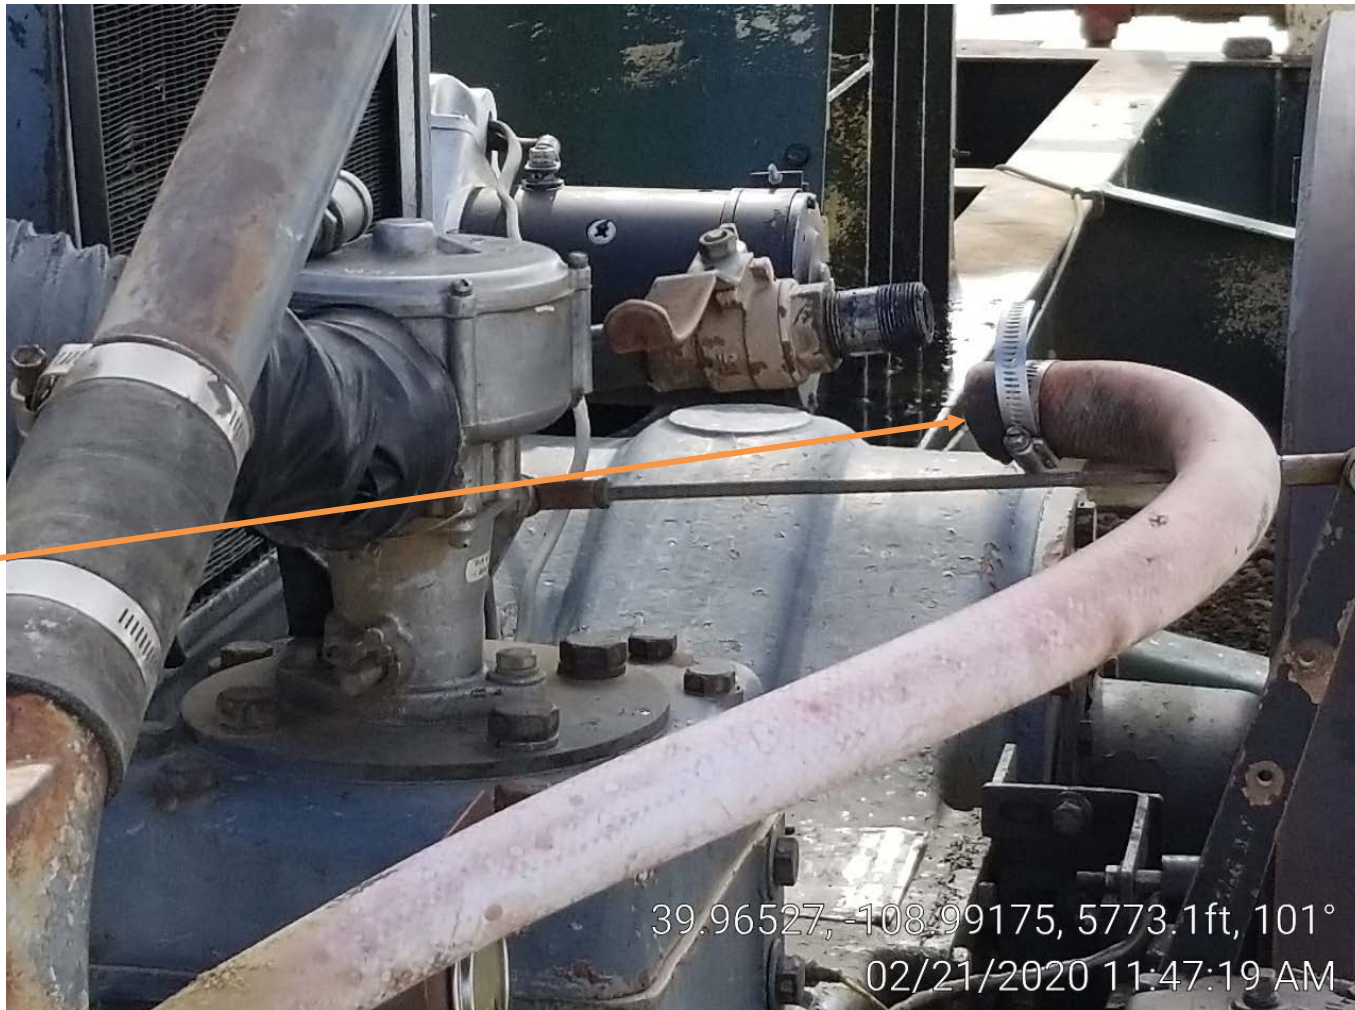
Gas leak

Photo 4. Gas leak at pump jack motor.

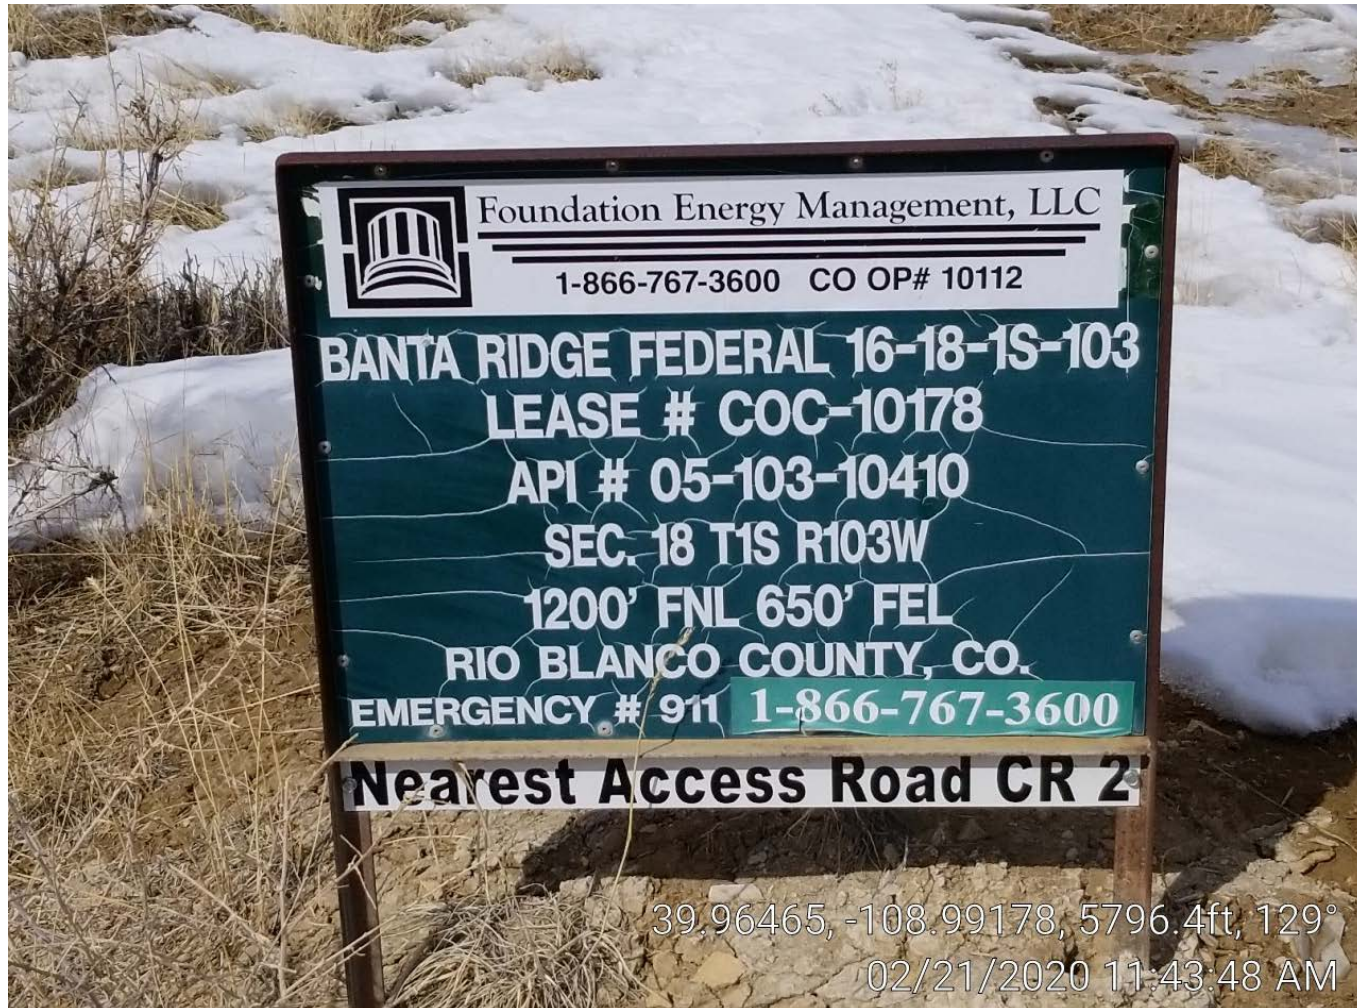
Photo 5. Battery sign.
