**Inspection Photos**  
**Location Name: Anschutz – O'Brien 5-61-33-57H**  
**Location ID: 430466**

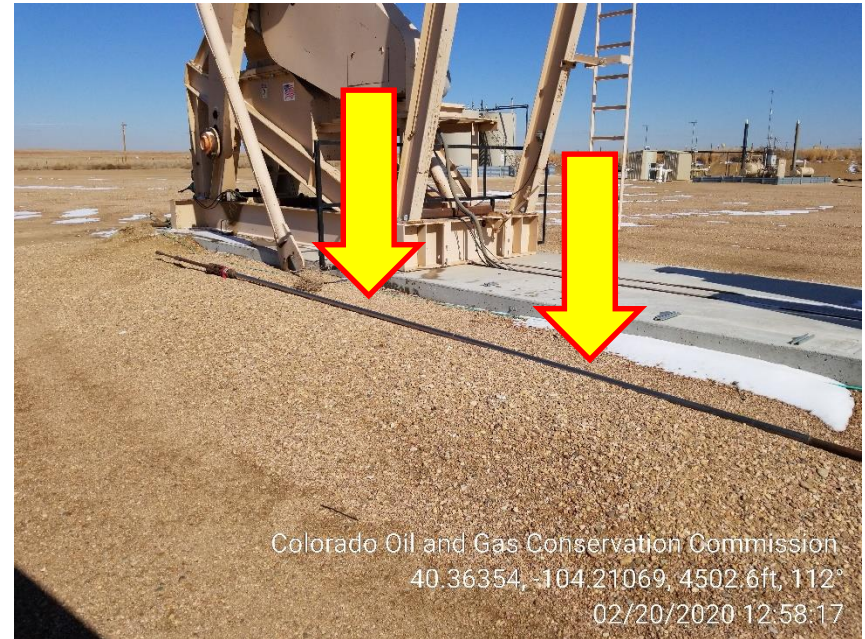
**Photo 2 – Unused Polish Rod at Pumping Unit**

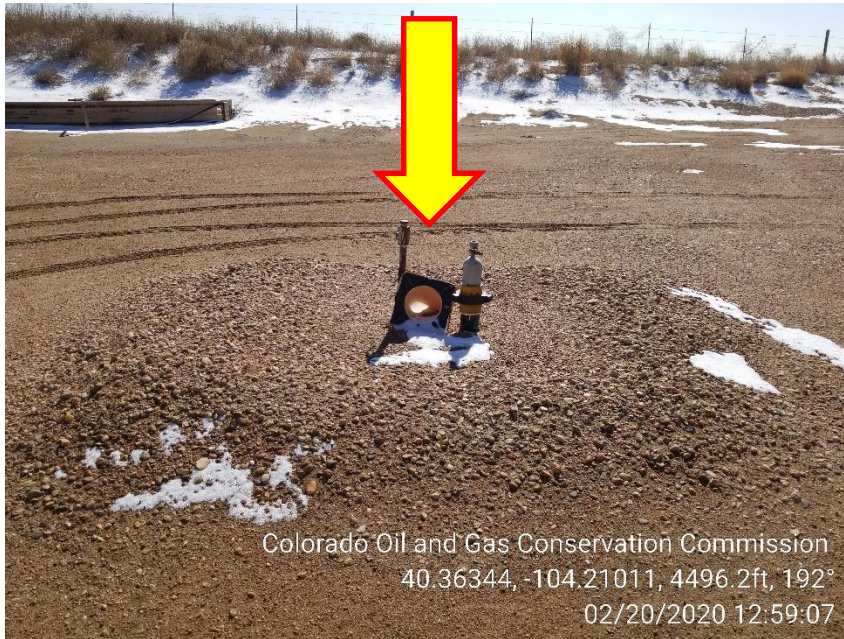
**Photo 3 – Unmarked Risers in the SE corner of location**

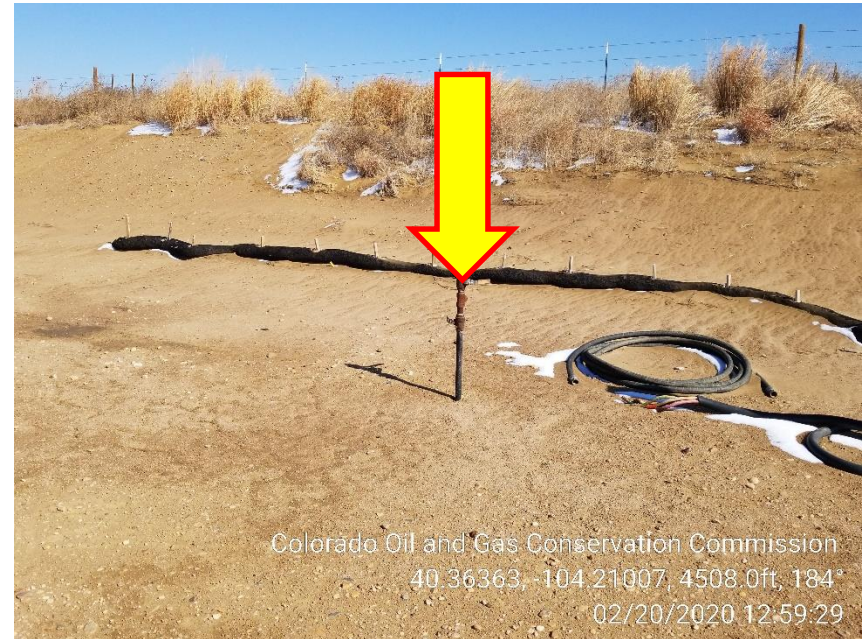
**Photo 4 – Unmarked Risers on the Eastside of location**

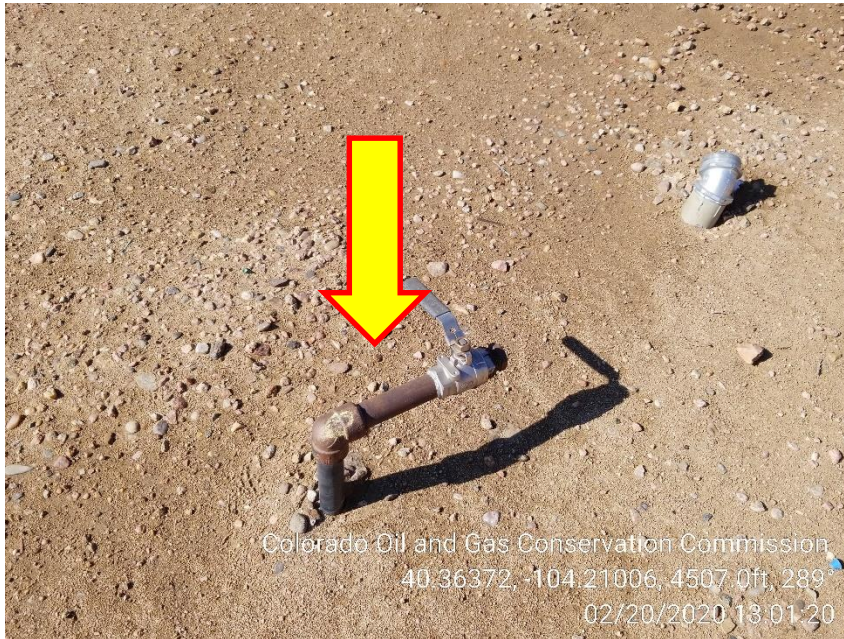
**Photo 5 – Unmarked Risers on the Eastside of location**

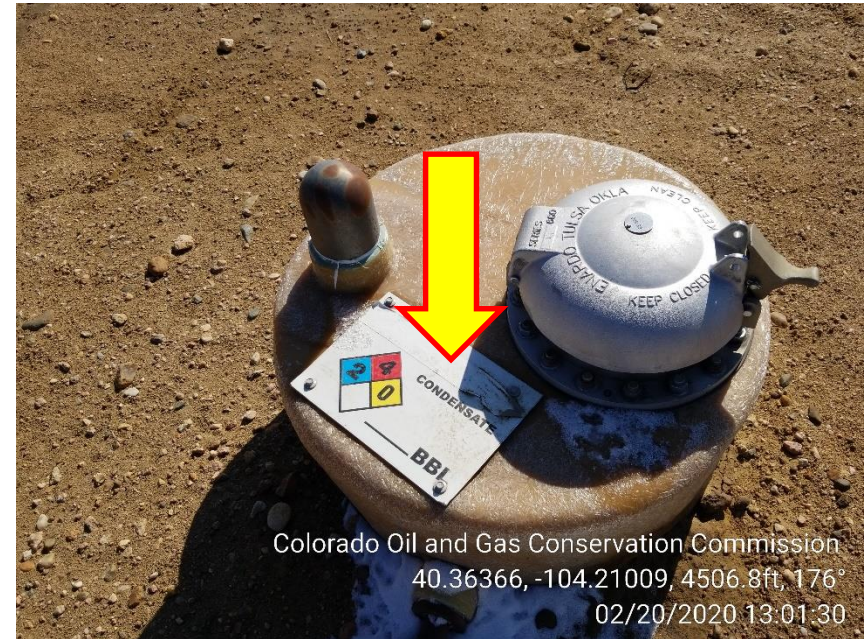
**Photo 6 – Condensate Tank missing Capacity**
