**Inspection Photos**  
**Divide Road Water Facility**  
**Location ID: #432790 & Facility ID: #432214**  
**Inspection Date: February 20, 2020**

**COLORADO**  
**Oil & Gas Conservation**  
**Commission**  
Department of Natural Resources

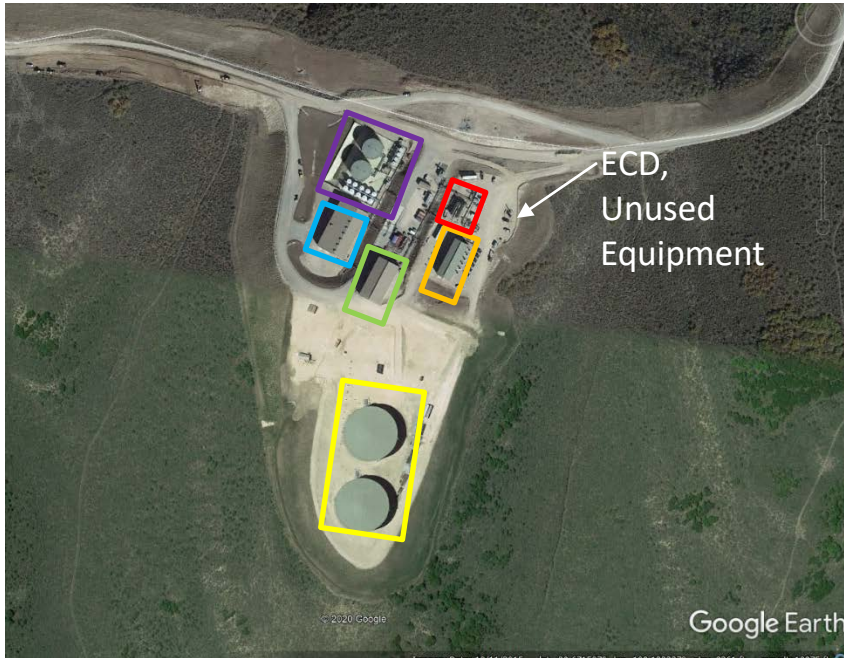
**Photo #1 – Google Earth Aerial of Facility ID #432214 dated 6/17/2016, color-coded to correspond to areas referenced in this Inspection Report.**

**Bullet separators, power generation, water storage tanks, pump building, DAF building, condensate tank battery.**

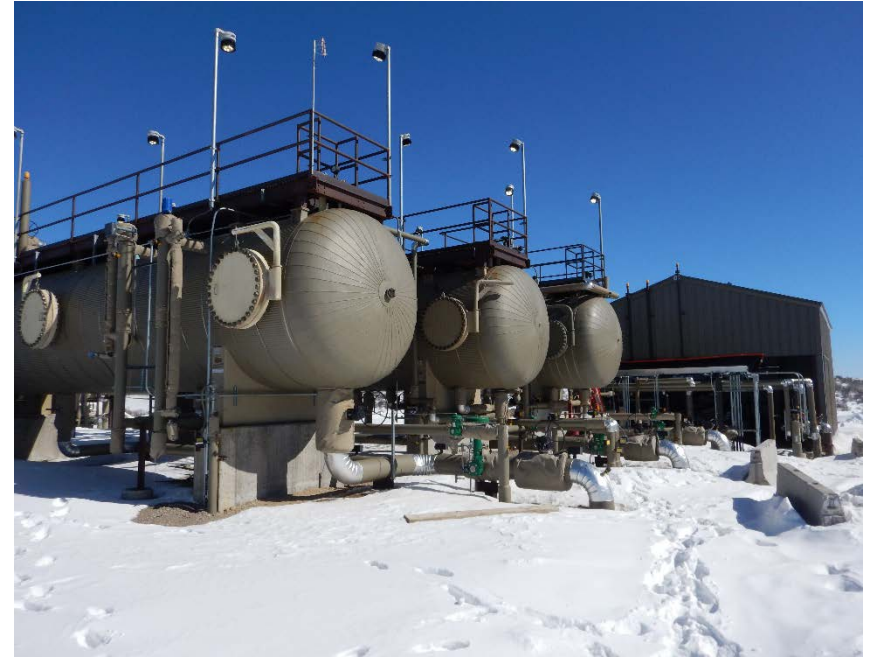
**Photo #2 – View of **bullet separators** from southwest.**

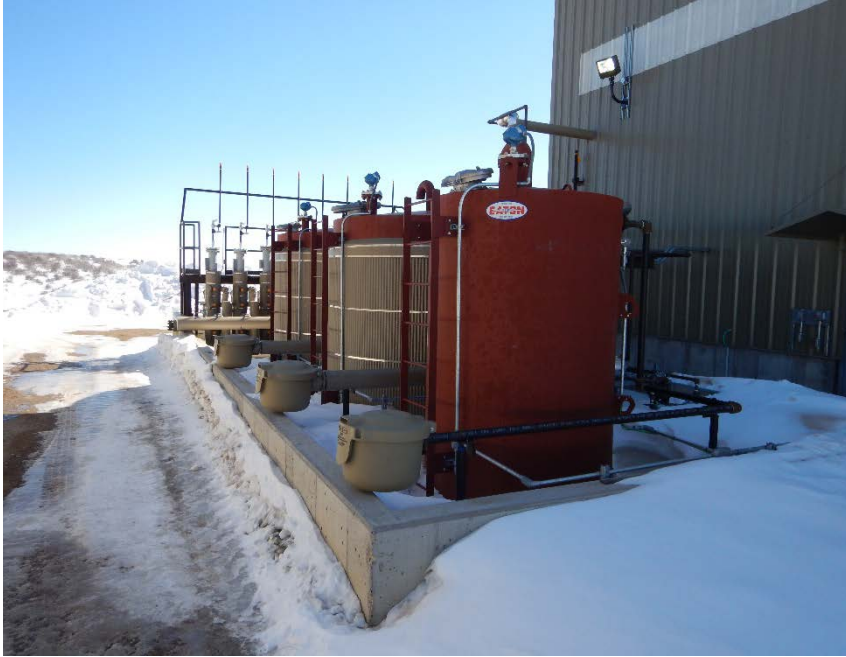
**Photo #3 – Tank battery on north side of power generation building contained motor oil and engine coolant tanks inside of cement secondary containment device with loadout containment devices.**

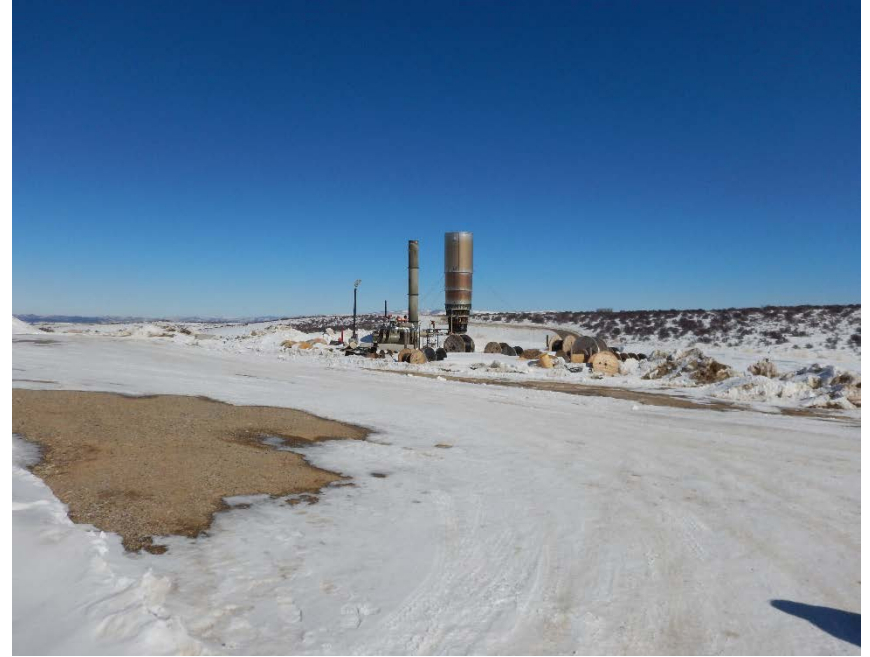
**Photo #4 – ECD and unused equipment stored in northeast corner of facility.**

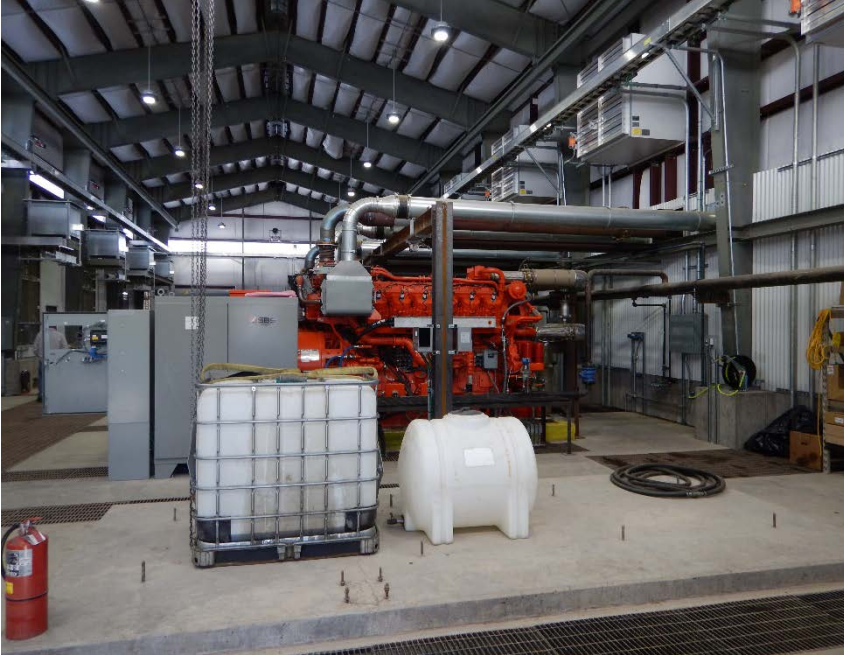
Photo #5 – View into the **power generation** building, from south. No accumulations of E&P waste were observed inside of this building during inspection.

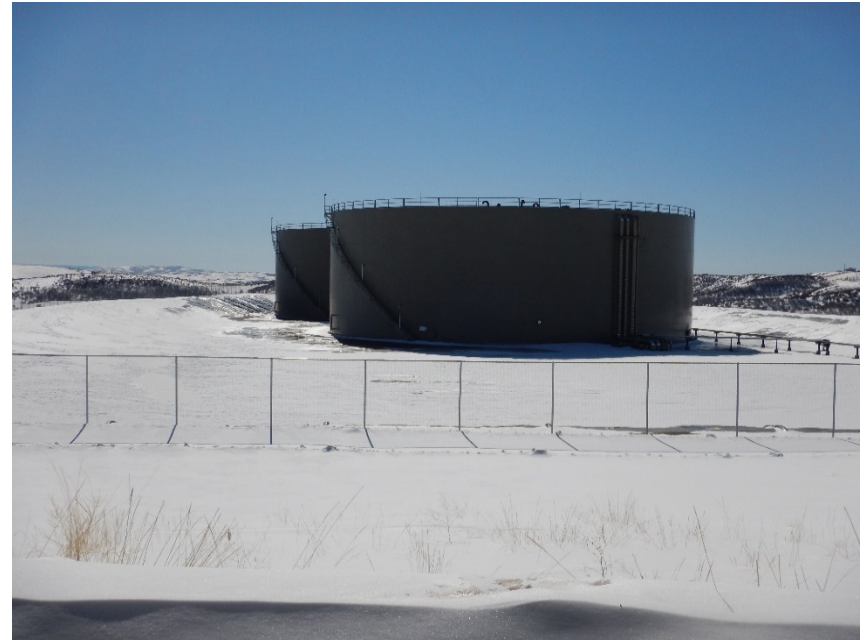
Photo #6 – View of **water storage tanks** inside of lined, fenced secondary containment, from north. Presence of snow on liner prevented closer inspection for liner integrity on inspection date.

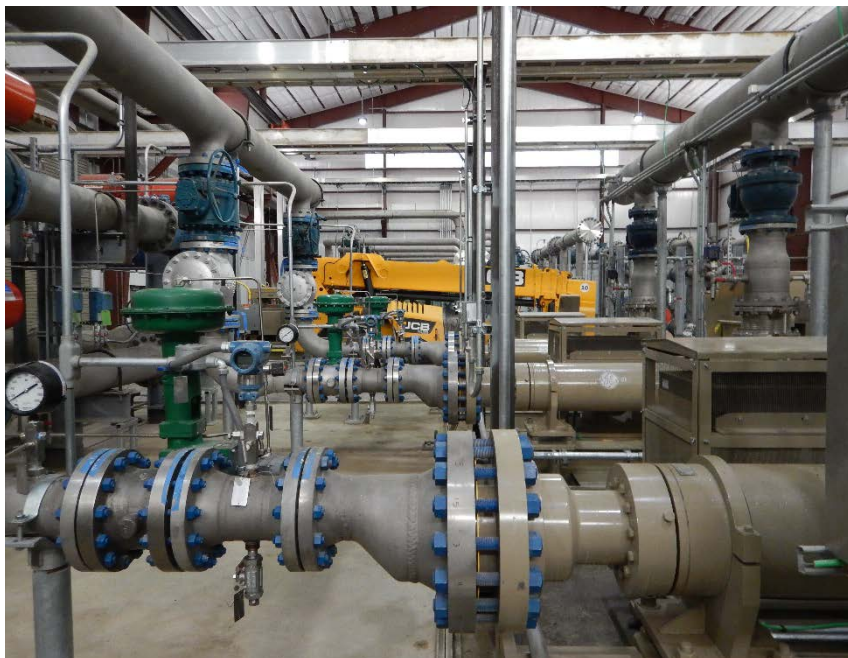
**Photo #7 – View of equipment inside of pump building. No accumulations of E&P waste were observed inside of this building during inspection.**

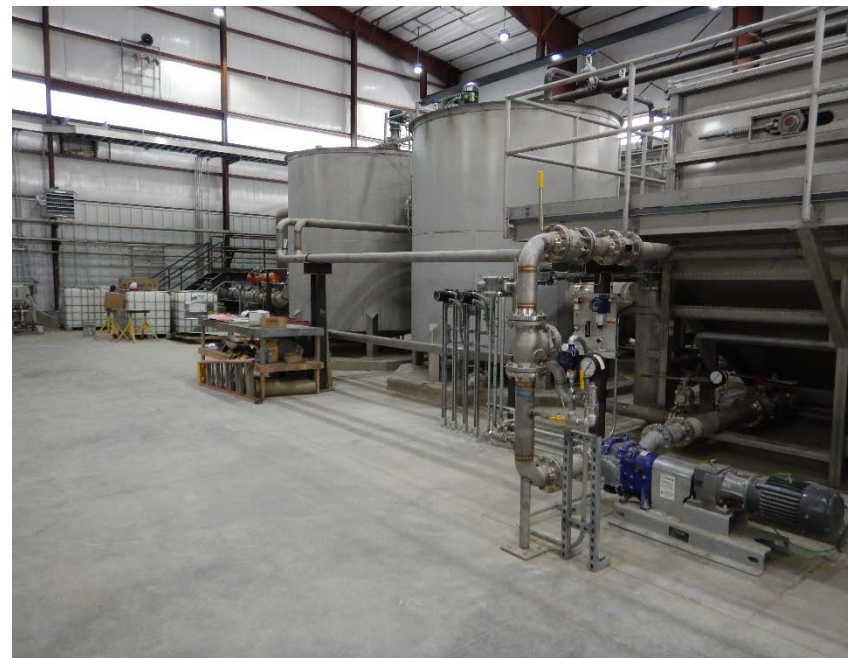
**Photo #8 – View of equipment inside of DAF building. No accumulations of E&P waste were observed inside of this building during inspection.**

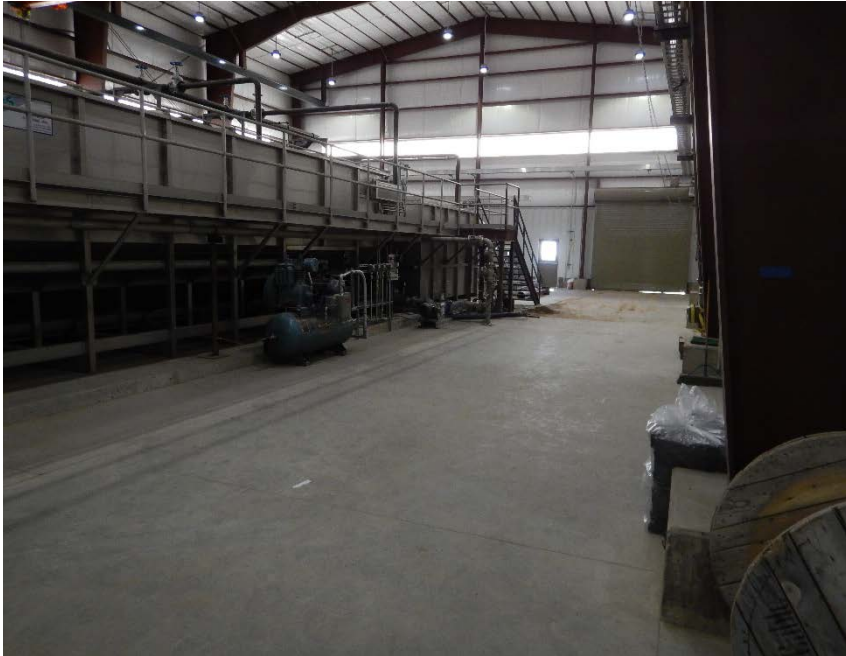
**Photo #9 - View of equipment inside of DAF building. No accumulations of E&P waste were observed inside of this building during inspection.**

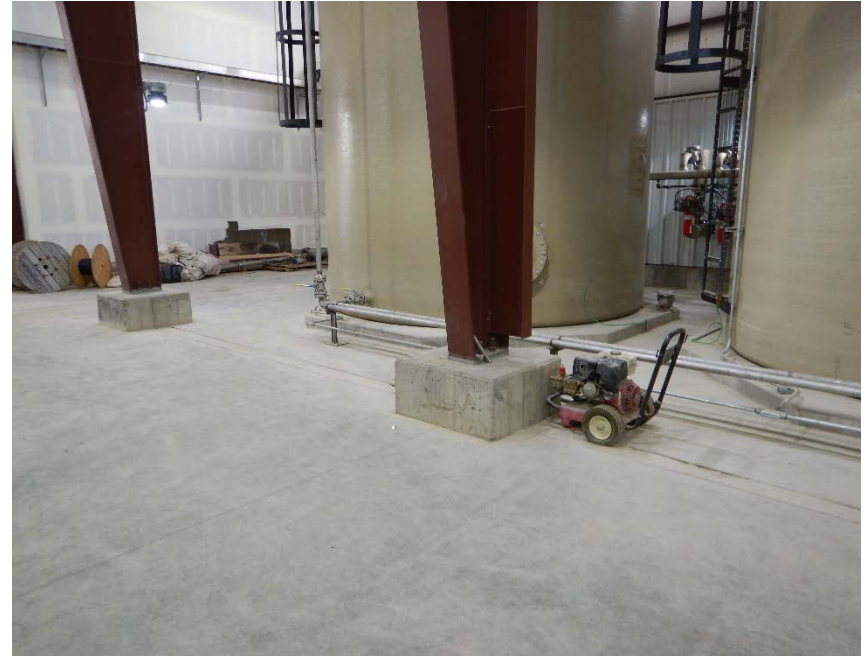
**Photo #10 - View of equipment inside of DAF building. No accumulations of E&P waste were observed inside of this building during inspection.**

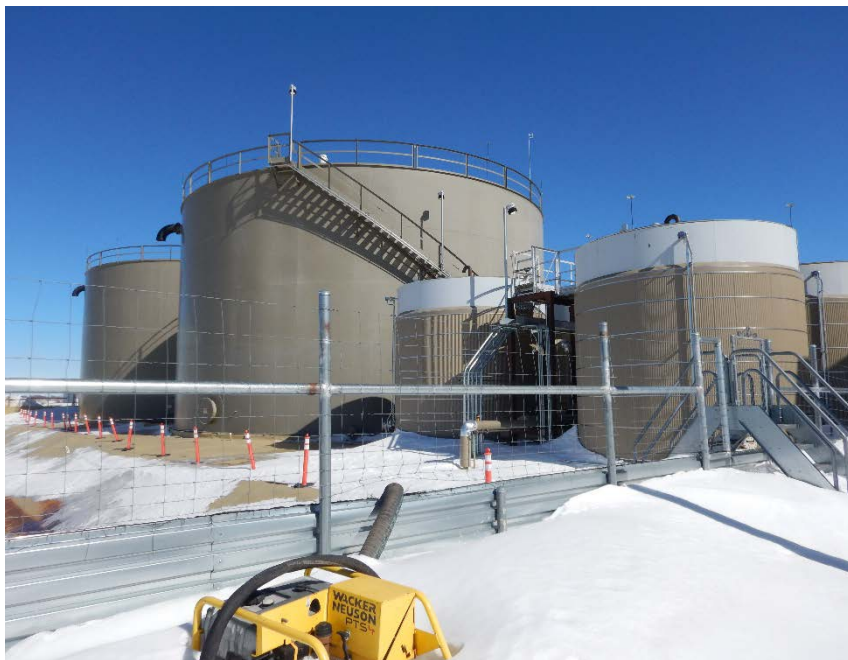
**Photo #11 – View of condensate tank battery from southwest.**

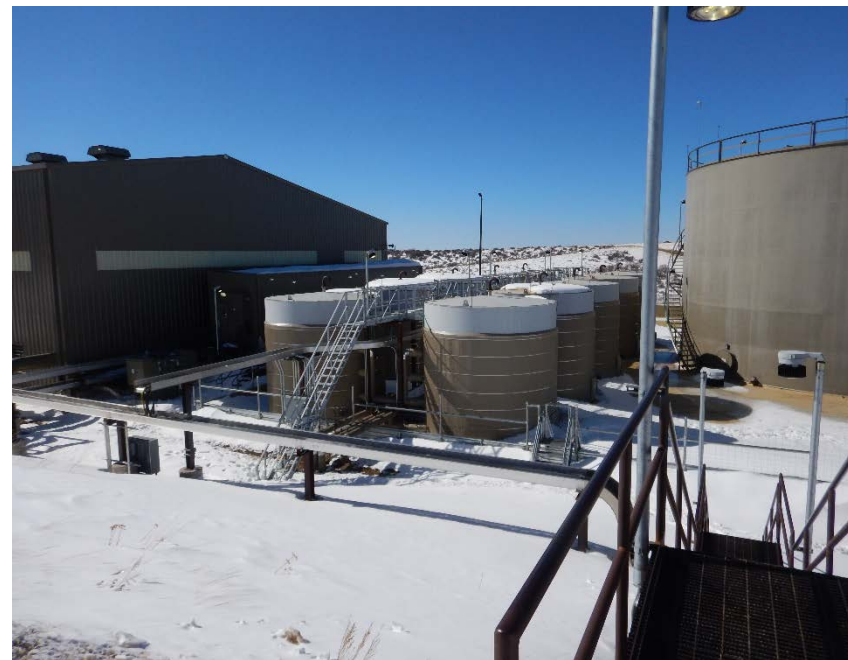
**Photo #12 - View of condensate tank battery from east, looking southwest.**

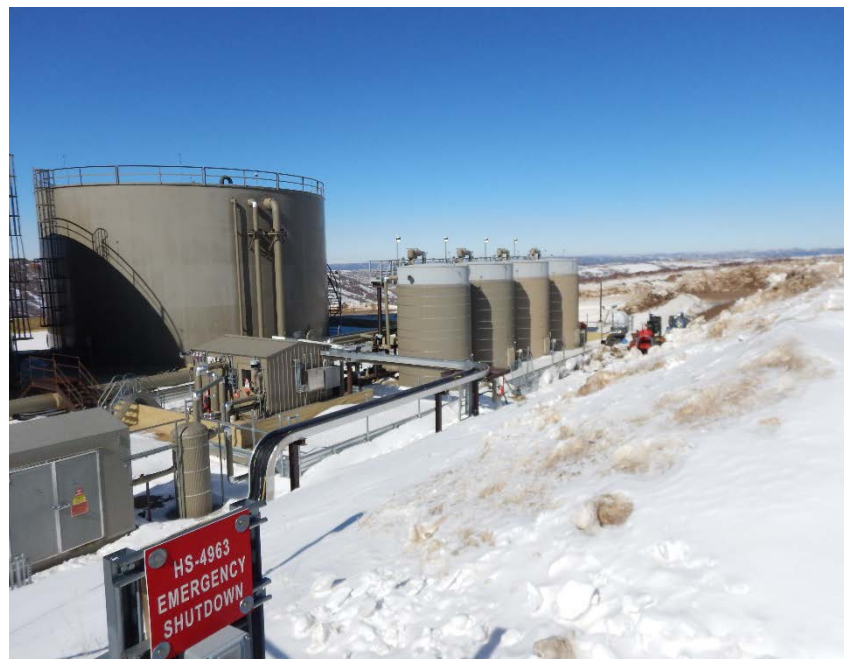
**Photo #13 - View of condensate tank battery from east, looking northwest.**
