Inspection Photos
Location Name: Pronghorn 31-34-6HZ
Location ID: 427009

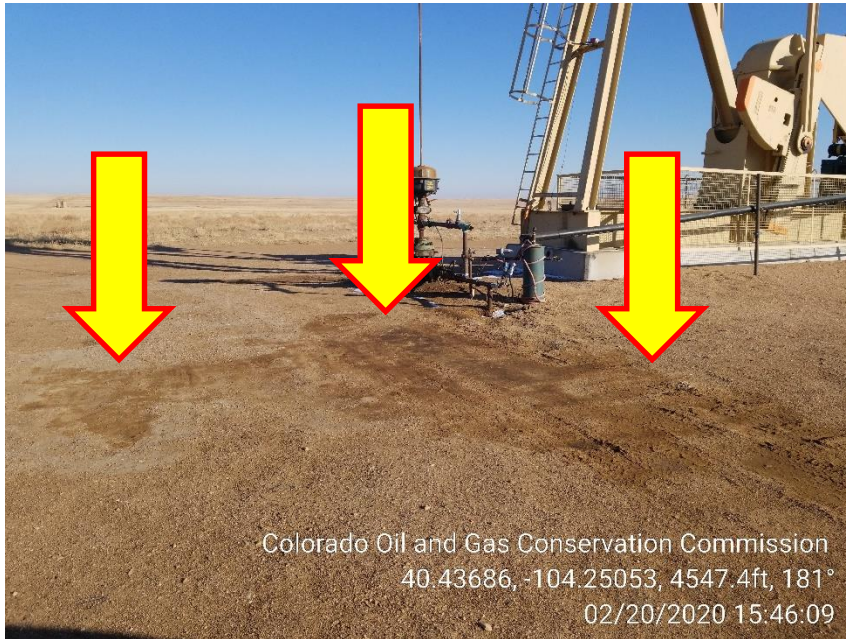
Photo 3 – Stained Soil at Wellhead

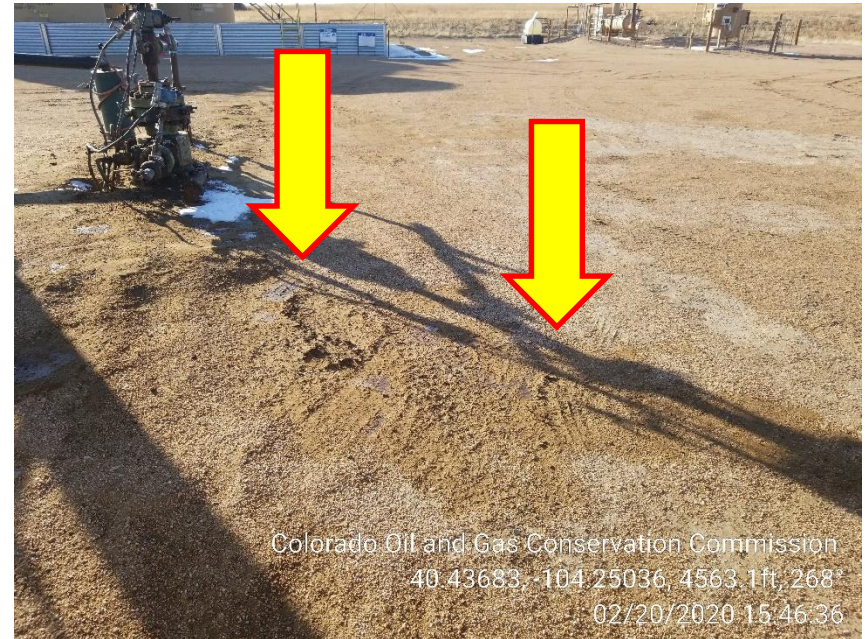
Photo 4 – Stained Soil at Wellhead

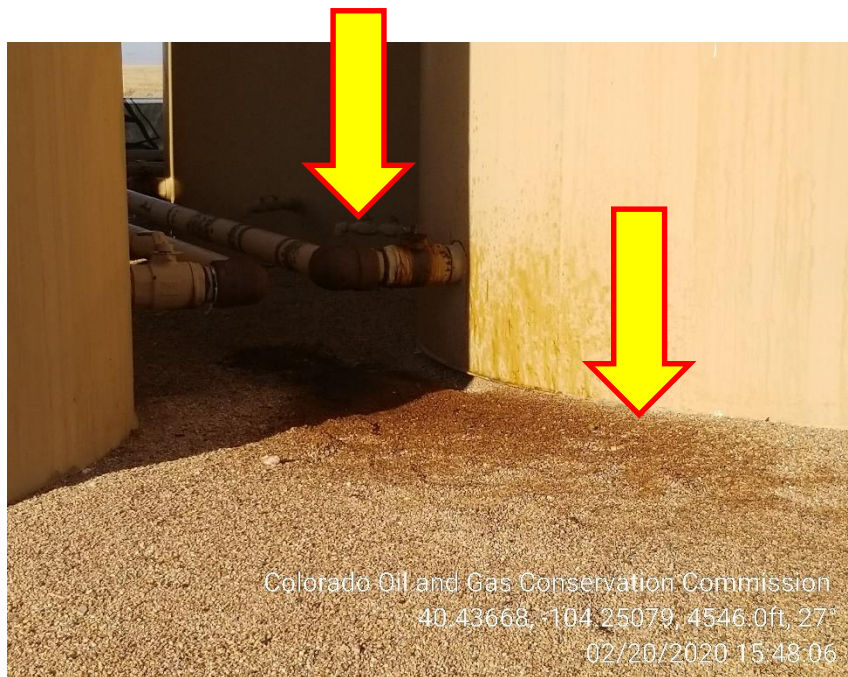
Photo 5 – Stained Soil at SE Tank inside Berm
