**Inspection Photos**  
**Location Name: YB-1**  
**API: 05-083-06252**

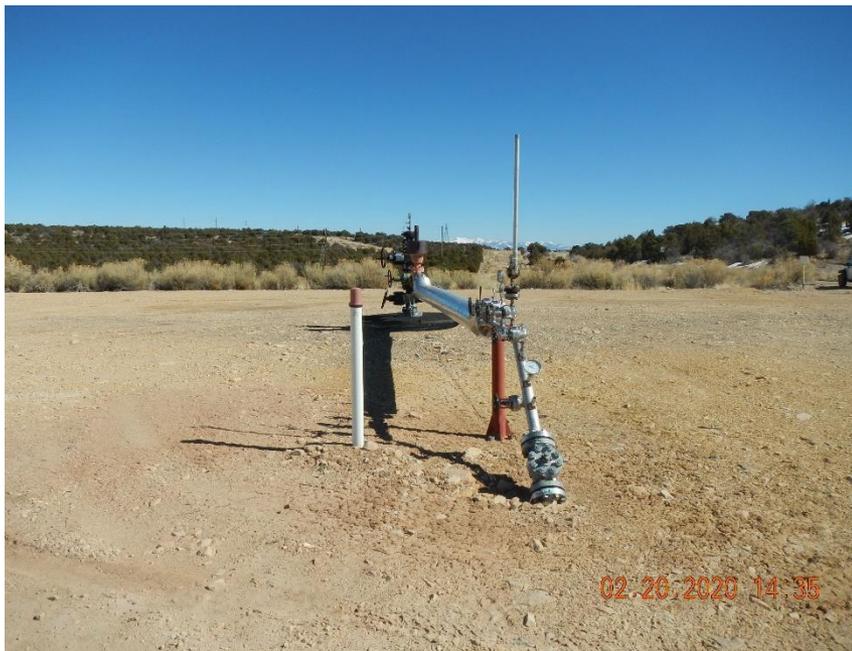
**YB-1 well head and flow line.**

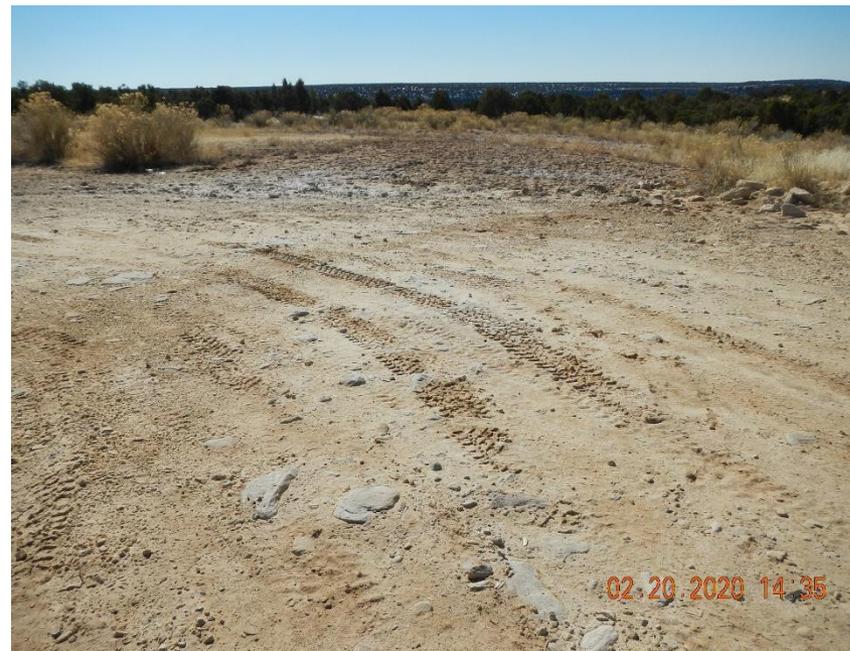
**Salt stained area to the SW of the well head.**

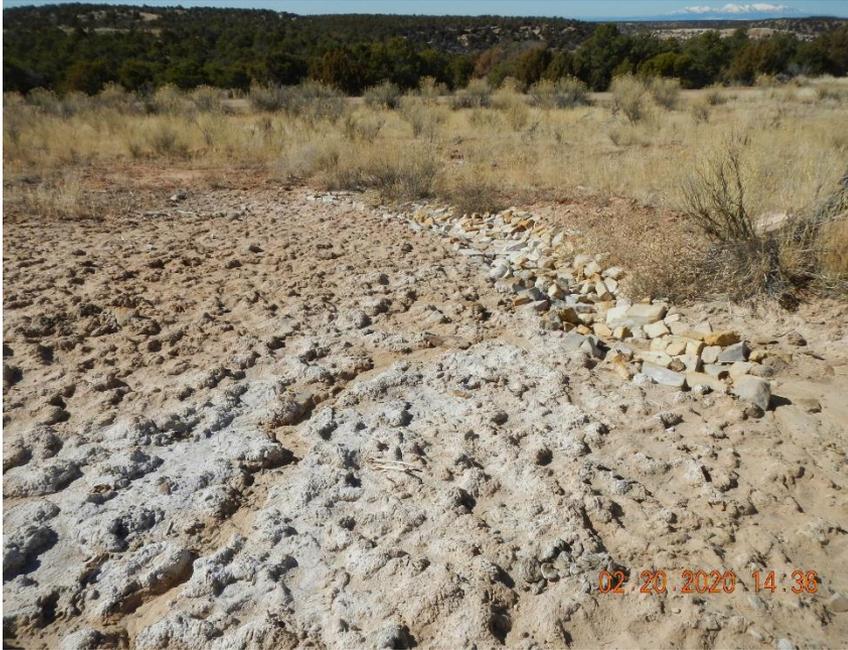
**Salt crusted soil and erosion along SW corner of location.**

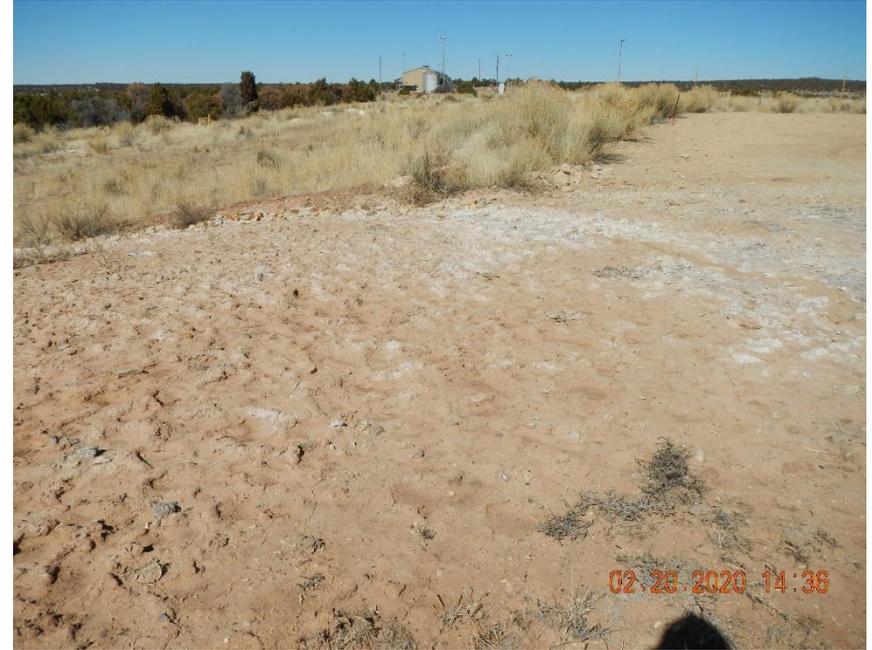
**Salt crusted storm water flow pattern along the SW corner of the location.**
