Inspection Photos
Location Name: YB-3
API: 05-083-06375

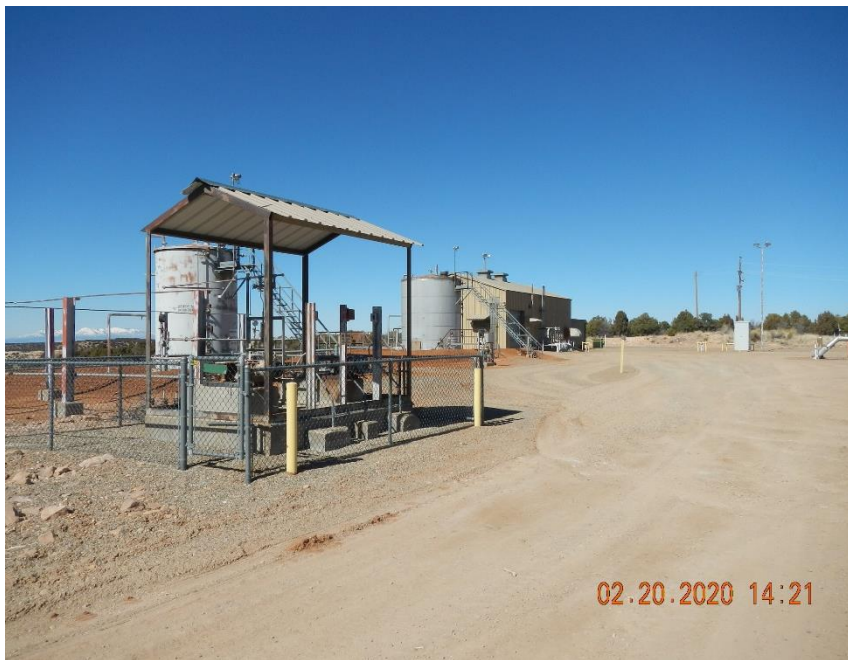
YB Cluster CDP and tank battery.

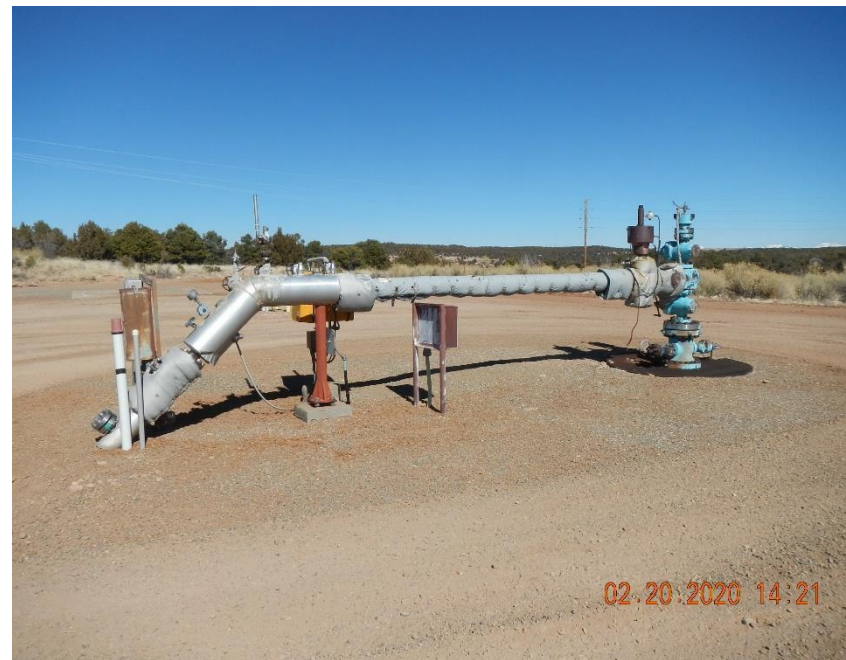
YB-3 well head and flow line.

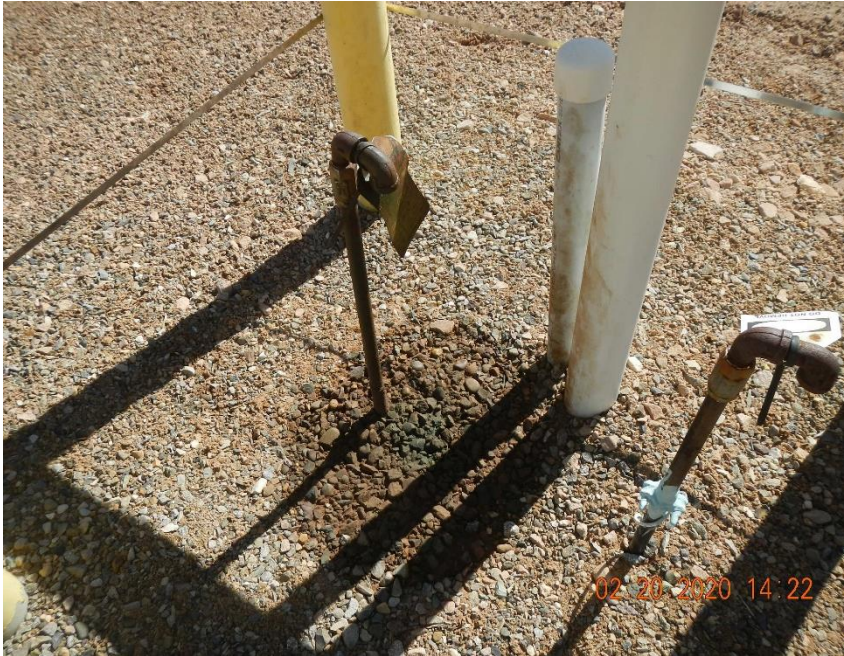
Staining below flow line vents from lubricant used during installation of internal sleeve.

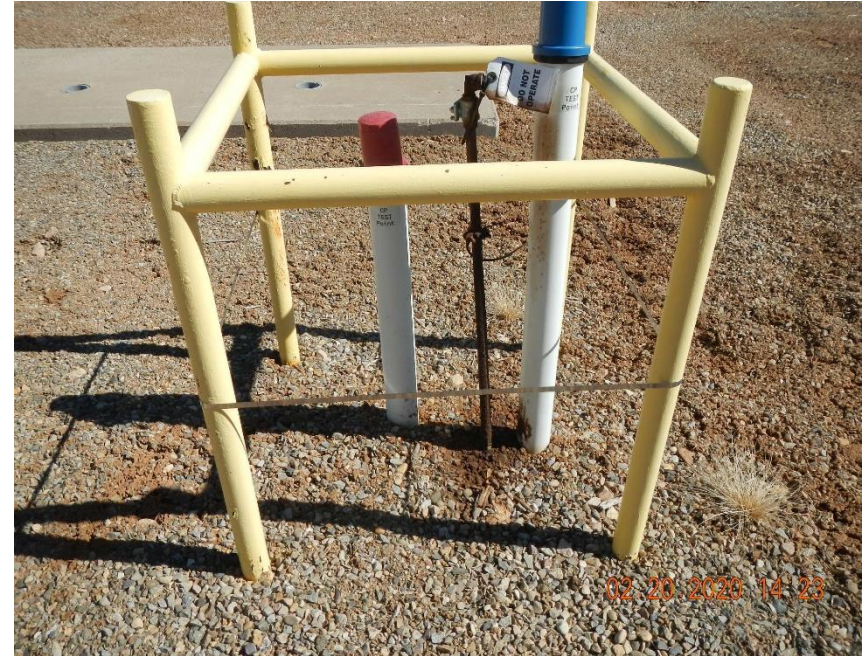
Lubricant weeping out of flow line vents.
