Inspection Photos
Operator: Hilcorp Energy
Location #: 067-08075
Date: 2/27/2020

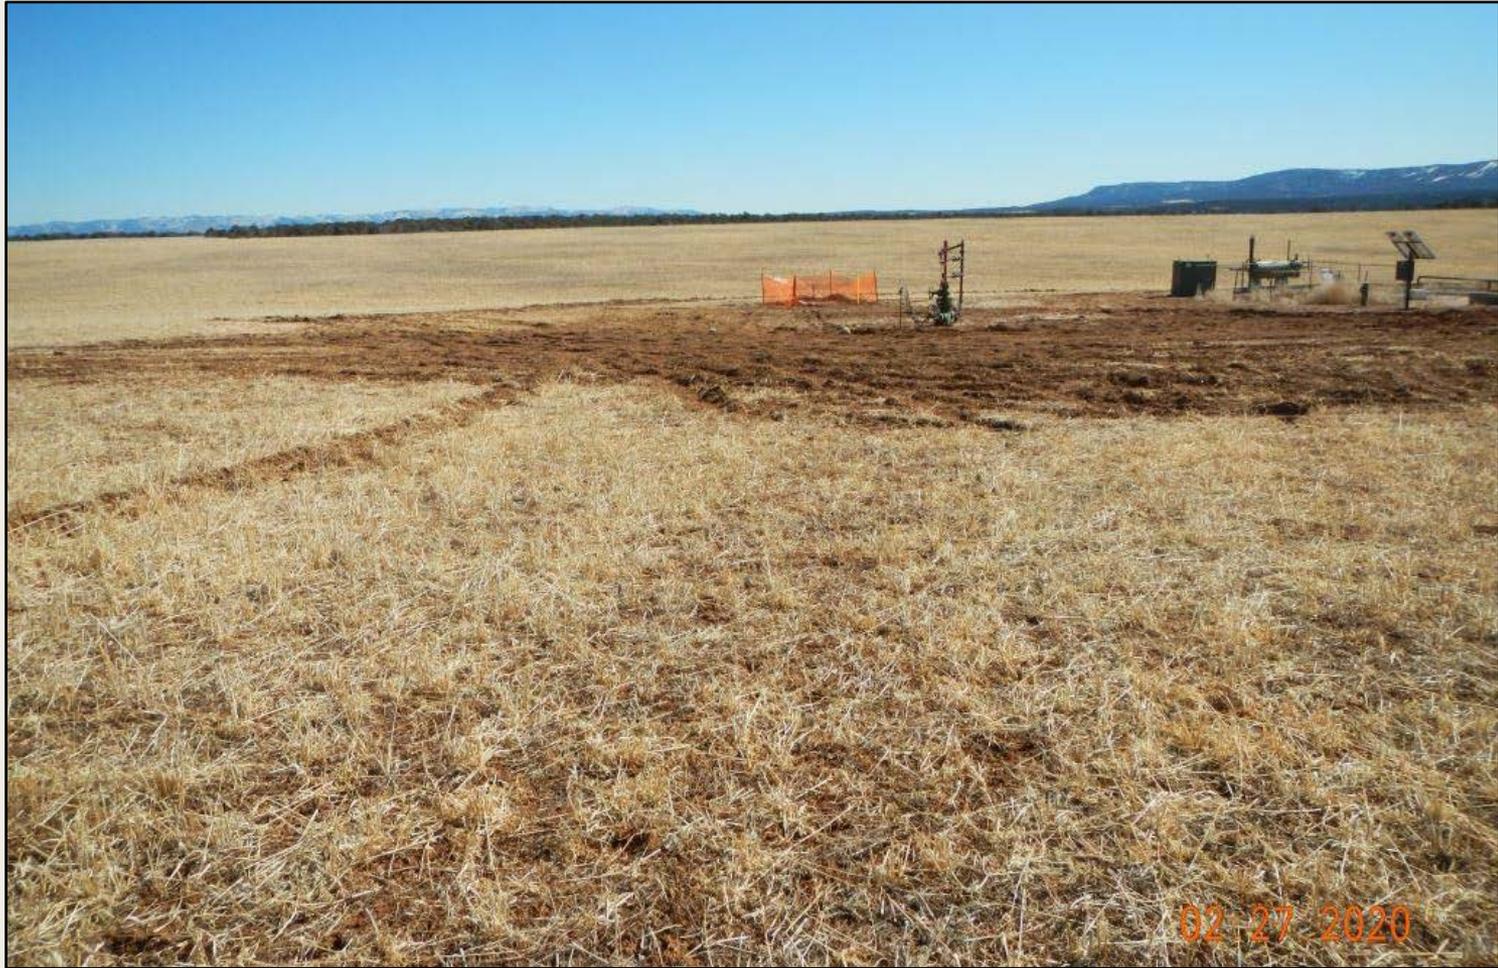
Photo 1. View of the project area from the northwestern corner facing center.

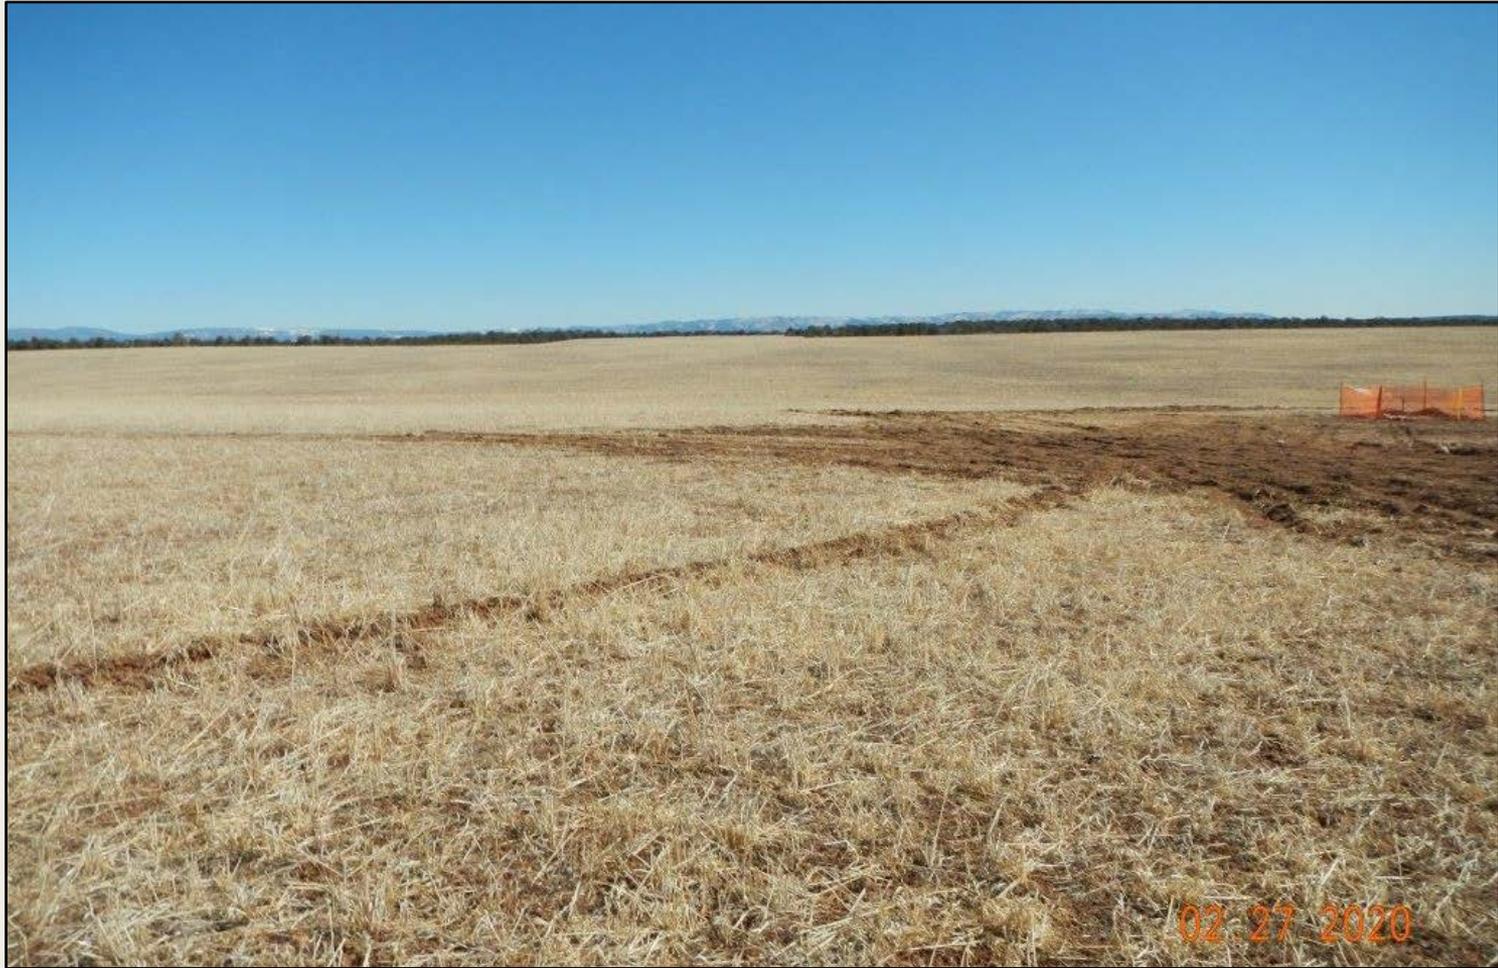
Photo 2. View of the northern project area from the northwestern project area facing eastward. Vegetation in reclamation area is approximately the same as surrounding irrigated field.

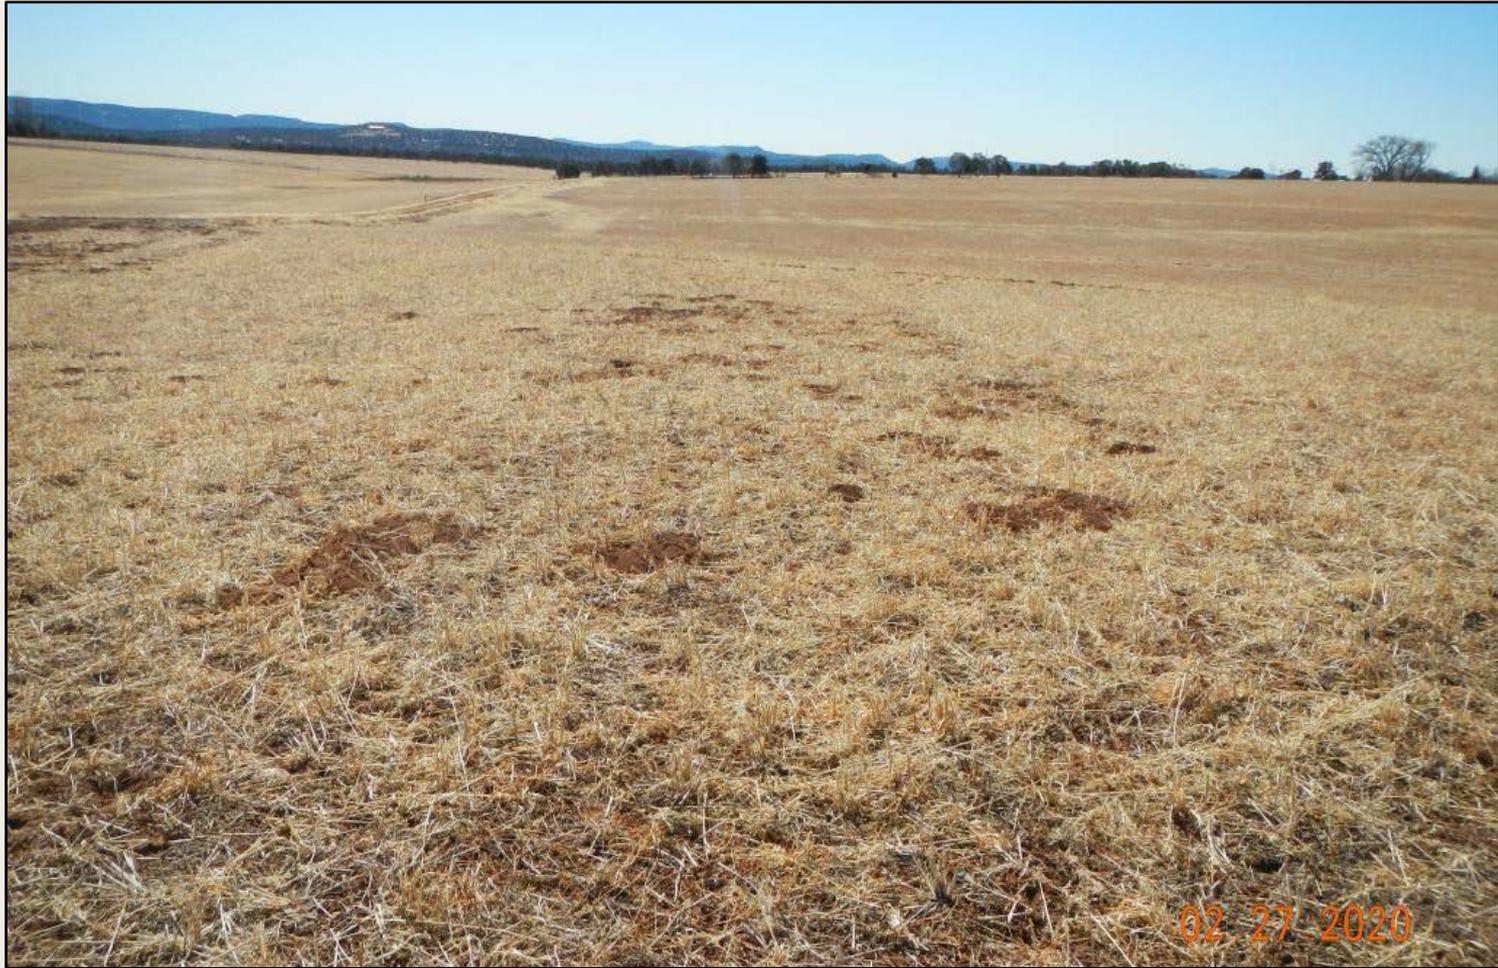
Photo 3. View of the western project area from the northwestern project area facing southward. Vegetation in reclamation area is approximately the same as surrounding irrigated field.

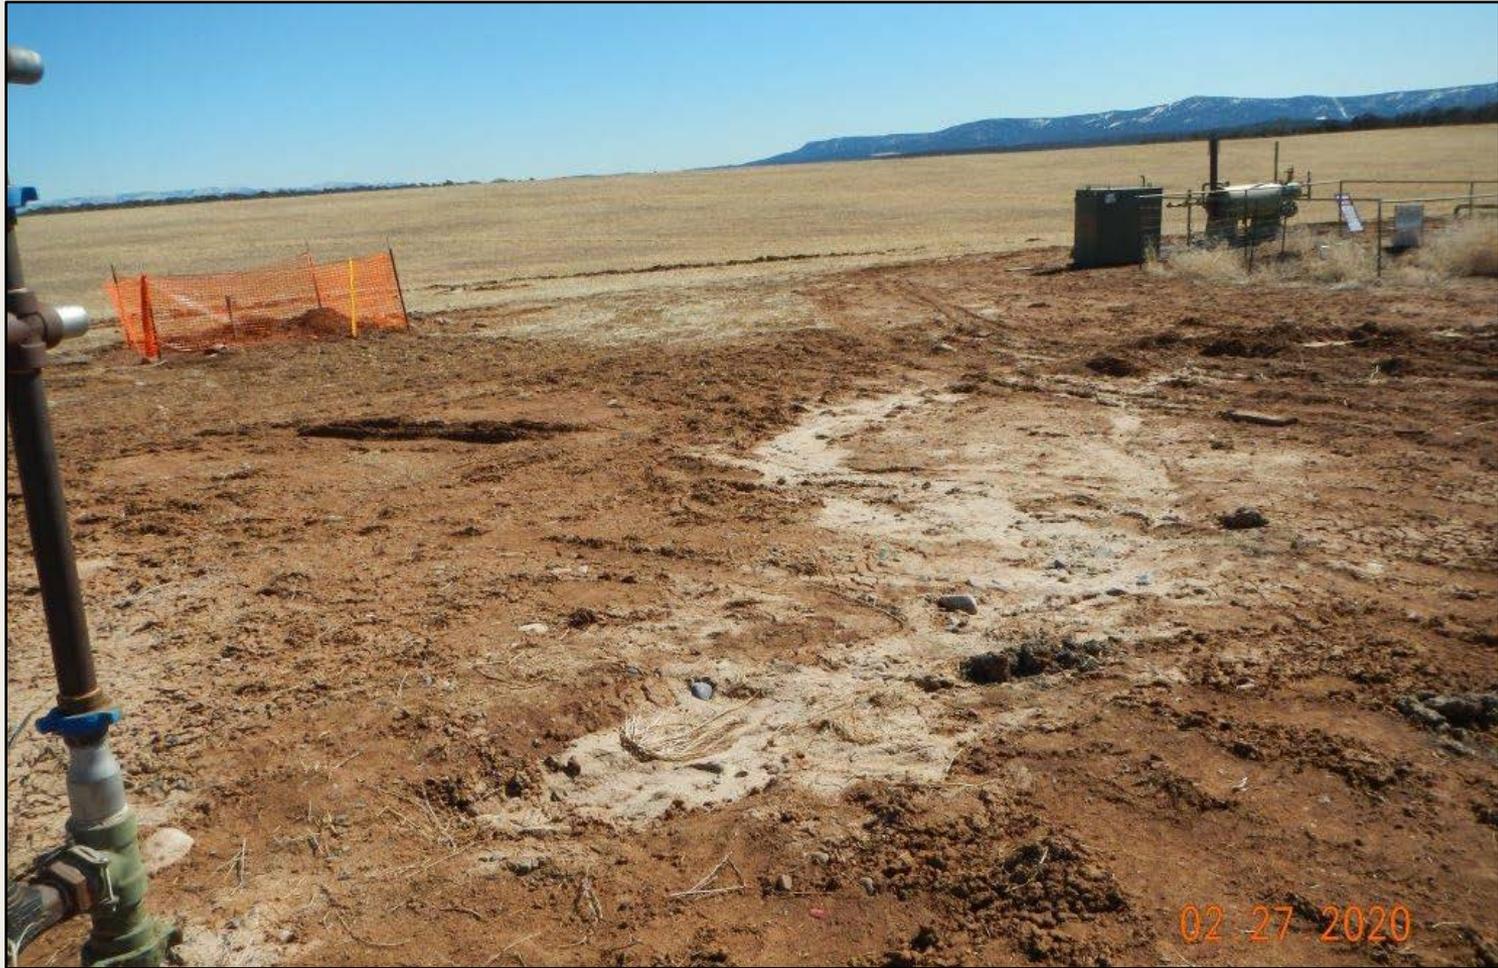
Photo 4. View of what appears to be release with discolored soil flowing toward southeast. Orange fencing surrounds an excavation area.

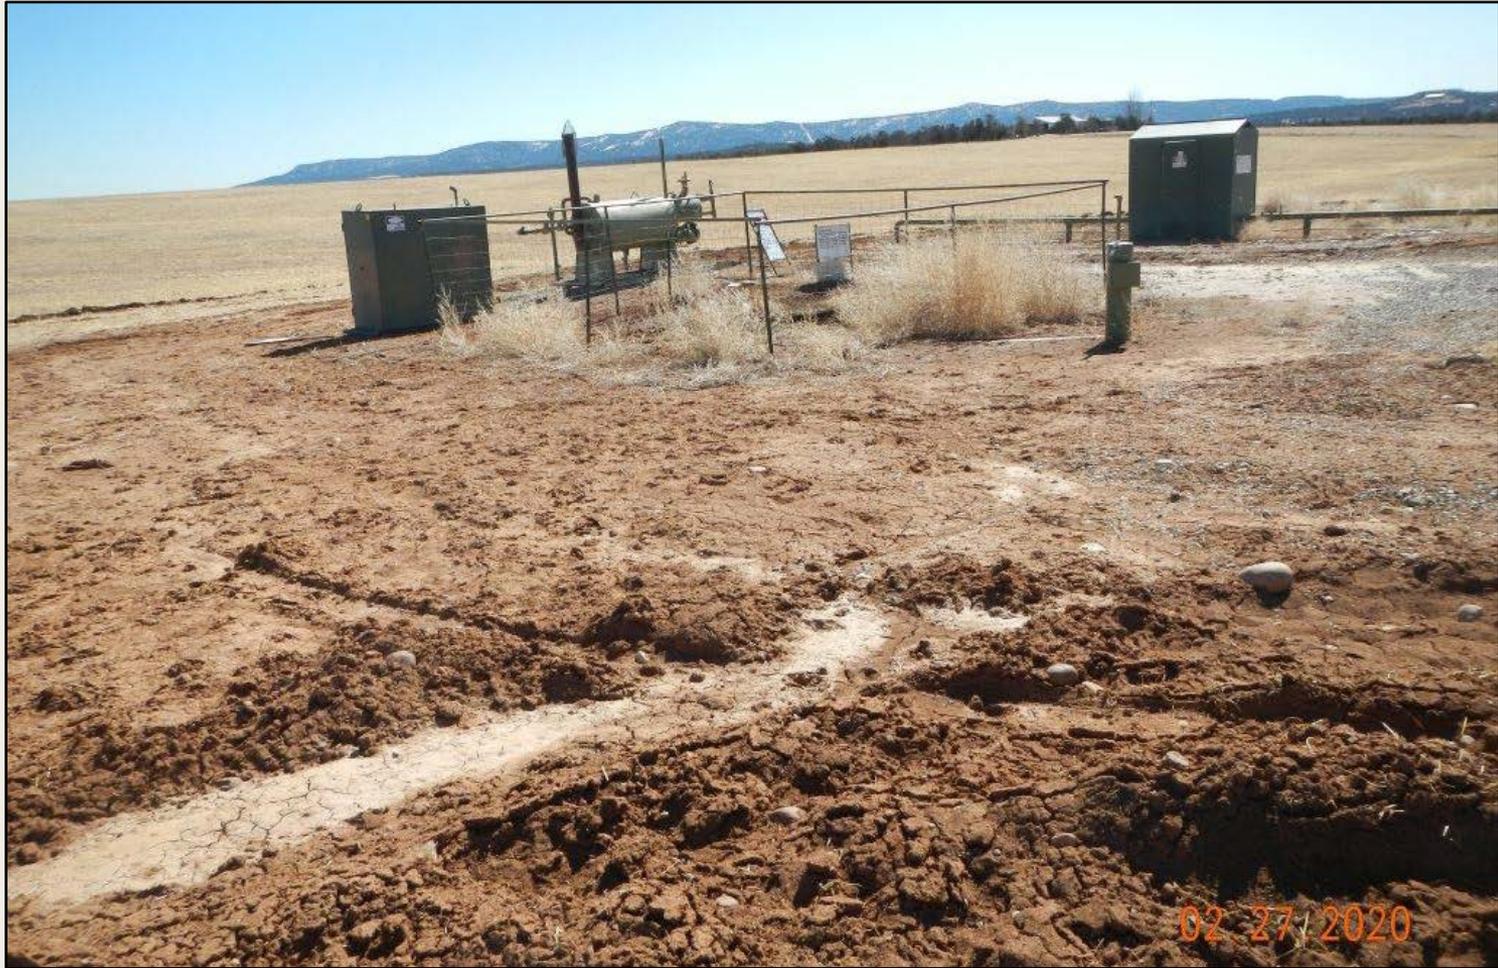
Photo 5. View of facilities in the southeastern project area. Lighter colored soil in flow pattern toward facilities and beyond, appears to be from release.

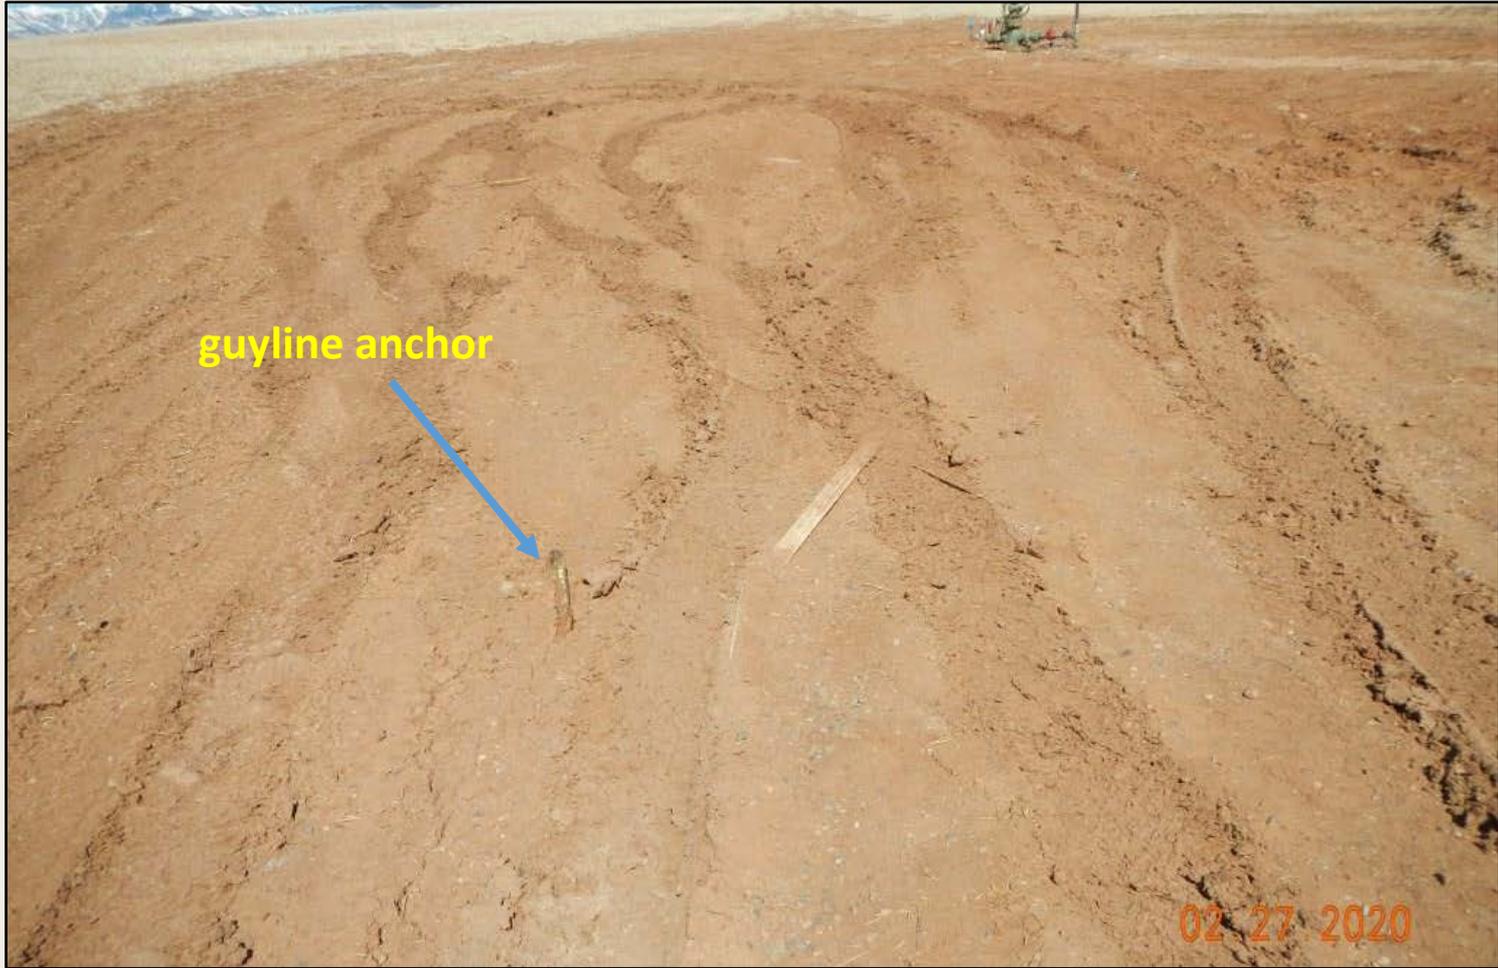
Photo 6. View of guyline anchor at well pad entrance where marker is no longer functioning, needs to be marked or removed.

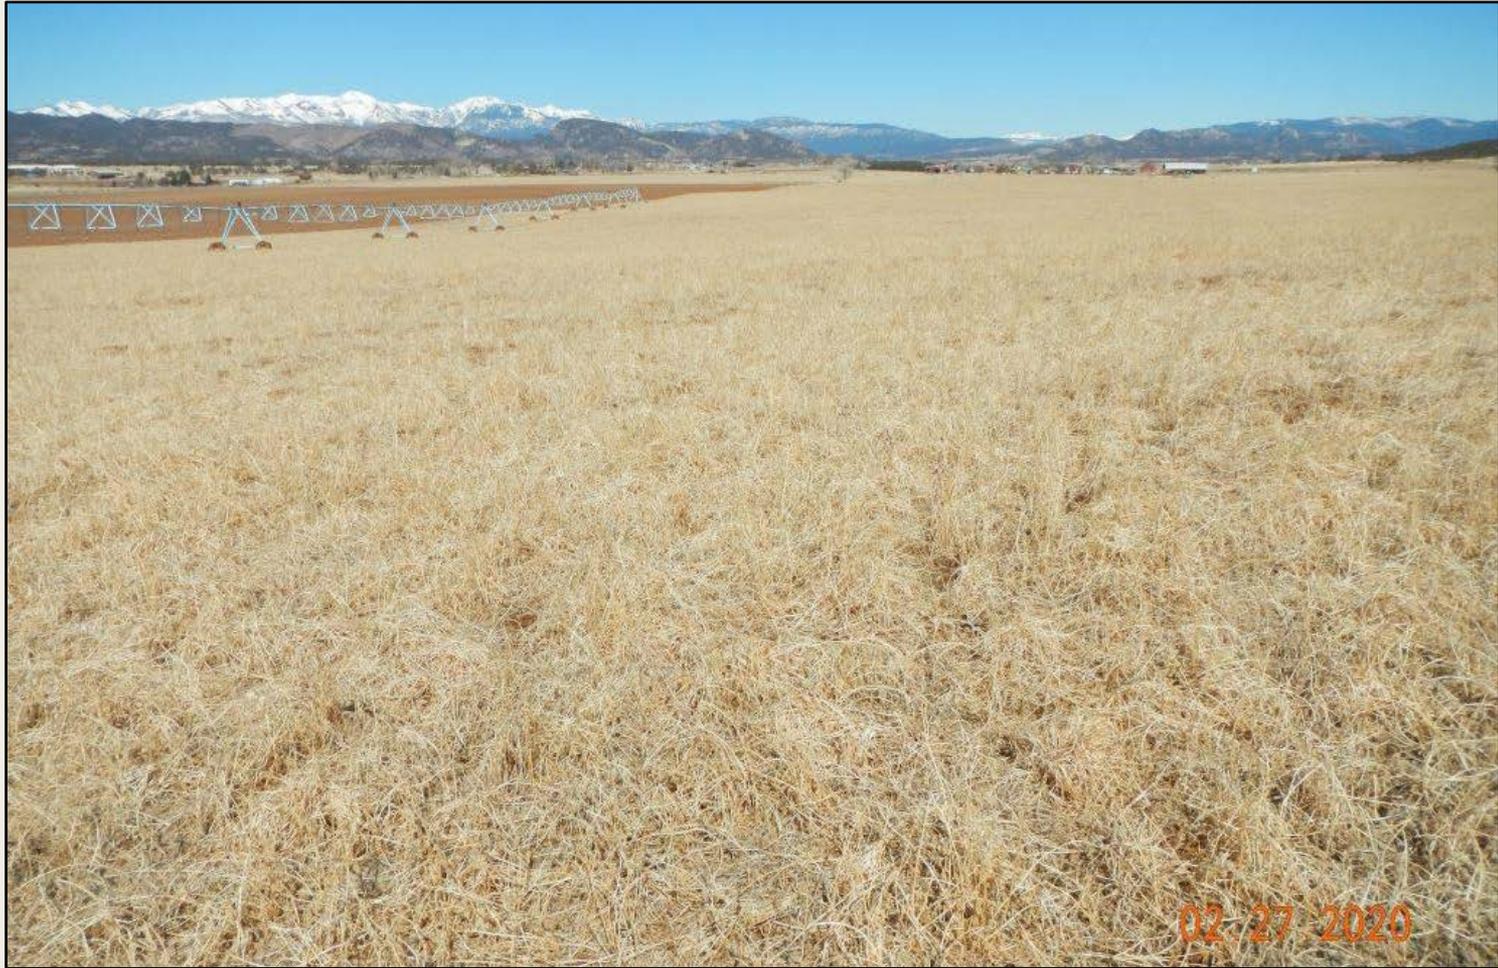
Photo 7. View of the reference area, comprised of irrigated field in dormant vegetative condition.
