Inspection Photos

Location Name: DROP OUT 24-8 CA DATE 3-13-20

API#: 05-071-08831

INSP. #: 695102225

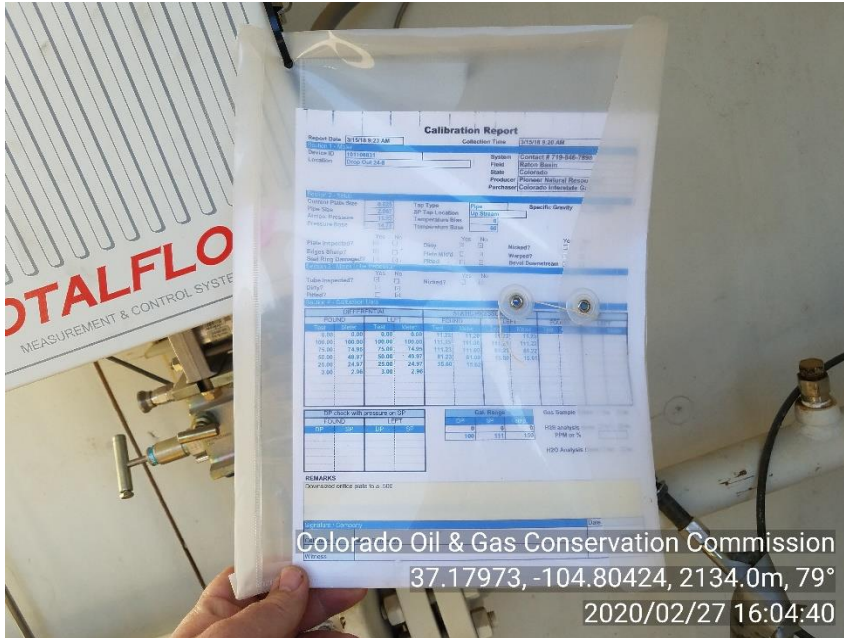
PHOTO 3: ACCORDING TO RECORDS POSTED IN METER HOUSE THIS METER HAS NOT BEEN CALIBRATED SINCE MARCH OF 2018 (ALTHOUGH THIS IS NOT A POINT OF SALES METER THE RULE WILL BE CHANGING AND AFTER JULY 1 OF THIS YEAR THIS WOULD BE A VIOLATION).

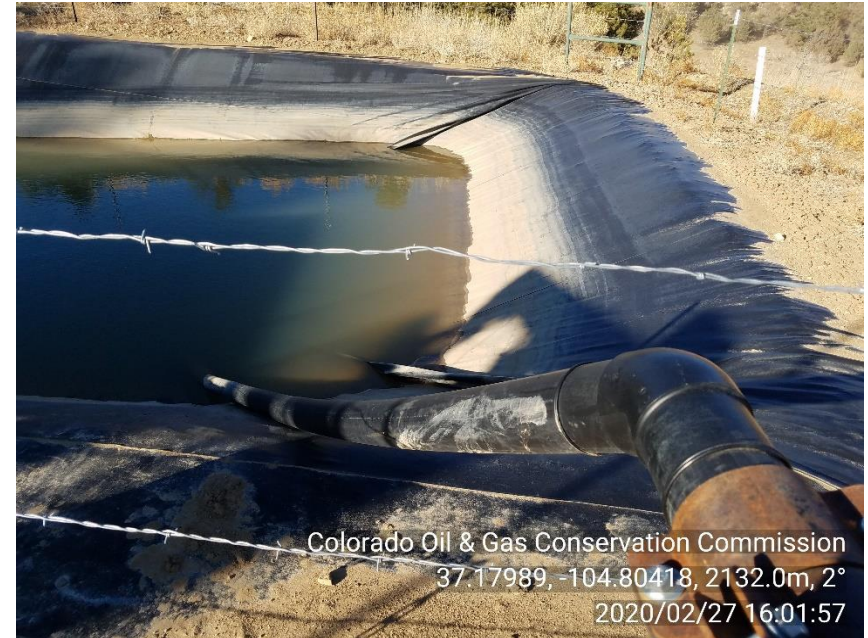
**PHOTO 4: NO FREEBOARD MARKER INSTALLED ON PIT.
INSTALL FREEBOARD MARKER IN ACCORDANCE WITH 902.b.
CA DATE 3-13-20.**

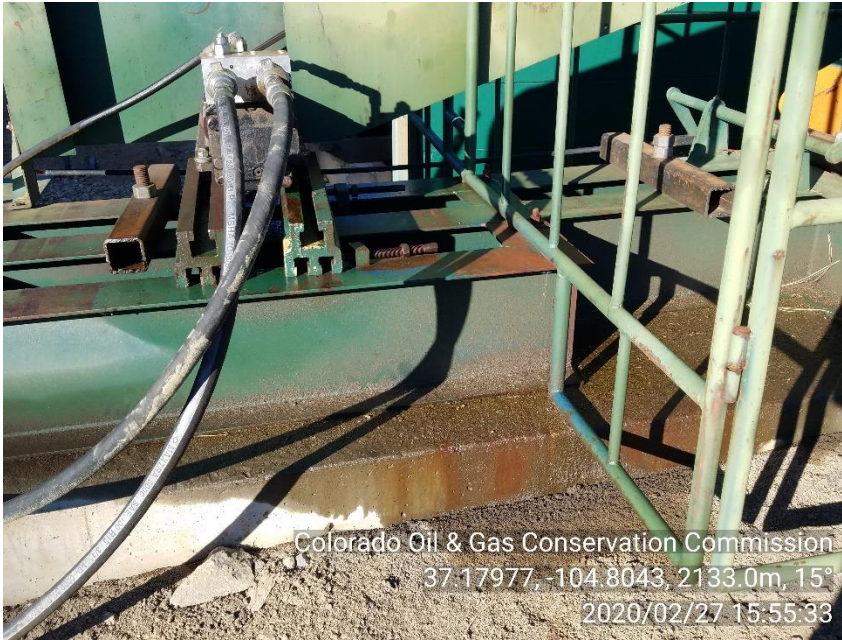
PHOTO 5: APPEARS THAT HYDRAULIC CONNECTIONS ARE LEAKING. REPAIR LEAKS ON ALL EQUIPMENT AND MAINTAIN ALL EQUIPMENT TO PREVENT LEAKS AND SOIL CONTAMINATION, Securely fasten all valves, pipes, and fittings to ensure good mechanical condition, inspect at regular intervals and maintain in good mechanical condition per Rule 605.d. CA DATE 3-13-20

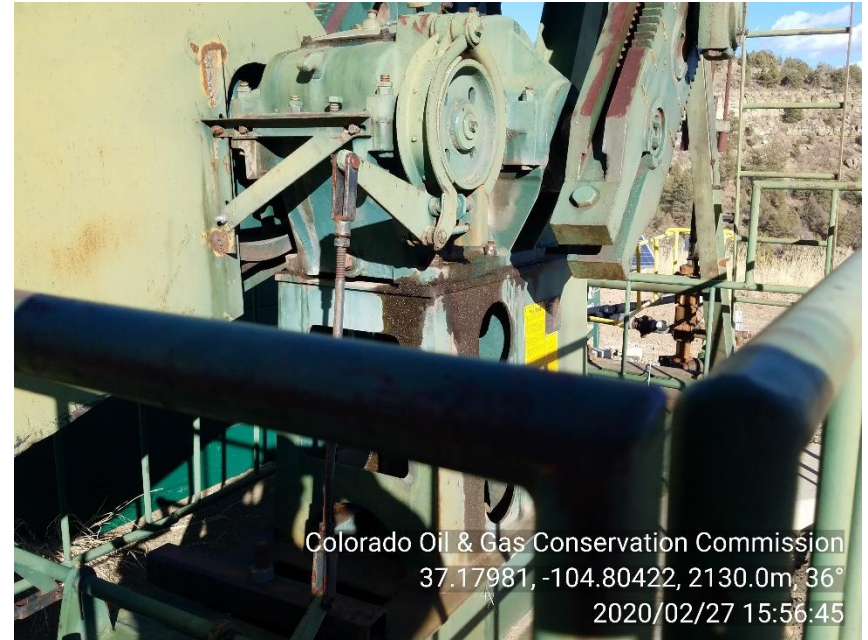
PHOTO 6: LEAKS ON PUMPJACK GEARBOX. REPAIR LEAKS ON ALL EQUIPMENT AND MAINTAIN ALL EQUIPMENT TO PREVENT LEAKS AND SOIL CONTAMINATION, Securely fasten all valves, pipes, and fittings to ensure good mechanical condition, inspect at regular intervals and maintain in good mechanical condition per Rule 605.d. CA DATE 3-13-20

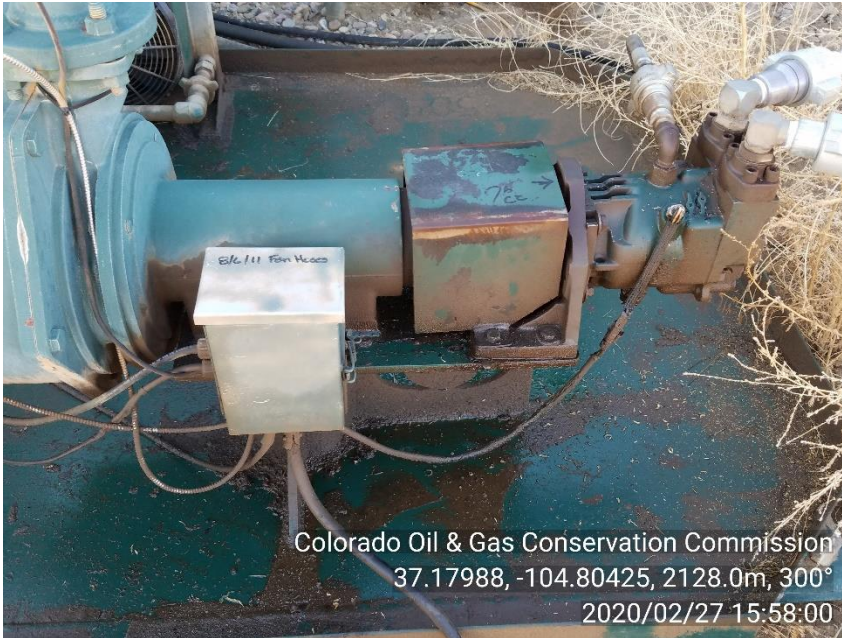
PHOTO 7: APPEARS THAT HYDRAULIC MOTOR ON COMPRESSOR IS LEAKING. REPAIR LEAKS ON ALL EQUIPMENT AND MAINTAIN ALL EQUIPMENT TO PREVENT LEAKS AND SOIL CONTAMINATION, Securely fasten all valves, pipes, and fittings to ensure good mechanical condition, inspect at regular intervals and maintain in good mechanical condition per Rule 605.d. CA DATE 3-13-20

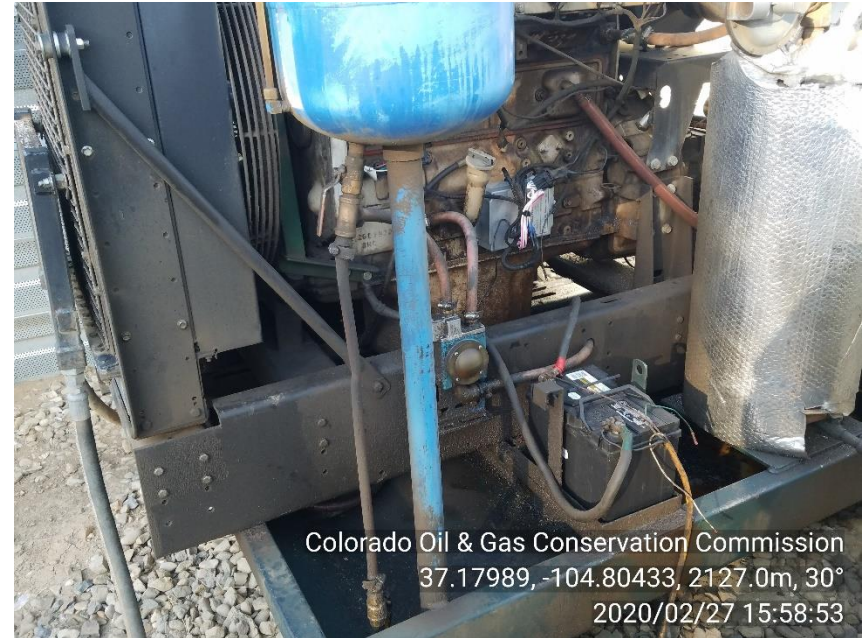
PHOTO 8: MOTOR ON COMPRESSOR ENGINE SKID IS LEAKING IN MULTIPLE SPOTS. REPAIR LEAKS ON ALL EQUIPMENT AND MAINTAIN ALL EQUIPMENT TO PREVENT LEAKS AND SOIL CONTAMINATION, Securely fasten all valves, pipes, and fittings to ensure good mechanical condition, inspect at regular intervals and maintain in good mechanical condition per Rule 605.d. CA DATE 3-13-20

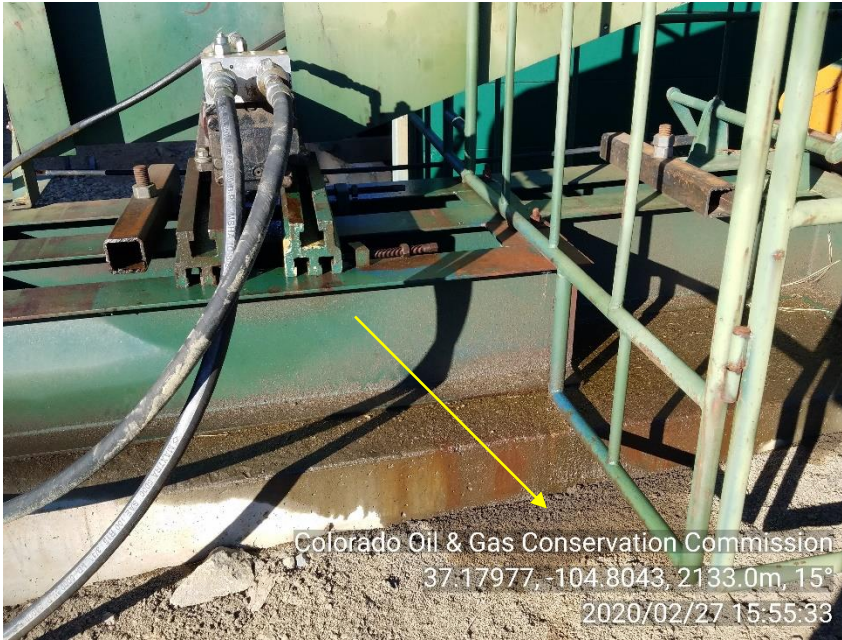
PHOTO 9: SOIL APPEARS TO BE CONTAMINATED FROM LEAKING HYDRALIC OIL. Conduct maintenance on equipment, cleanup stained material and review self inspection processes. CA DATE 3-3-20.

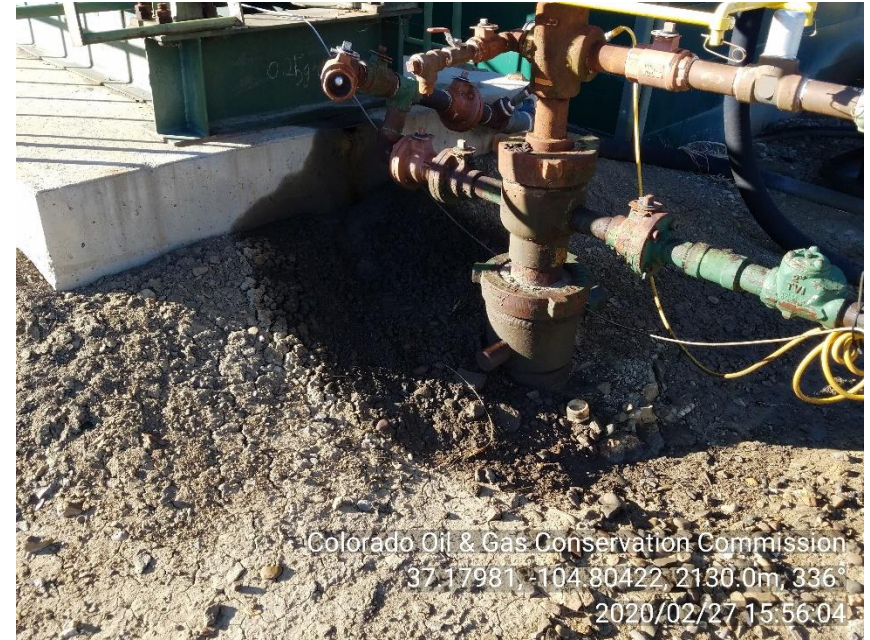
PHOTO 10: IMPACTED SOIL STARTING FROM PUMPJACK PAD AROUND WELLHEAD. Conduct maintenance on equipment, cleanup stained material and review self inspection processes. CA DATE 3-3-20.

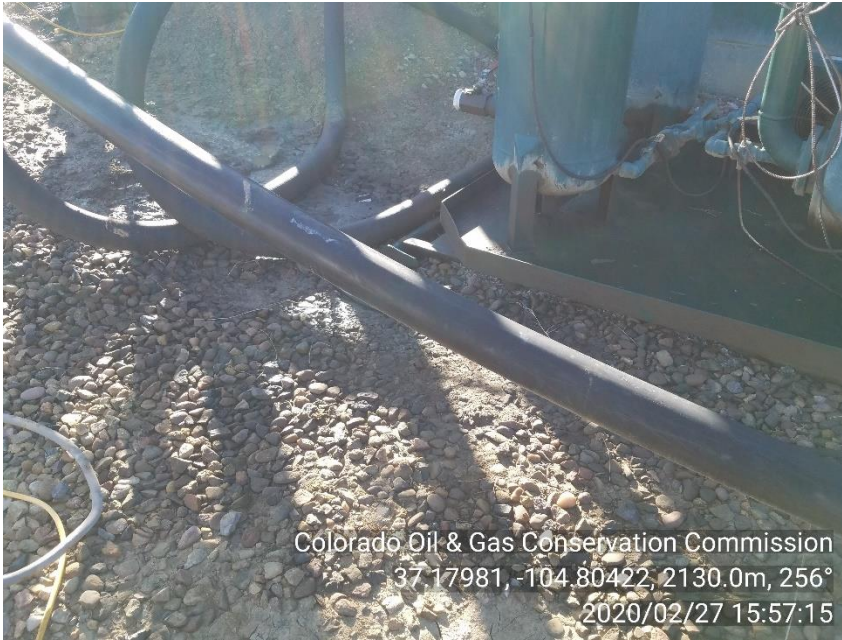
PHOTO 11: IMPACTED SOIL ALL AROUND AND UNDER COMPRESSOR SKID. Conduct maintenance on equipment, cleanup stained material and review self inspection processes. CA DATE 3-3-20.

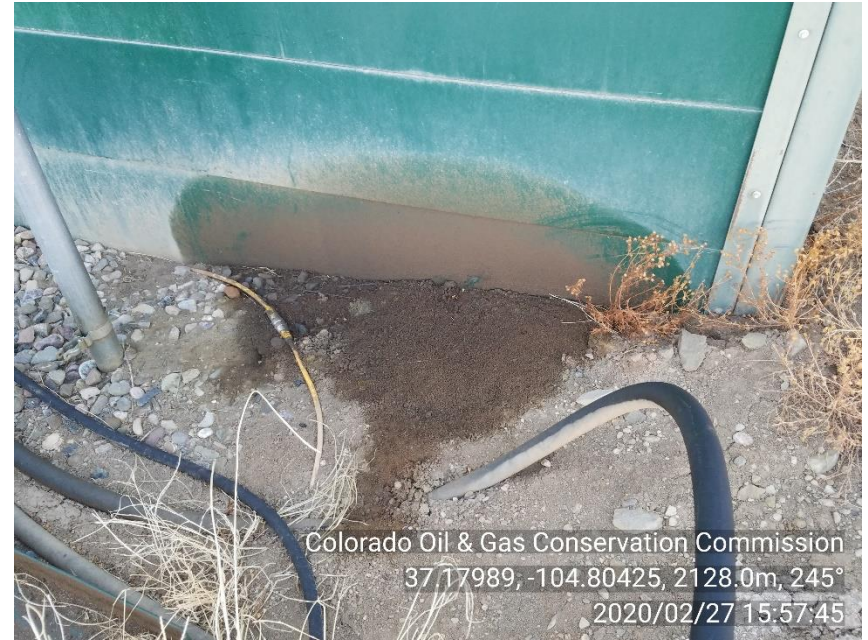
PHOTO 12: IMPACTED SOIL NEAR SOUND WALLS BETWEEN COMPRESSOR SKID AND SOUND WALL. Conduct maintenance on equipment, cleanup stained material and review self inspection processes. CA DATE 3-3-20.

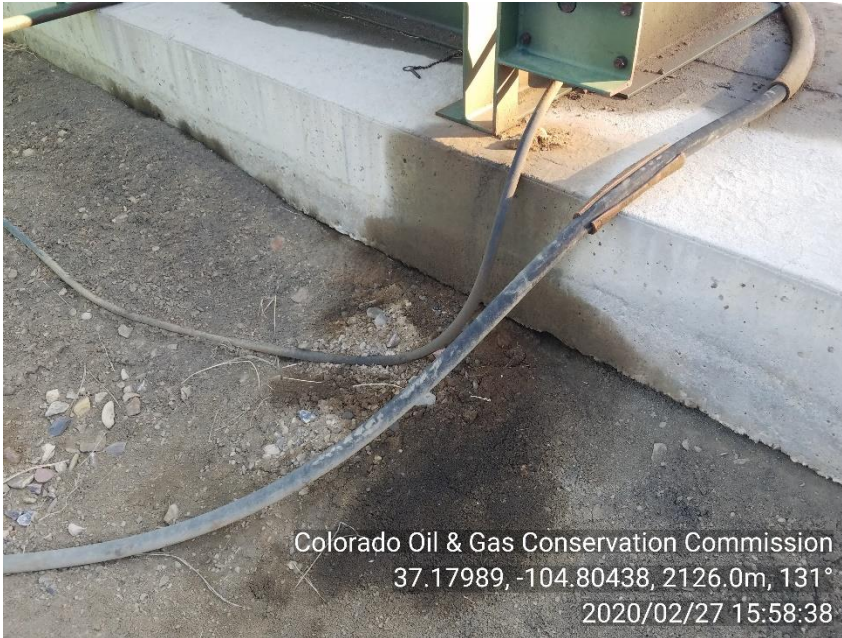
PHOTO 13: IMPACTED SOIL NEXT TO PUMPJACK PAD NEAR SOUND WALL. Conduct maintenance on equipment, cleanup stained material and review self inspection processes. CA DATE 3-3-20.

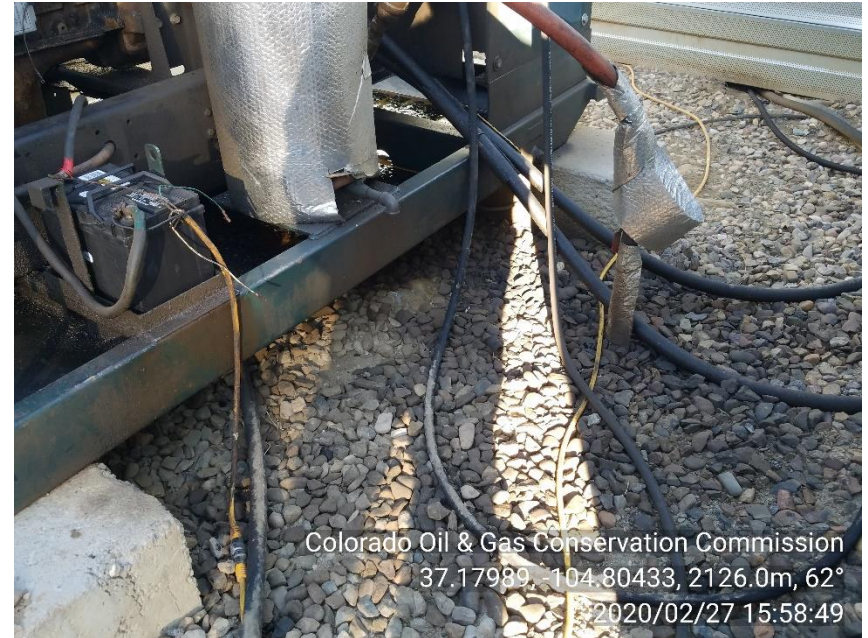
PHOTO 14: IMPACTED SOIL NEAR PRIME MOVER INSIDE SOUND WALLS. Conduct maintenance on equipment, cleanup stained material and review self inspection processes. CA DATE 3-3-20.

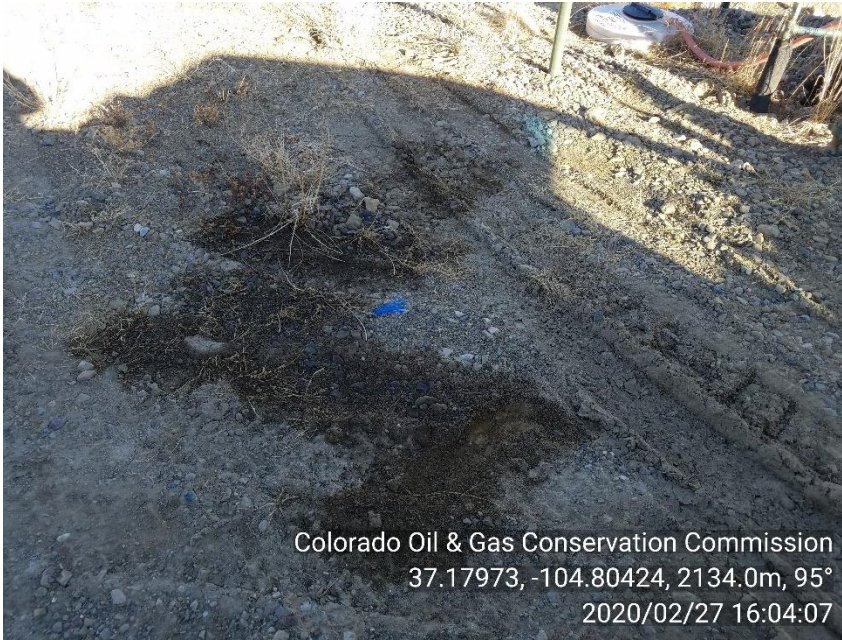
PHOTO 15: IMPACTED SOIL NEXT METER HOUSE.

Conduct maintenance on equipment, cleanup stained material and review self inspection processes. CA DATE 3-3-20.

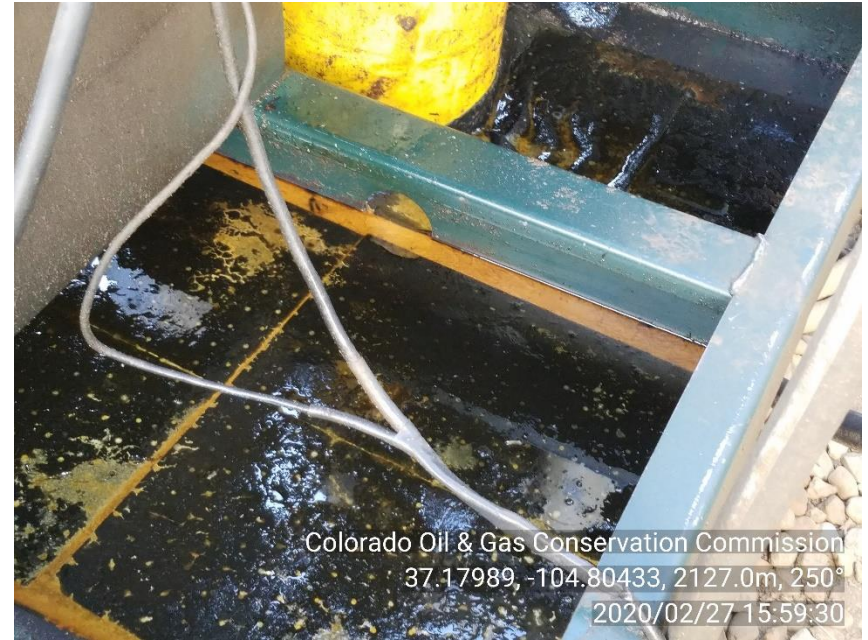
PHOTO 16: OILY WASTE INSIDE PRIME MOVER

SKID. Comply with general provisions of the oil and gas act for wildlife protection. CA DATE 3-13-20.
