Grand Mesa Operating CO, Dado 2-21
073-06770

Inspection #688306990

2/27/2020

Surface Cementing Inspection

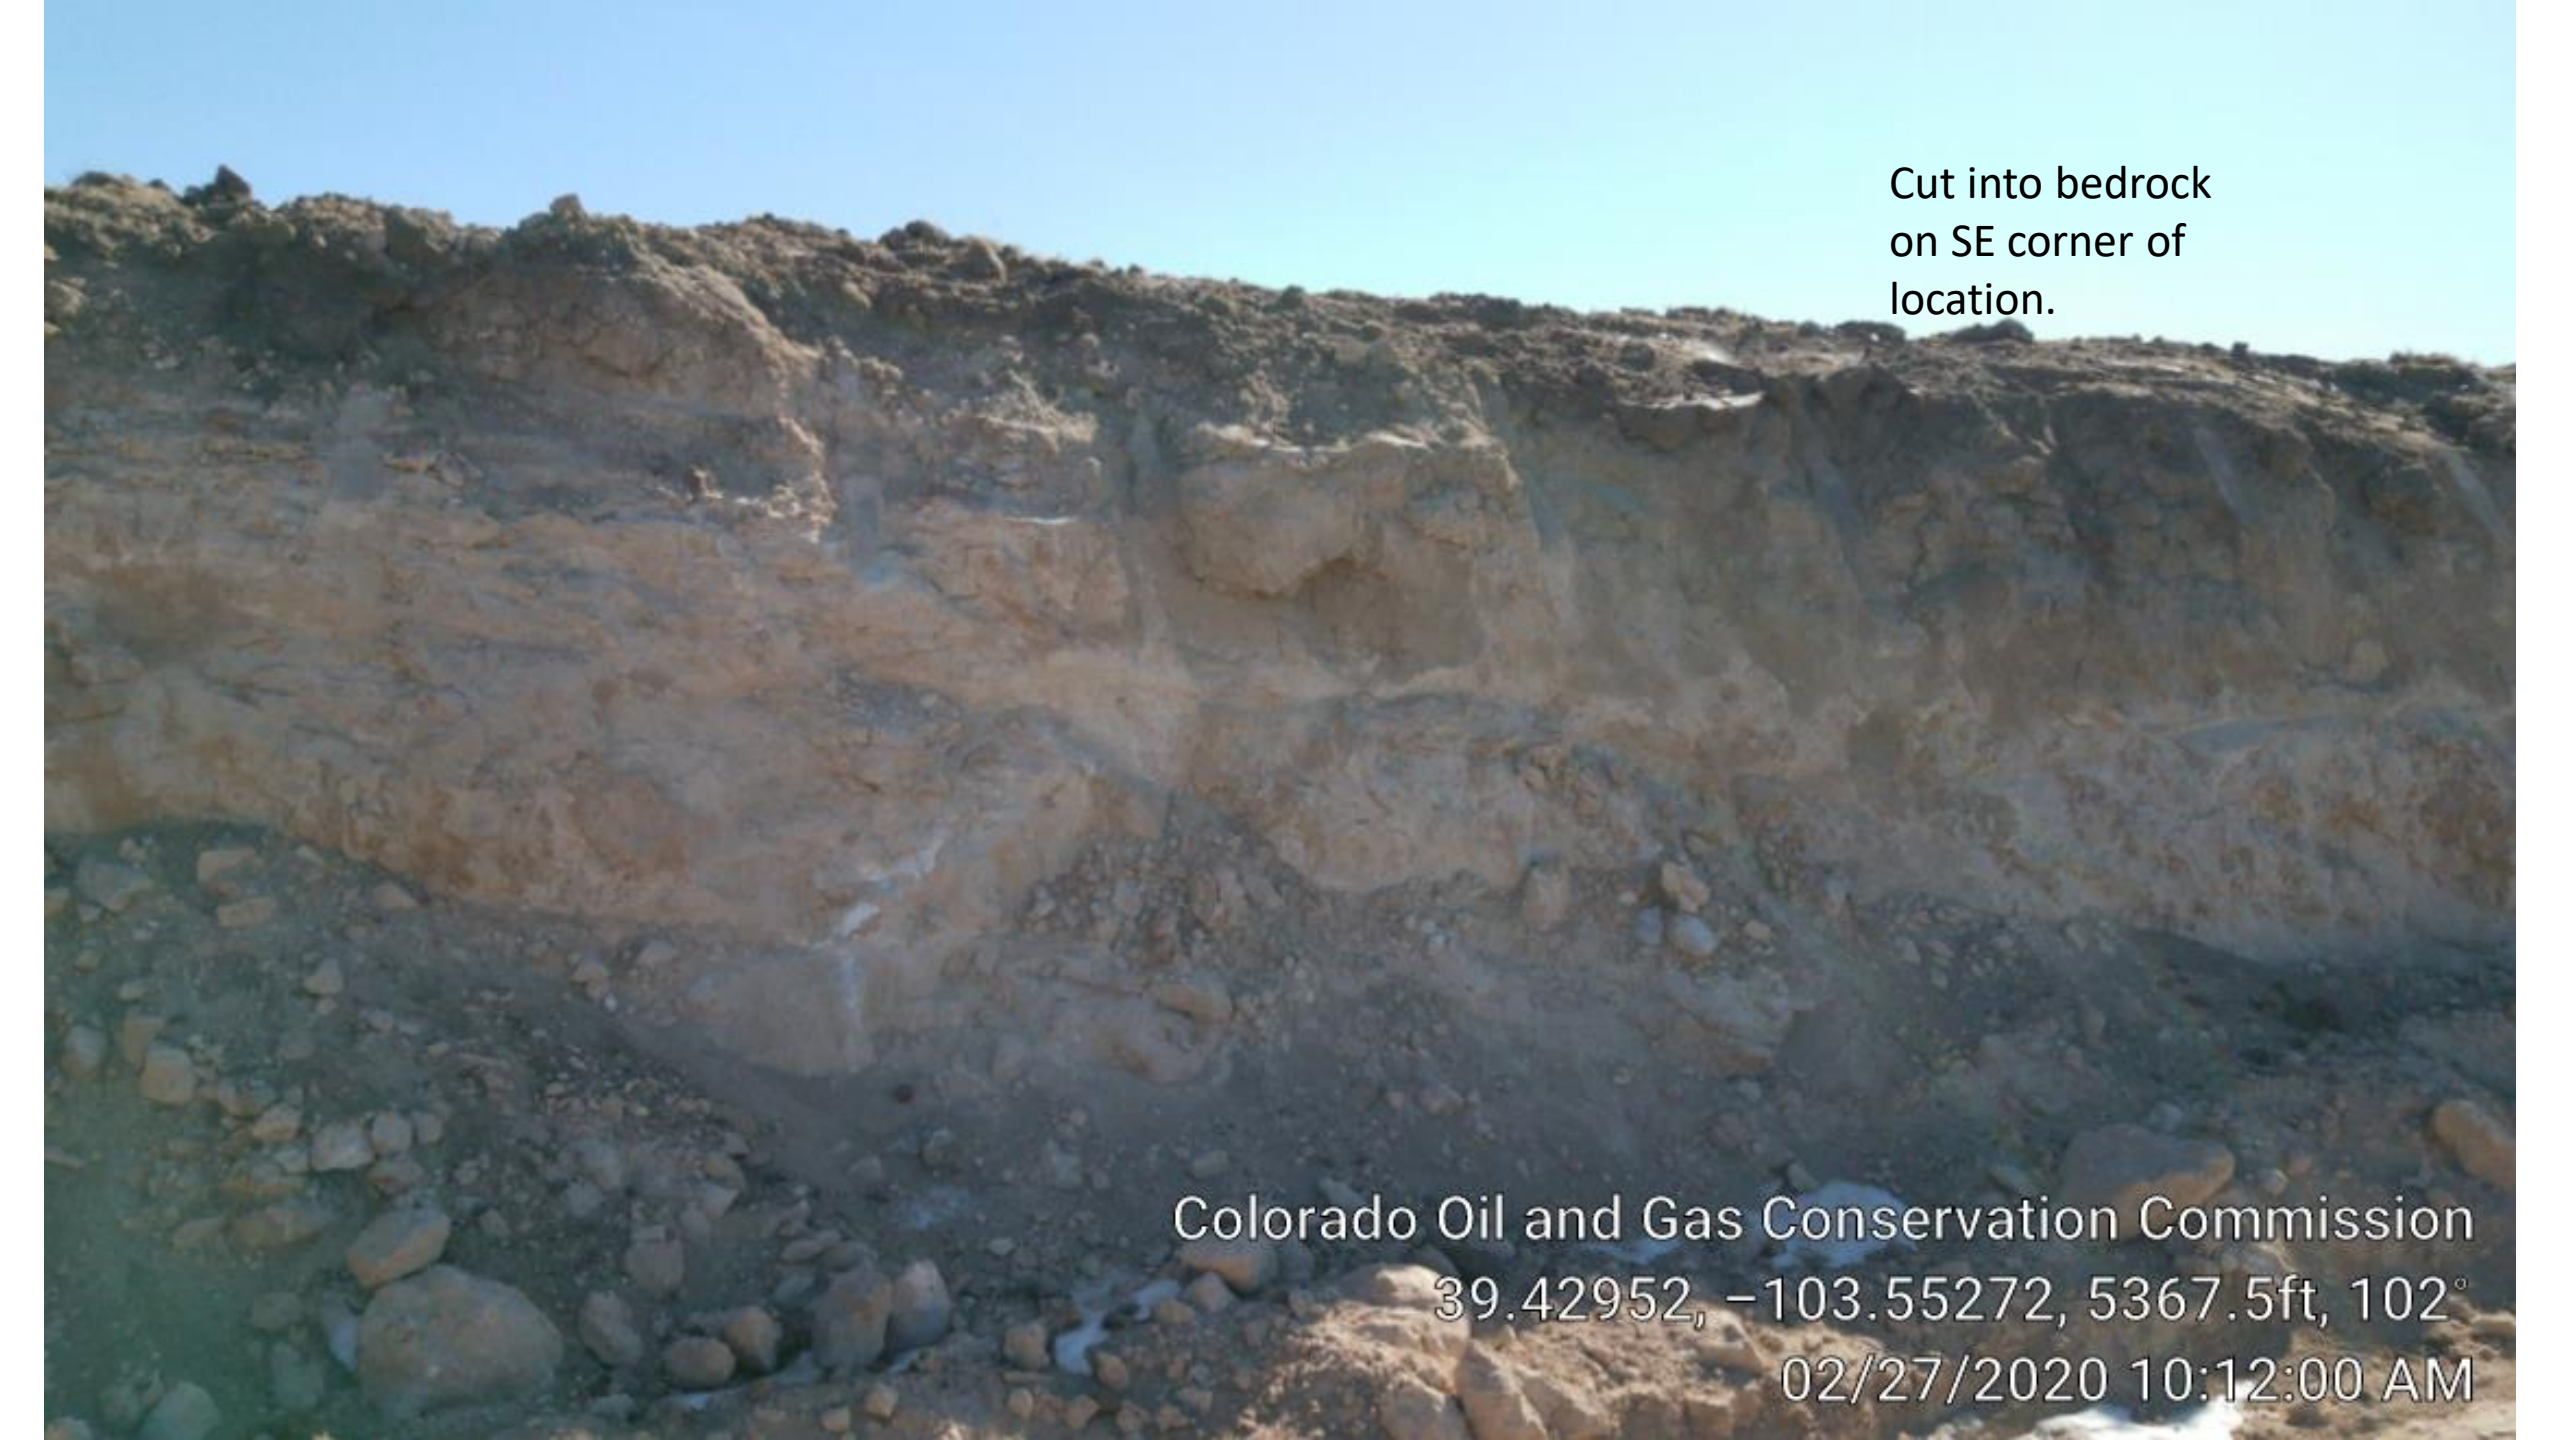
Cut into bedrock
on SE corner of
location.
