# Inspection Photos

Operator: Logos Operating  
Location/API #: 067-09136  
Date: 2-27-2020

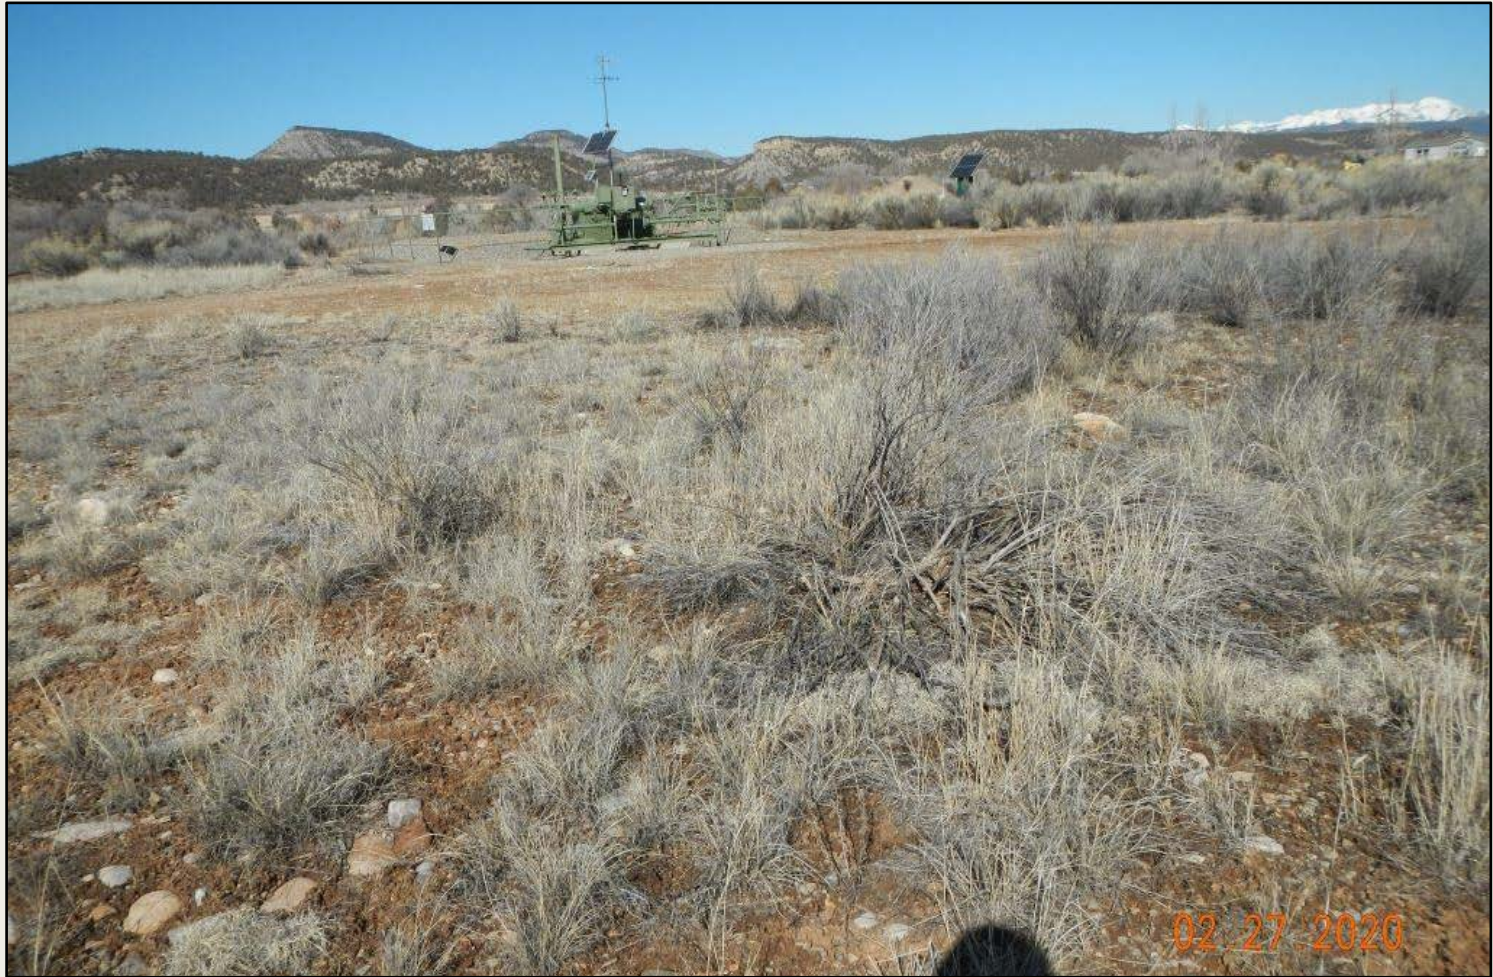
Photo 1. View of the project area from the northeastern corner facing center.

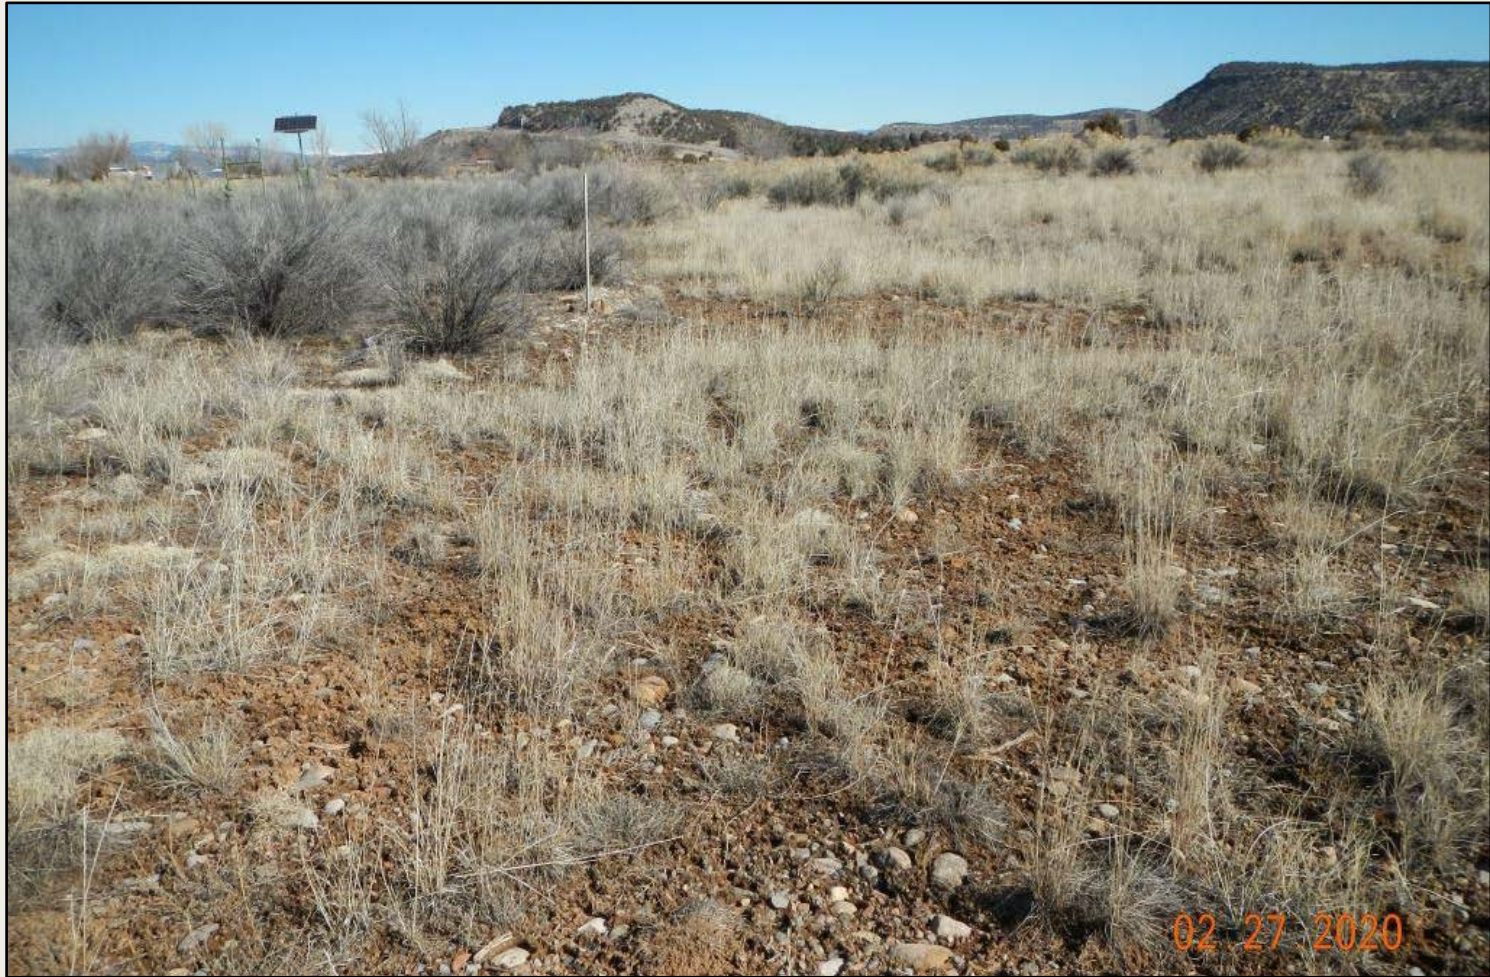
Photo 2. View of the eastern project area from the southeastern corner facing northward. Revegetation is progressing with grasses such as sand dropseed, western wheatgrass, and blue grama.

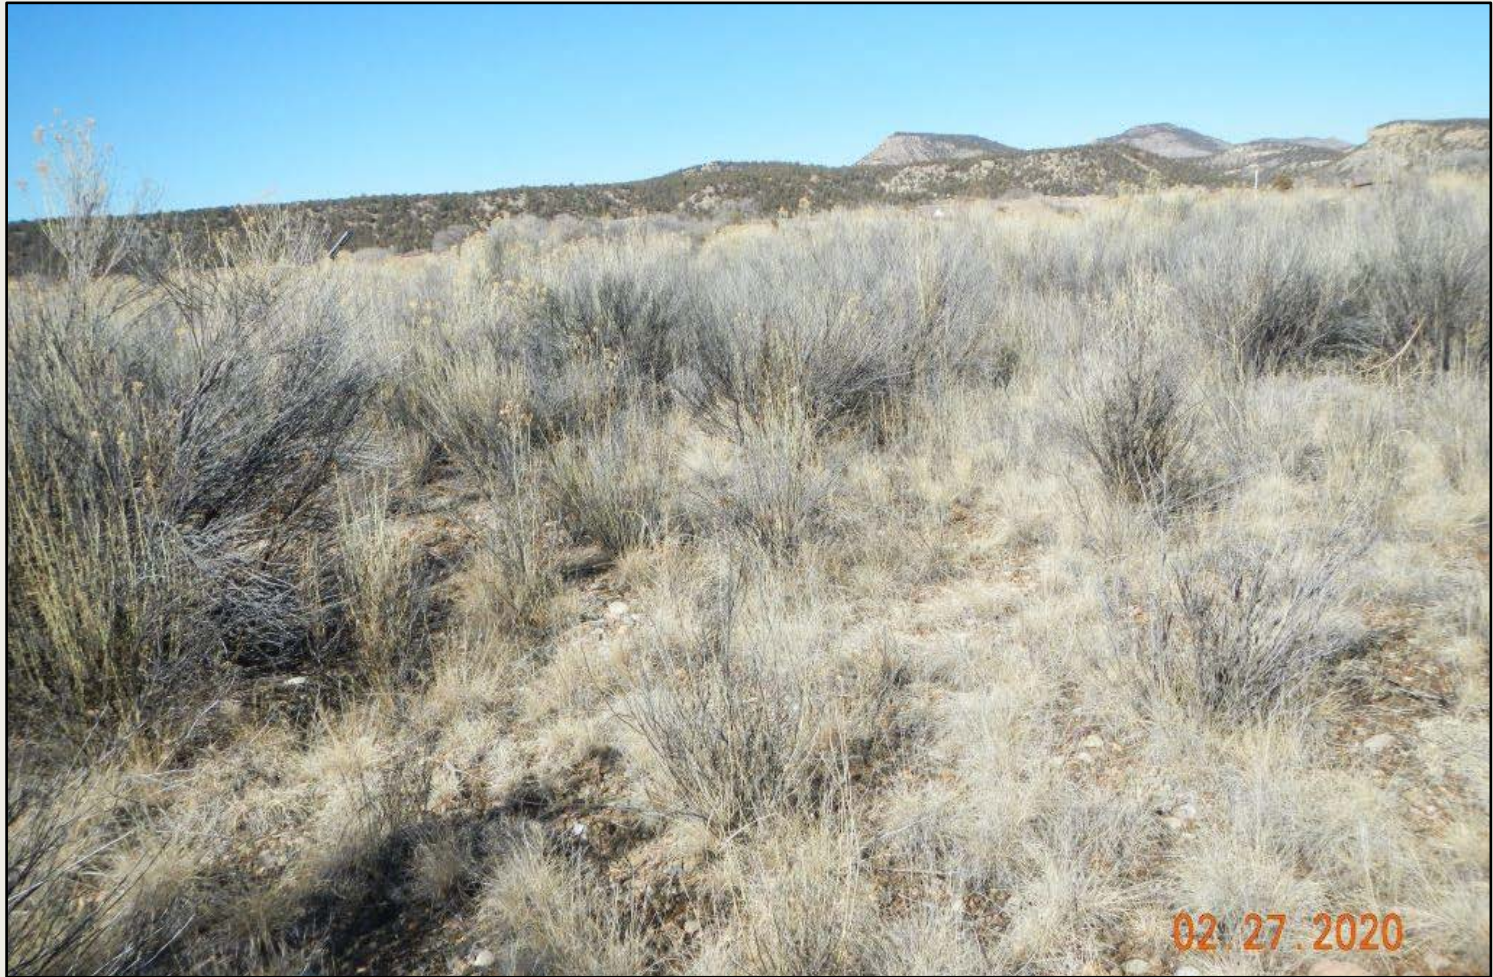
Photo 3. View of the northern project area from the northeastern portion facing westward.

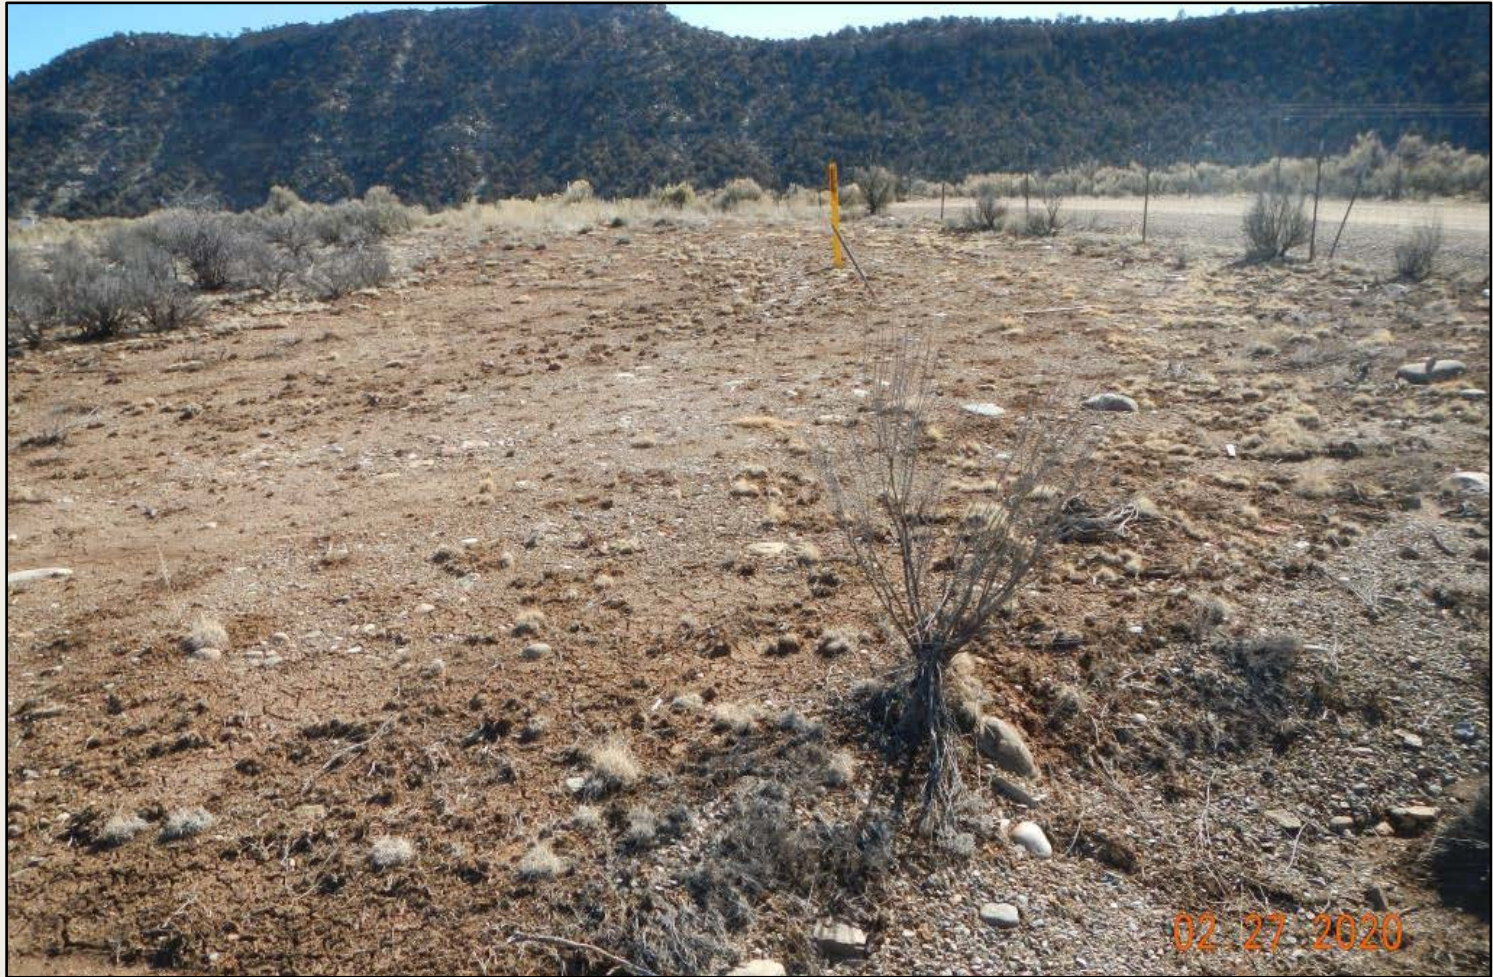
Photo 4. View of area along pipeline corridor where vegetation is sparse and appears to be killed. Shrubs are killed.

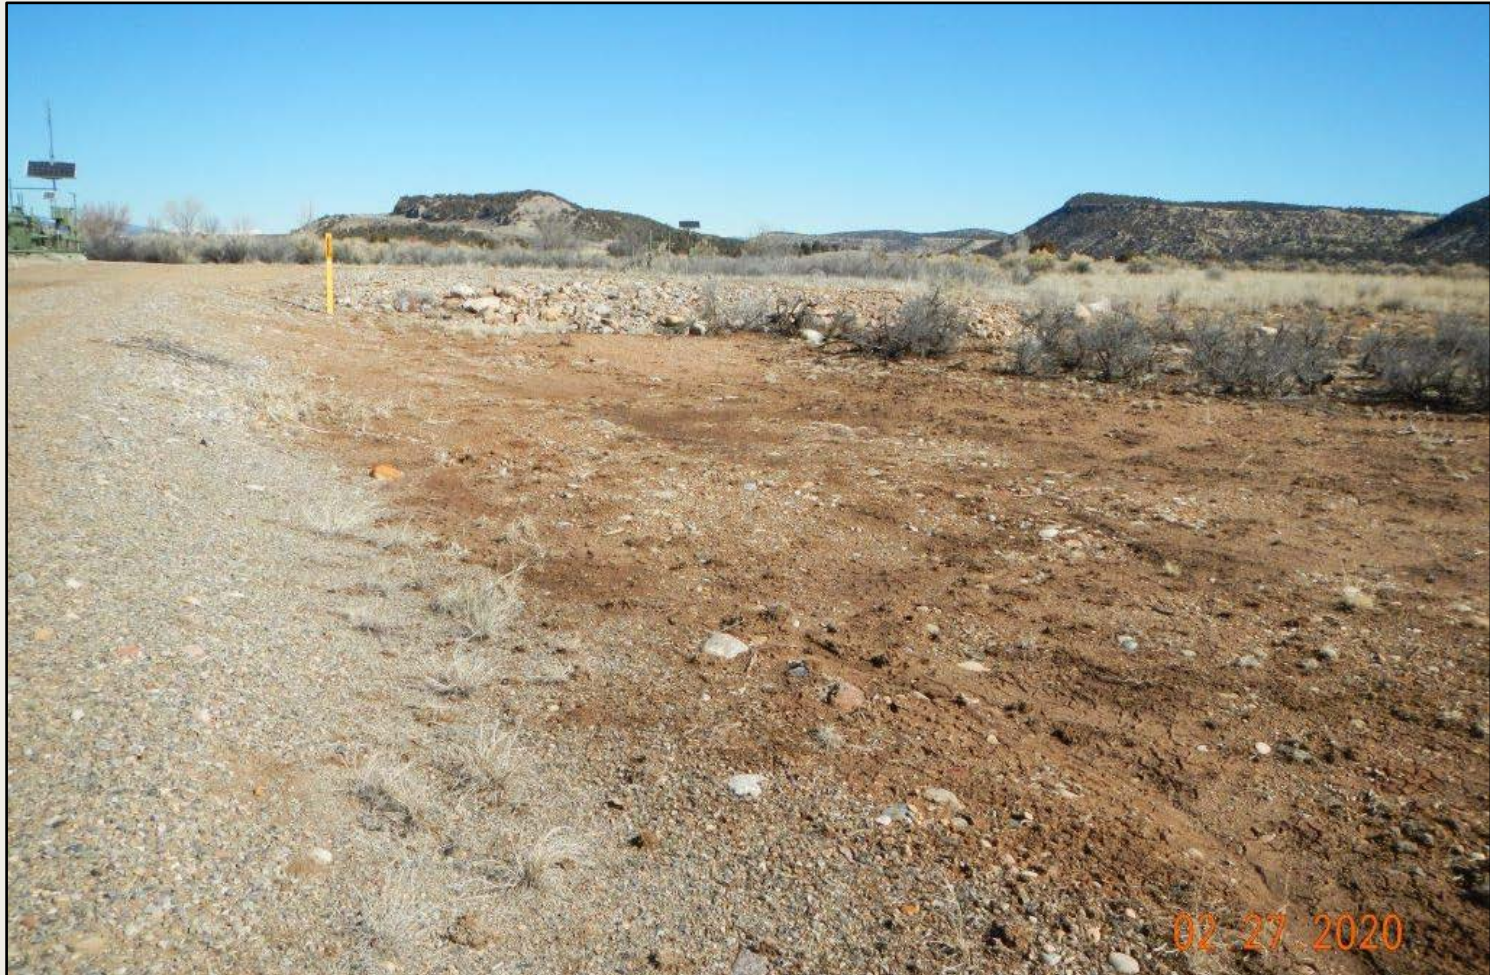
Photo 5. Another view of area along pipeline corridor, adjacent to access road, with little vegetative cover and sagebrush shrubs in background are killed.

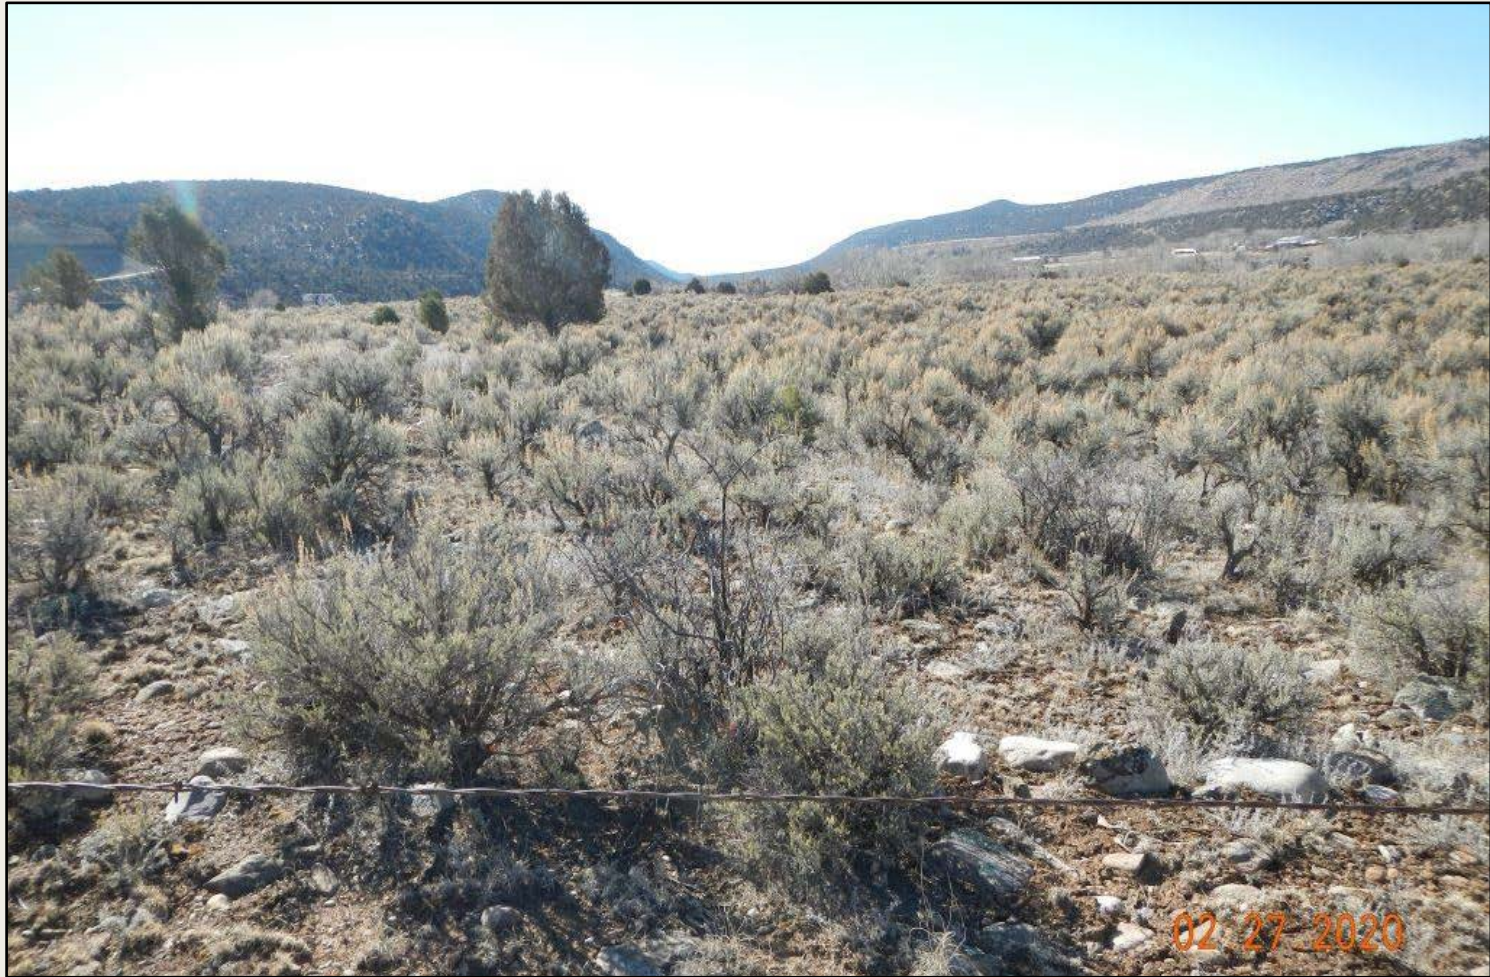
Photo 6. View of reference area vegetation comprised of sagebrush shrubland with mixed grasses such as blue grama and forbs such as snakeweed, in the understory.
