Inspection Photos
Location Name: UPRR 23 PAN AM M #2
Location ID: 319982

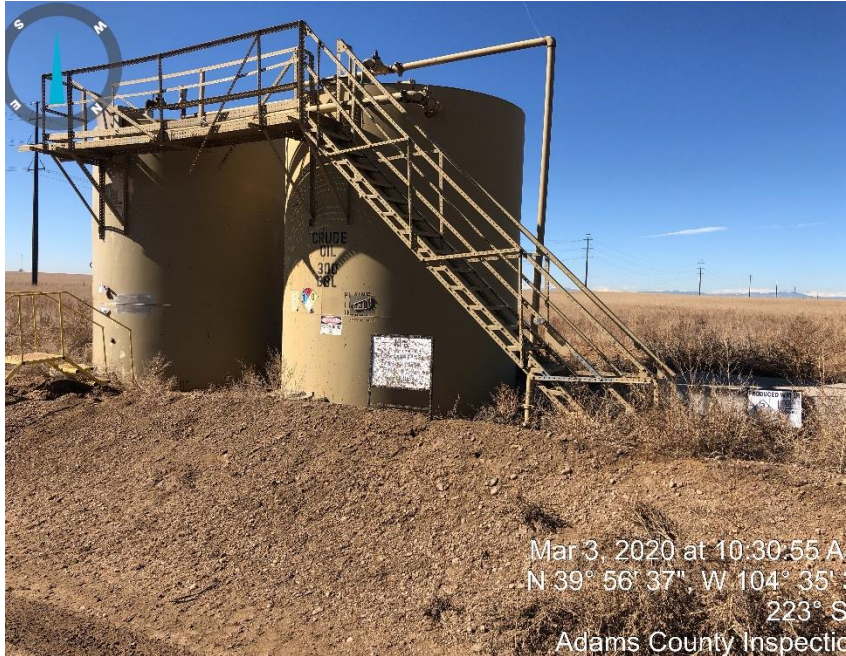
Photo #1 tanks

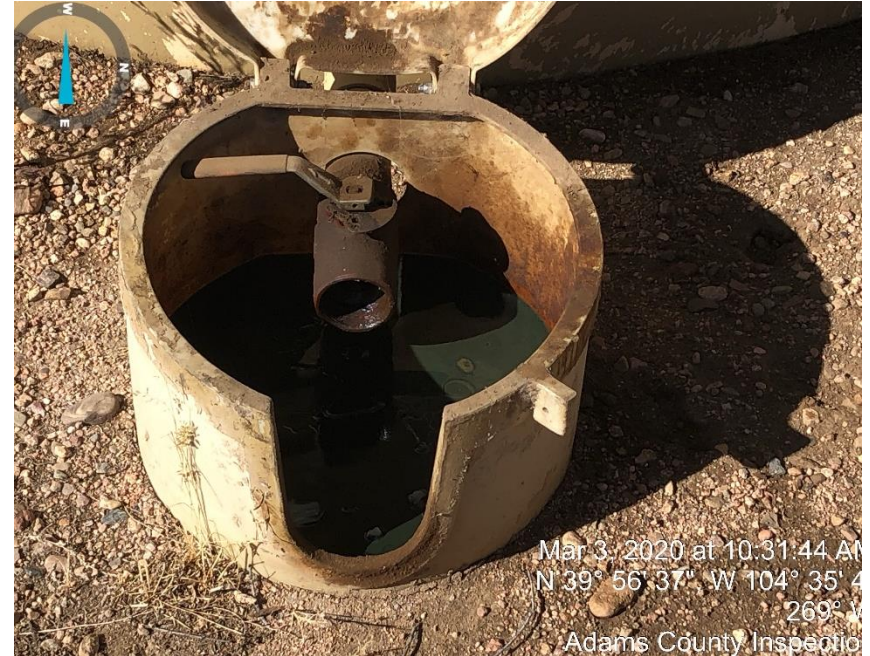
Photo #2 missing Bullplug

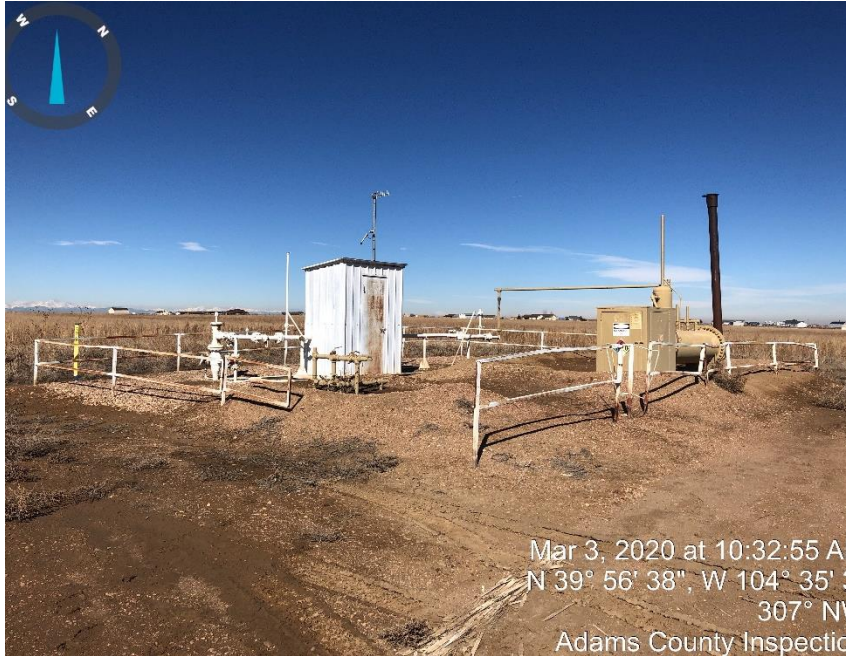
Photo #3 separator

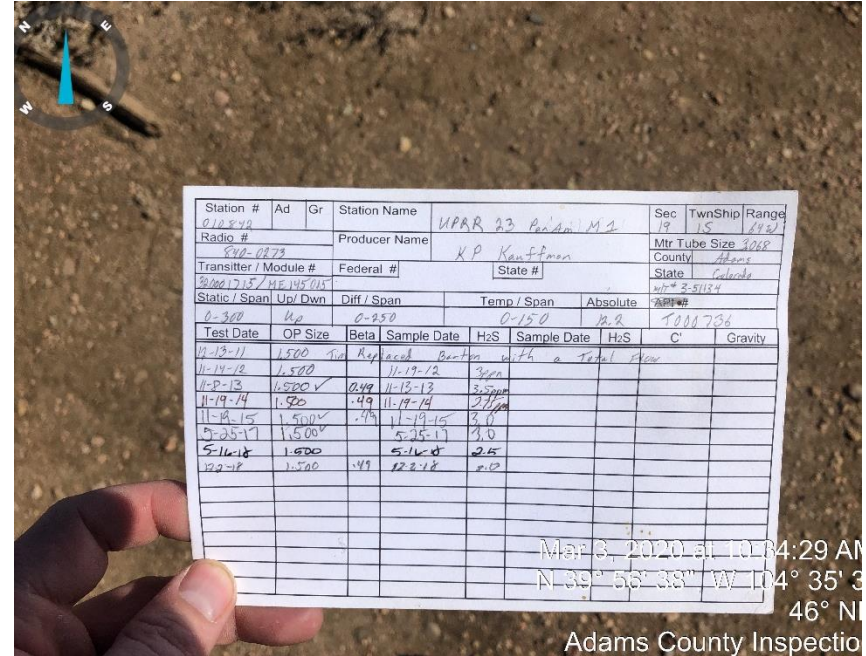
Photo #4 meter out of calibration

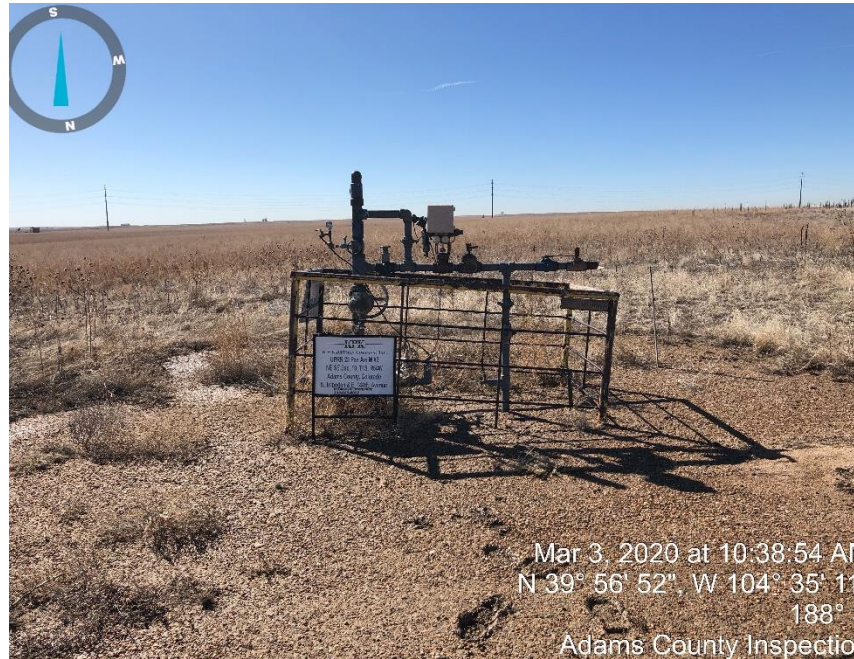
Photo #5 wellhead
