Inspection Photos
Operator Name: Foundation Energy
Location ID: 322352

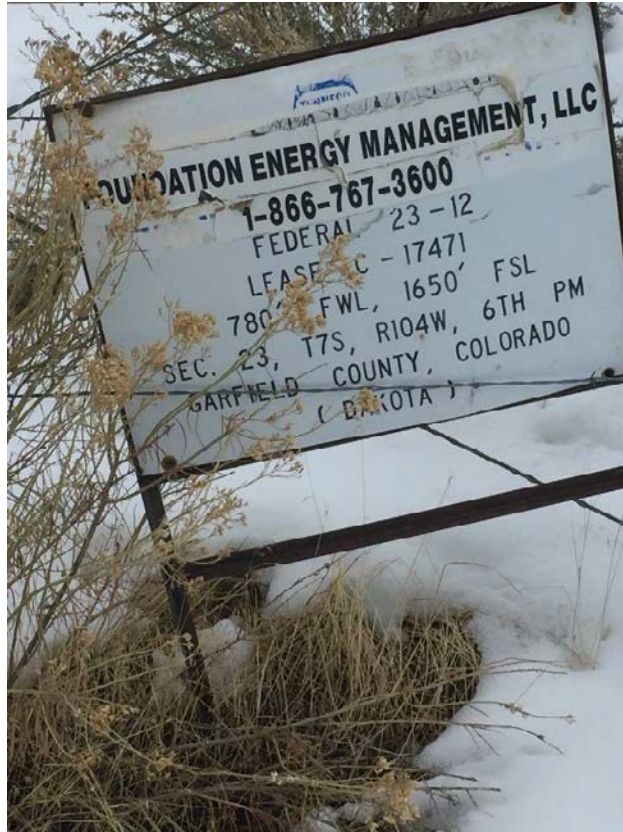
Location sign

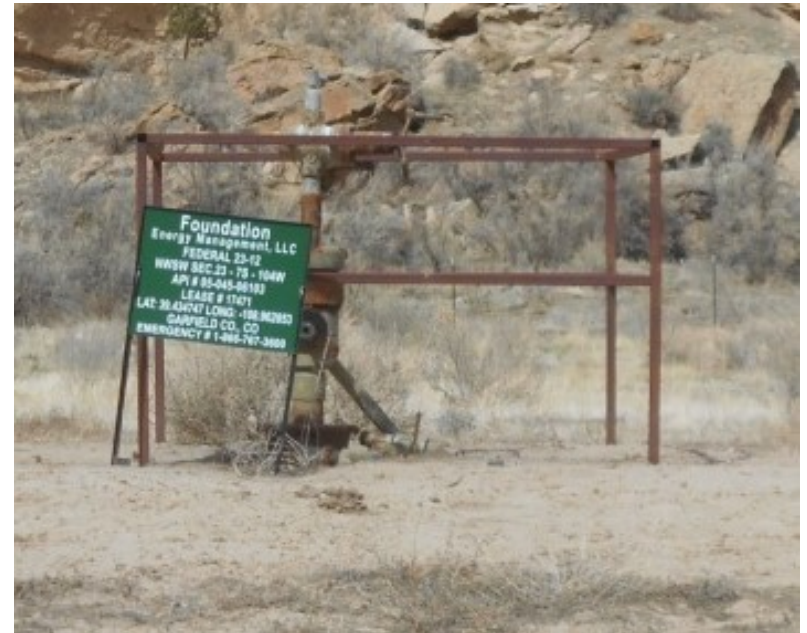
Wellhead picture 3-27-2018 with
flowline at angle

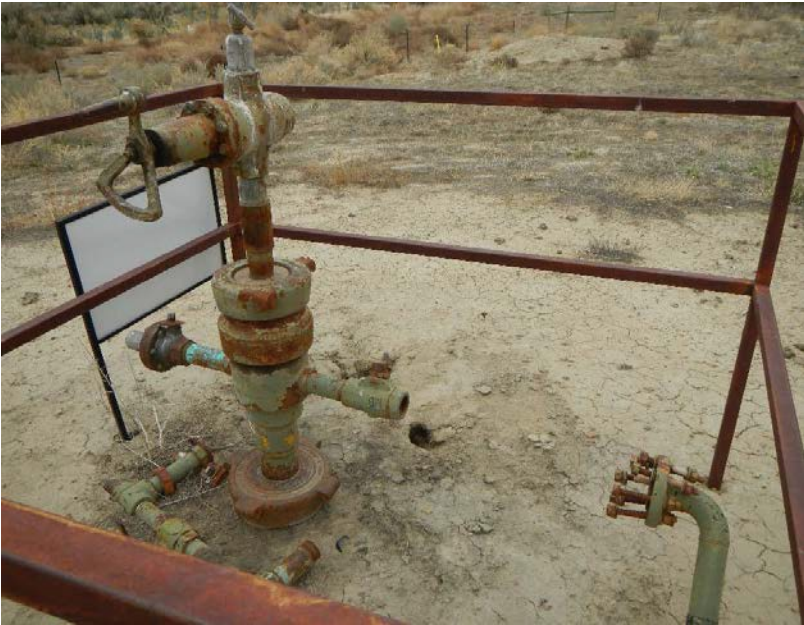
Wellhead picture 3-21-2018, with flowline riser in picture, operator stated they don't use bolt up flange in picture and flowline belongs to Excel Energy

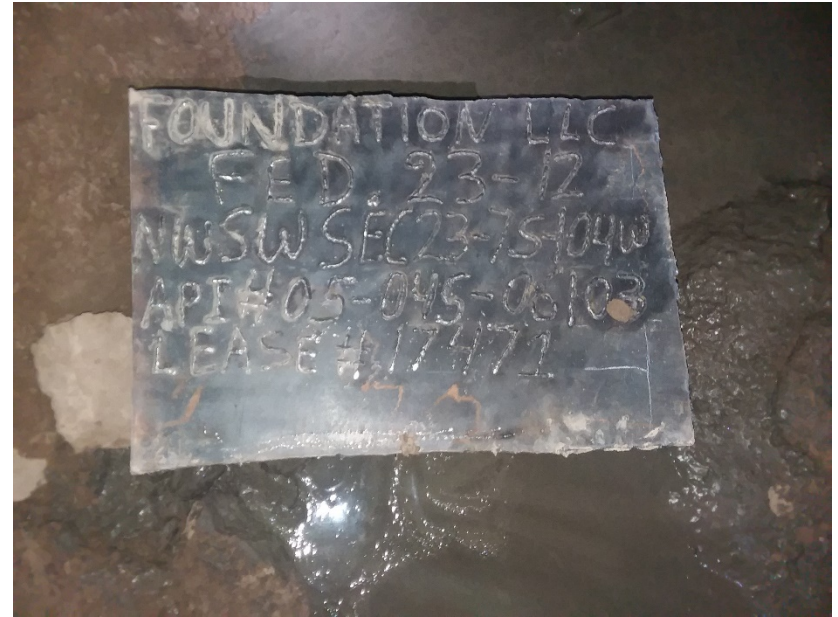
Well head sign, installed below grade

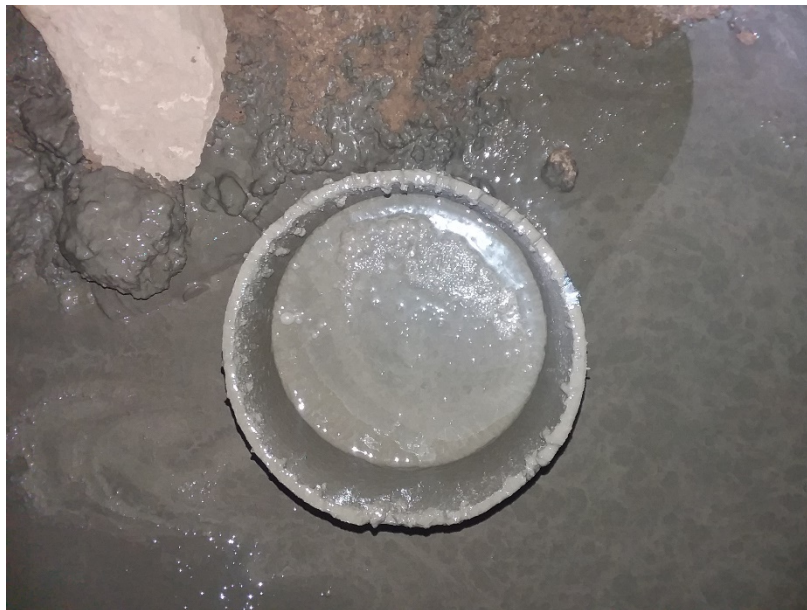
**Wellhead picture with cement to
surface**
