Inspection Photos

Location Name: ADAMIC 1-20 FOLLOWUP

API#: 05-071-06020

INSP. #: 695102279

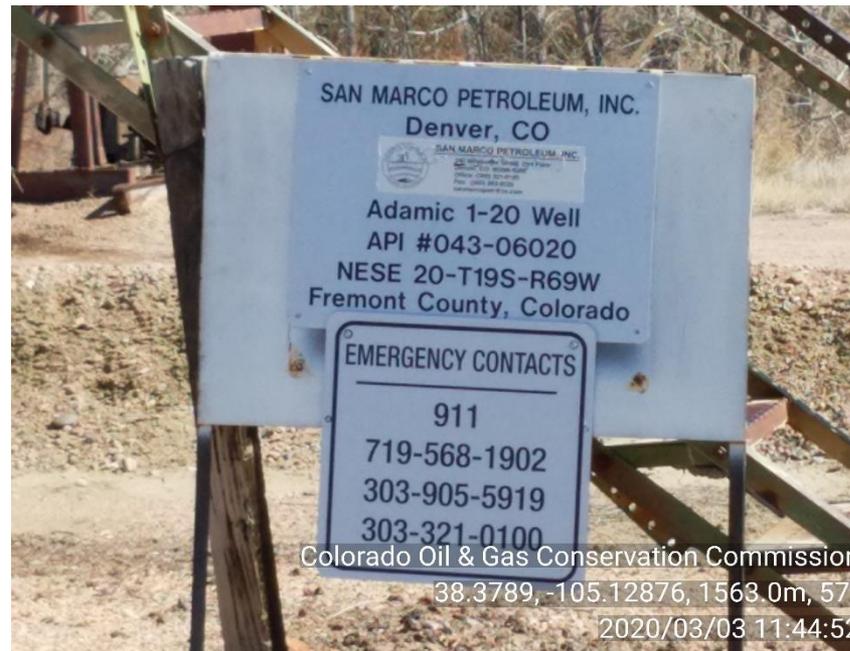
PHOTO 2: WELL SIGN/ CA FOR 911 ON EMERGENCY CONTACT HAS BEEN ADDRESSED.

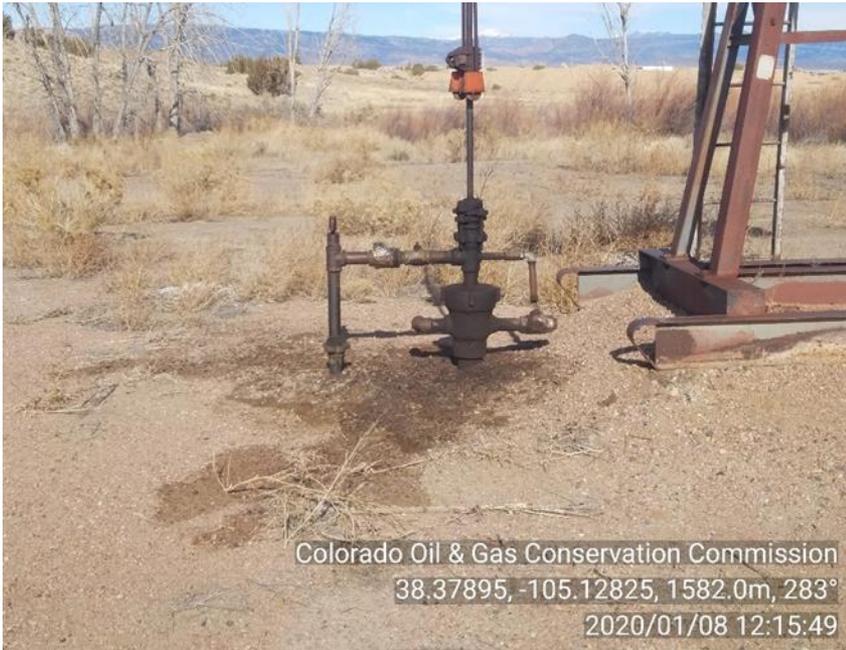
PHOTO 3: PHOTO FROM PREVIOUS INSPECTION (695101985). IT APPEARS THAT CA HAS NOT BEEN ADDRESSED.

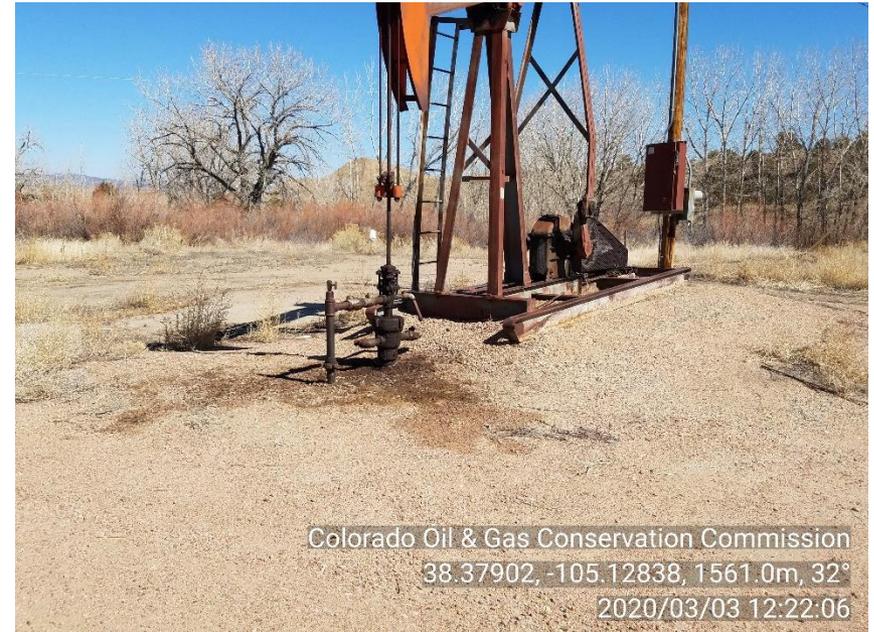
PHOTO 4: IT APPEARS THAT WELLHEAD IS LEAKING PRODUCED OIL, AREA OF IMPACTED SOIL APP. 6' BY 3' AROUND WELLHEAD. Securely fasten all valves, pipes, and fittings to ensure good mechanical condition, inspect at regular intervals and maintain in good mechanical condition per Rule 605.d. Properly treat or dispose of oily waste in accordance with 907.e. ACTION REQUIRED IMMEDIATELY AS CA DATE FROM PRIOR INSPECTION HAS PAST.

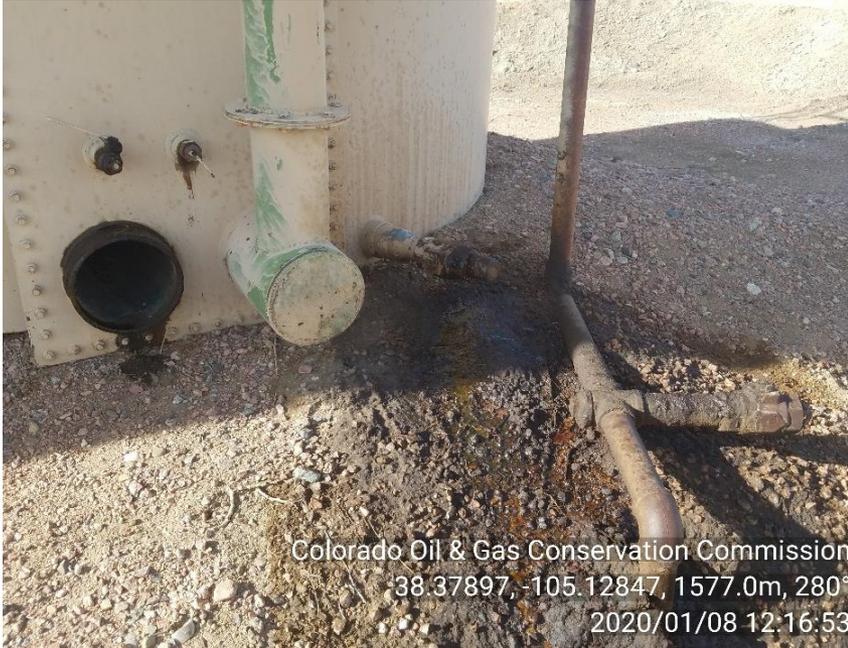
PHOTO 5: PHOTO FROM PREVIOUS INSPECTION (695101985). IT APPEARS THAT CA HAS NOT BEEN ADDRESSED.

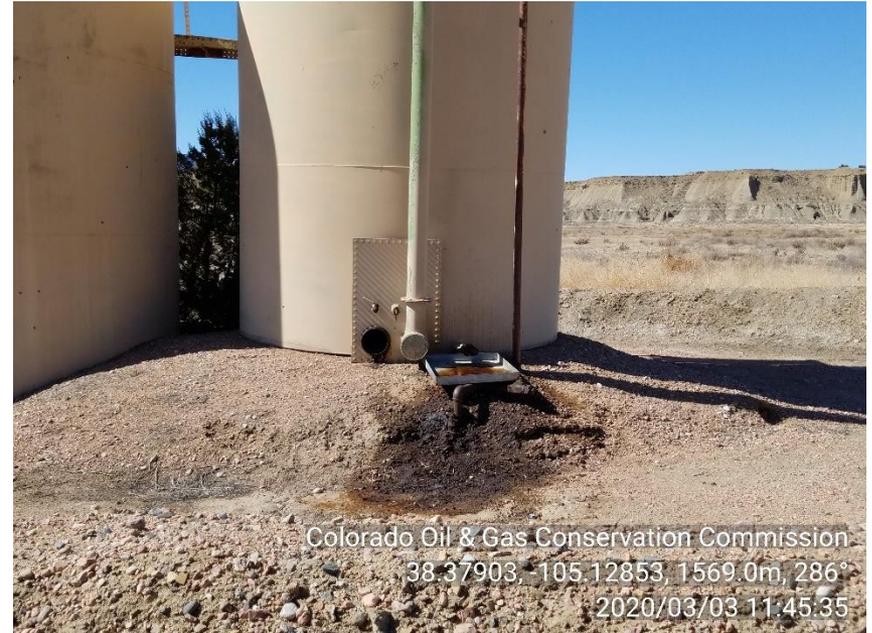
PHOTO 6: A BULLPLUG ON 210 BBL TANK IS LEAKING. THERE IS AN AREA OF IMPACTED SOIL APP. 3' BY 6' NEAR LEAKING PLUG. CALLED CONTACT NUMBER POSTED ON BATTERY SIGN AND HAD TO LEAVE A MESSAGE. **Securely fasten all valves, pipes, and fittings to ensure good mechanical condition, inspect at regular intervals and maintain in good mechanical condition per Rule 605.d. Properly treat or dispose of oily waste in accordance with 907.e.**

ACTION REQUIRED IMMEDIATELY AS CA DATE FROM PRIOR INSPECTION HAS PAST.

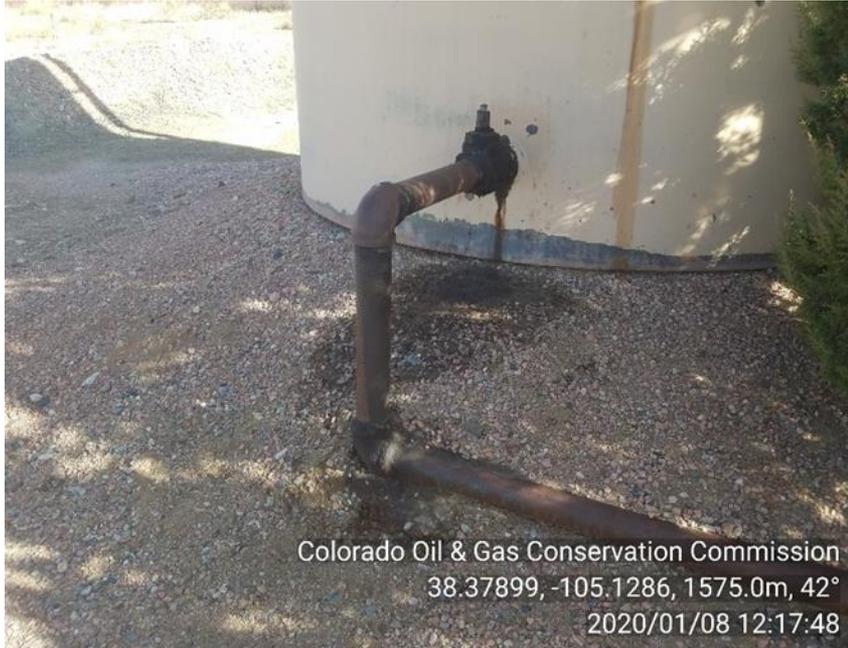
PHOTO 7: PHOTO FROM PREVIOUS INSPECTION (695101985). IT APPEARS THAT CA HAS NOT BEEN ADDRESSED.

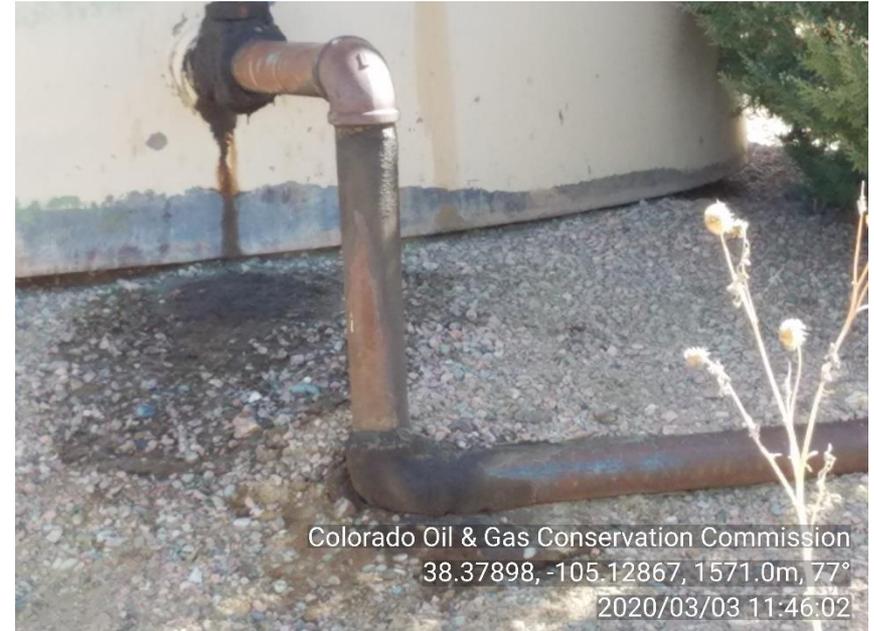
PHOTO 8: VALVE ON 210 BBL TANK IS SEEPING. THERE IS AN AREA OF IMPACTED SOIL APP. 3' BY 1' NEAR SEEPING VALVE.. Securely fasten all valves, pipes, and fittings to ensure good mechanical condition, inspect at regular intervals and maintain in good mechanical condition per Rule 605.d. Properly treat or dispose of oily waste in accordance with 907.e.

ACTION REQUIRED IMMEDIATELY AS CA DATE FROM PRIOR INSPECTION HAS PAST.

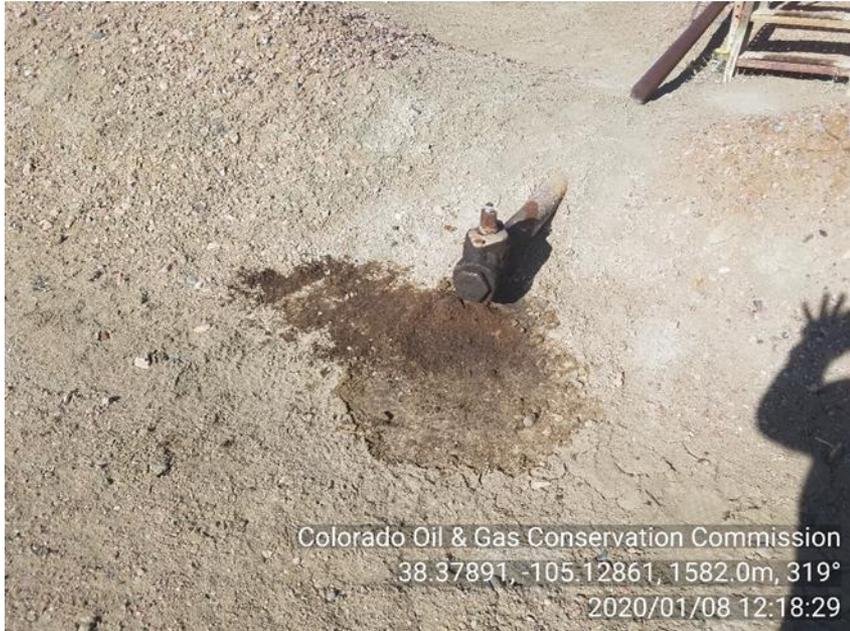
PHOTO 9: PHOTO FROM PREVIOUS INSPECTION (695101985). IT APPEARS THAT CA HAS NOT BEEN ADDRESSED.

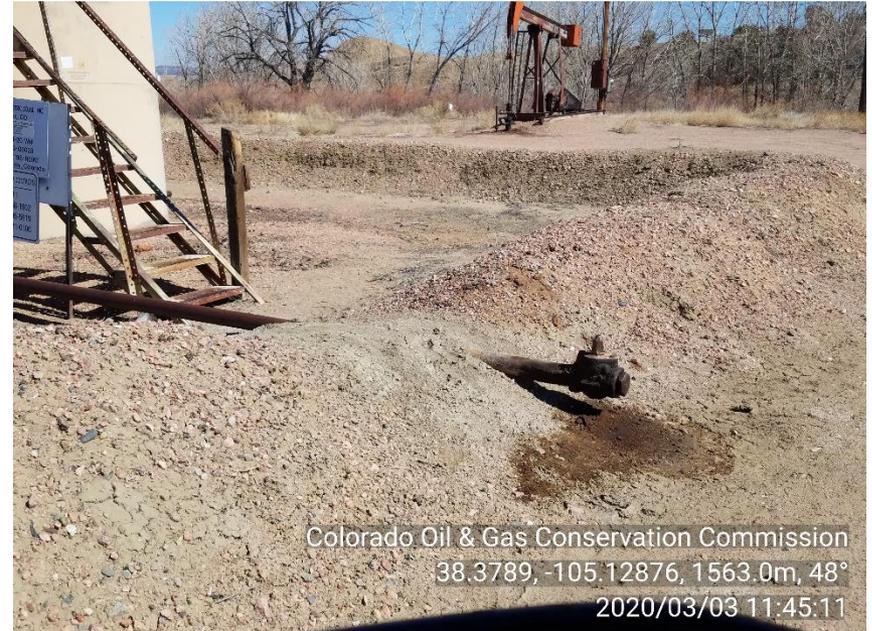
PHOTO 10: LOADOUT LINE IS PLUMBED OUTSIDE SECONDARY BMP. THERE IS AN AREA OF IMPACTED SOIL OUTSIDE OF BURM) APP. 1' BY 2' AROUND LOADOUT. **INSTALL SECONDARY BMP TO PREVENT OILY WASTE FROM MIXING WITH STORM WATER PER RULE 1002.f. Properly treat or dispose of oily waste in accordance with 907.e.**

ACTION REQUIRED IMMEDIATELY AS CA DATE FROM PRIOR INSPECTION HAS PAST.

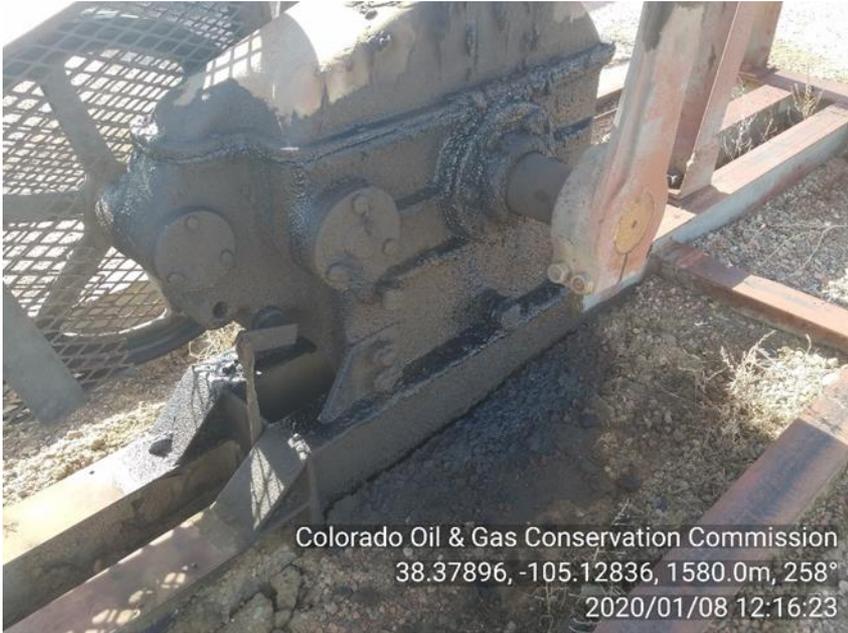
PHOTO 11: PHOTO FROM PREVIOUS INSPECTION (695101985). IT APPEARS THAT CA HAS NOT BEEN ADDRESSED.

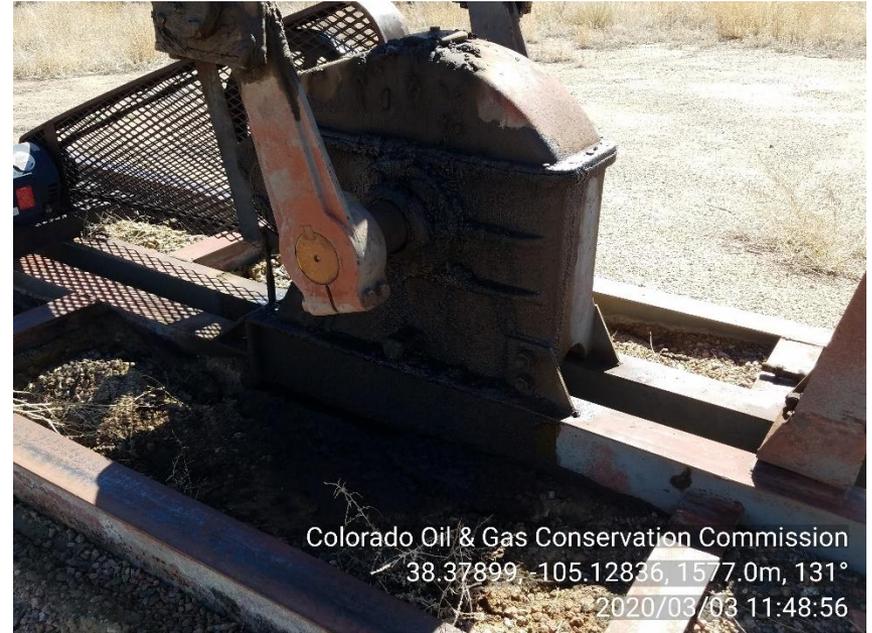
PHOTO 12: APPEARS THAT GEAR BOX ON PUMPJAKE IS LEAKING, THERE IS AN AREA OF IMPACTED SOIL BENEATH GEARBOX. Securely fasten all valves, pipes, and fittings to ensure good mechanical condition, inspect at regular intervals and maintain in good mechanical condition per Rule 605.d. Properly treat or dispose of oily waste in accordance with 907.f. ACTION REQUIRED IMMEDIATELY AS CA DATE FROM PRIOR INSPECTION HAS PAST.
