McLaughlin 72
API: 05-103-01143
Inspection: 679707043

Doc# 1309614

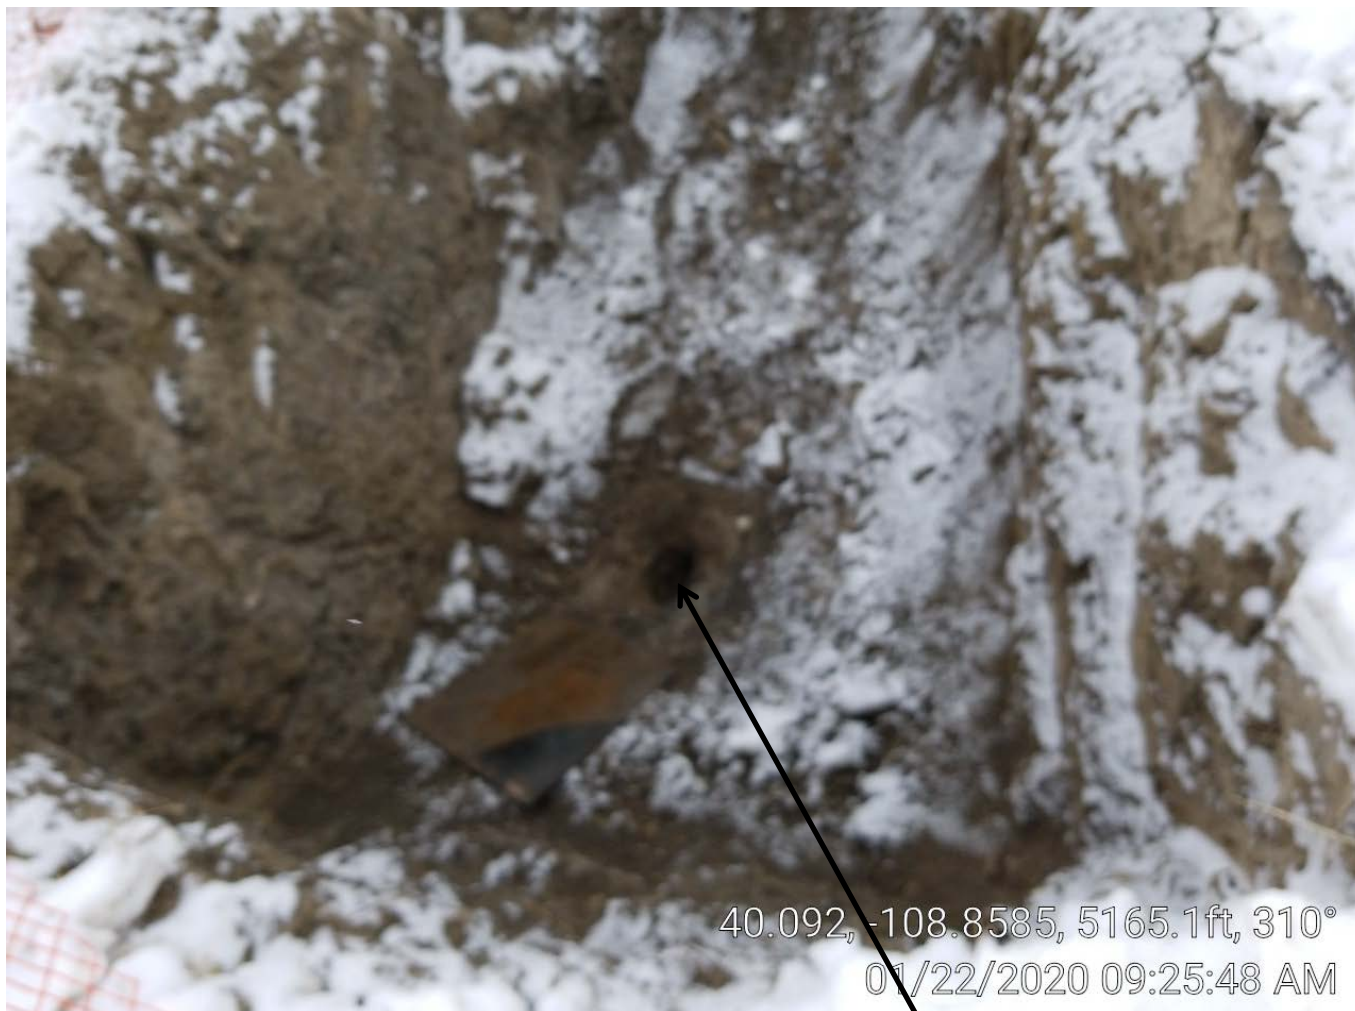
Photo 1. Excavated Location.

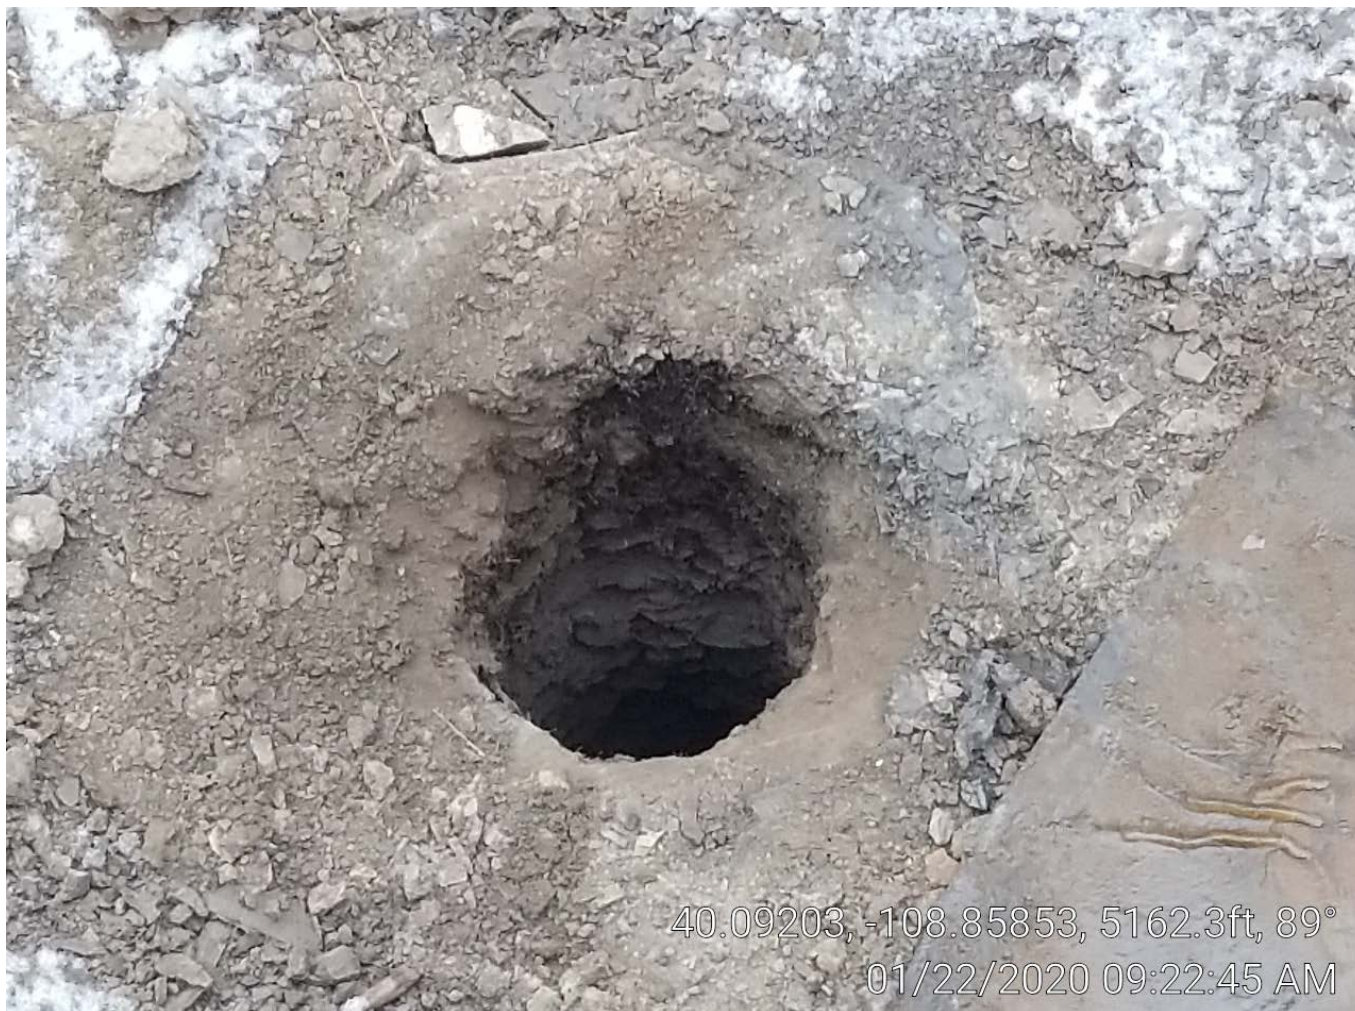
Well bore

Photo 2. Well bore.

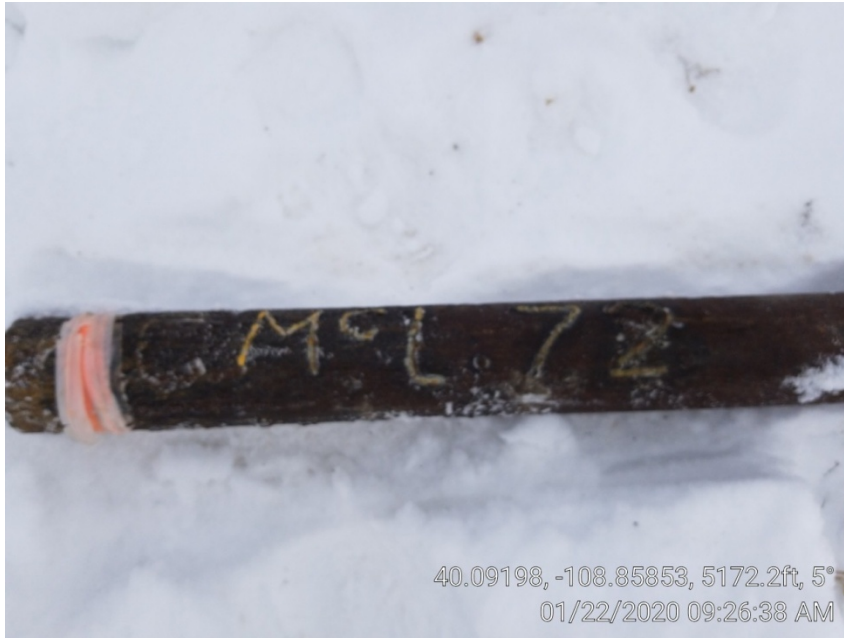
Photo 3. Well marker.

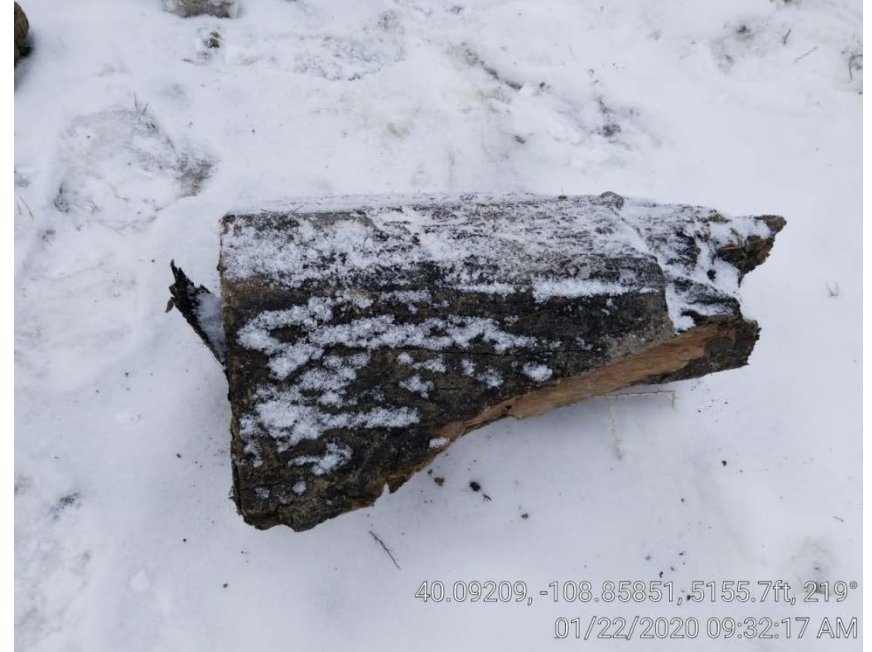
Photo 4. Wood used to plug well bore in ~1953.

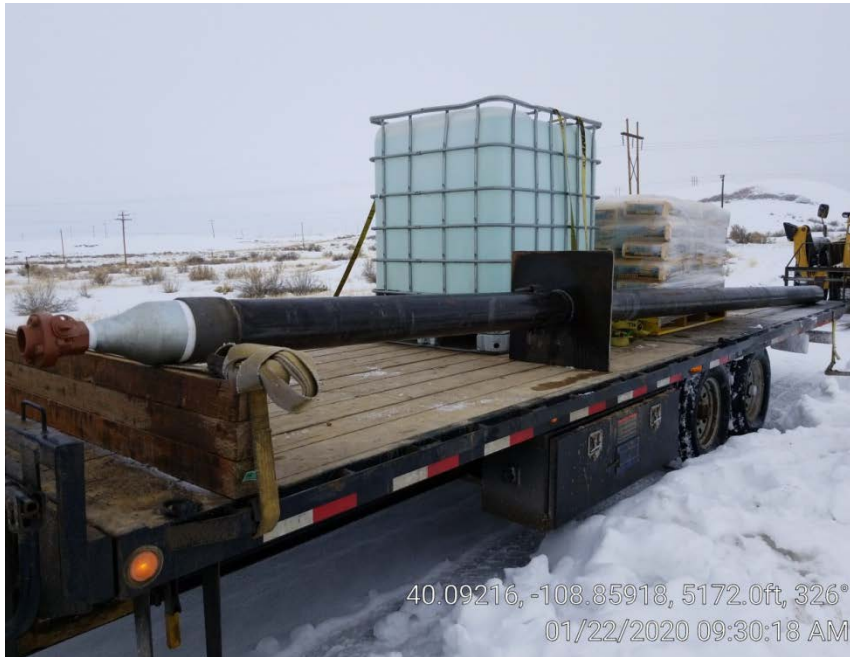
Photo 5. Surface casing installed 1-22-2020 to plug well.

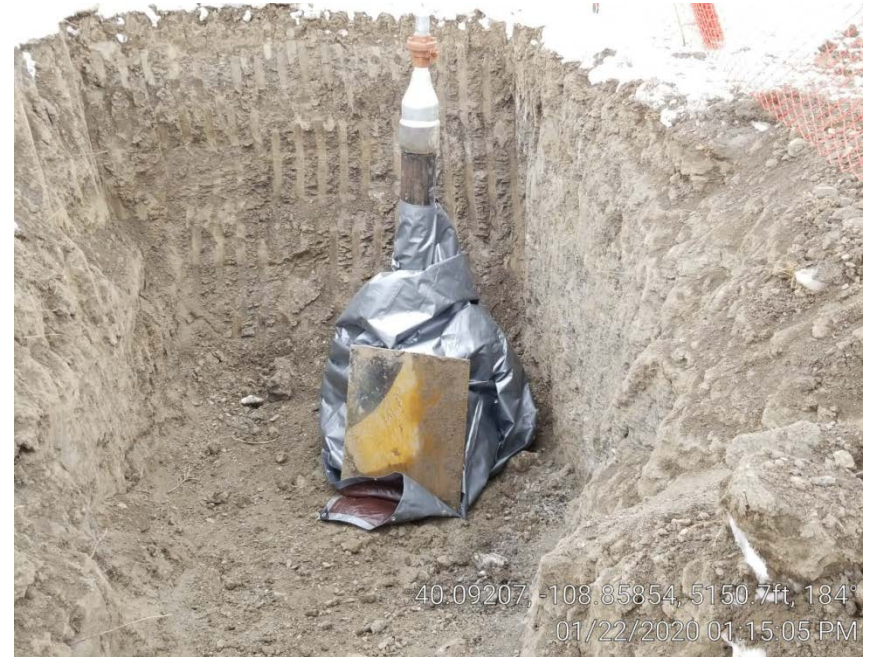
Photo 6. New surface casing installed.
