Pit Status Evaluation Form**Pit Overview:**

Pit Name: HETRICK 1-29	Facility ID: 114641
Current Status: Unknown	Status Date: 9/23/1999
Current Operator:	
Updated Operator:	
Form 15 Pit Permit Doc #:	Permit Date:
Related Facilities: HETRICK #1-29 (API 05-009-06368, Facility ID 205454, Loc ID 321070)

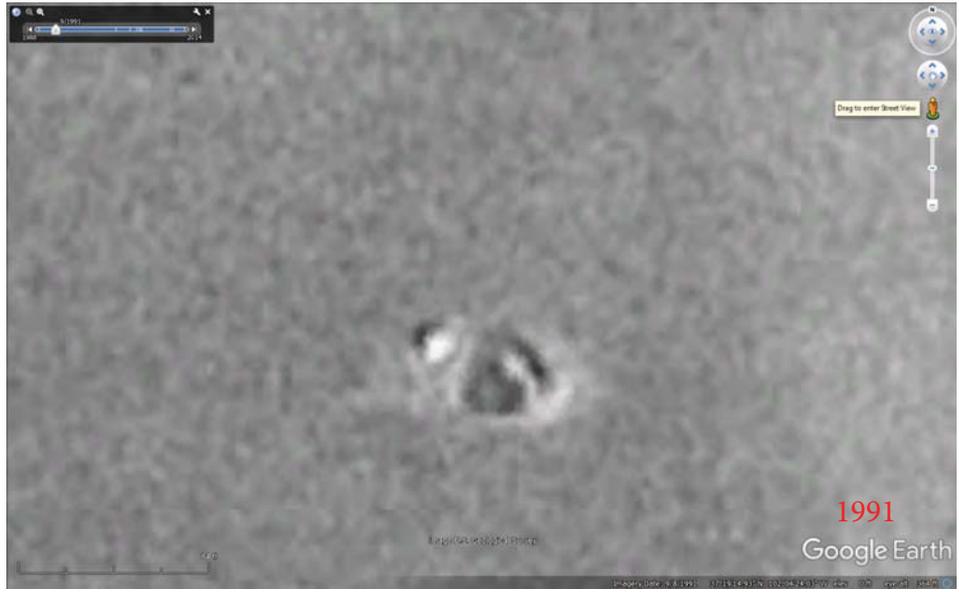
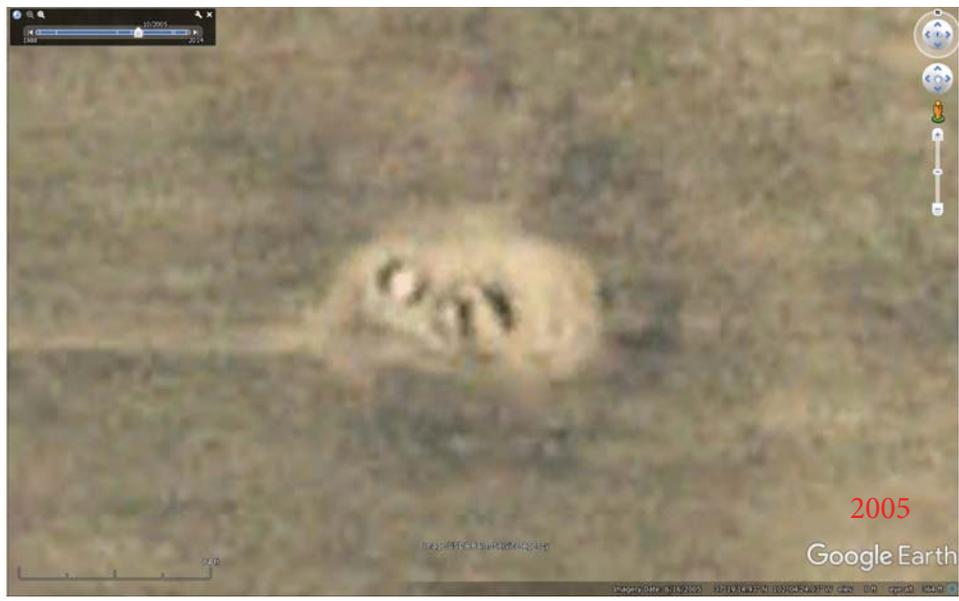
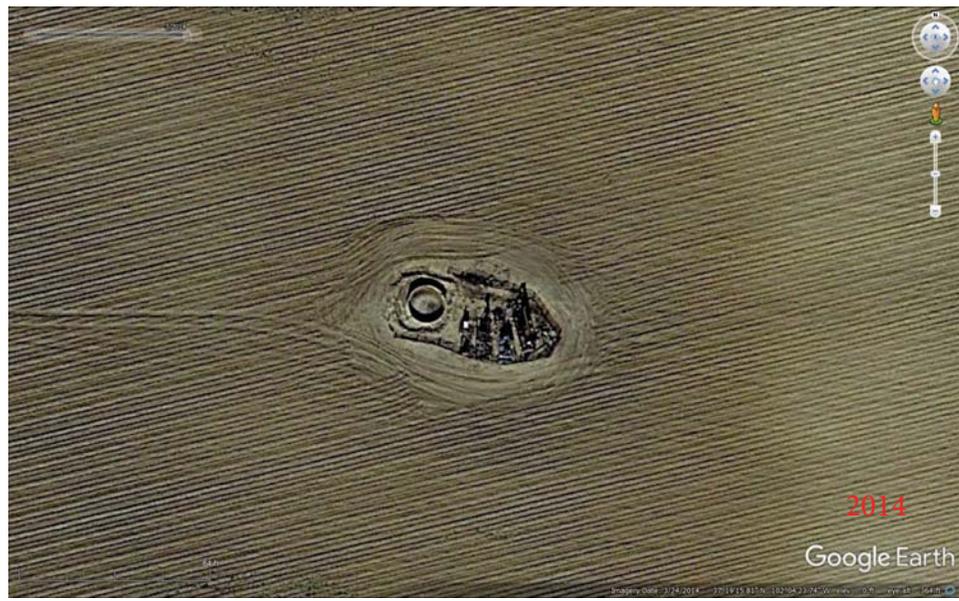
| <input checked="" type="checkbox"/> | Aerial Photo Verification (photos attached) | |

No evidence of a pit on location

Based on records review there is no evidence that there was a pit on location; inspection reports document an open top fiberglass produced water tank on location. Pit status has been changed to closed.
