## Inspection Photos

Location Name: Starkey 14-28-969

Facility ID: CE&P 454686

Inspection Date: February 27, 2020

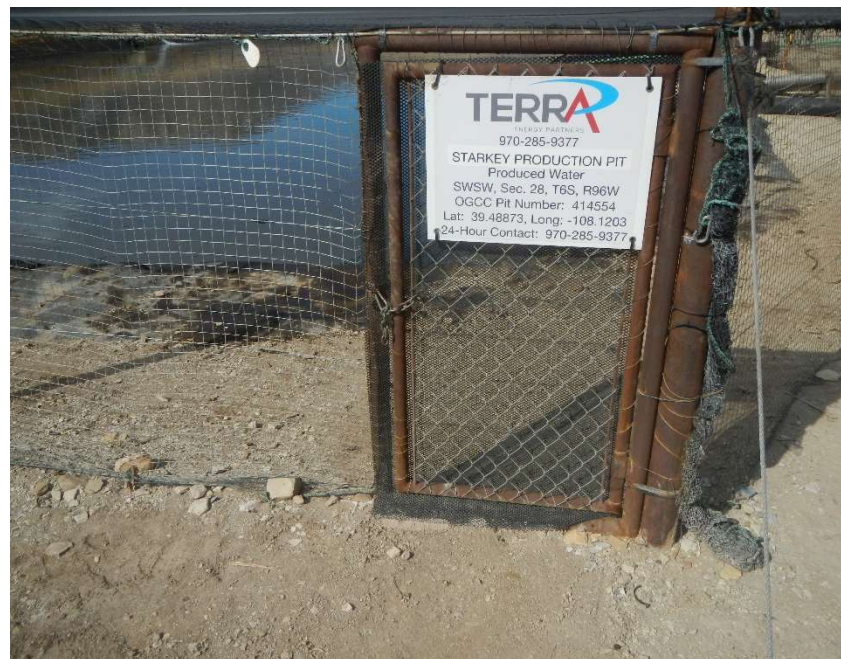
**Starkey Production Pit sign. Note oil accumulation on upper pit liner and soil at the southeast corner of the pit.**

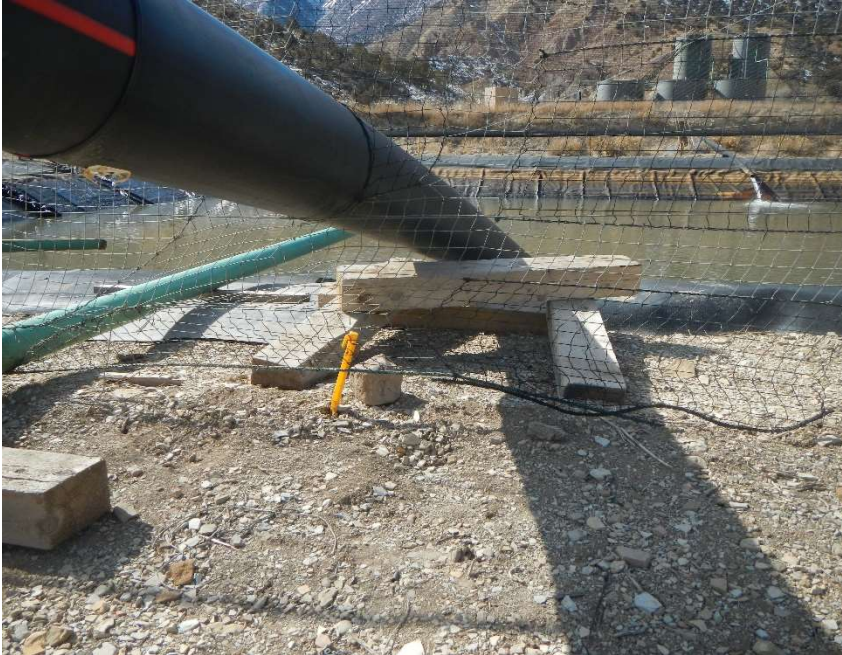
Gaps in the base of the wildlife mesh on the east side of the pit. Note that pipe support cribbing is in disrepair.

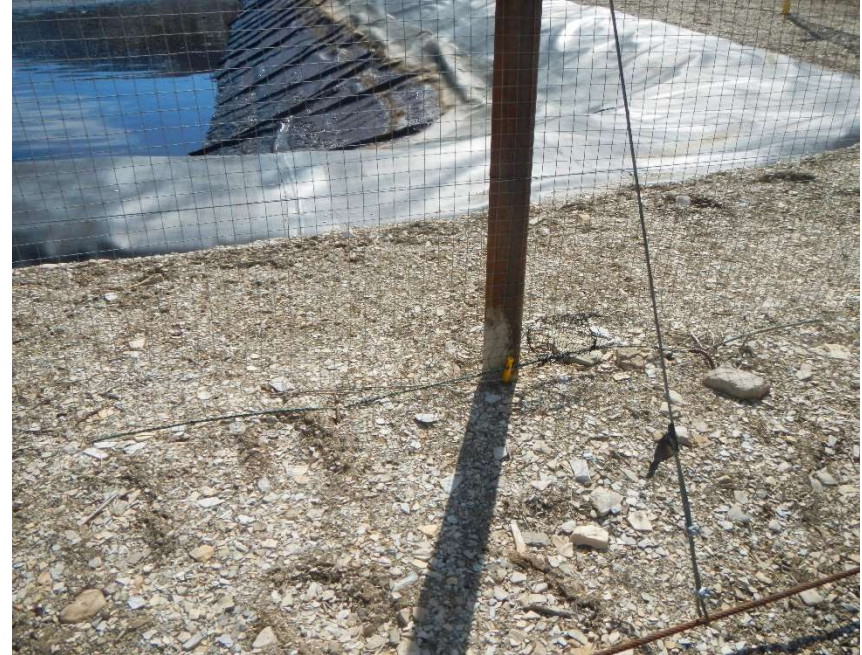
Gaps in the base of the wildlife mesh on the east side of the pit.

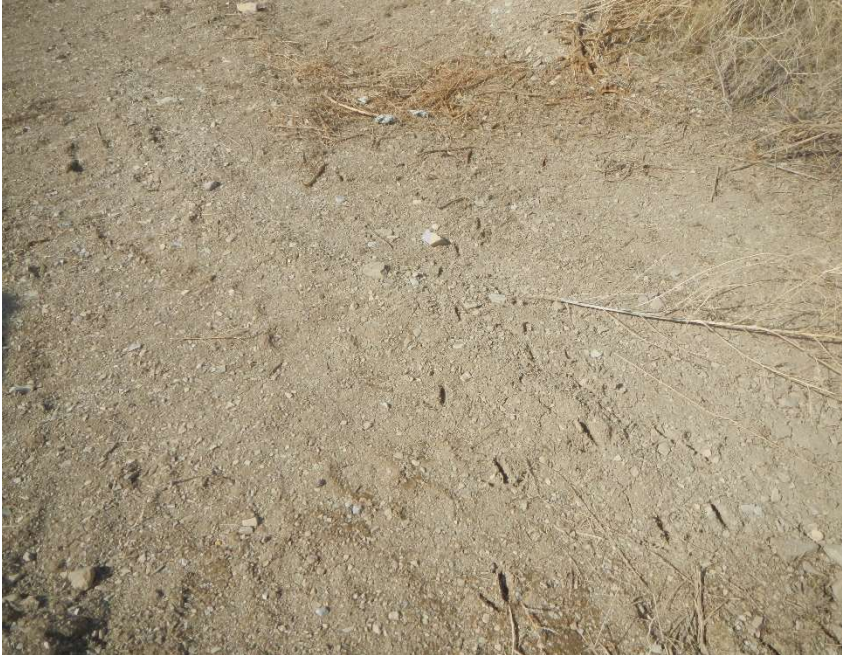
**Wildlife foot prints located on the perimeter of the pit.**

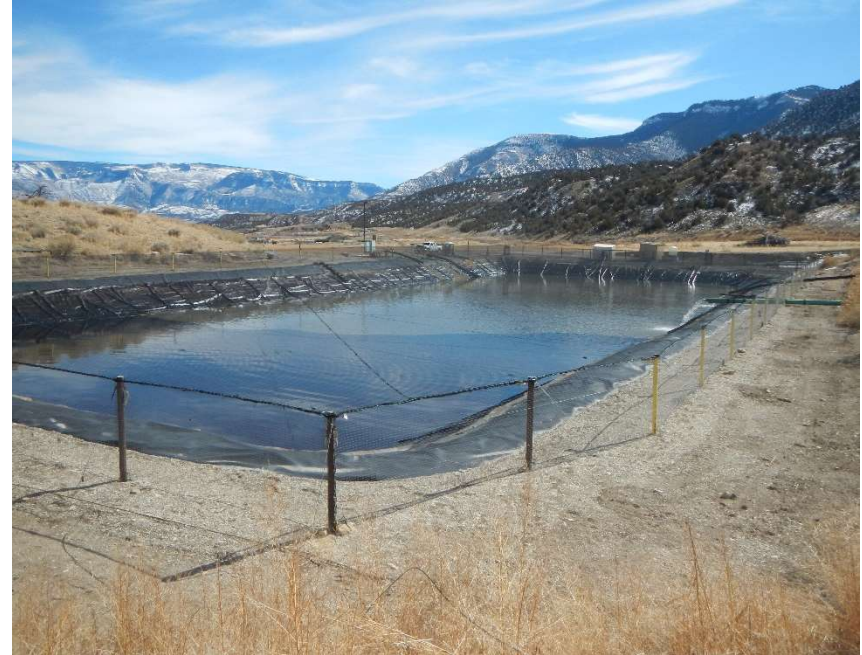
**Free product present on ~20% of the pit fluid and liner.**

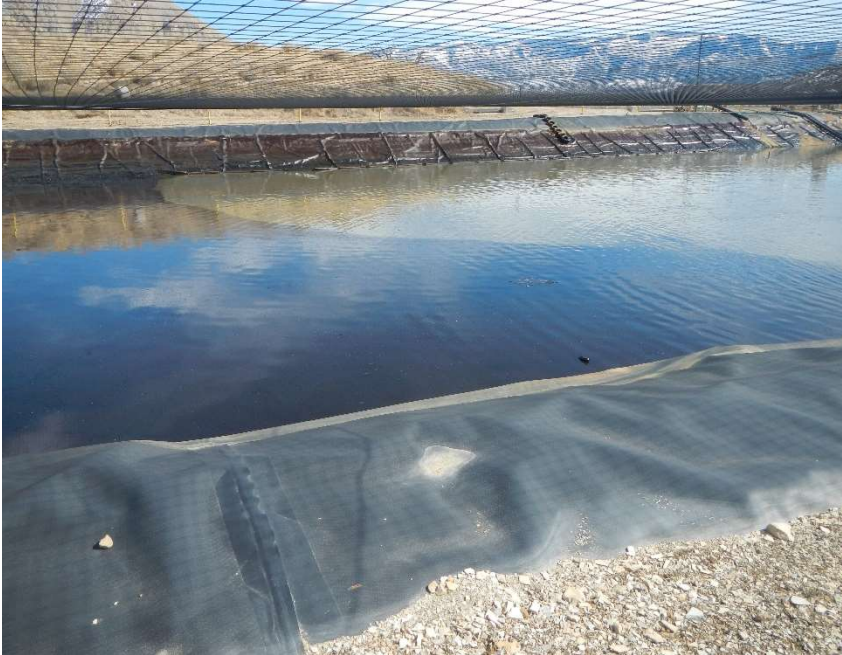
Free product present on of the pit fluid (~20%) and liner.

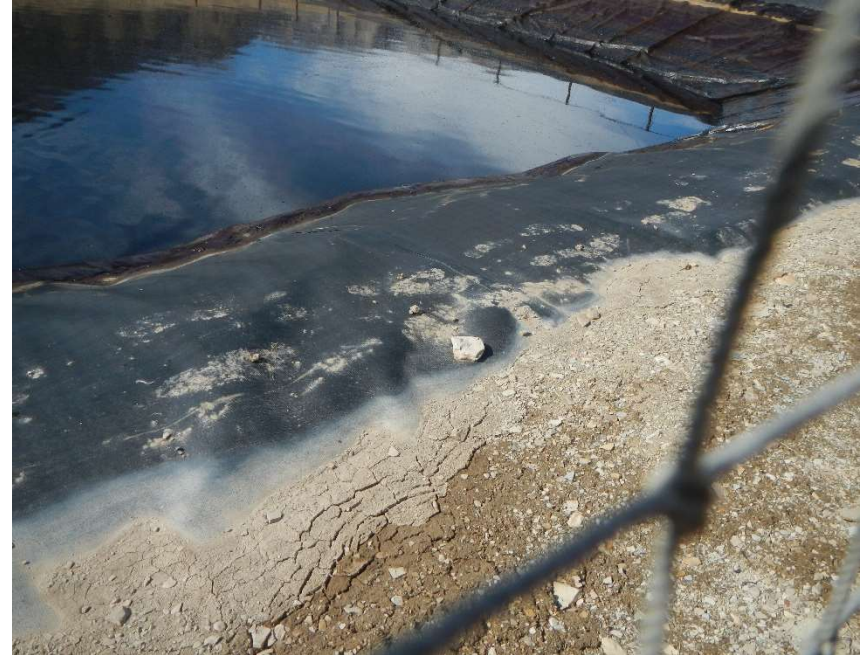
Sediment encroaching on pit liner.

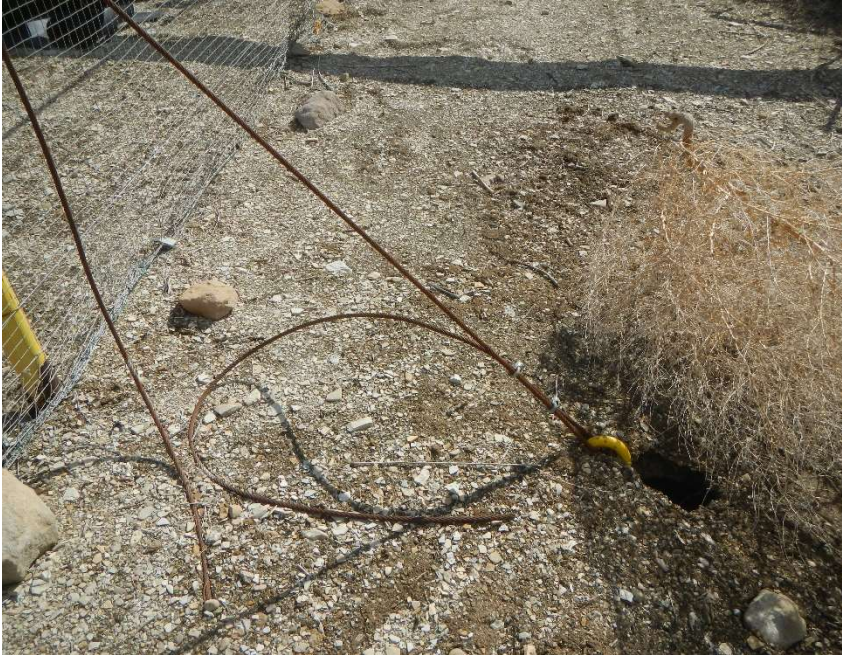
**Subsidence around rig anchor supports on the west side of the pit.**

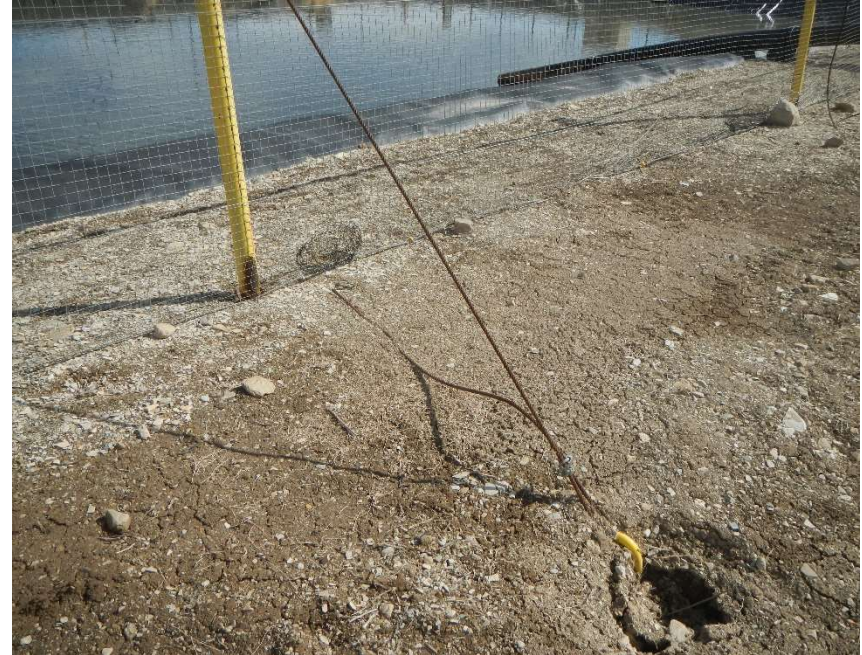
**Subsidence around rig anchor supports on the west side of the pit and the netting support bollards leaning towards the east.**

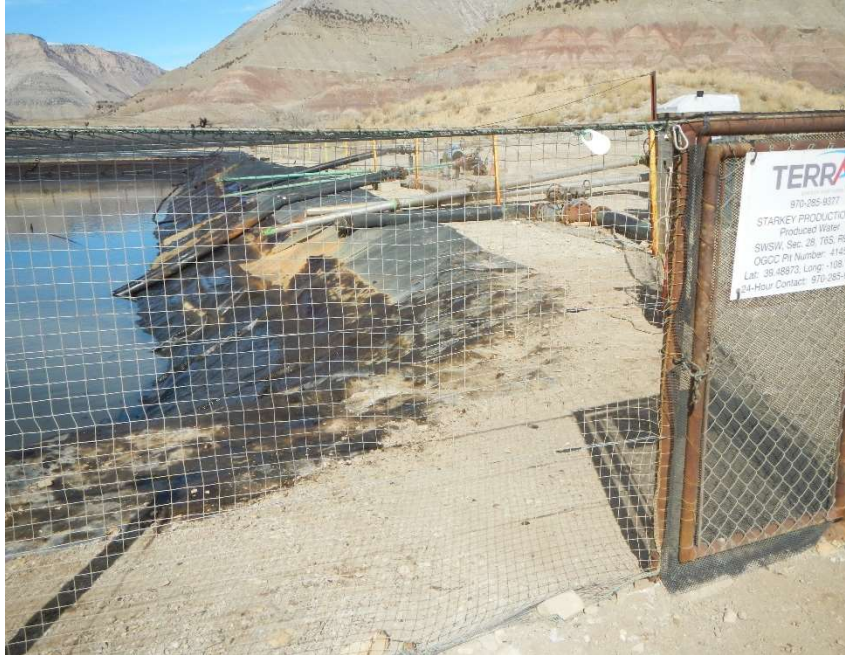
**Oil stained soil on the southeast corner of the pit.**

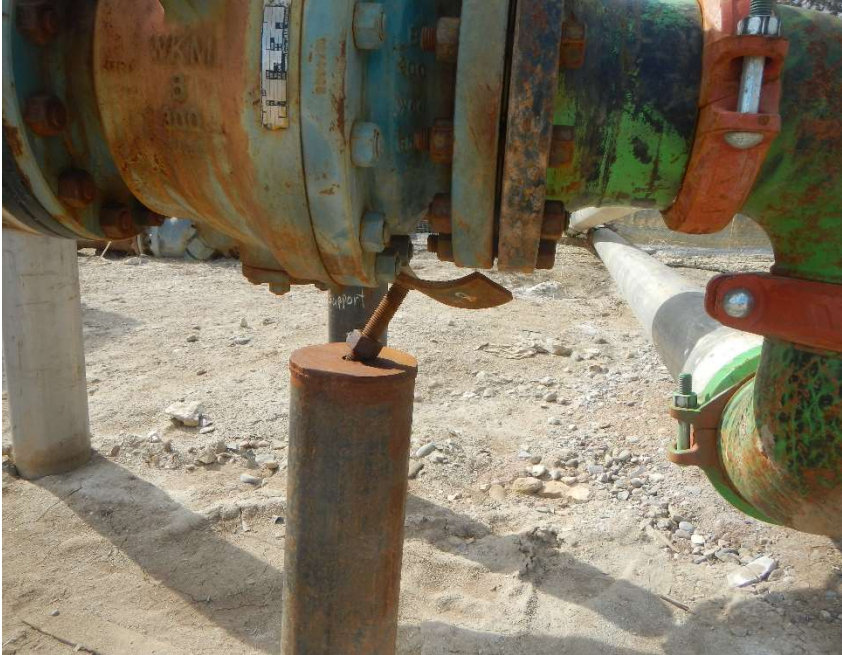
**Flow line support in disrepair.**

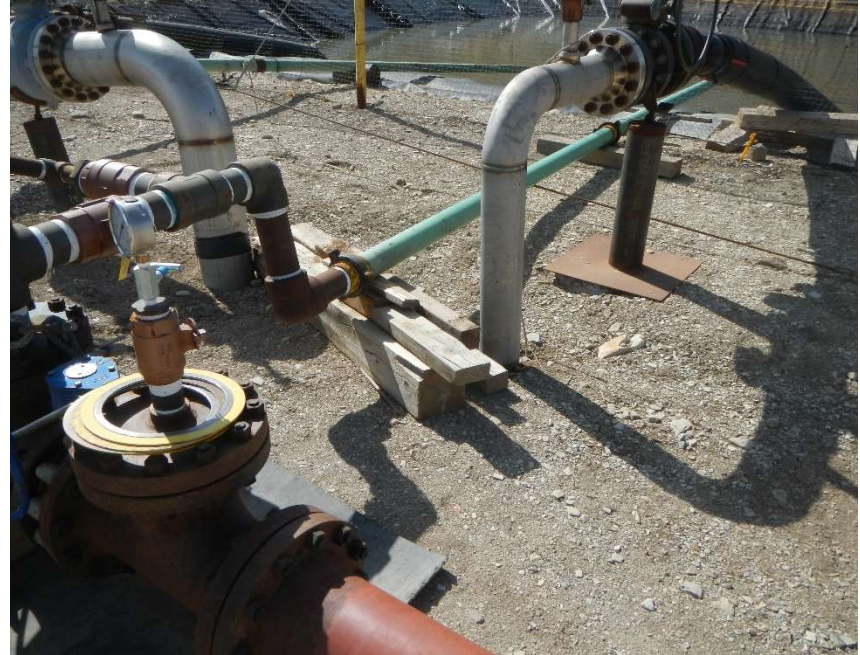
**Flow line cribbing and support in disrepair.**

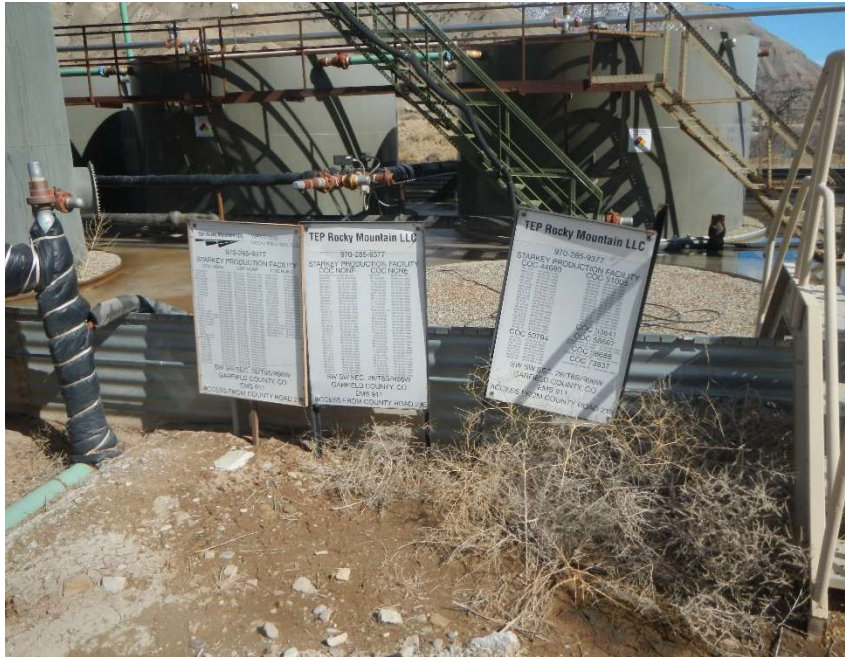
**Tank battery sign, impacted material and vegetation.**

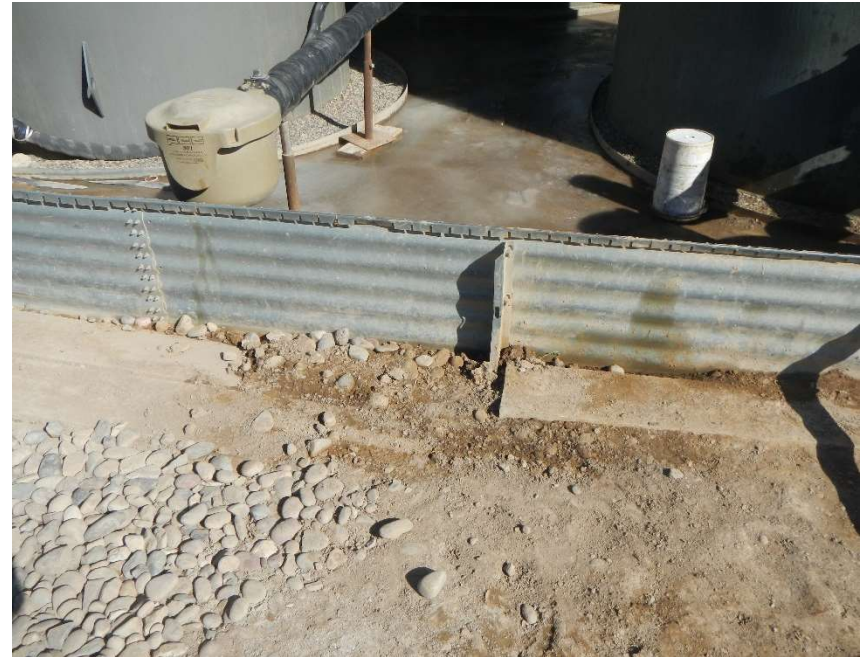
**Impacted material around the load out area of the tank battery.**

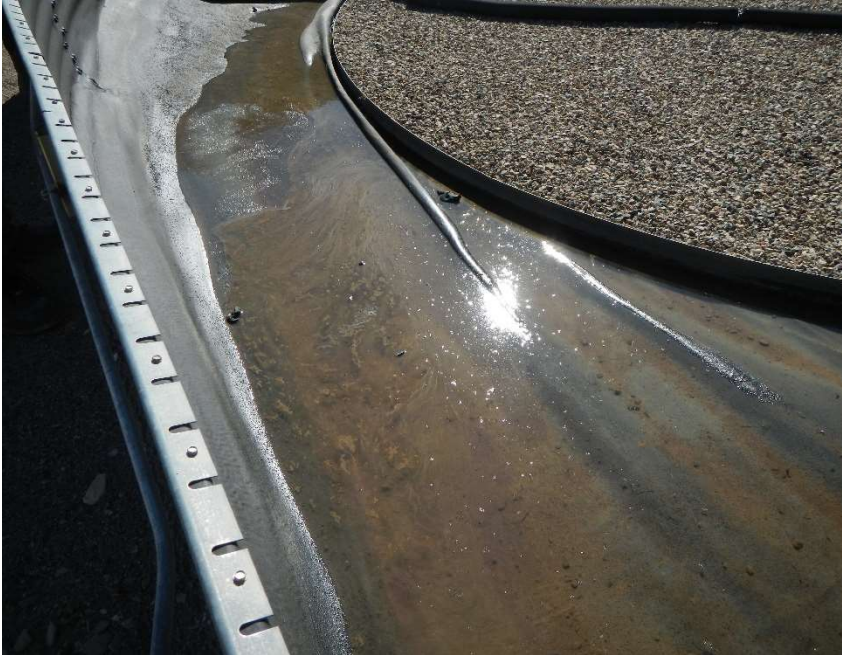
**Potential impacted fluids within the tank battery secondary containment.**

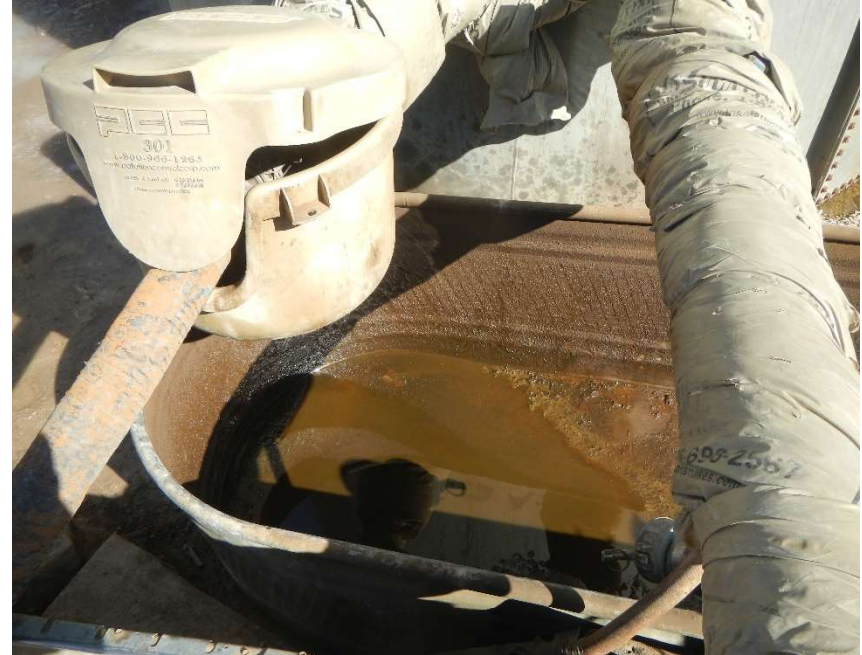
**Photo #18 – Trough containing potential impacted fluid located beneath the tank battery load out.**

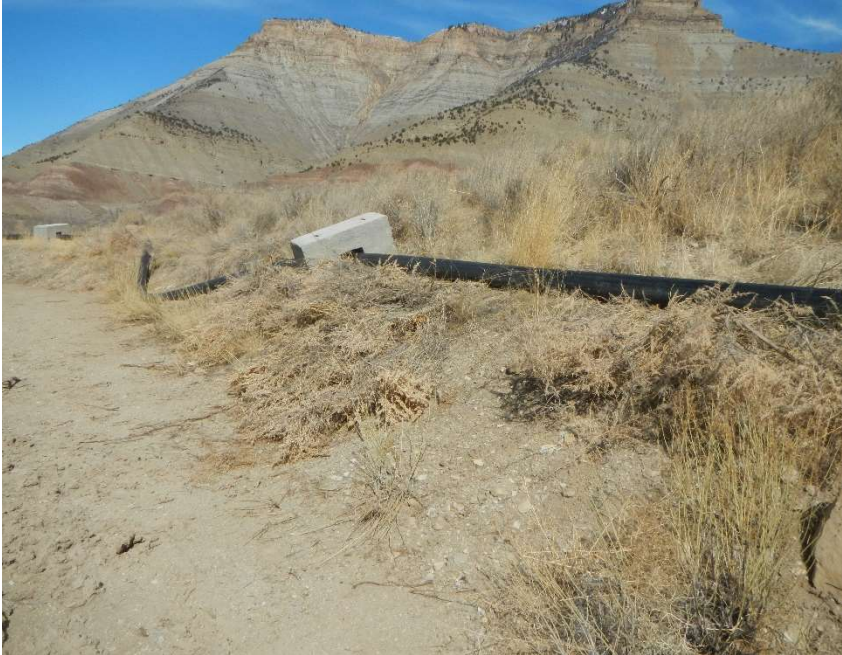
**Movement of 12-16-inch poly pipe located east of Pit ID 414554.**

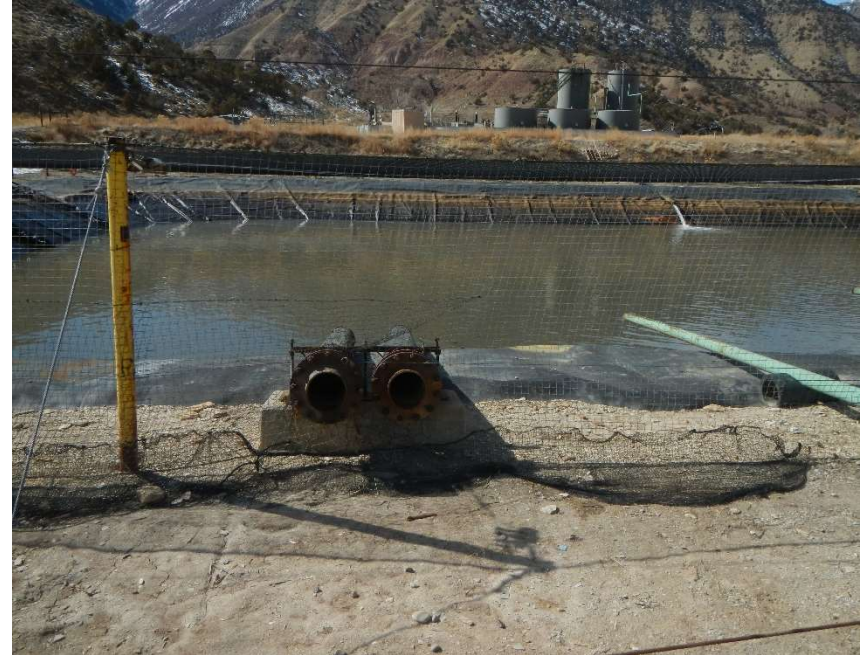
**Uncapped manifold on the eastern side of the pit.**

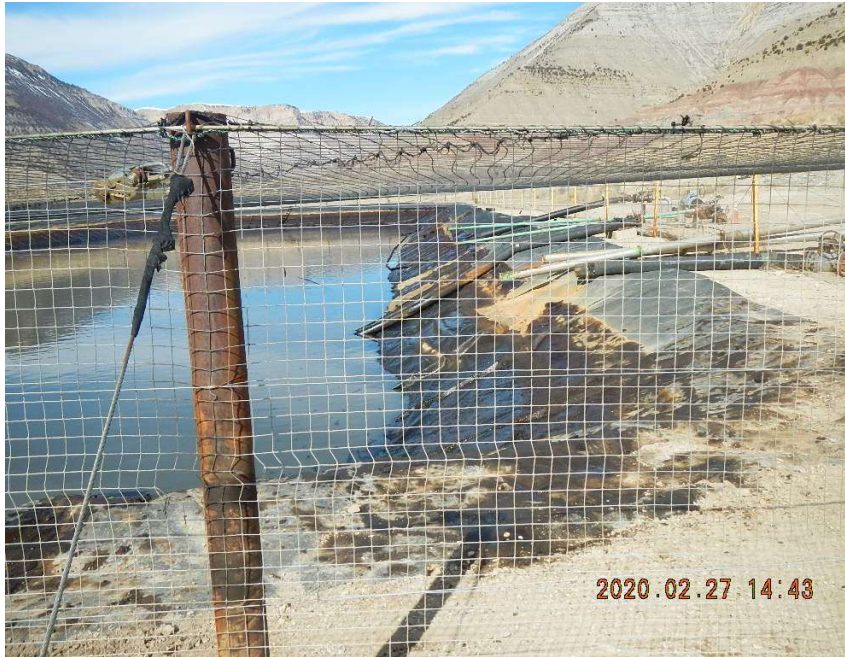
**Hoses and poly line resting directly on the pit liner.**

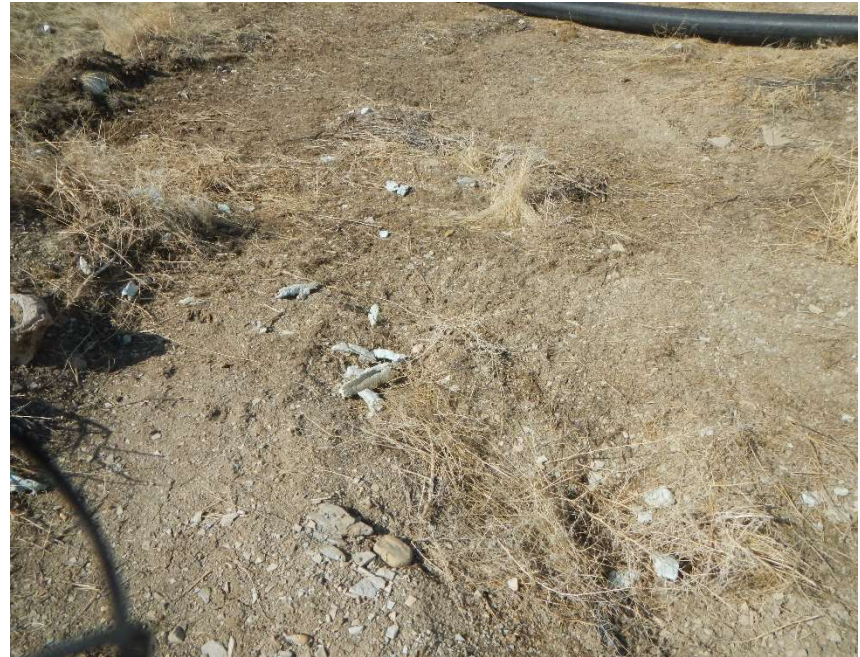
**Trash on location**

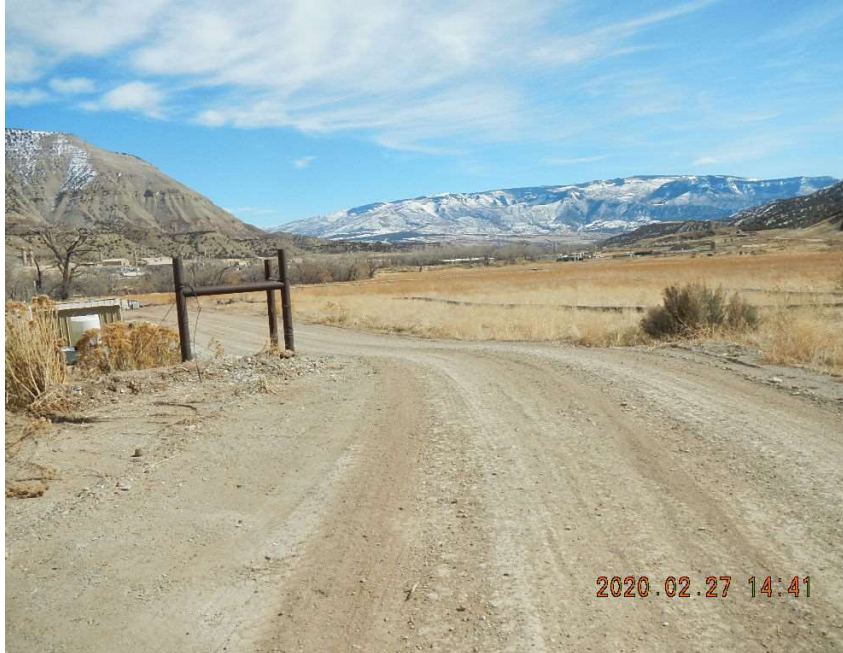
**Uncontrolled access to the location.**

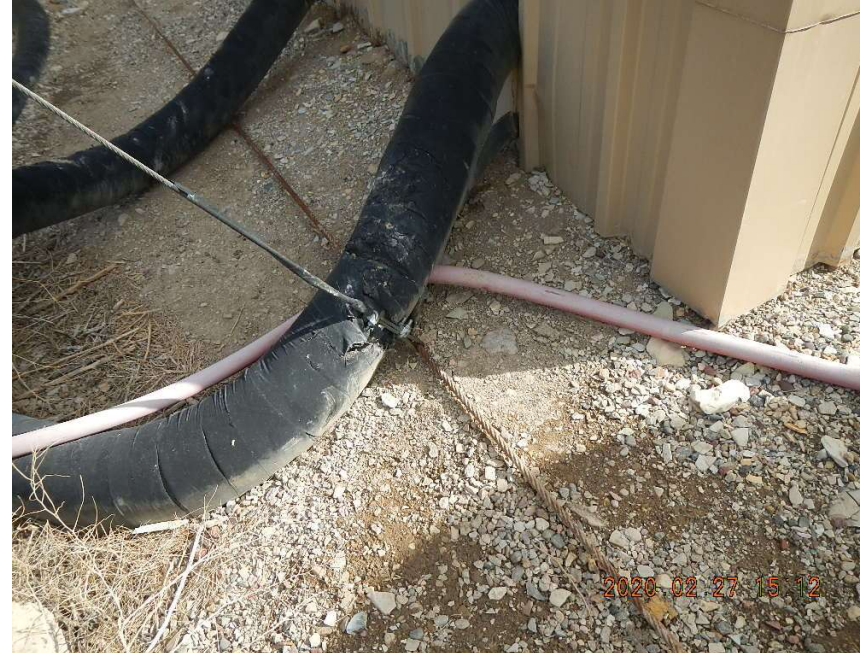
**Net support guy wire wearing through pipe insulation and pipe.**

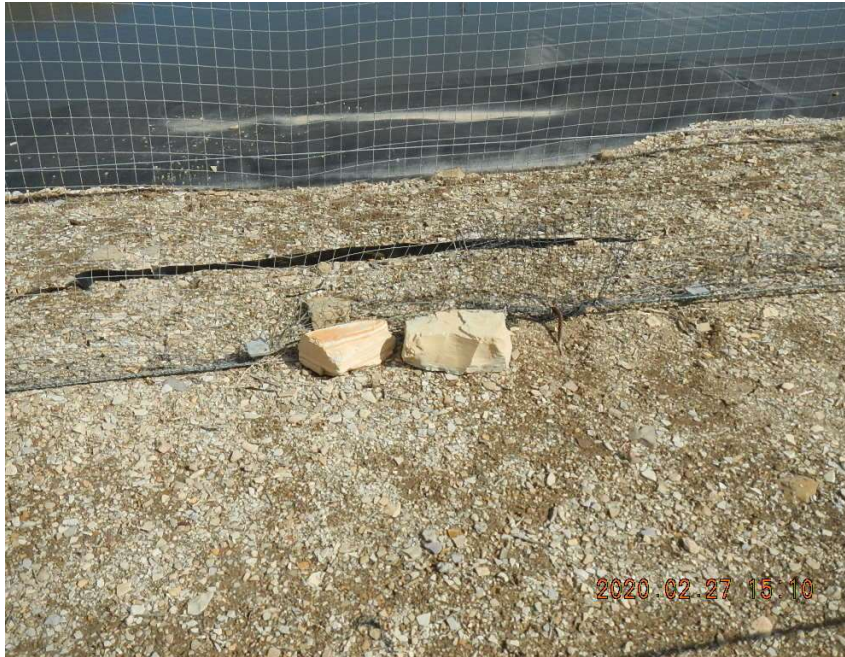
**Gaps in net secured with rocks.**

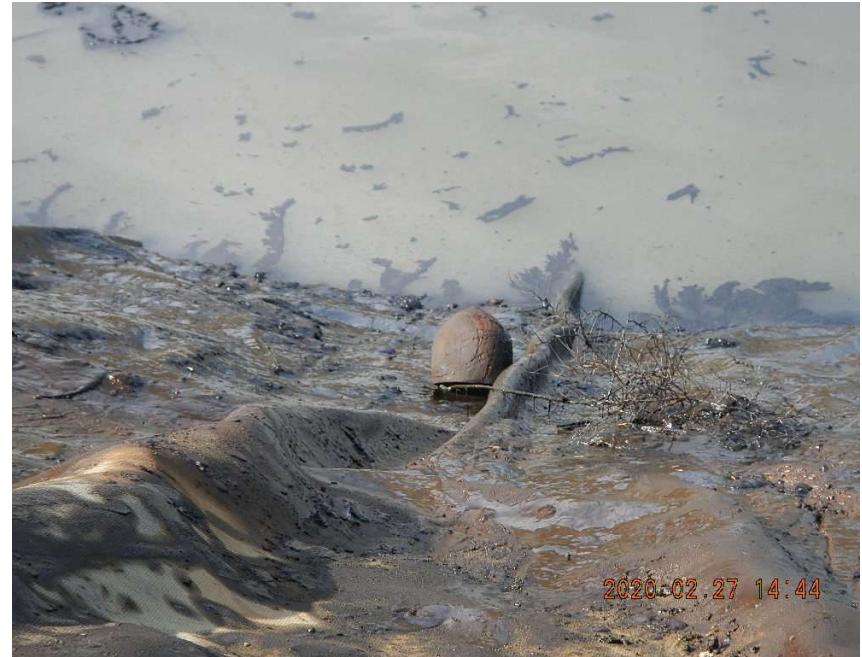
**Trash and debris on pit liner within the pit.**

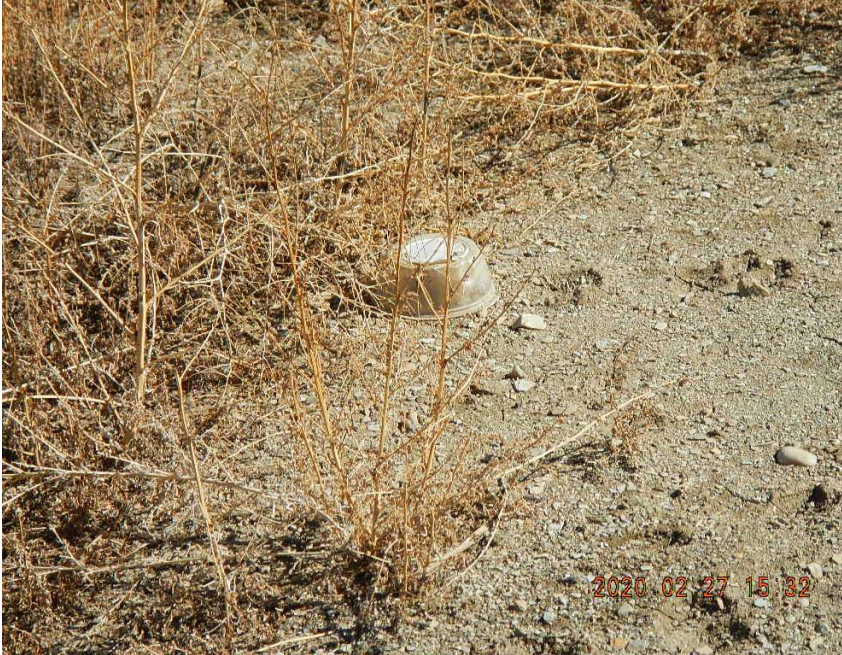
**Site wide trash.**

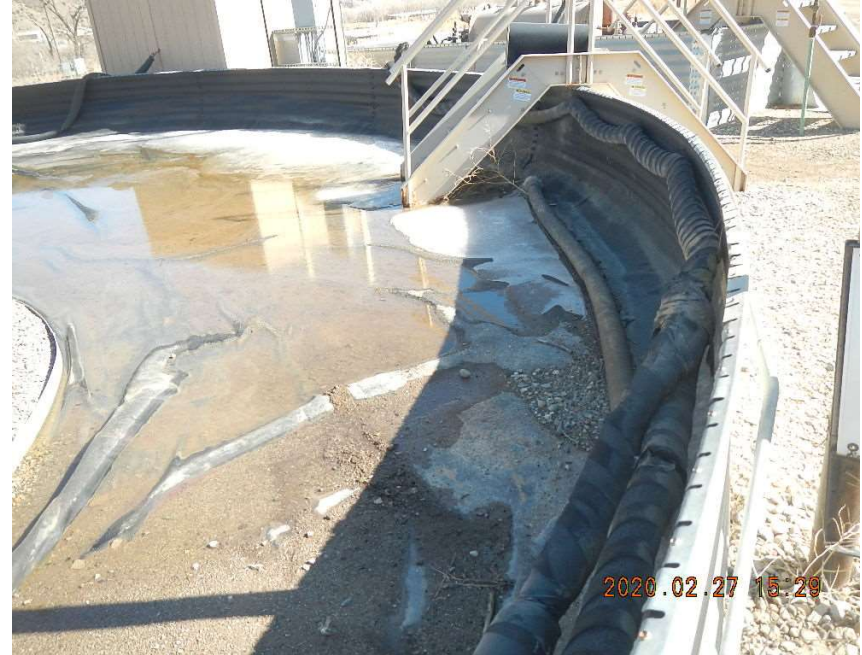
**Unused equipment within the tank battery secondary containment.**

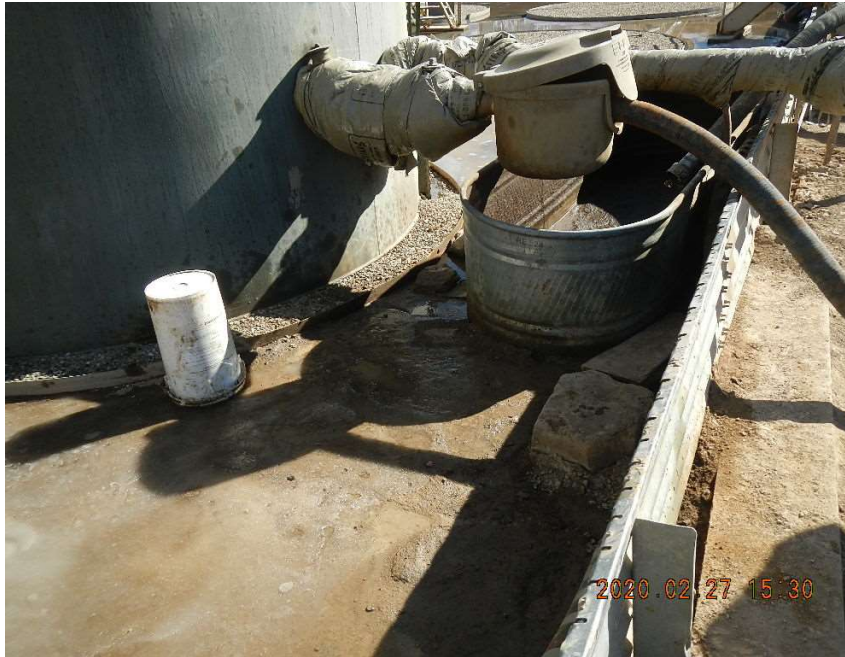
**Potential impacted fluids within the tank battery secondary containment.**

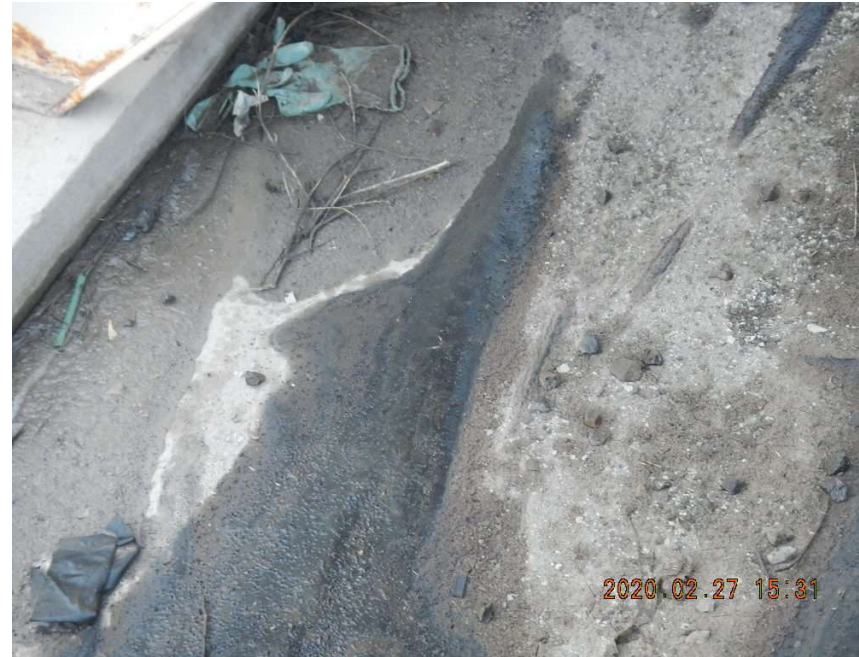
**Trash and debris within the tank battery secondary containment.**

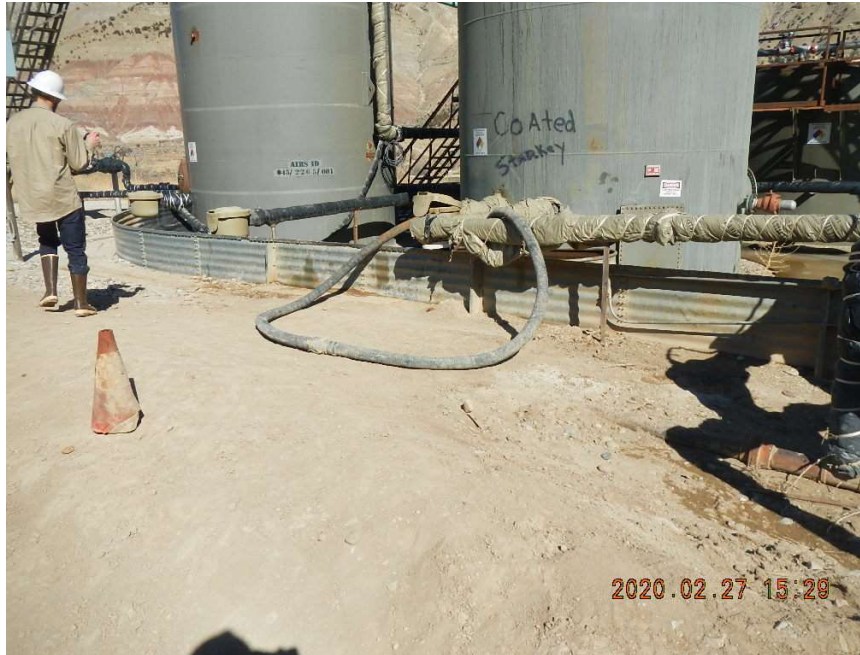
**Load out hose draped over equipment, staining on the exterior of the tank battery secondary containment.**

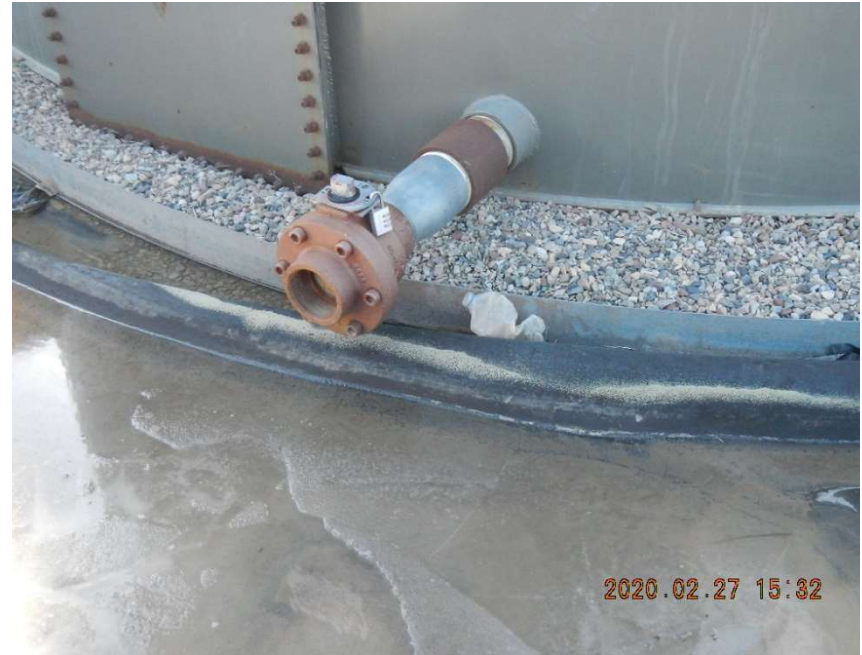
**Trash within the tank battery secondary containment.**
