**Inspection Photos**  
**Operator: Williford Resources**  
**API#: 067-06347**  
**Date: 3/4/2020**

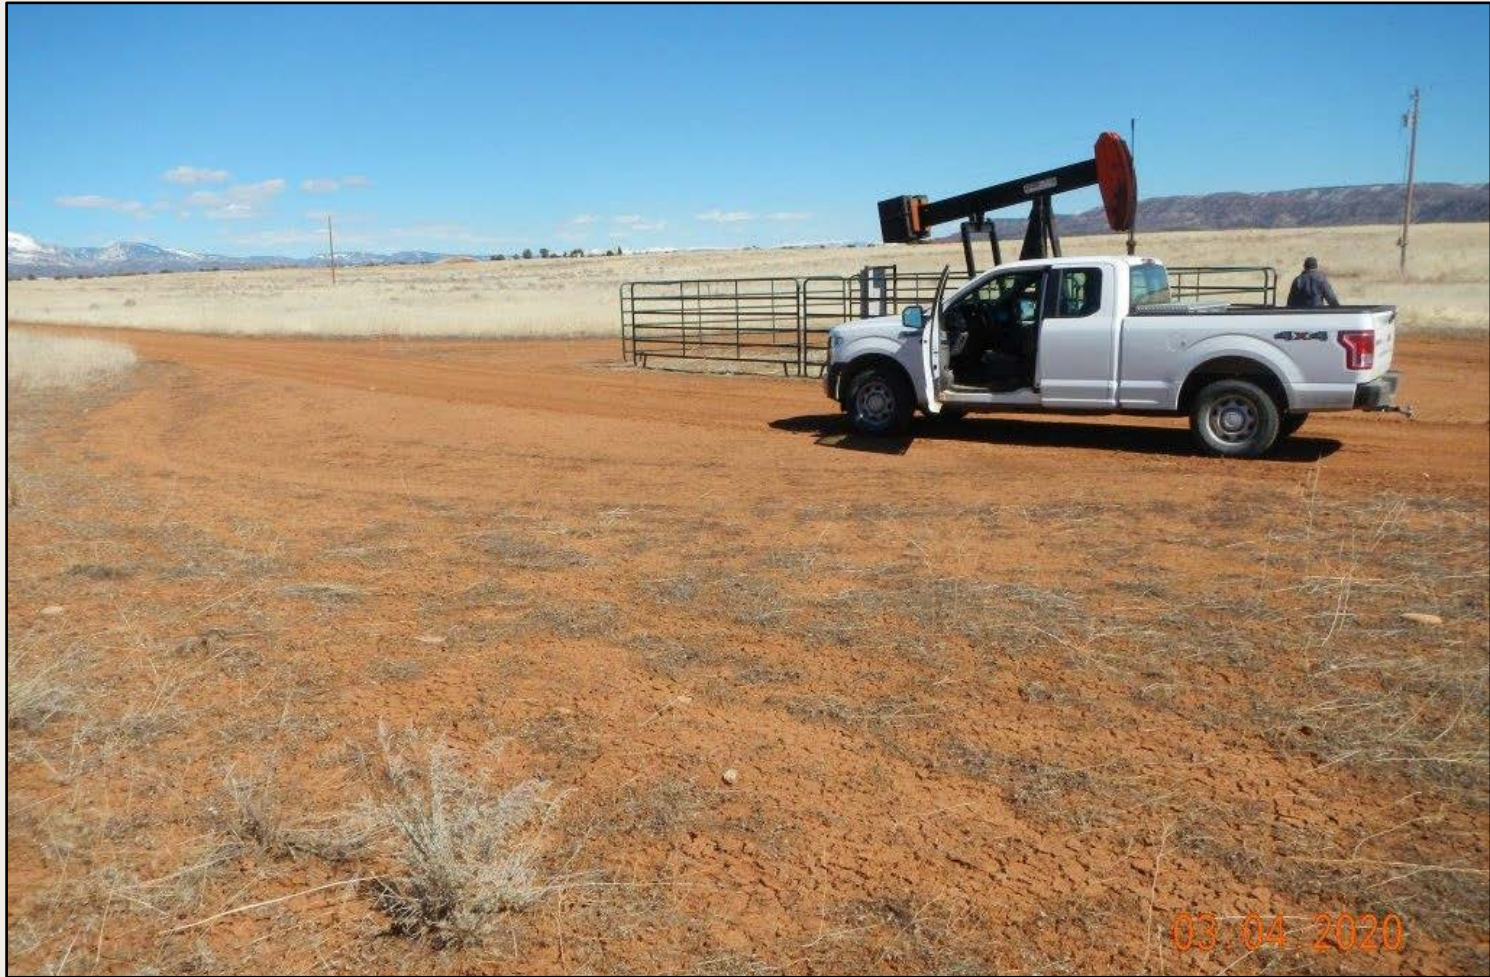
Photo 1. View of the project area from the southwestern corner facing center.

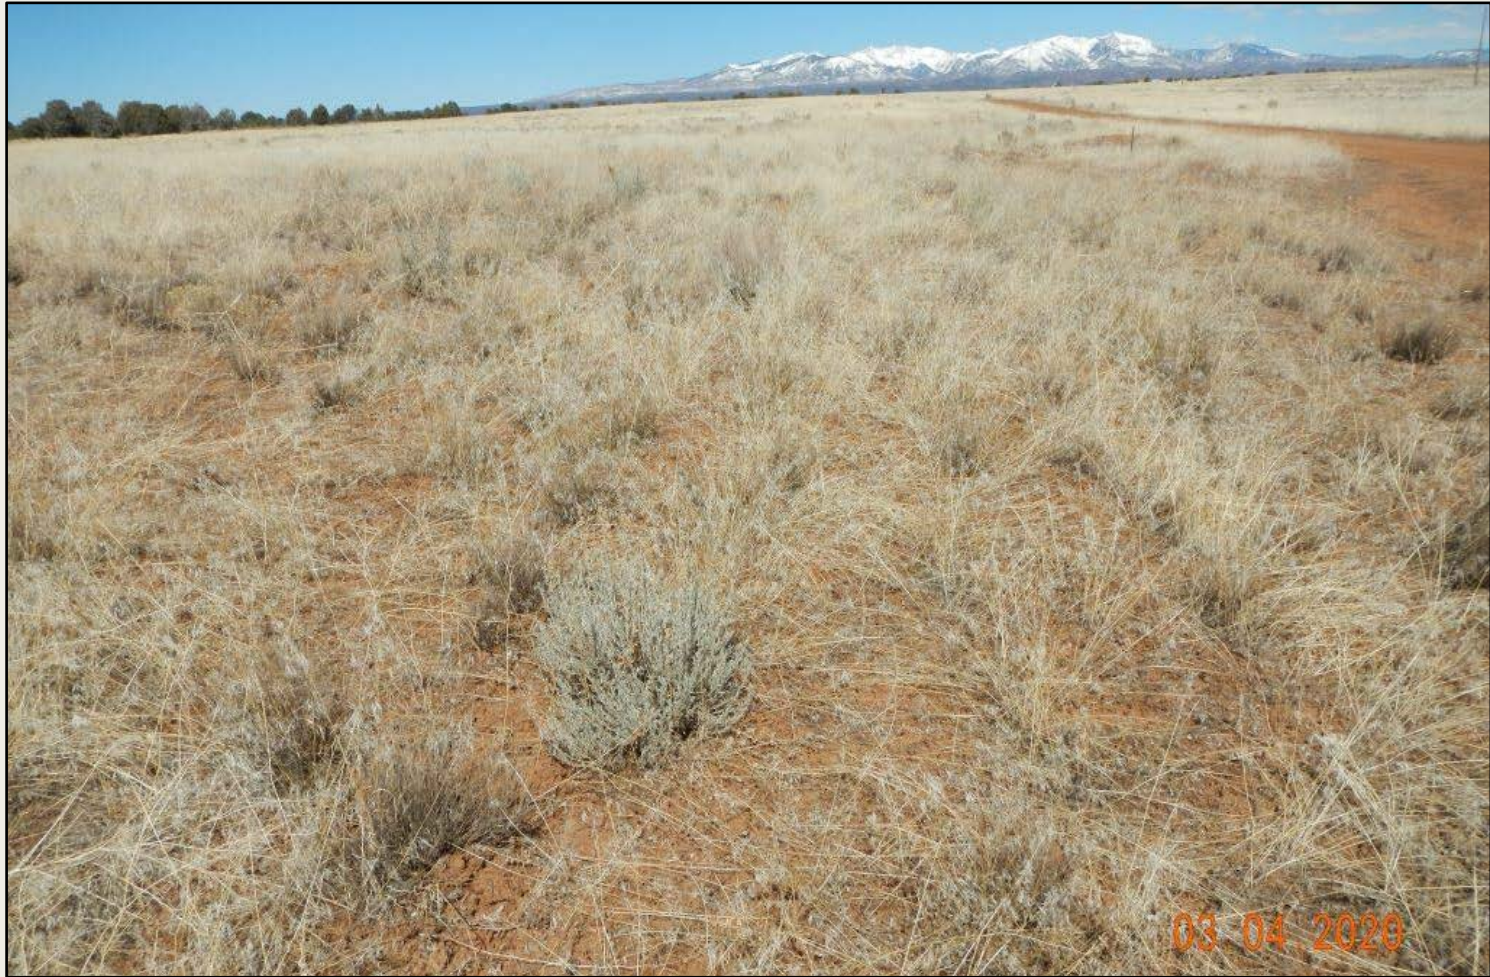
Photo 2. View of the western project area from the southwestern corner facing northward. Vegetation is largely comprised of sagebrush, snakeweed, and weeds such as cheatgrass.

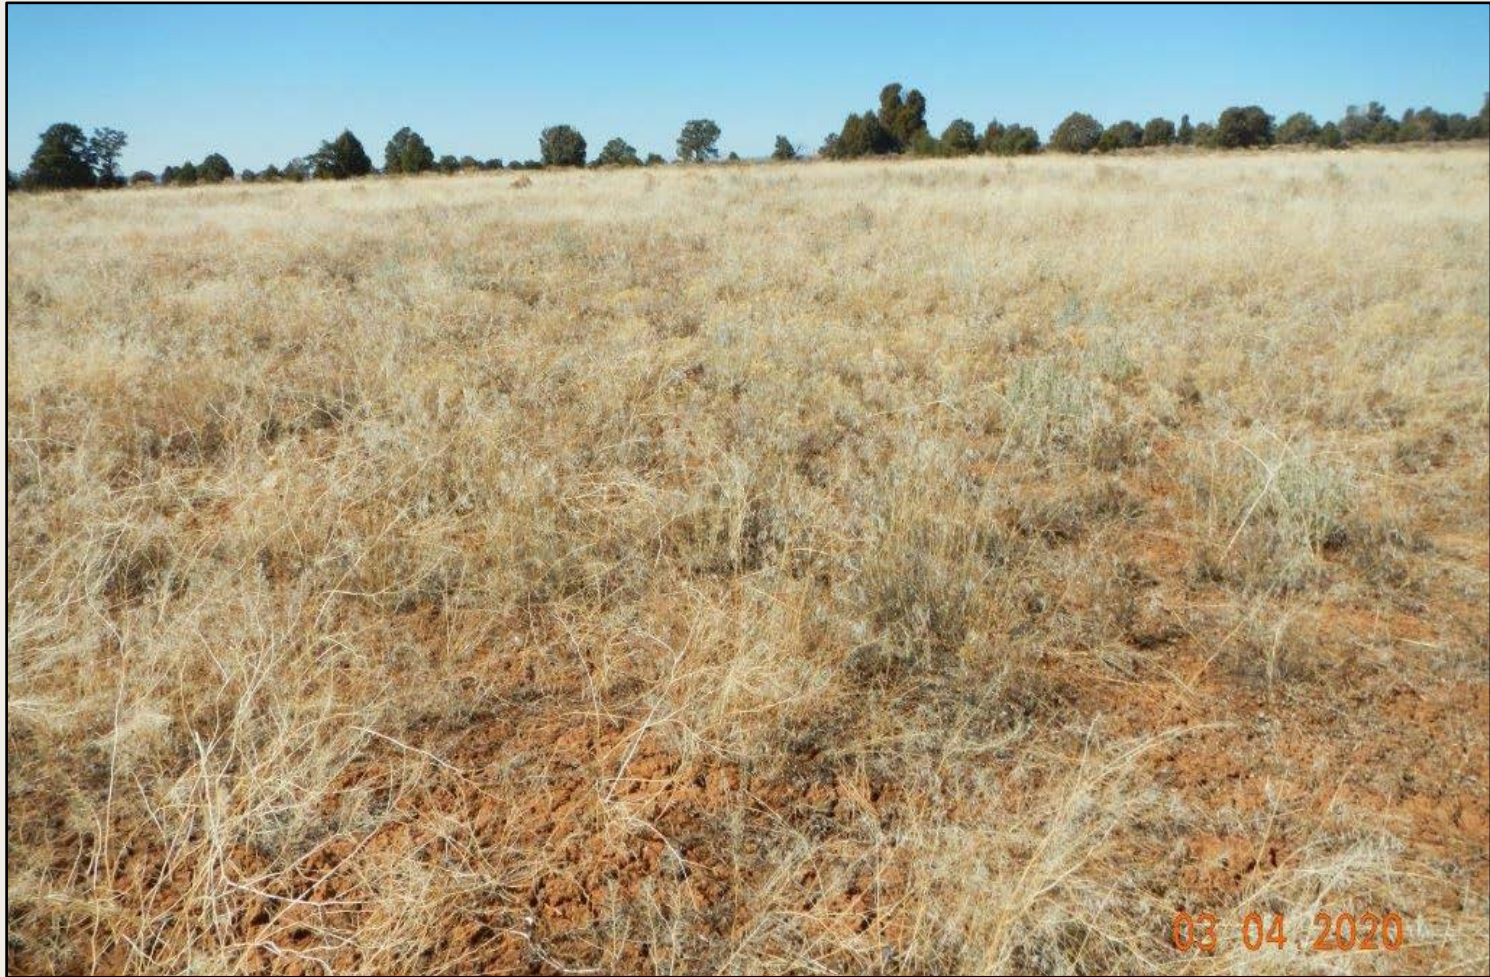
Photo 3. View of reference area vegetation west of the project area, similar to vegetation in the western project area.
