Inspection Photos
Operator: Williford Resources
API#: 067-06607
Date: 3/4/2020

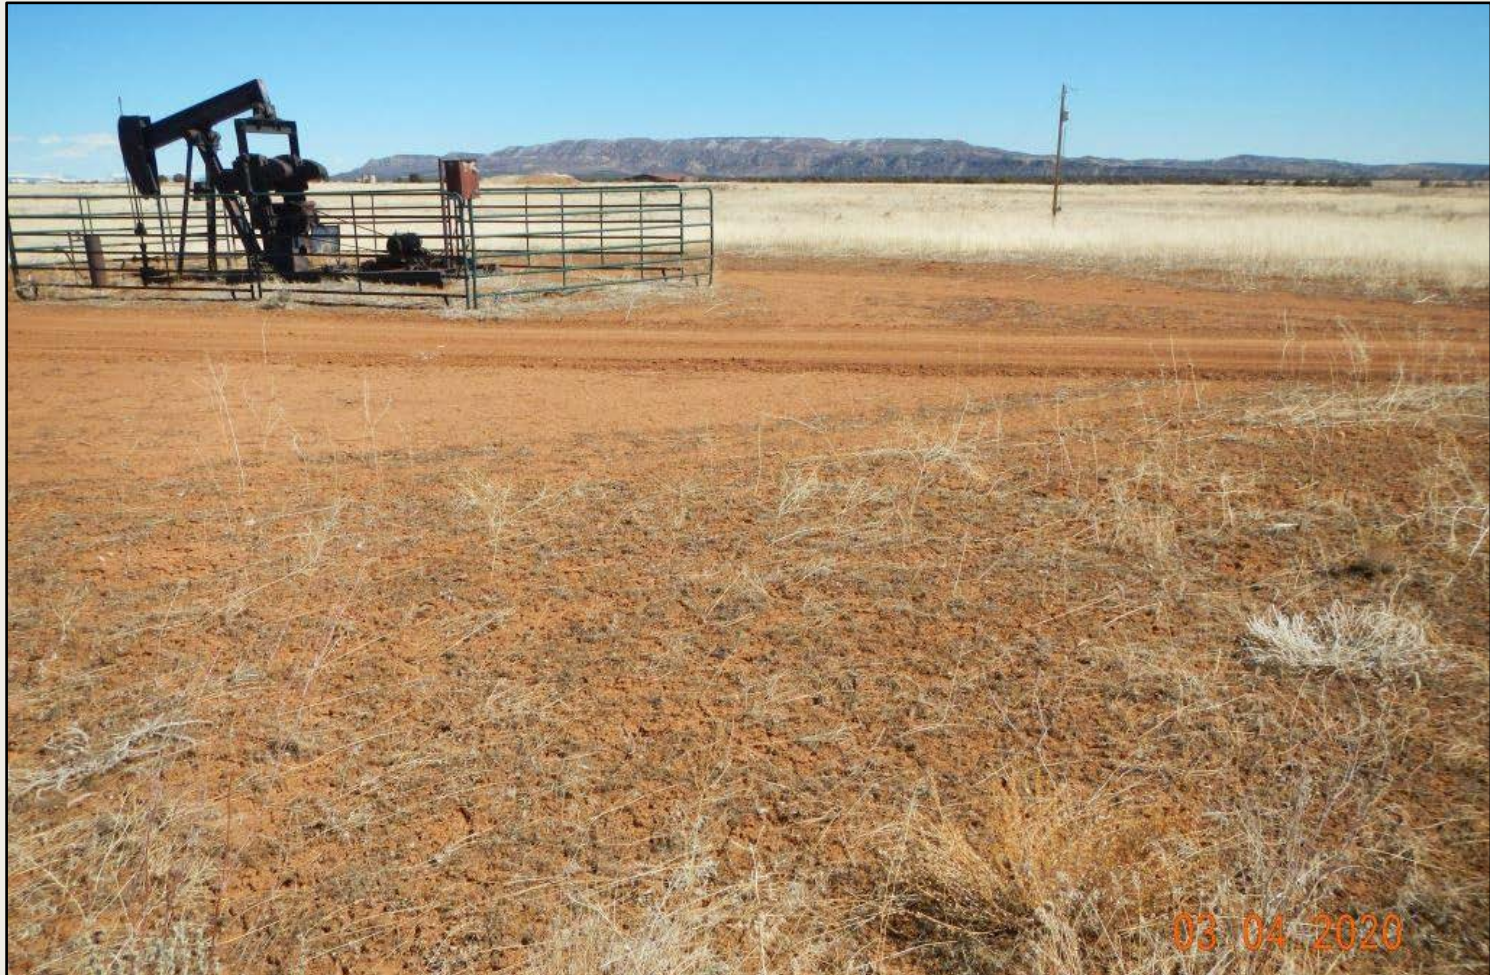
Photo 1. View of the project area from the southwestern corner facing center.

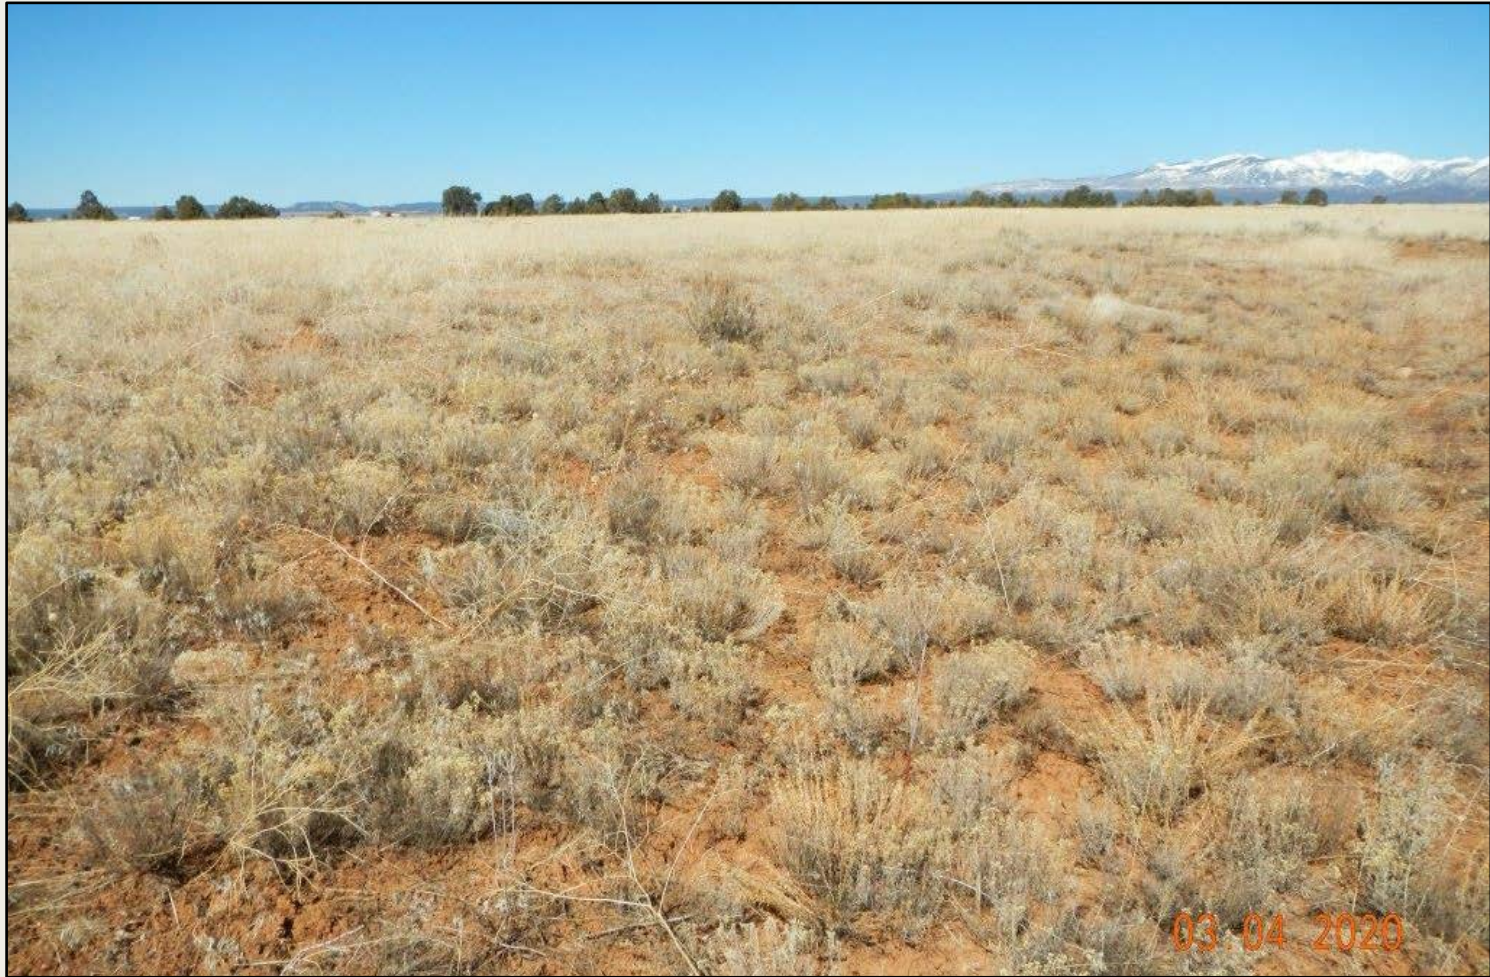
Photo 2. View of the western project area from the southwestern corner facing northward. Vegetation is largely comprised of sagebrush, snakeweed, and weeds such as cheatgrass.
