Inspection Photos
Operator: Williford Resources
API#: 067-06671
Date: 3/4/2020

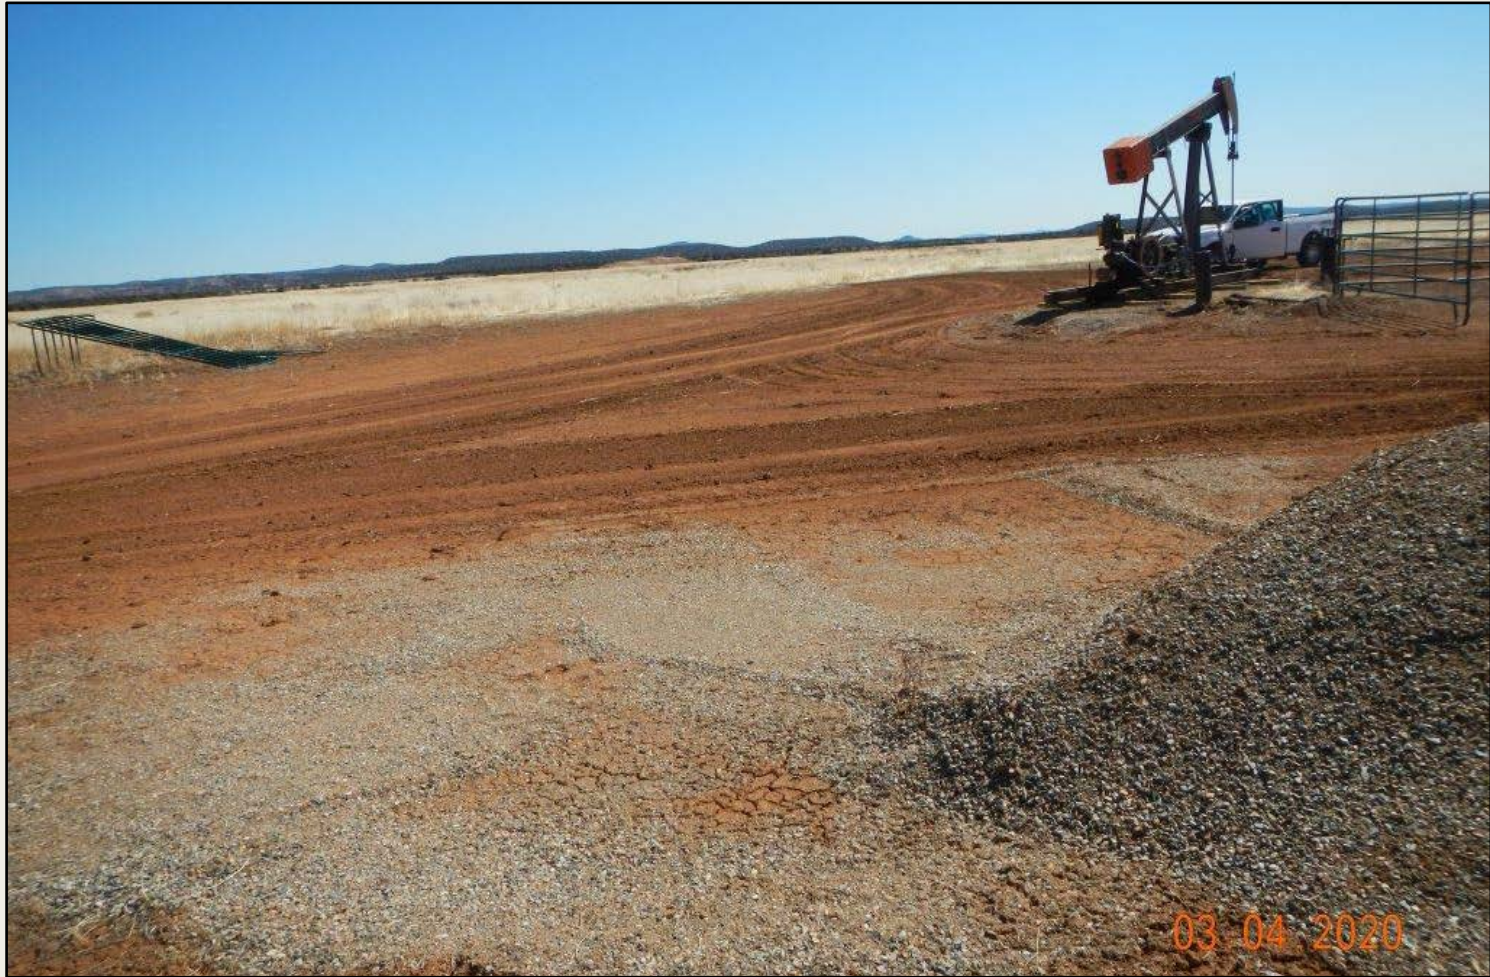
Photo 1. View of the project area from the northwestern corner facing center.

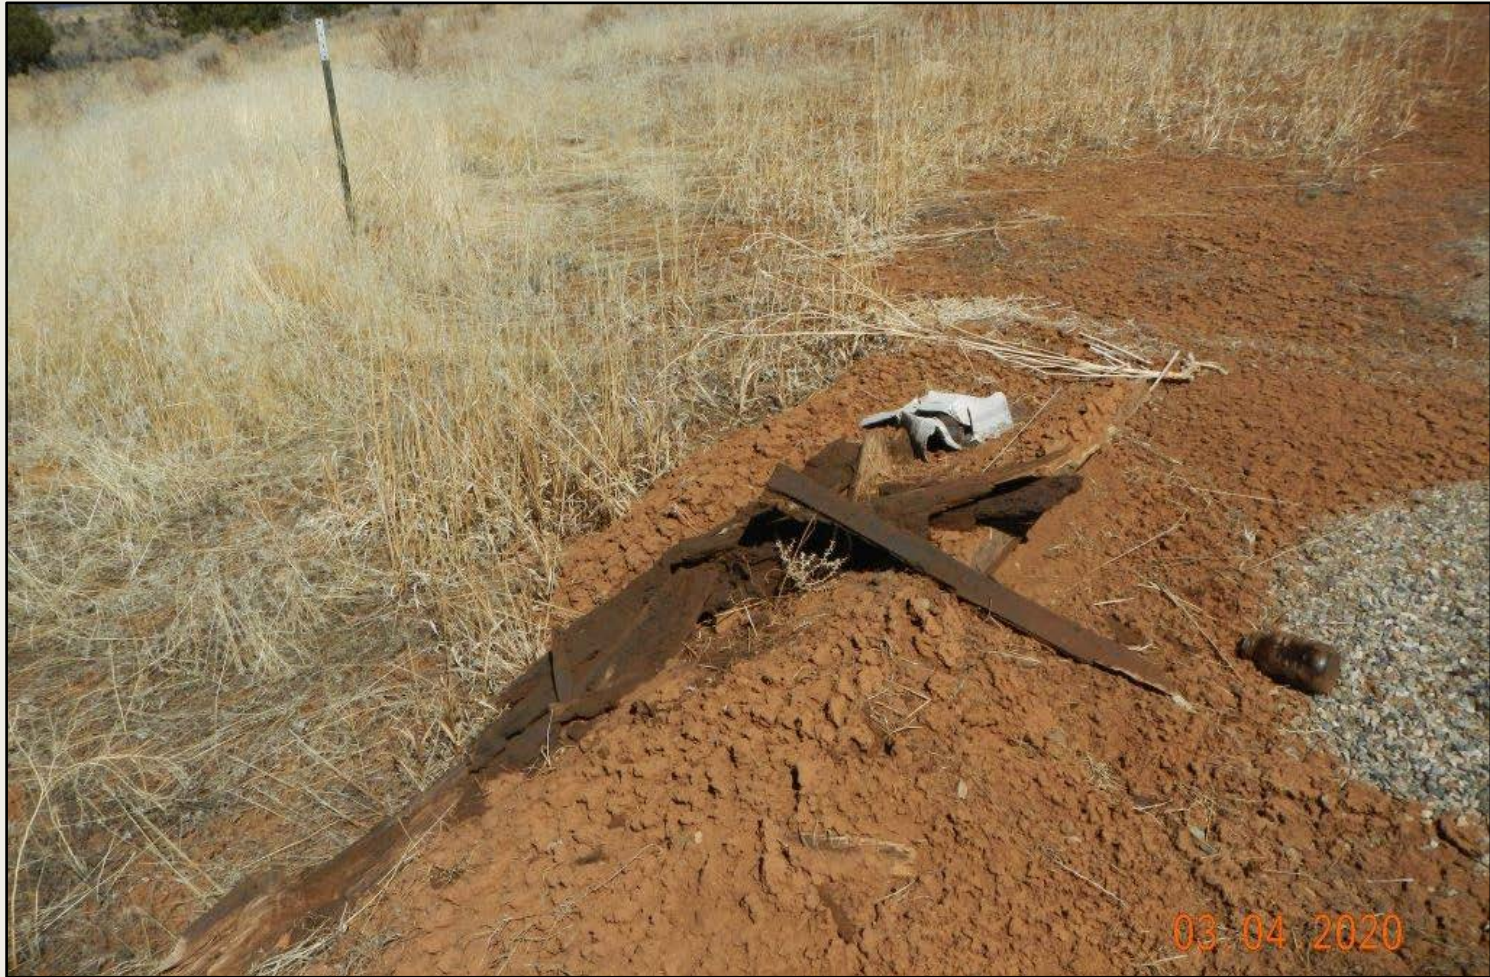
Photo 2. View of hydrocarbon-stained material remains in the northwestern project area.

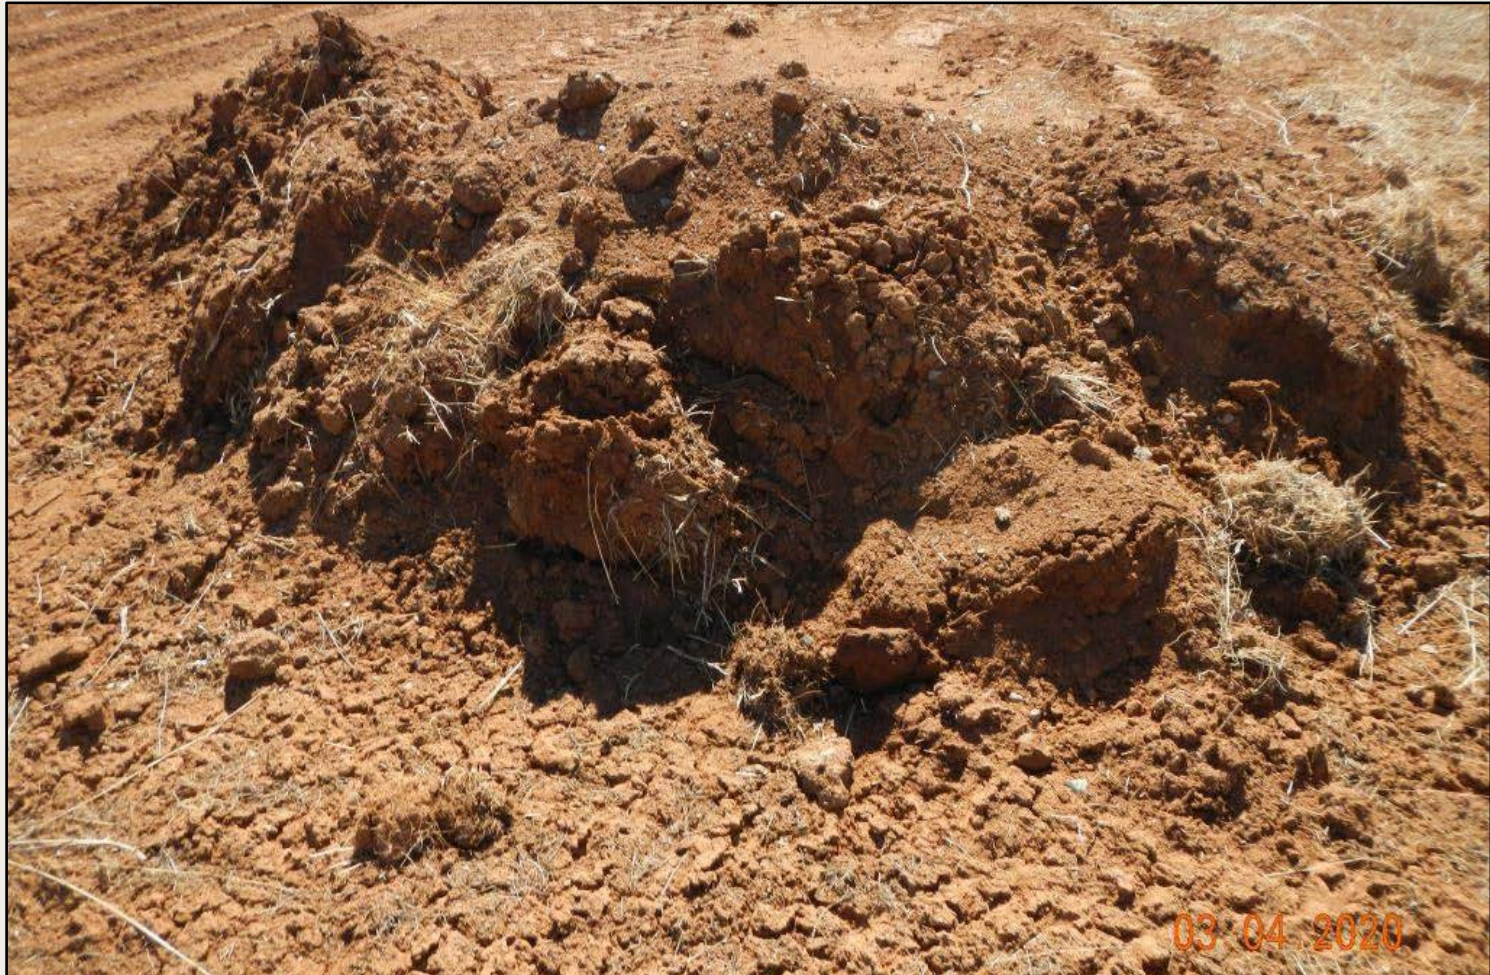
Photo 3. View of soil pile with what appears to be impacted material, stored within the northwestern project area.

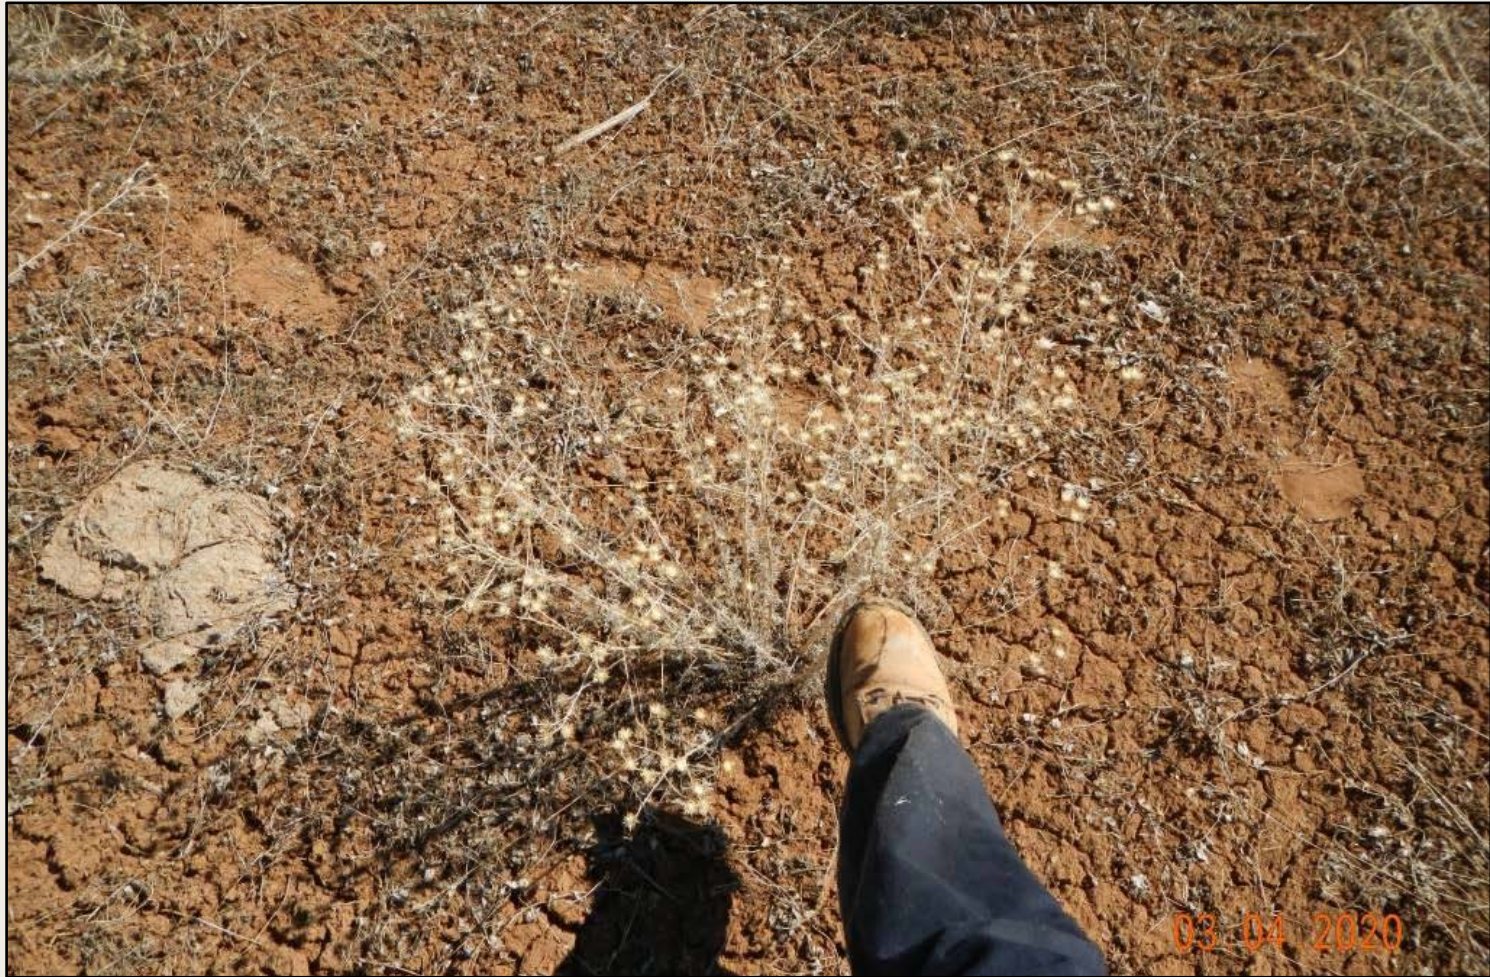
Photo 4. View of spotted knapweed plant observed along the eastern edge of the project area. Approximately 20 individuals observed in a dormant condition.
