# Inspection Photos

API: 061-06876

Operator: PIONEER NATURAL RESOURCES

Inspection Date: 3/6/2020

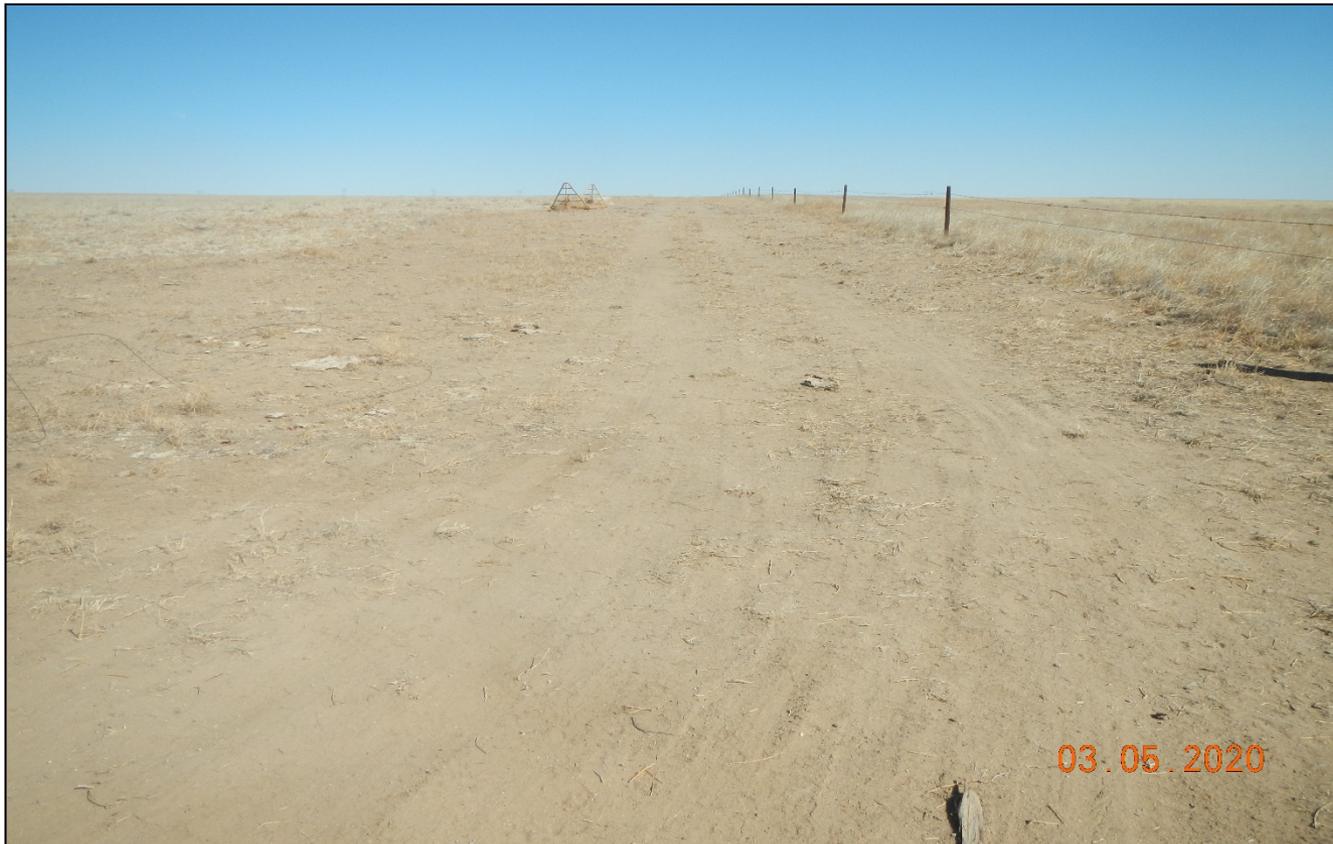
**Photo 1.** Facing east at the beginning of the access road. The road is bare of vegetation and not reclaimed.

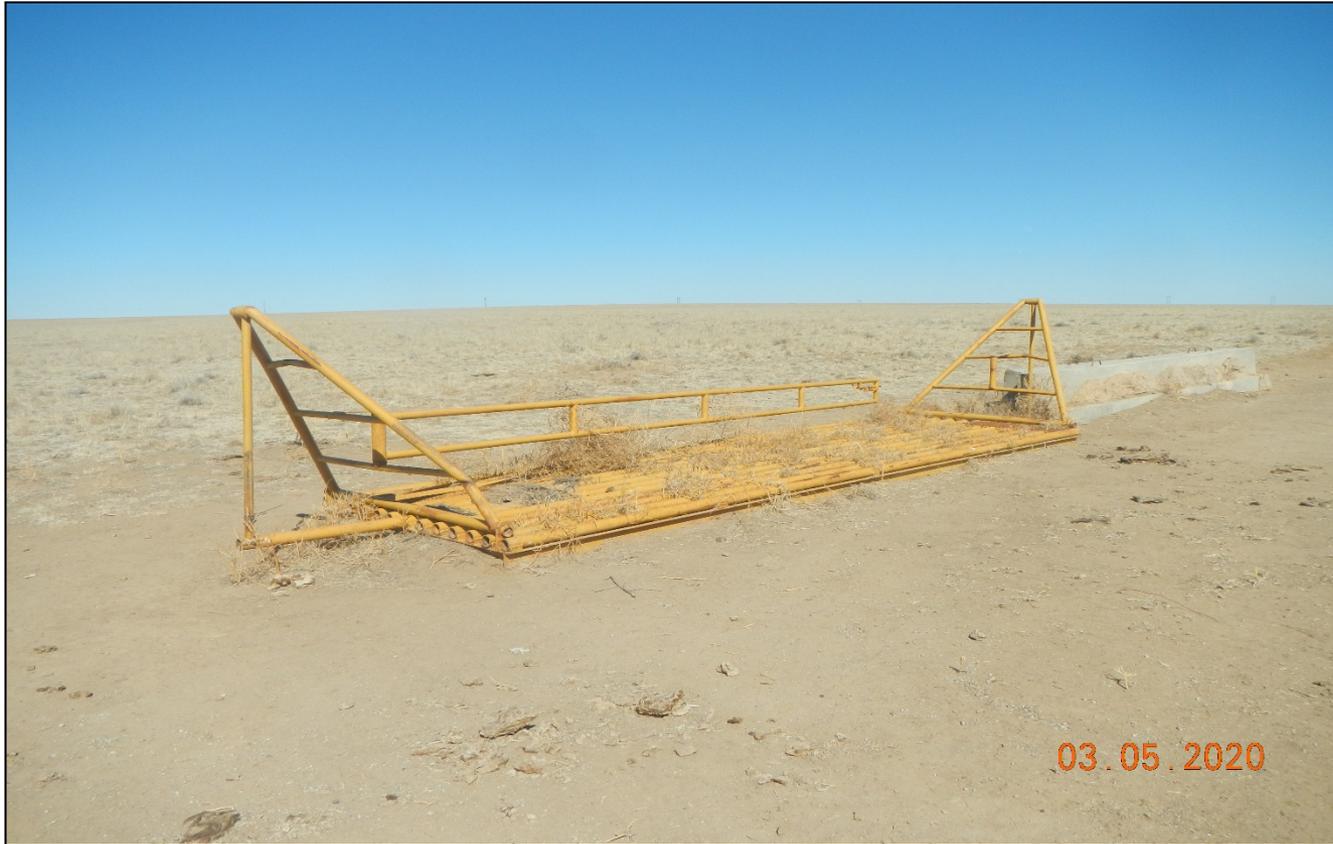
**Photo 2.** The cattle guard has been removed and left near the beginning of the access road. The cattle guard and cement need to be removed.

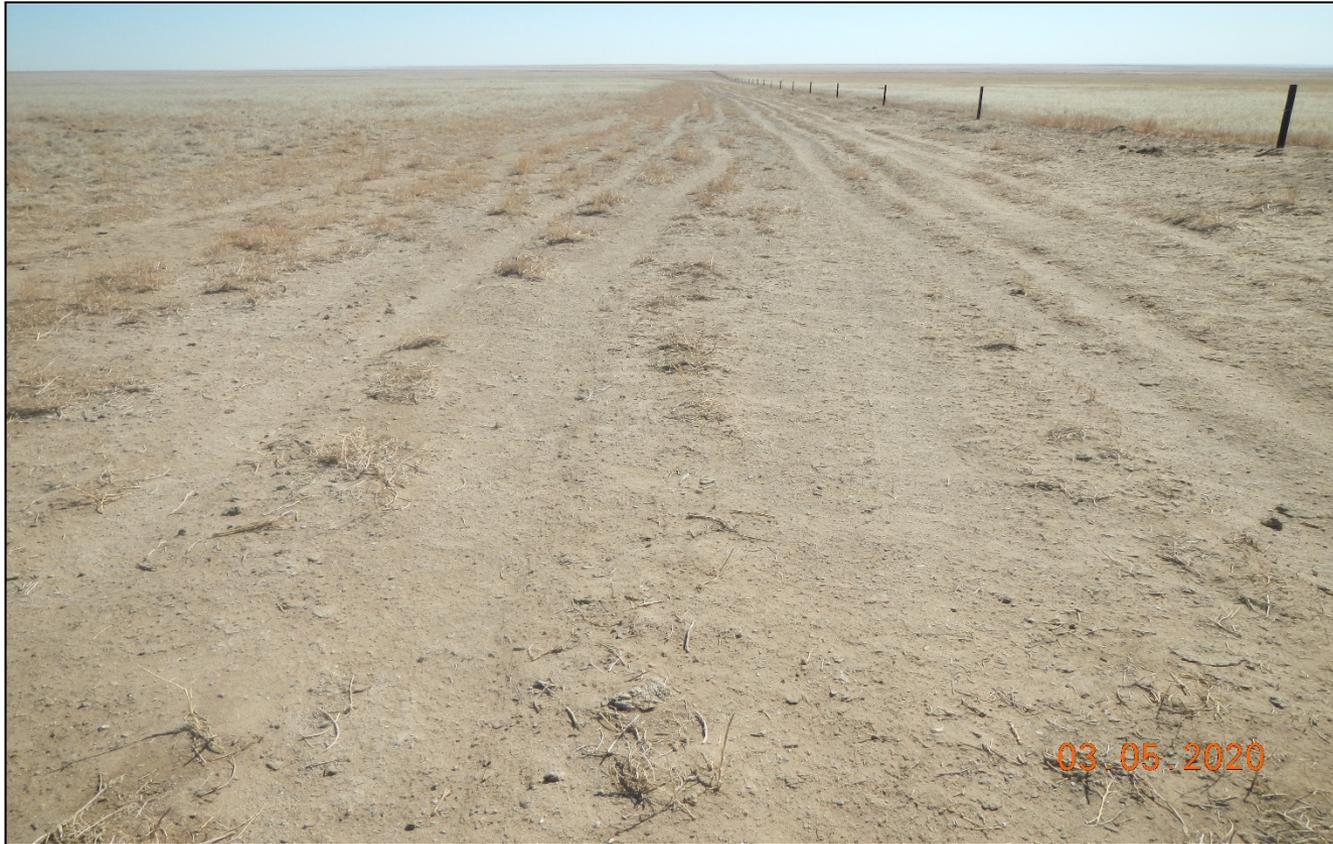
**Photo 3.** Facing south along the former access road. The access road is bare of vegetation and there is signs of wind erosion occurring.

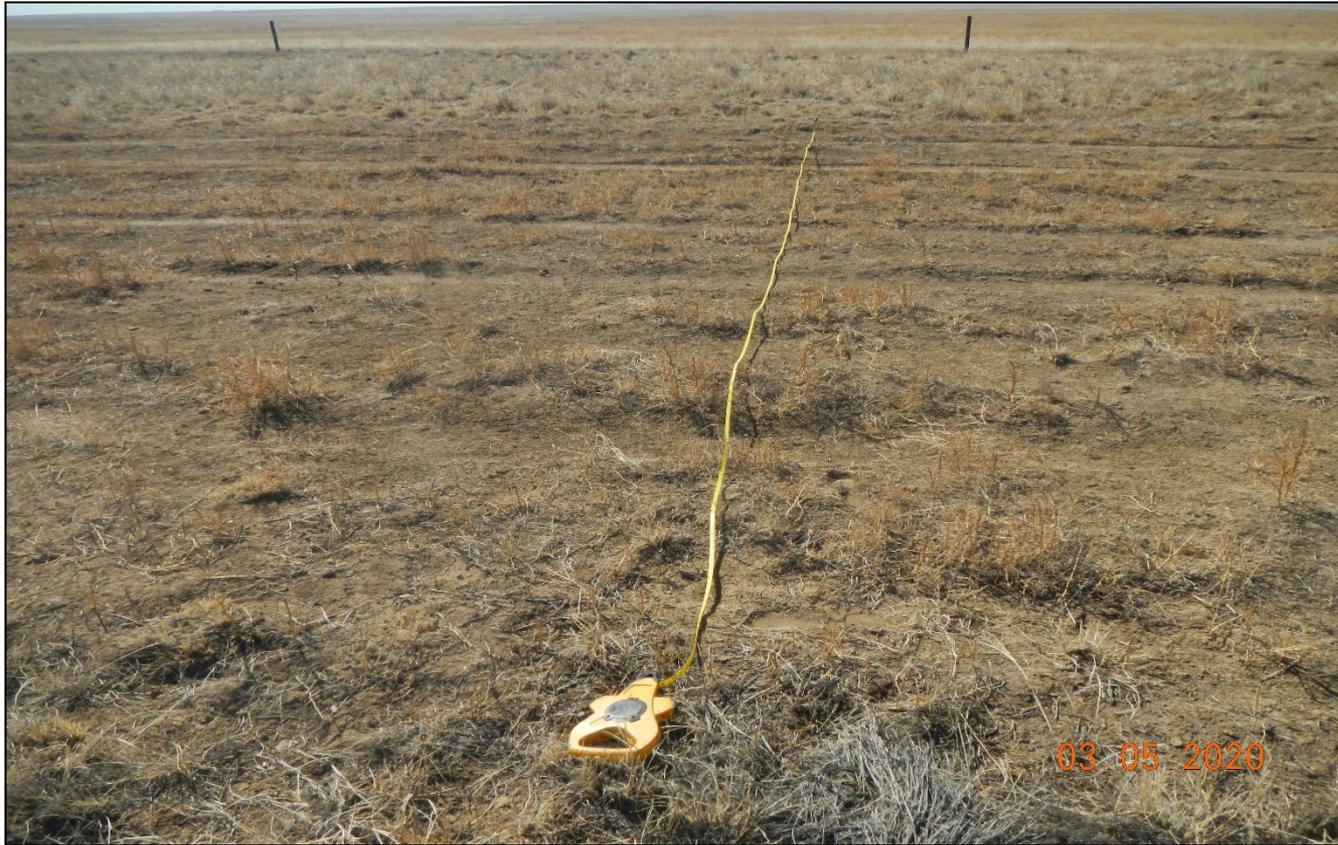
**Photo 4.** The disturbance of the access road was measured to be approximately 50 feet wide.

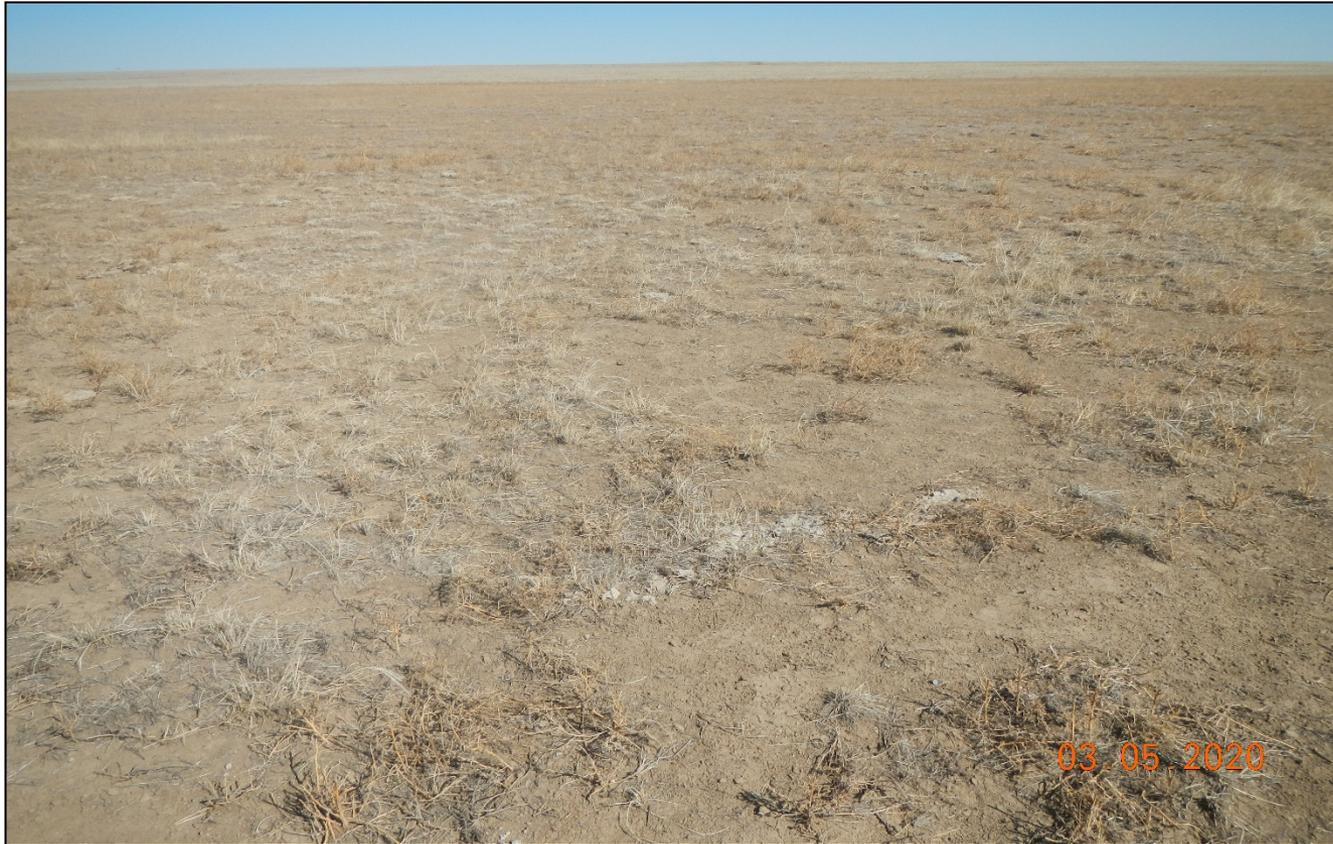
**Photo 5.** Facing east toward the location. The location does not have desirable vegetation establishment.

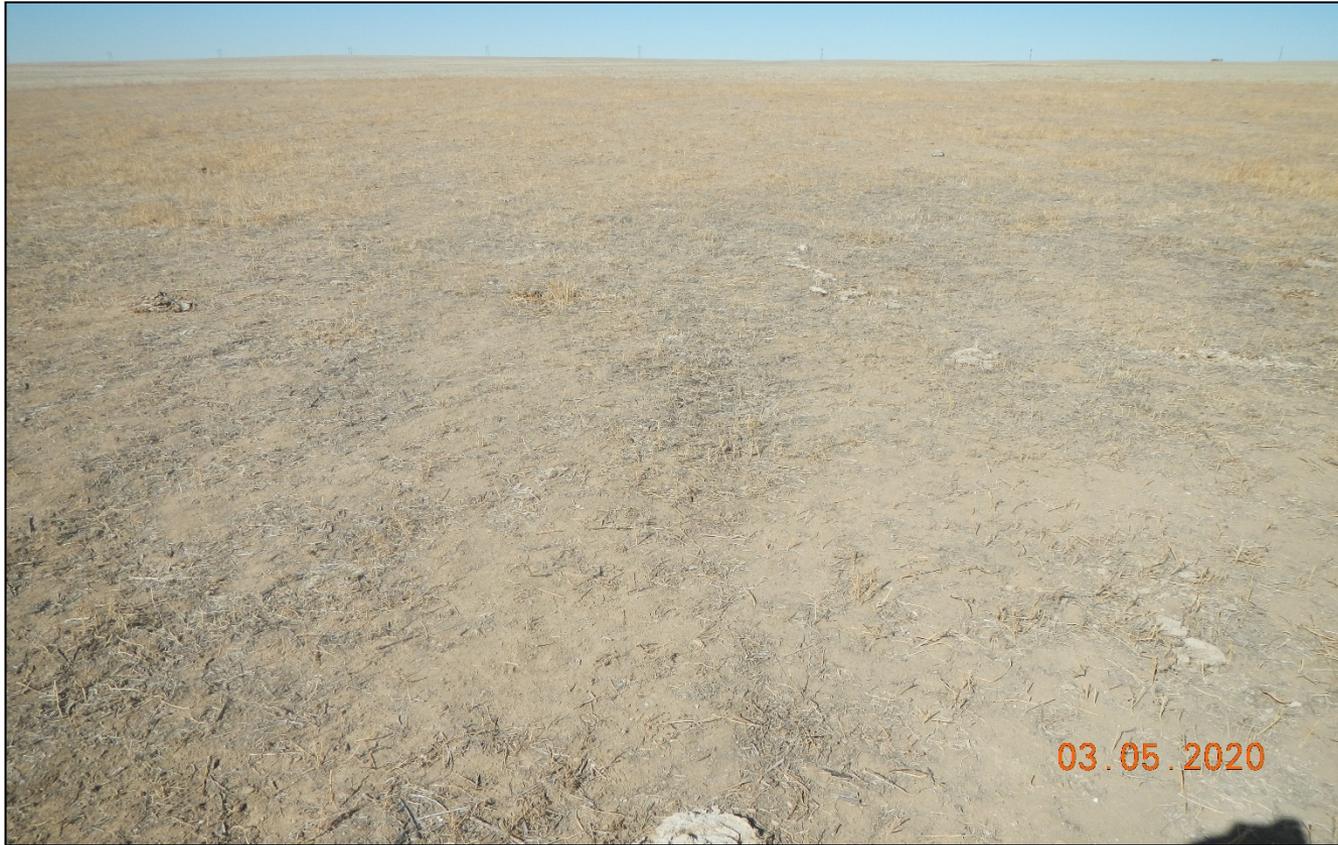
**Photo 6.** Facing north at the center of the location. The location does not have desirable vegetation establishment. There is bare ground and weeds throughout the location.

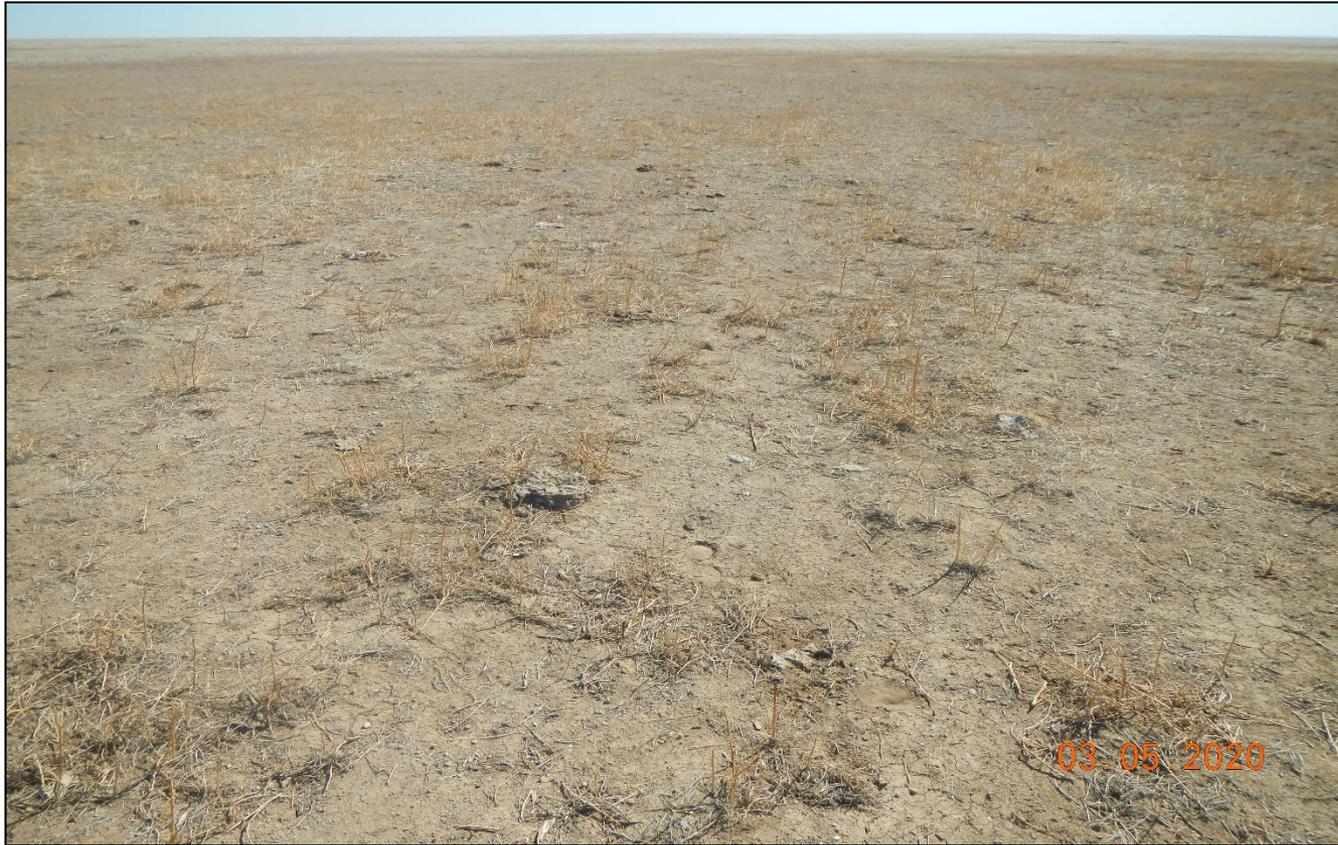
**Photo 7.** North side of the location facing south toward the location.

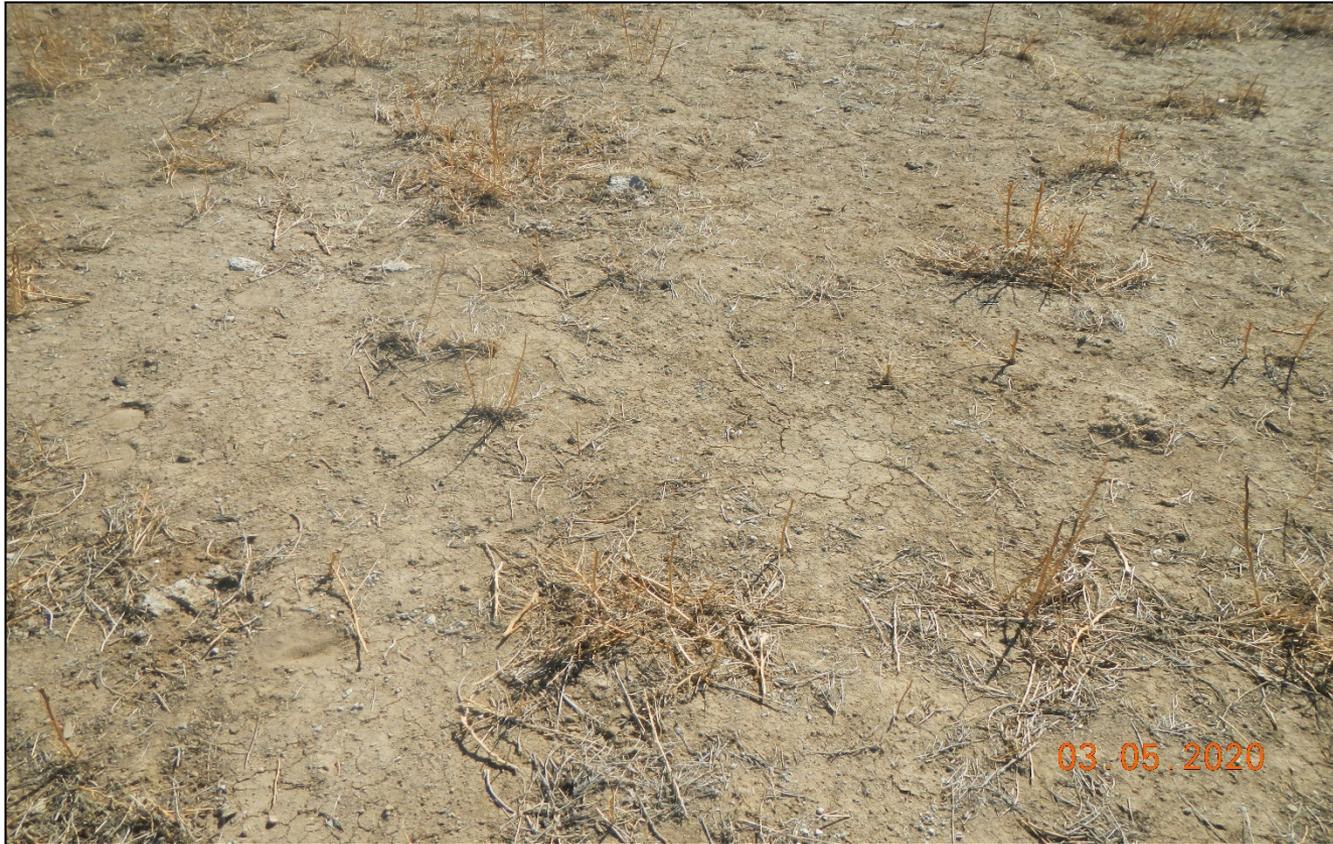
**Photo 8.** View groundcover at the location shows bare soil which is susceptible to erosion. There is also weed debris (Kochis sp.) shown in the photo.

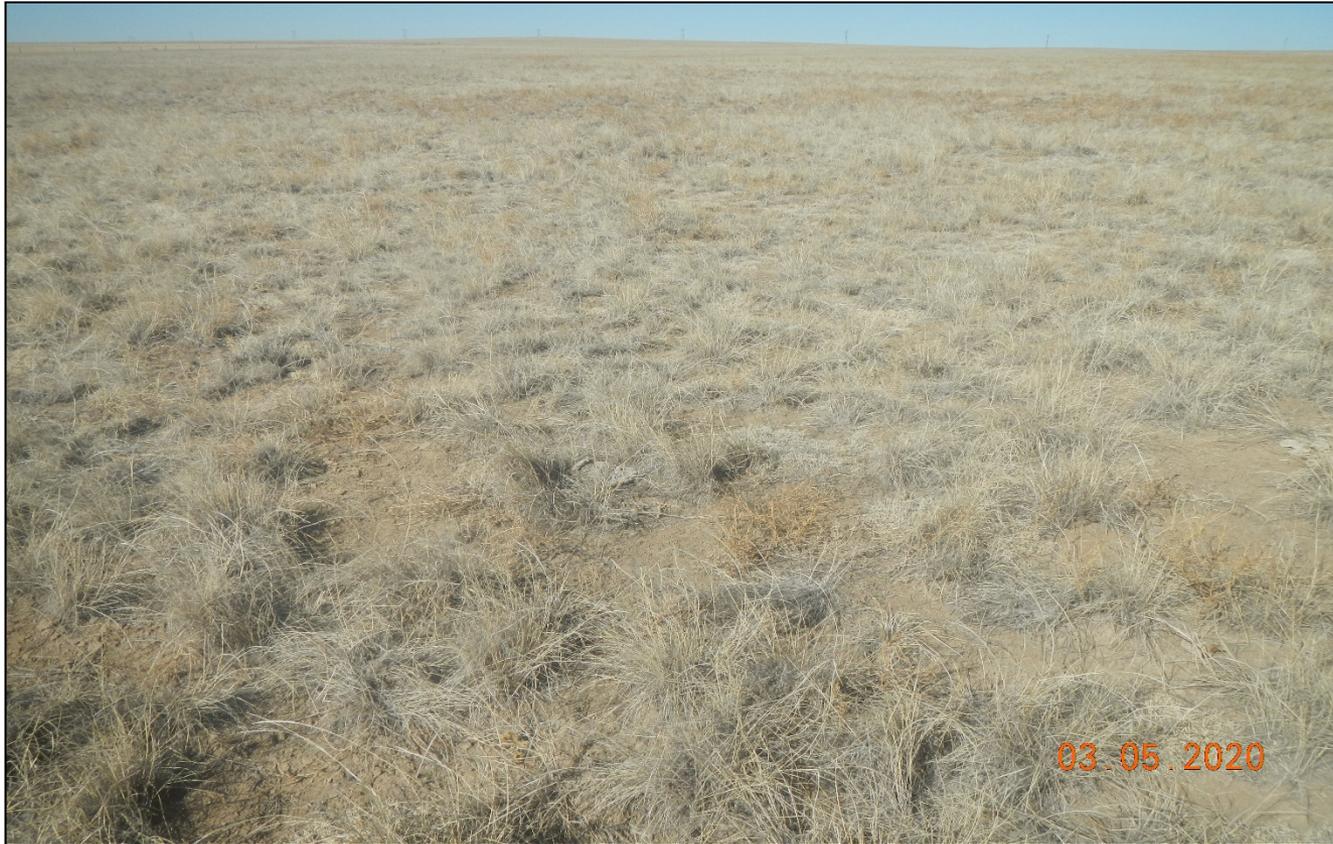
**Photo 9.** Facing north toward the surrounding reference area which consists of desirable vegetation such as Blue grama, Sand dropseed, among other native species.
