Inspection Photos  
Operator: Williford Resources  
API#: 067-06772  
Date: 3/4/2020

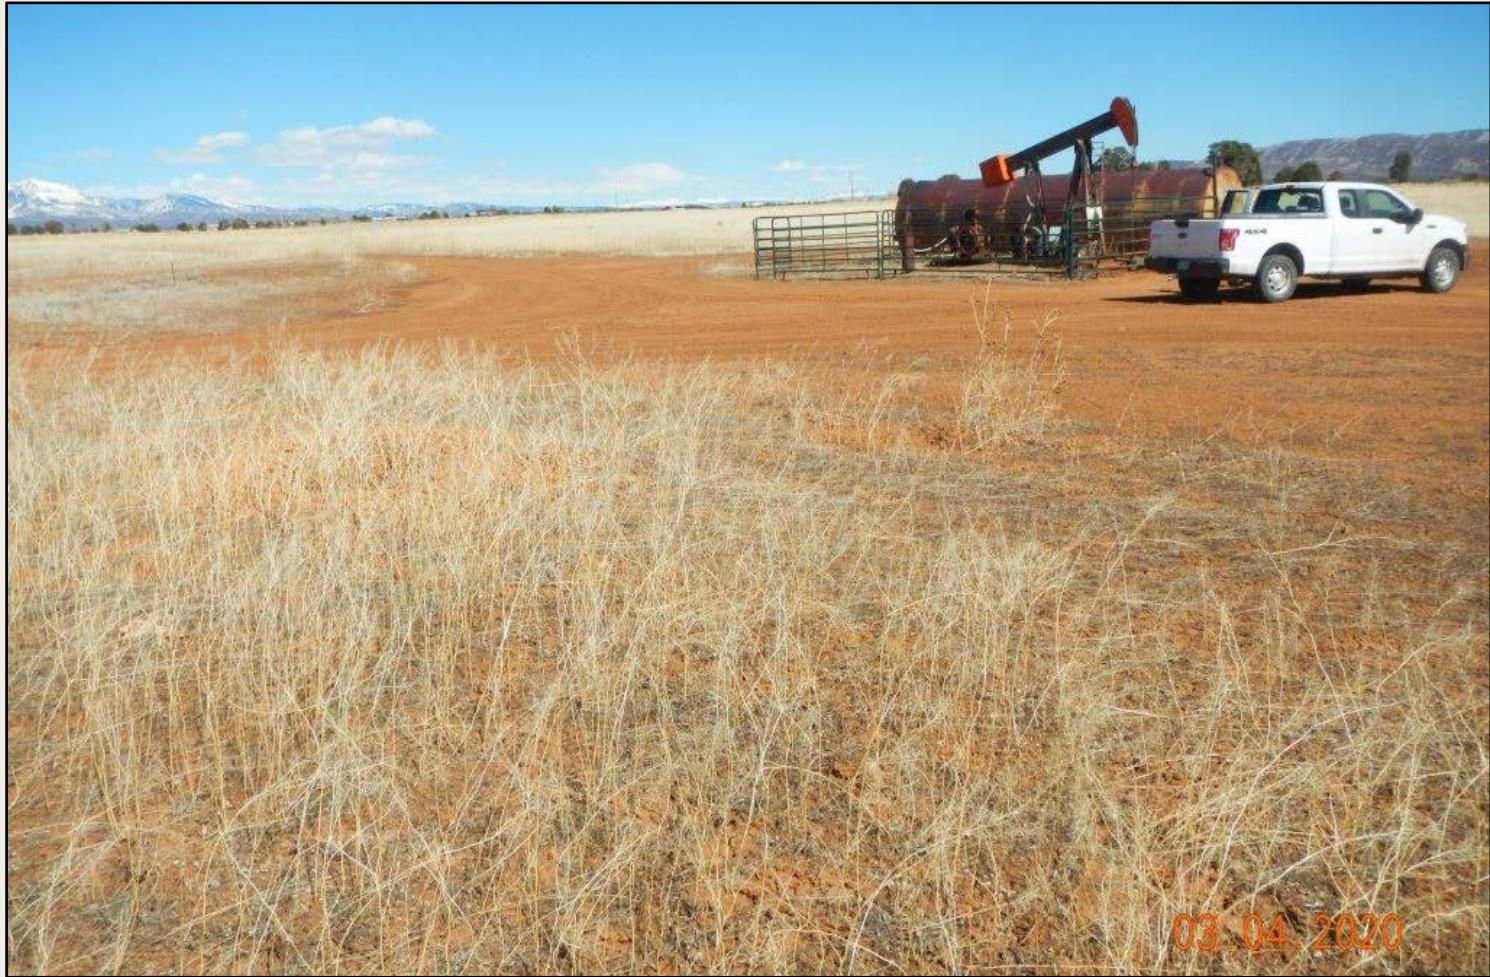
Photo 1. View of the project area from the southwestern corner facing center.

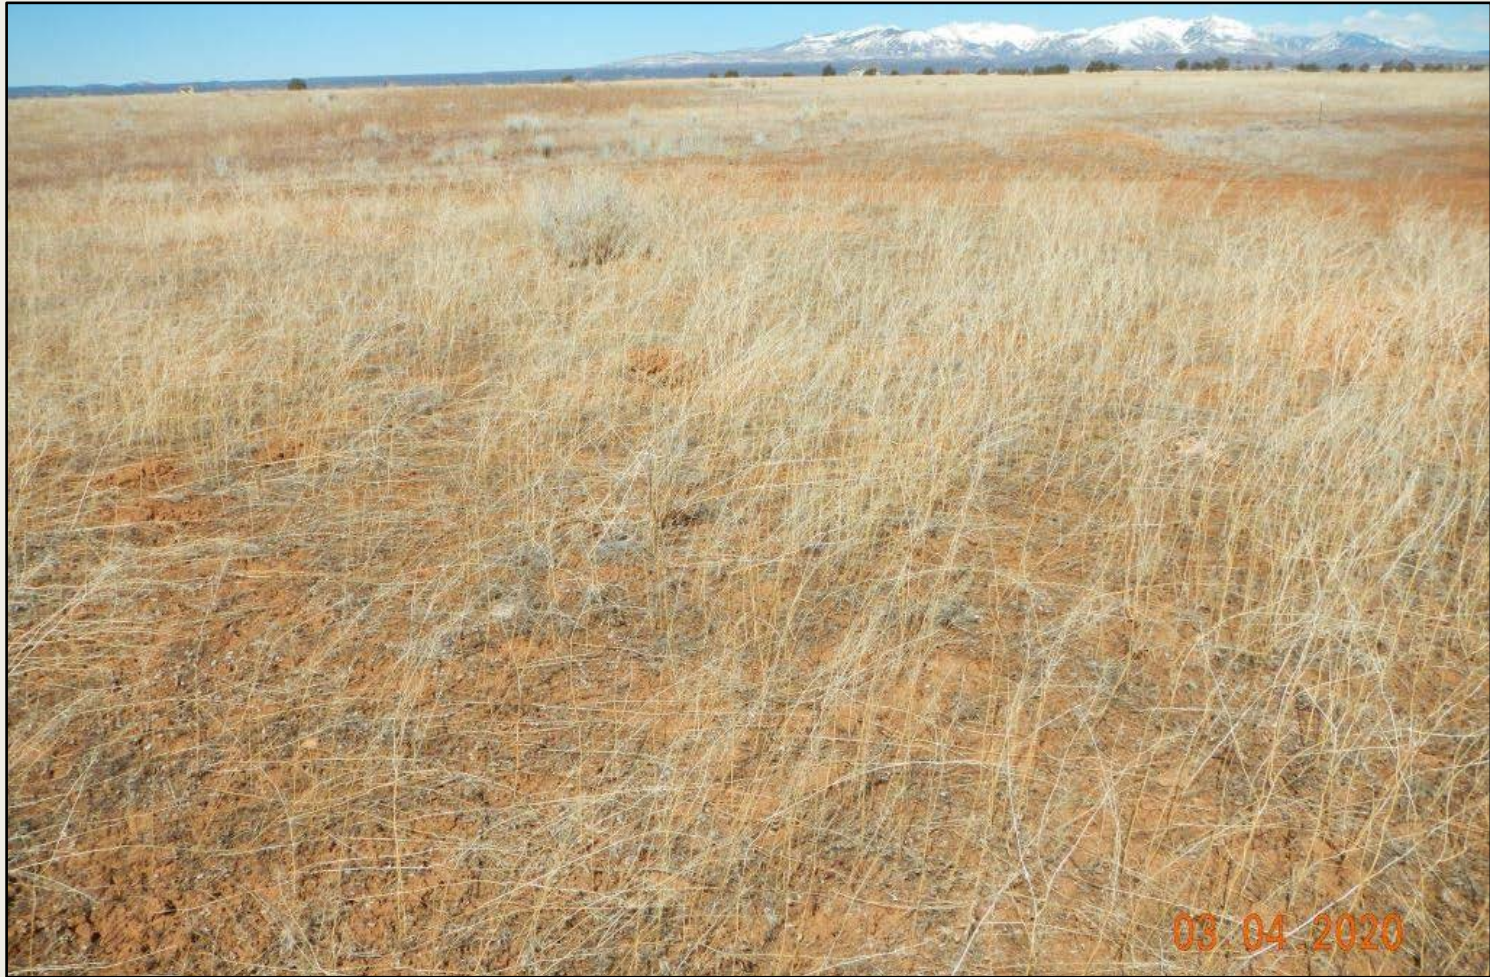
Photo 2. View of the western project area from the southwestern corner facing northward. Vegetation is in a dormant condition with scattered shrubs such as rubber rabbitbrush and sagebrush, as well as weedy annual grasses and forbs, similar to the reference area.

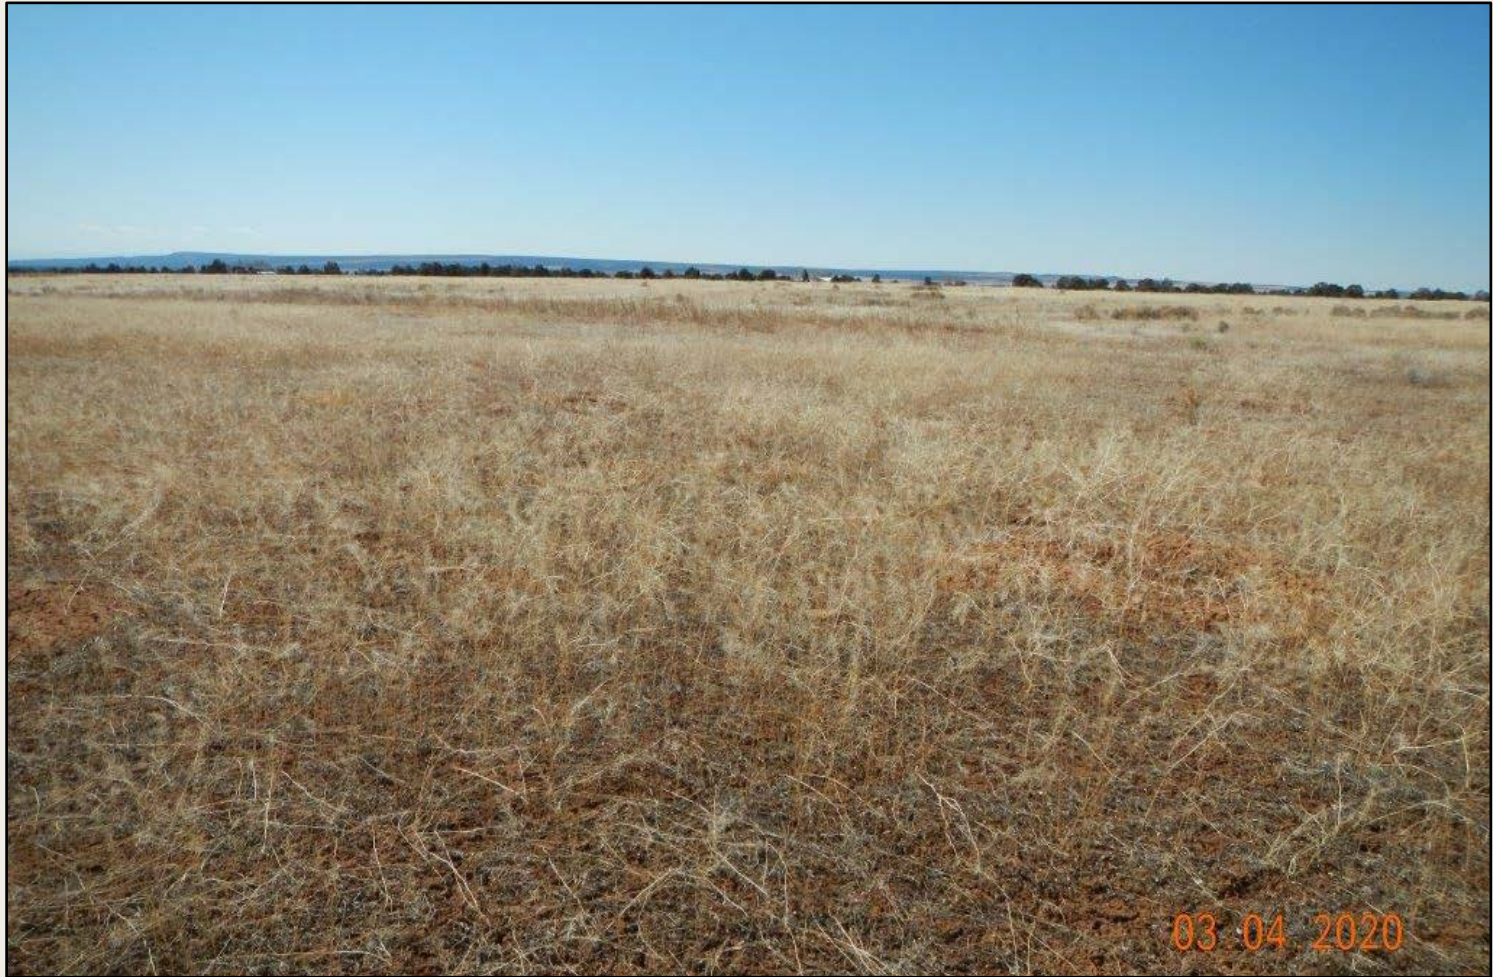
Photo 3. View of reference area vegetation west of the project area, largely comprised of scattered shrubs such as rubber rabbitbrush and sagebrush, as well as weedy annual grasses and forbs,
