Inspection Photos
Location Name: SG E34 496 Pad
Inspection Date: February 28, 2020

COLORADO
Oil & Gas Conservation
Commission
Department of Natural Resources

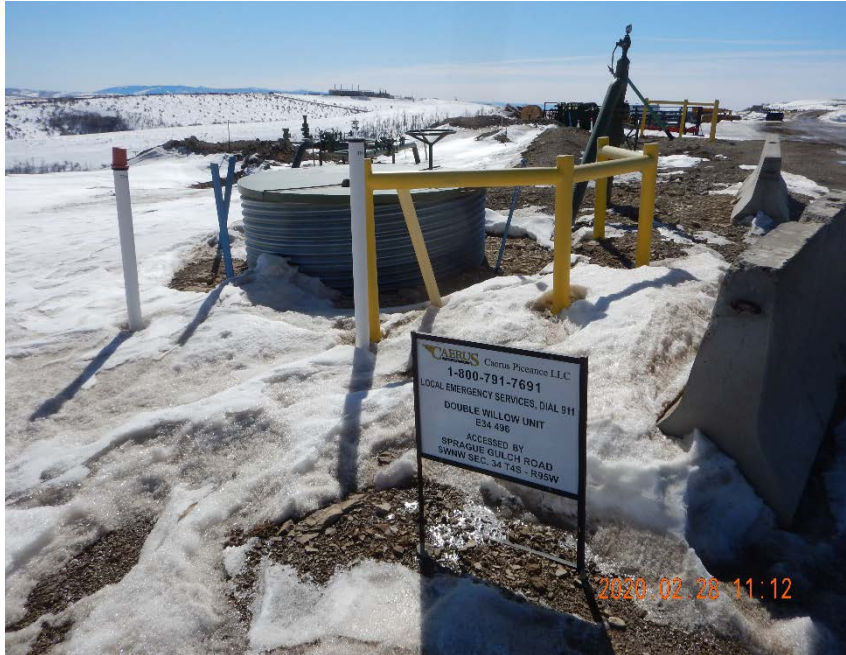
Photo #1 – Sign located in northeast corner of pad.

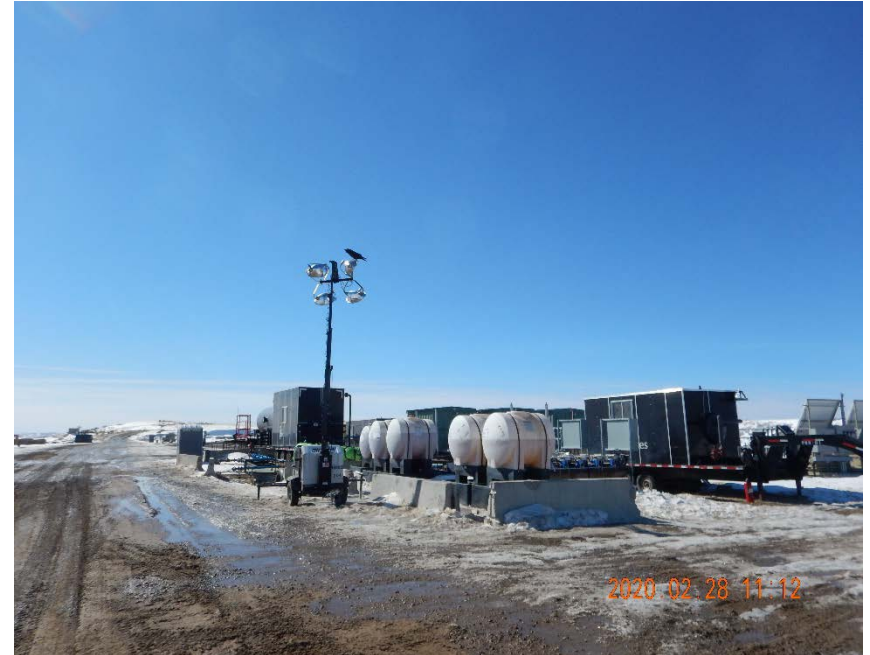
Photo #2 – Day tanks located in northwest corner of pad.

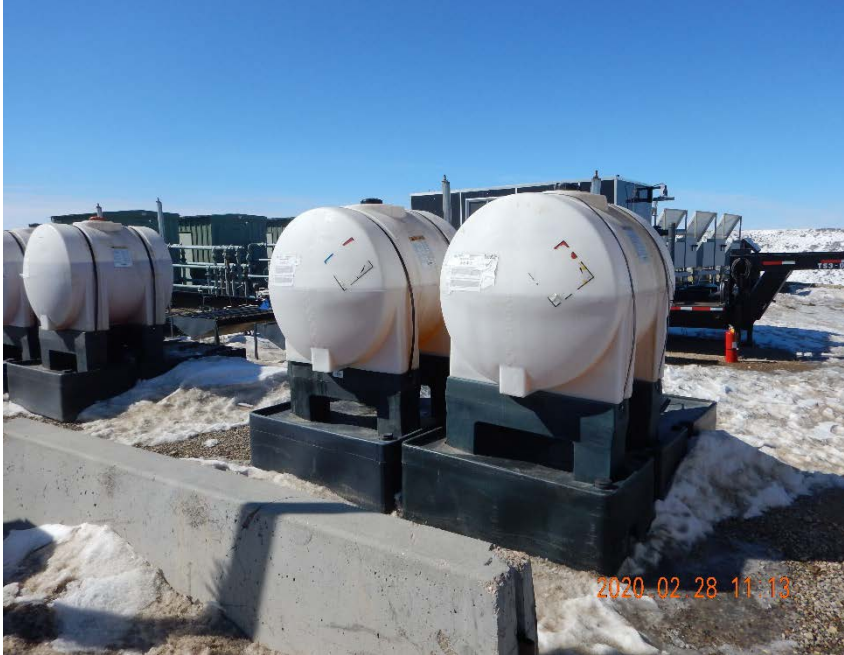
Photo #3 – NFPA placards on day tanks were damaged and tank labels were faded on inspection date.

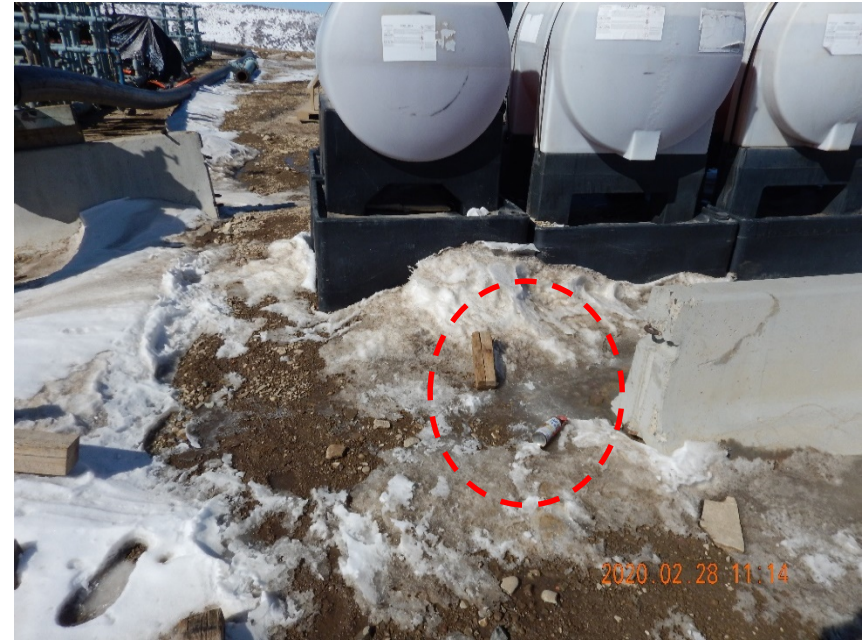
Photo #4 – Trash and debris in day tank area.

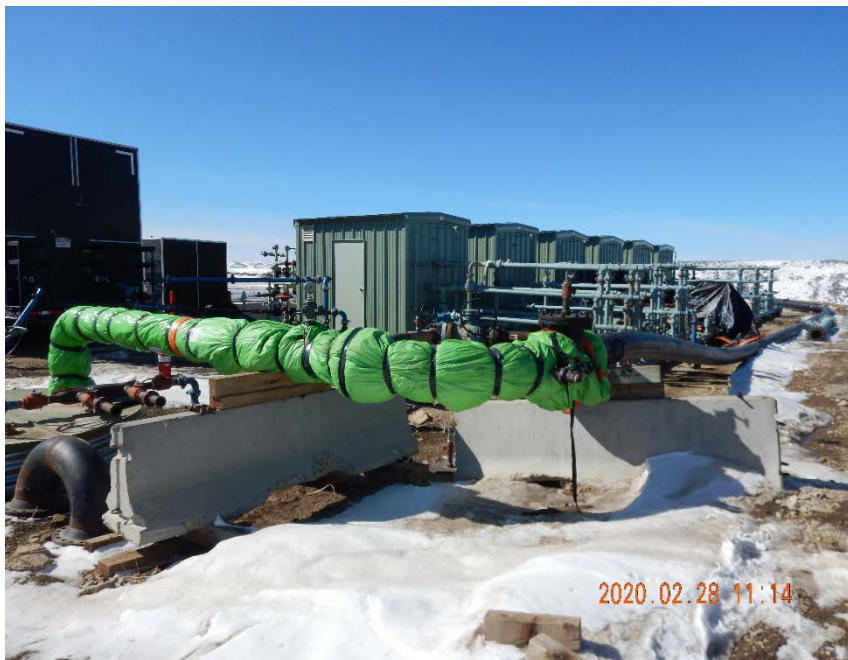
Photo #5 – HDPE surface line and gas meter sheds with flowline risers located on north side of pad.

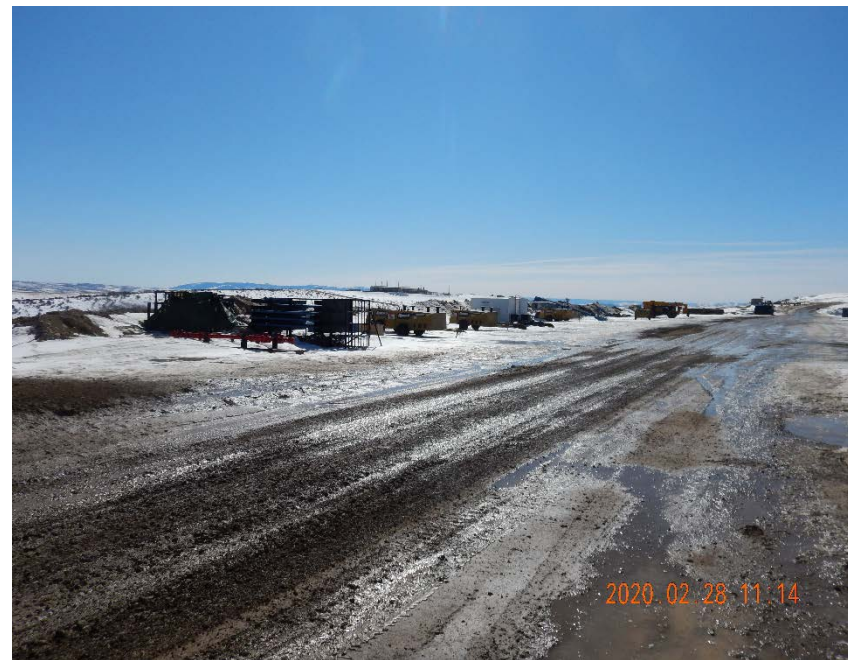
Photo #6 – East side of pad was used for equipment storage on inspection date.

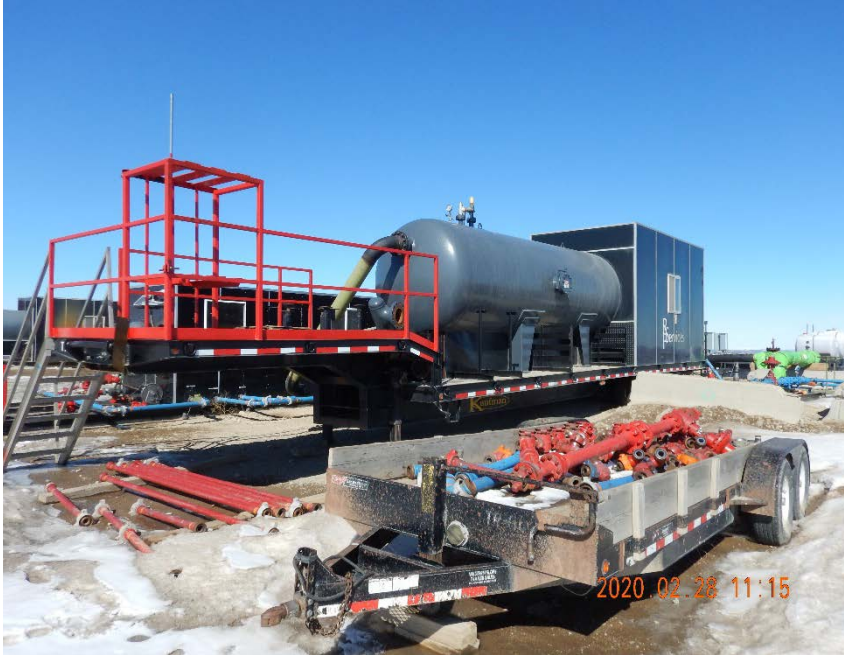
Photo #7 – RP Services separators and equipment stored on north side of pad (1).

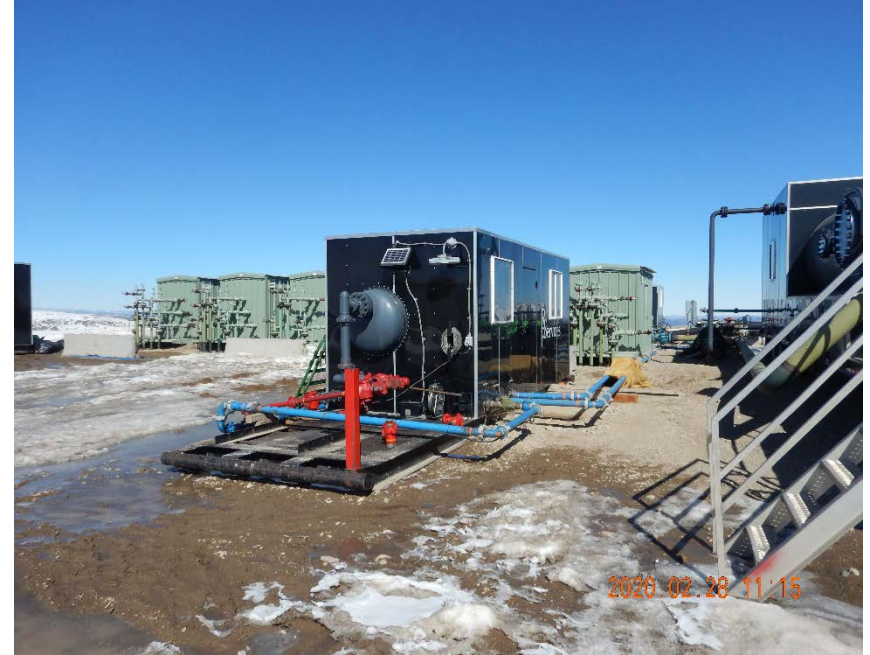
Photo #8 - RP Services separators and equipment stored on north side of pad (2).

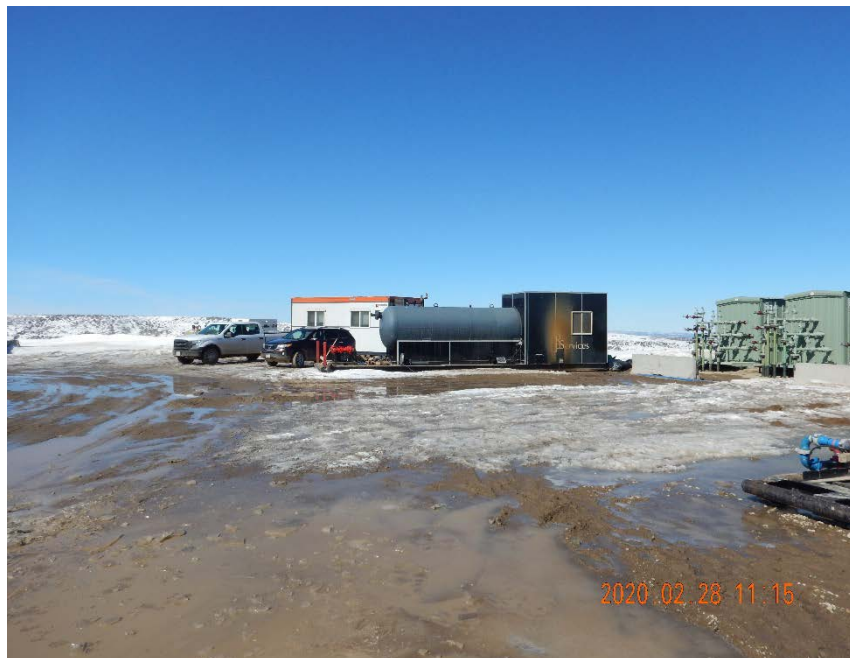
Photo #9 - RP Services separators and equipment stored on north side of pad (3).

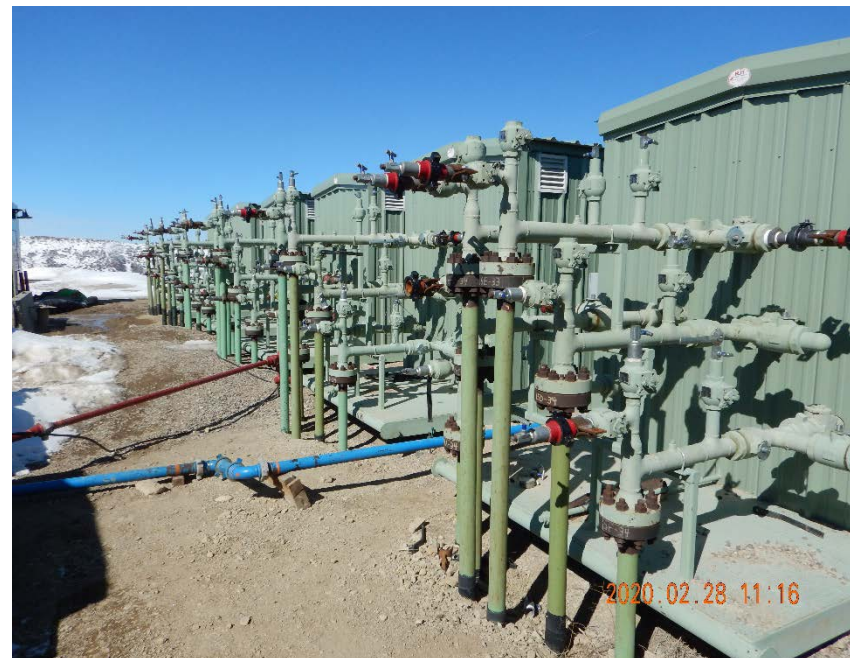
Photo #10 – Flowline risers at meter sheds located on north side of pad.

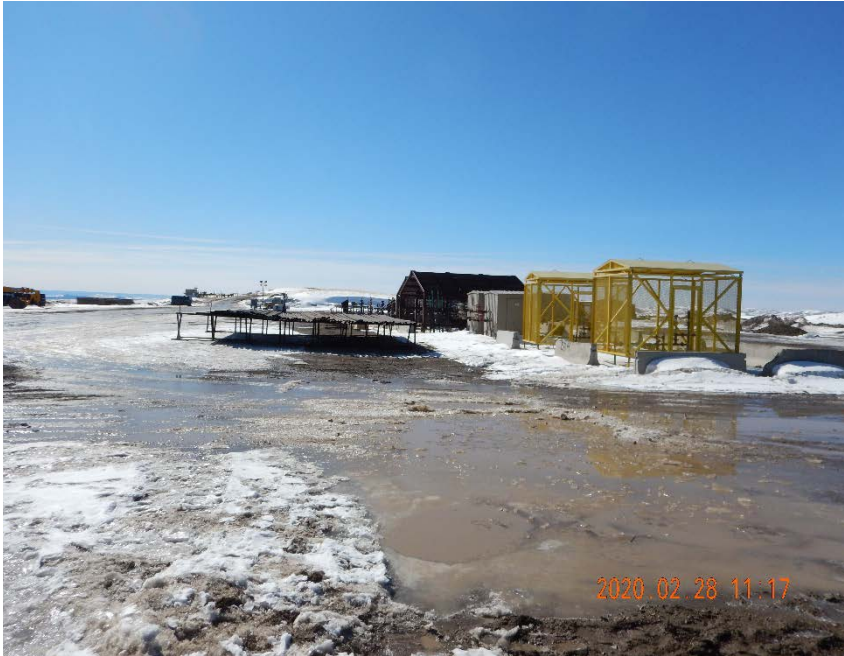
Photo #11 – View of wellheads located in center of pad (from north).

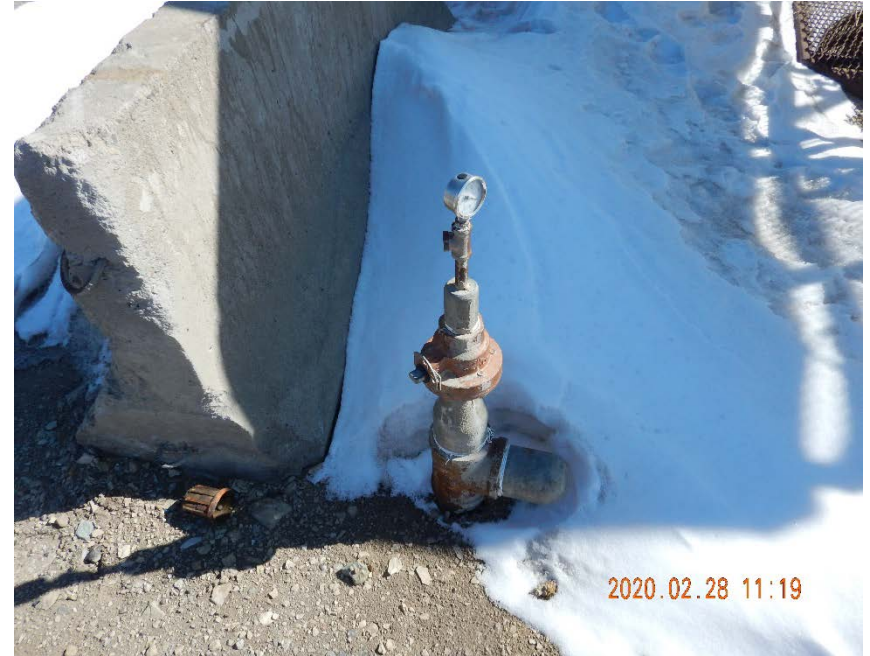
Photo #12 – Unmarked flowline riser located NW of wellheads.

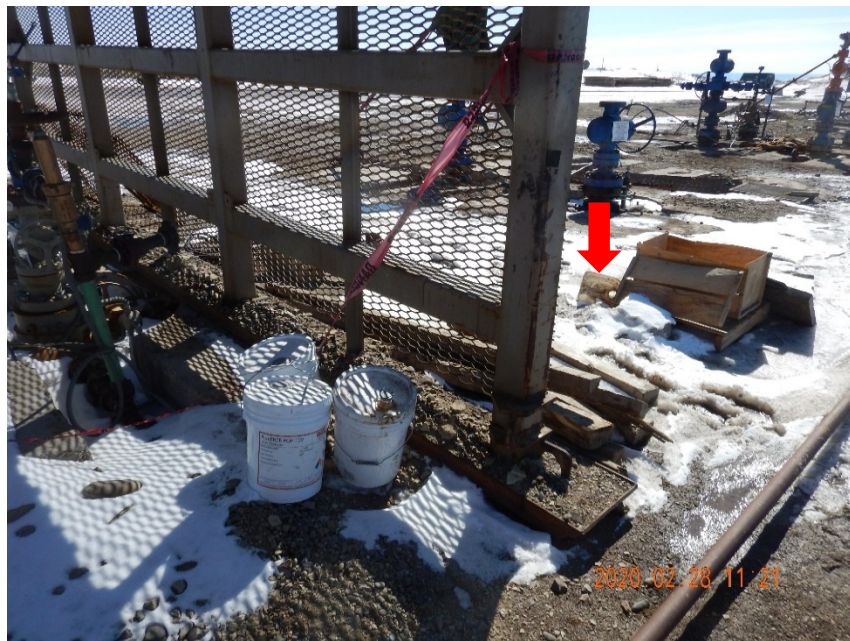
Photo #13 – Chemical storage buckets and wood debris located on west side of wellhead area. Note overturned chemical storage container marked by red arrow.

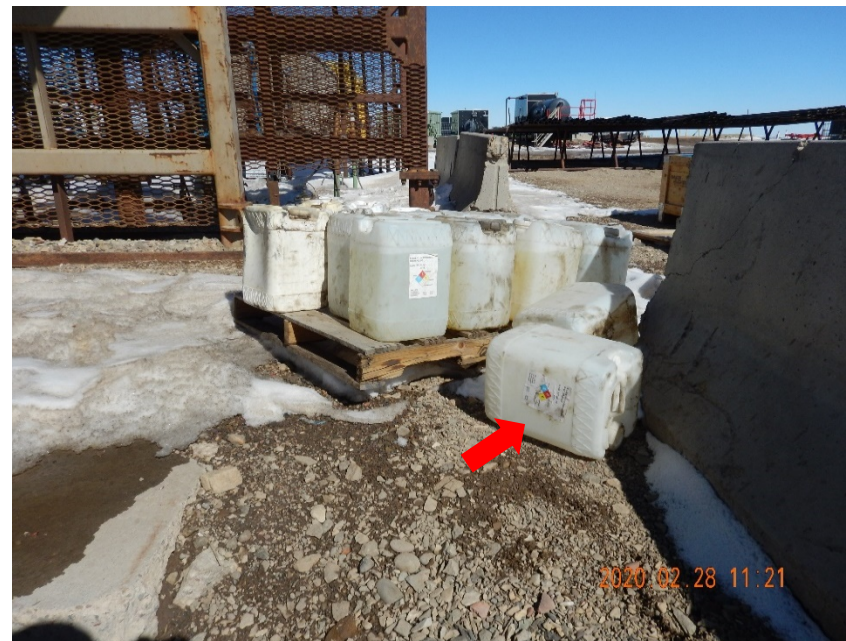
Photo #14 – Chemical storage containers and additional equipment located on east side of wellhead area. Note overturned chemical storage container marked by red arrow.

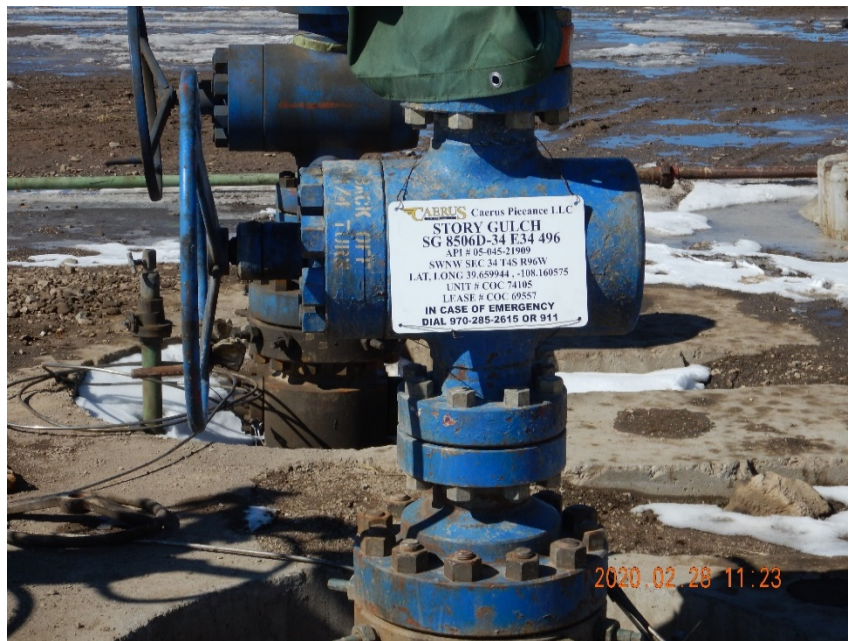
Photo #15 – Well sign for API #05-045-21909.

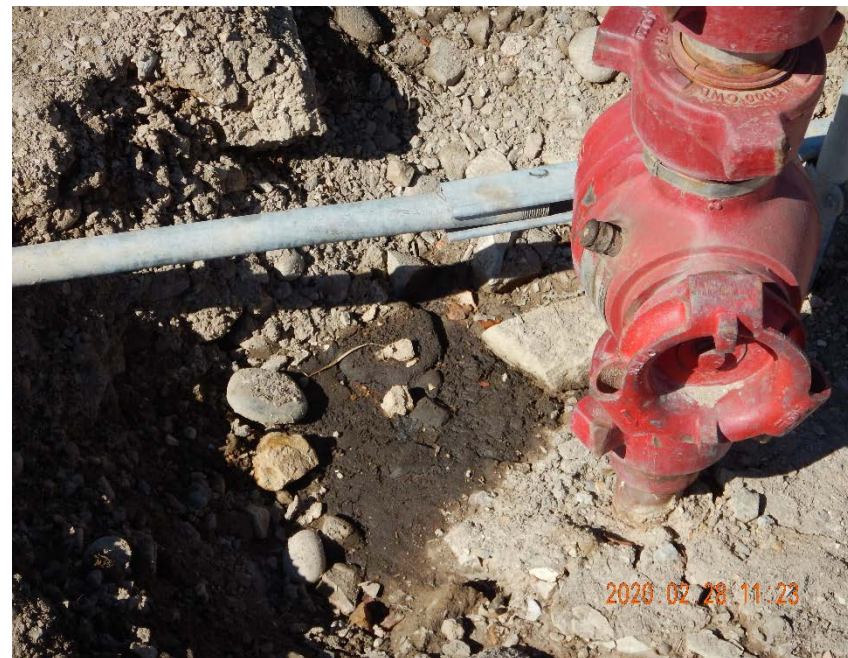
Photo #16 – Localized accumulation of oil-stained soil on east side of API #05-045-21909.

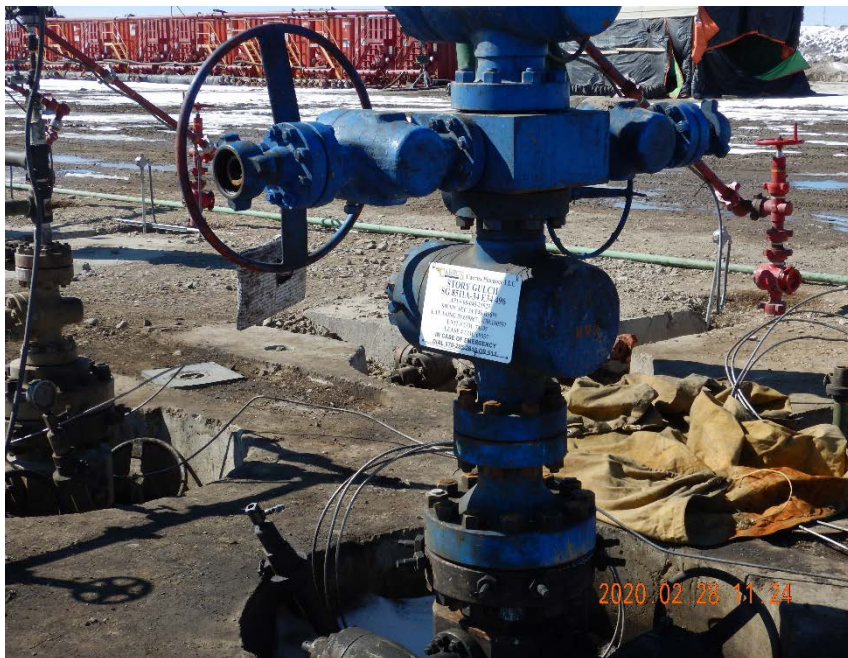
Photo #17 – Well sign for API #05-045-21923.

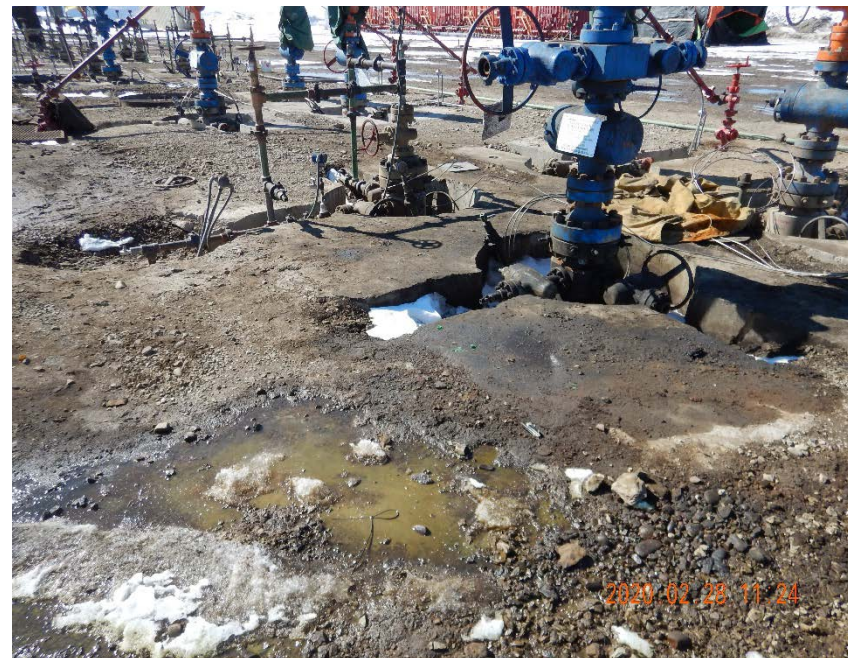
Photo #18 – Localized hydrocarbon staining, impacted fluids, and stained soil located west of API #05-045-21923.

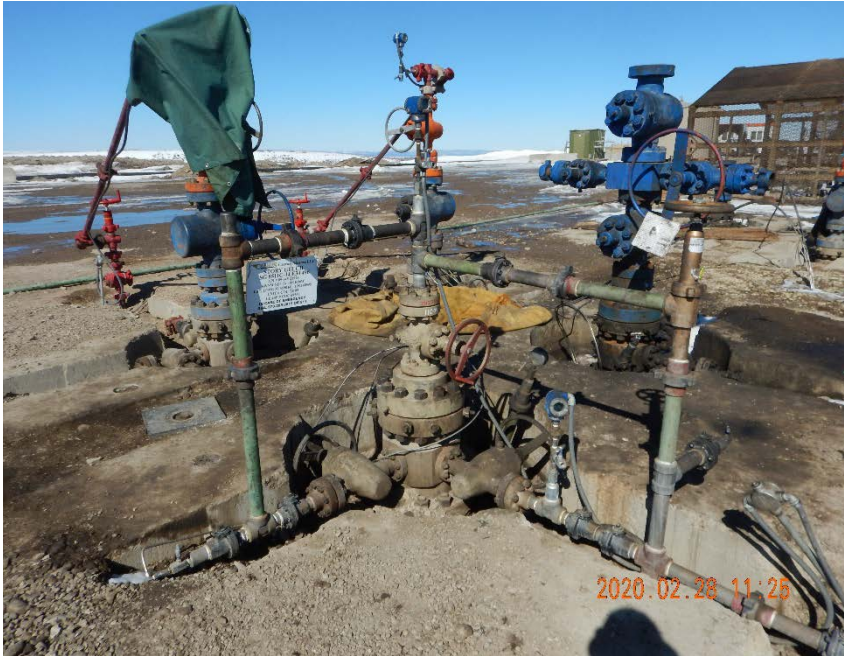
Photo #19 – Localized accumulations of hydrocarbon staining on cement and soil in vicinity of API #05-045-21928.

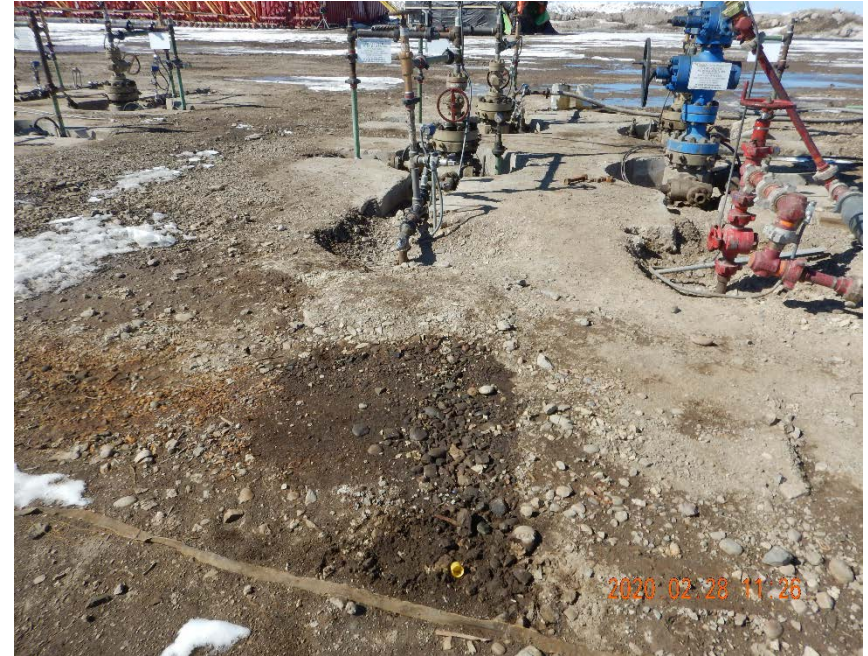
Photo #20 – Localized accumulation of oil-stained soil east of API #05-045-21919.

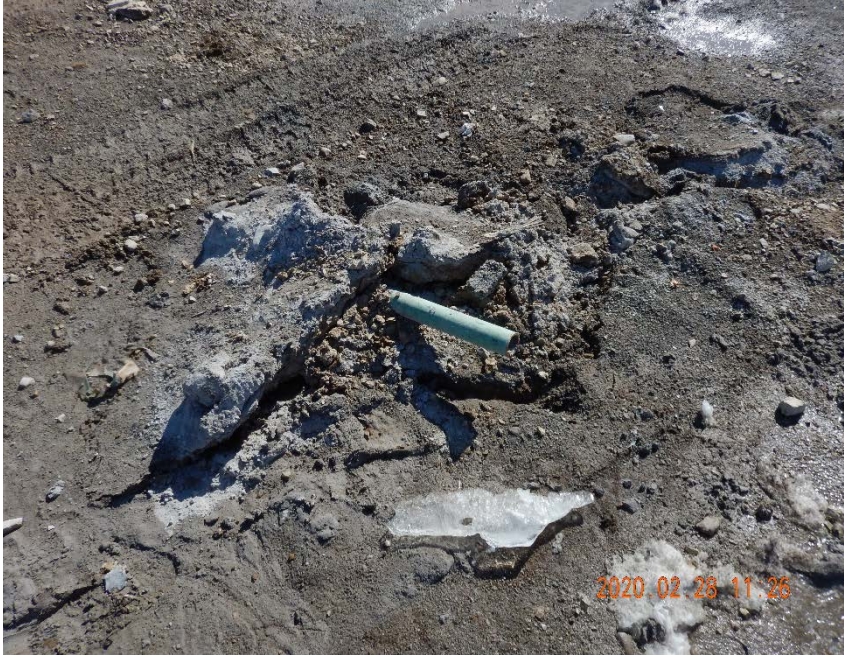
Photo #21 – Concrete debris with pipe located southeast of wellheads.

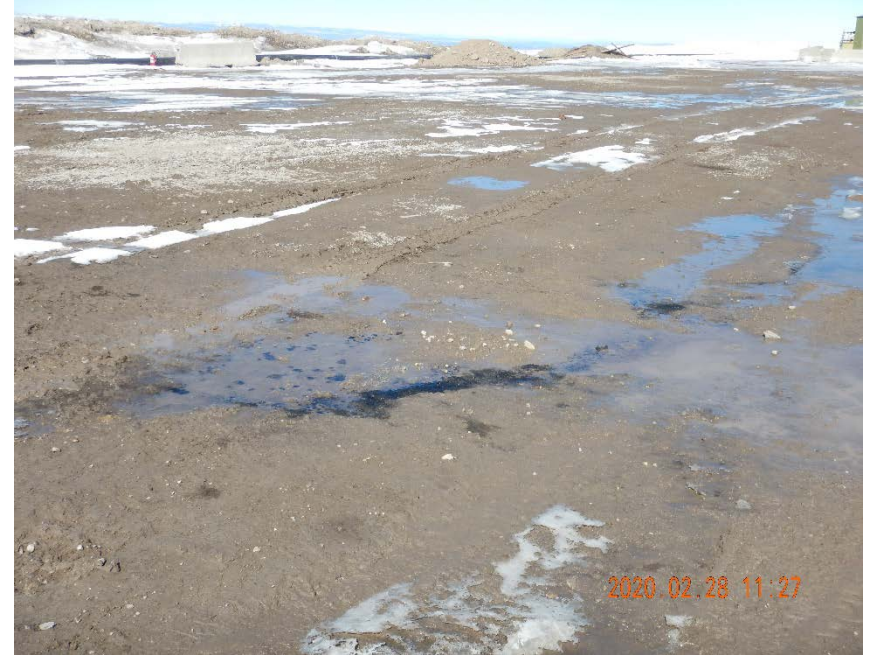
Photo #22 – Localized accumulations of oil-stained soil located west of wellheads (1).

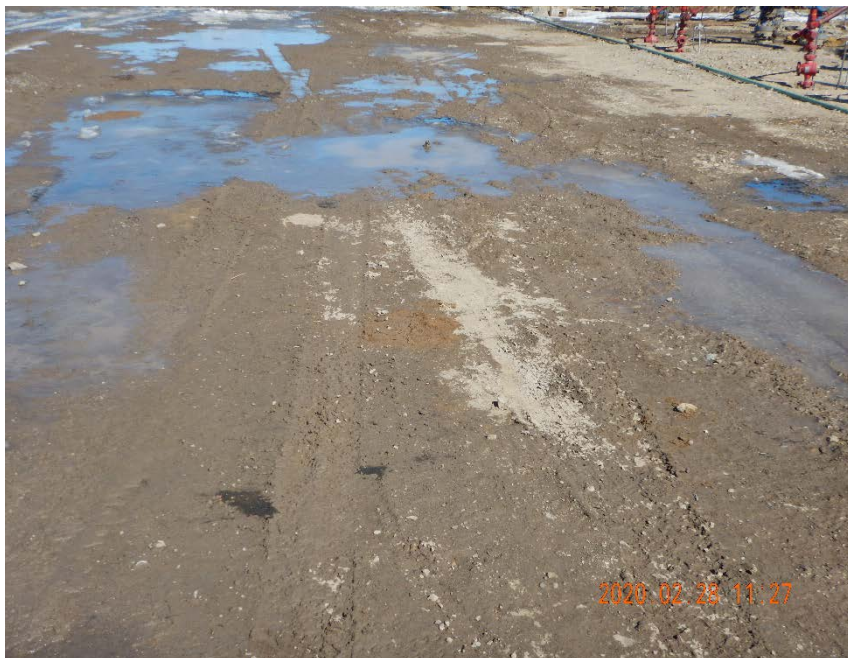
Photo #23 - Localized accumulations of oil-stained soil located west of wellheads (2).

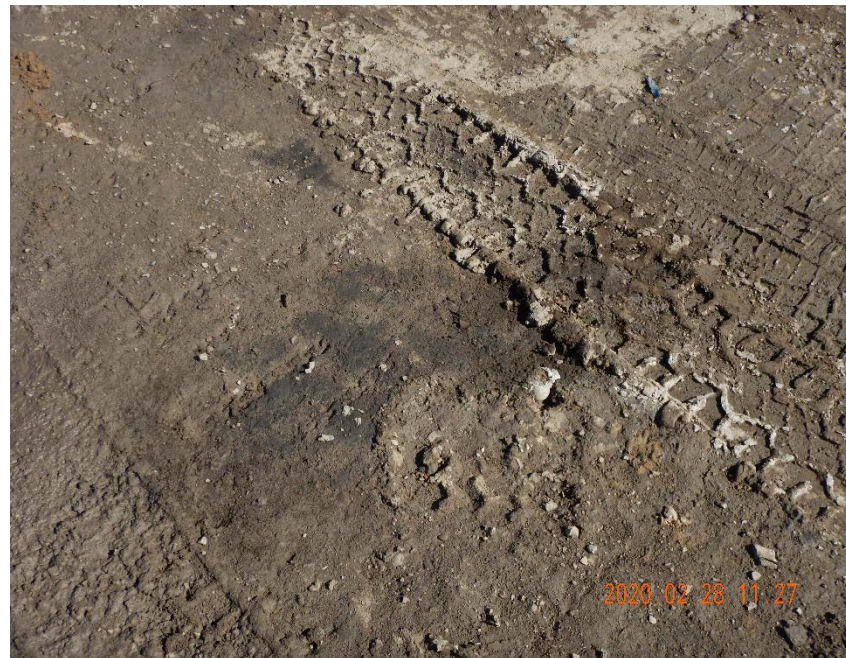
Photo #24 - Localized accumulations of oil-stained soil located west of wellheads (3).

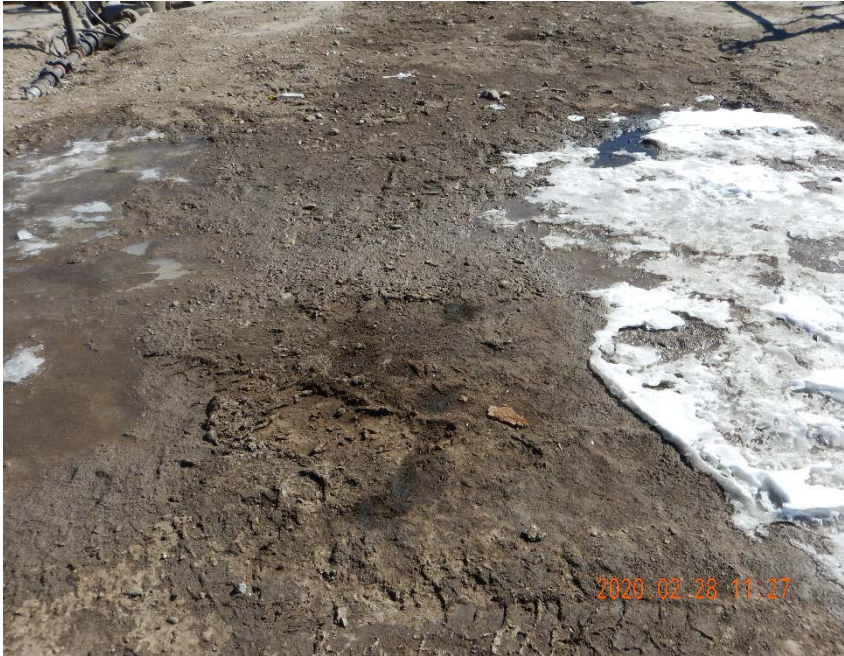
Photo #25 - Localized accumulations of oil-stained soil located west of wellheads (4).

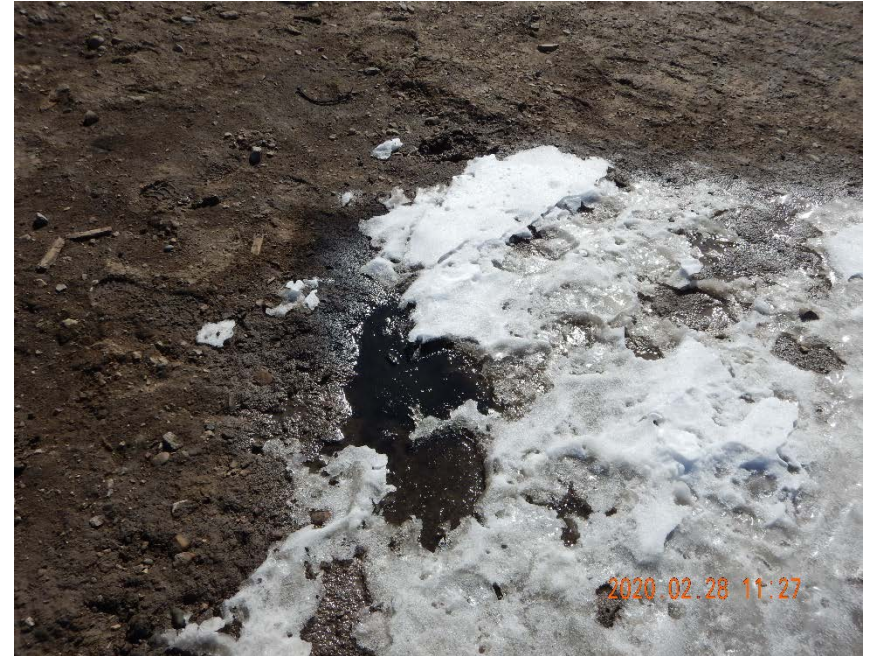
Photo #26 - Localized accumulations of oil-stained soil located west of wellheads (5).

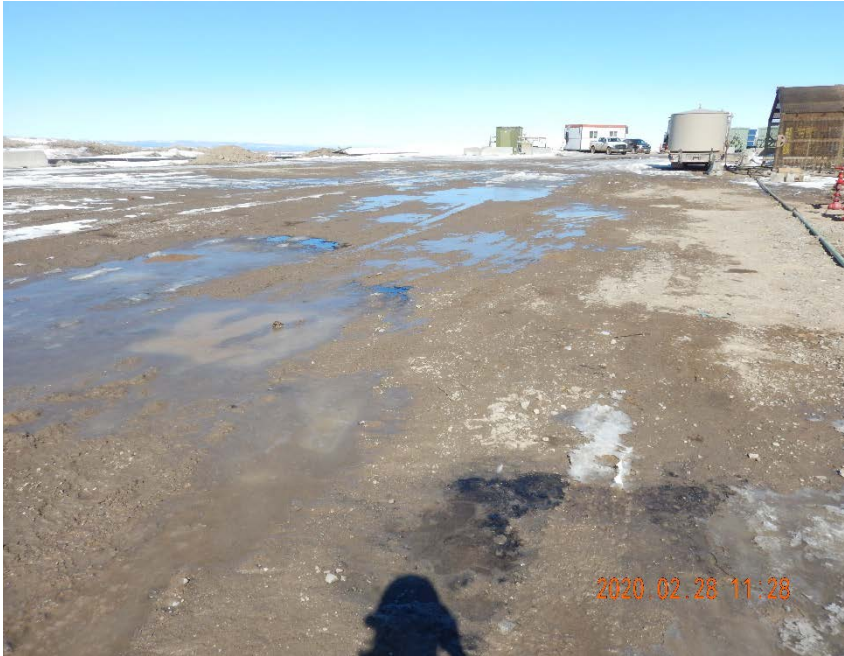
Photo #27 - Localized accumulations of oil-stained soil located west of wellheads (6).

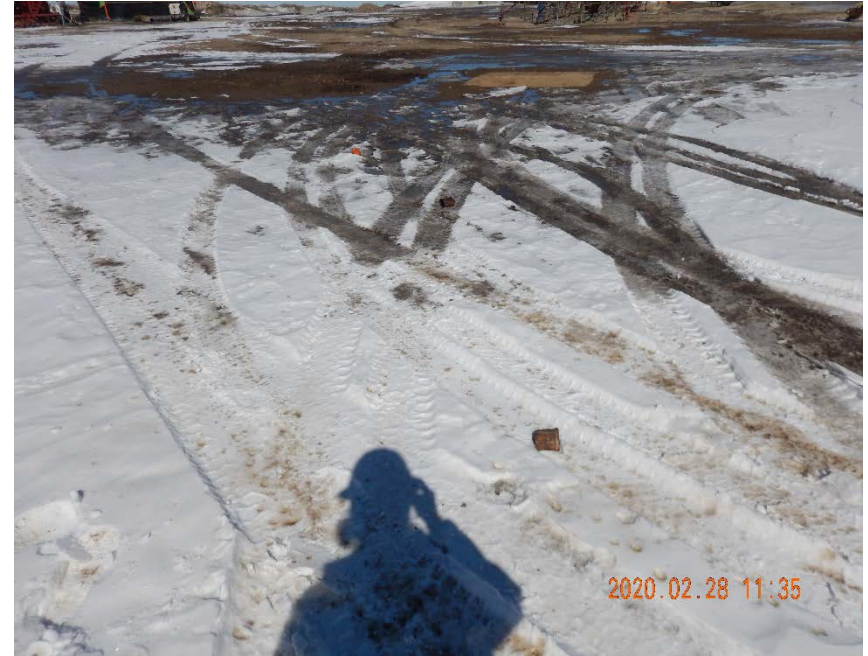
Photo #28 – Trash, oil-stained soil, and impacted snow on south side of pad.

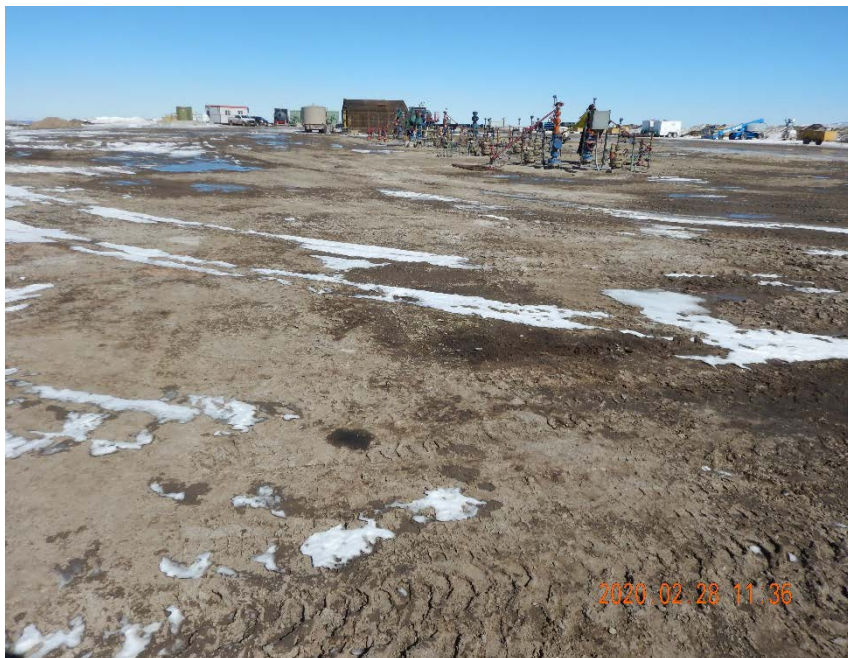
Photo #29 – Localized accumulations of oil-stained soil on south side of pad.

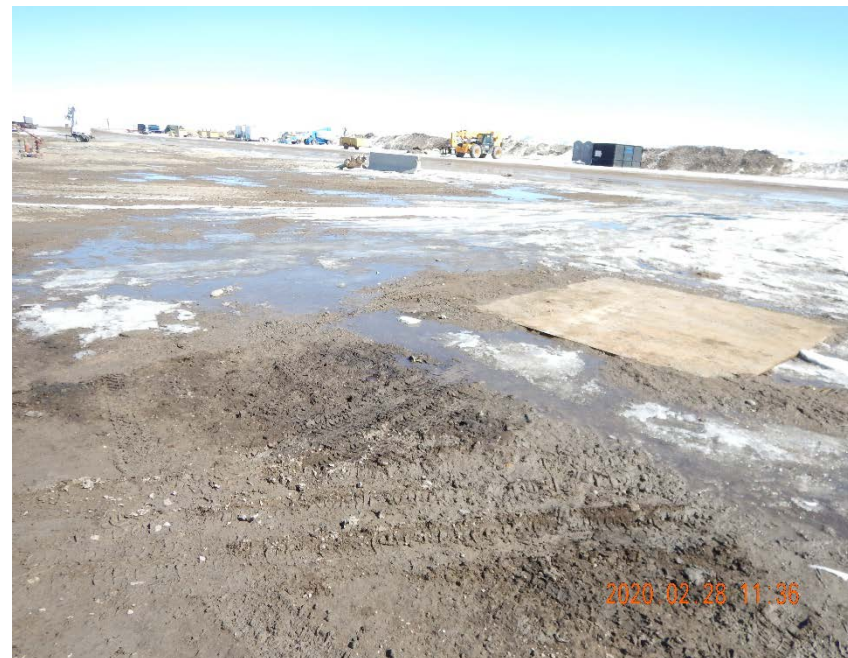
Photo #30 – Localized accumulations of oil-stained soil and wood debris on south side of pad.

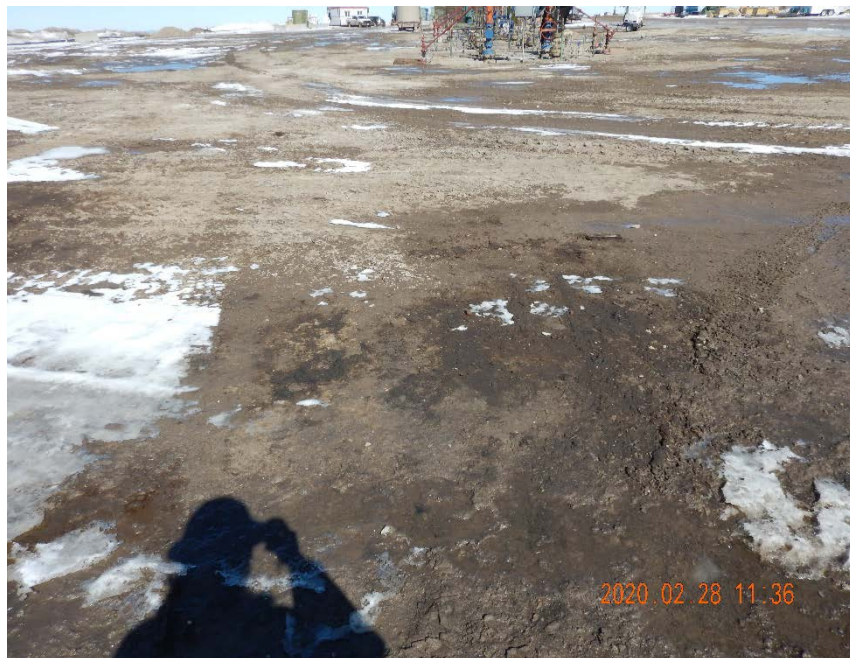
Photo #31 – Localized accumulations of oil-stained soil and impacted fluids on south side of pad.

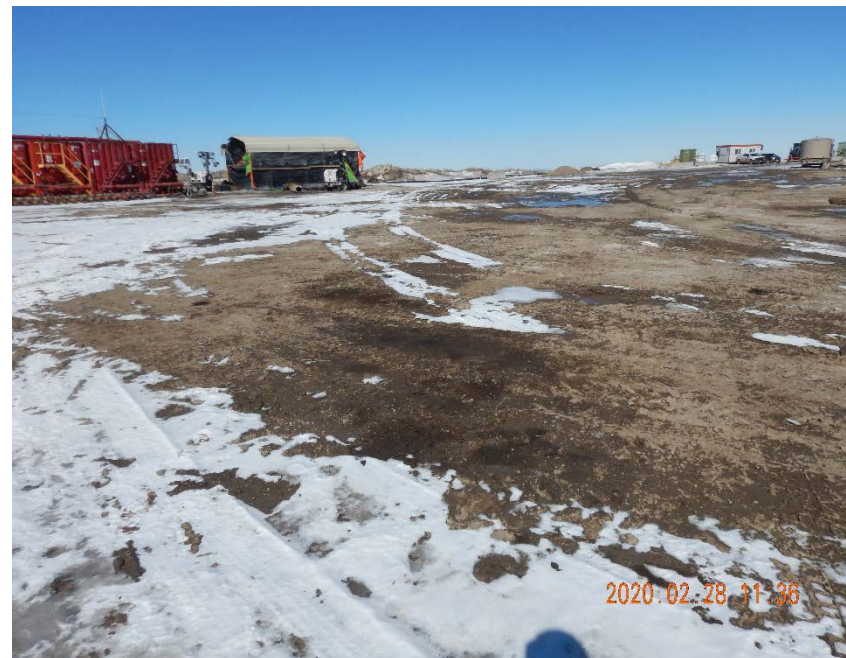
Photo #32 – Localized accumulations of oil-stained soil and impacted fluids on south side of pad.

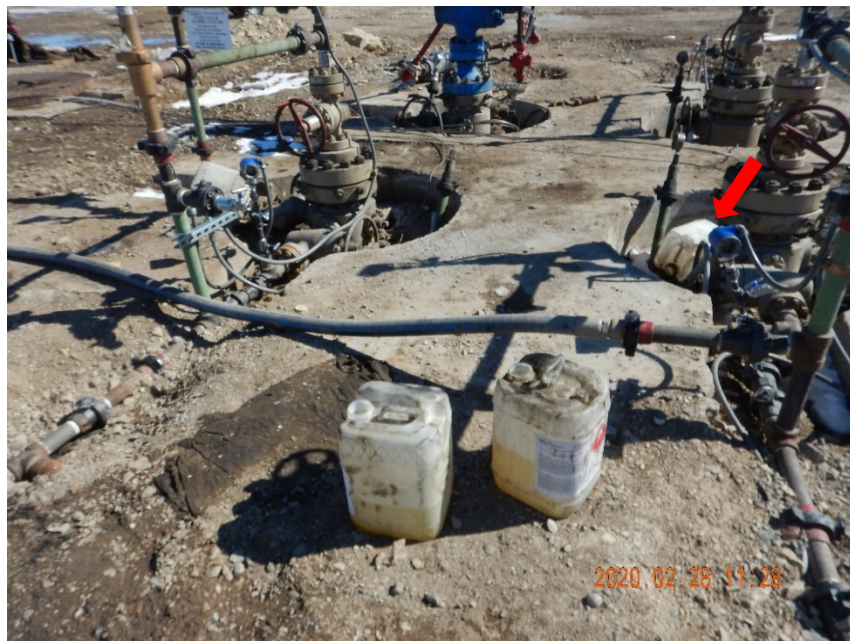
Photo #33 – Localized accumulations of oil-stained soil and chemical storage containers with trash stored on west side of API #05-045-21905. Note overturned chemical storage container marked by red arrow.

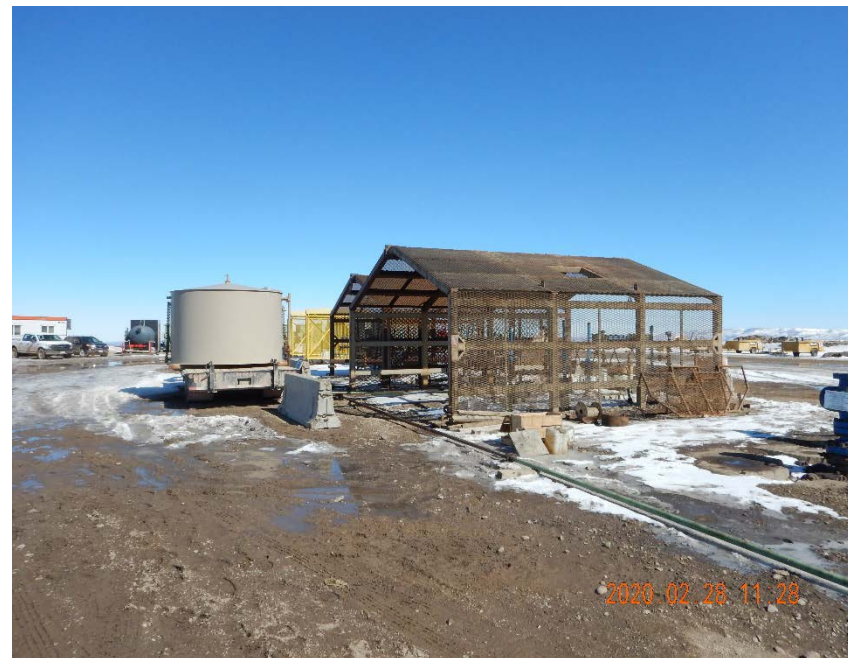
Photo #34 – AST on trailer located west of wellheads was plumbed to surface lines on inspection date. AST did not have any secondary containment devices installed.

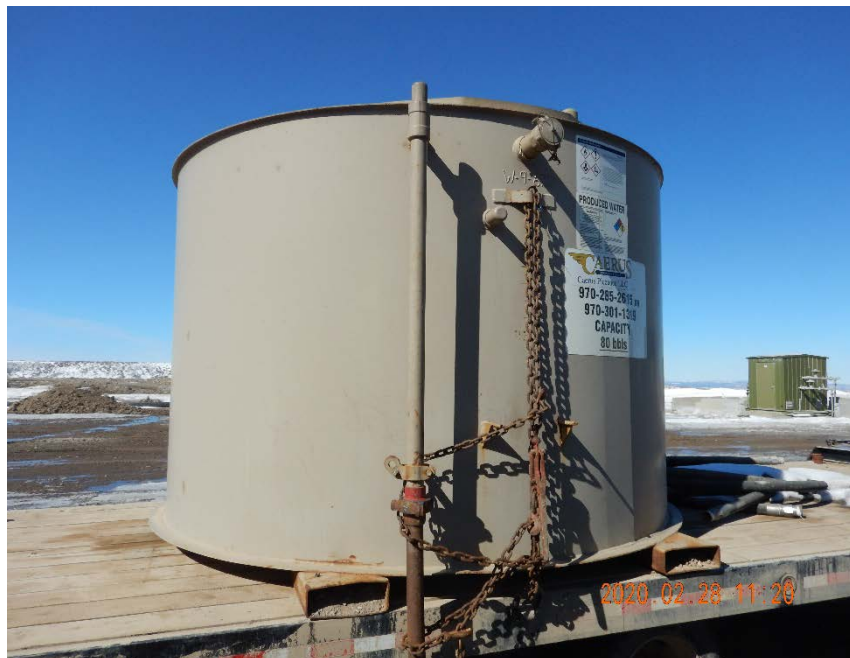
Photo #35 – AST from previous photo is labeled to contain Produced Water with a capacity for 80 bbls.

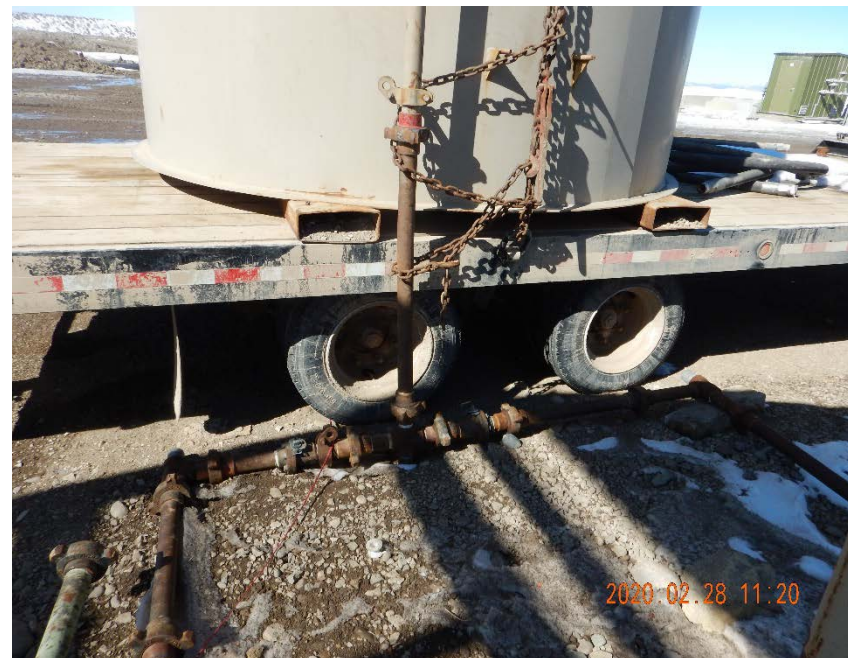
Photo #36 – Close-up of surface flowlines lined to 80 bbl produced water AST lacking secondary containment device.

This issue was brought to the operator's attention via a phone call and email on inspection date.

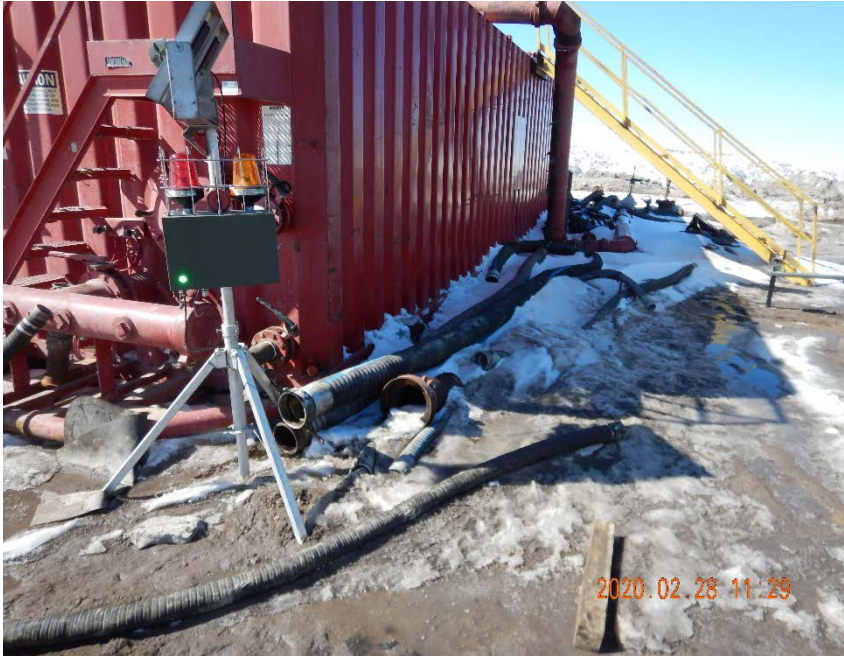
Photo #37 – Equipment storage and wood debris on north side of frac tanks that were being stored in southwest corner of pad on inspection date.

Note lack of earthen berm/secondary containment around frac tanks. Operator indicated via email that the tanks were inactive on inspection date.

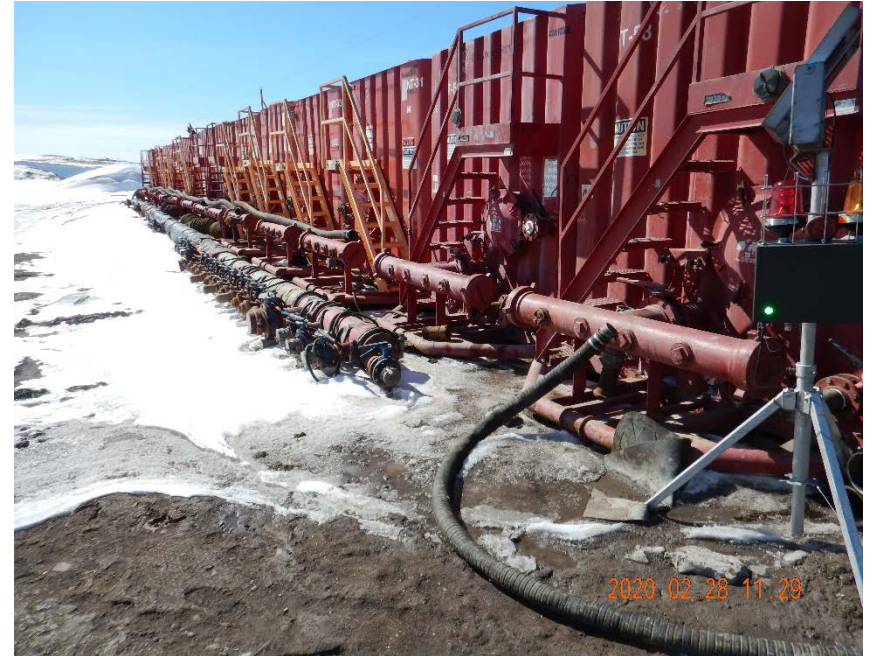
Photo #38 – View of frac tanks from northeast. Frac tanks lacked content labels and NFPA placards on inspection date.

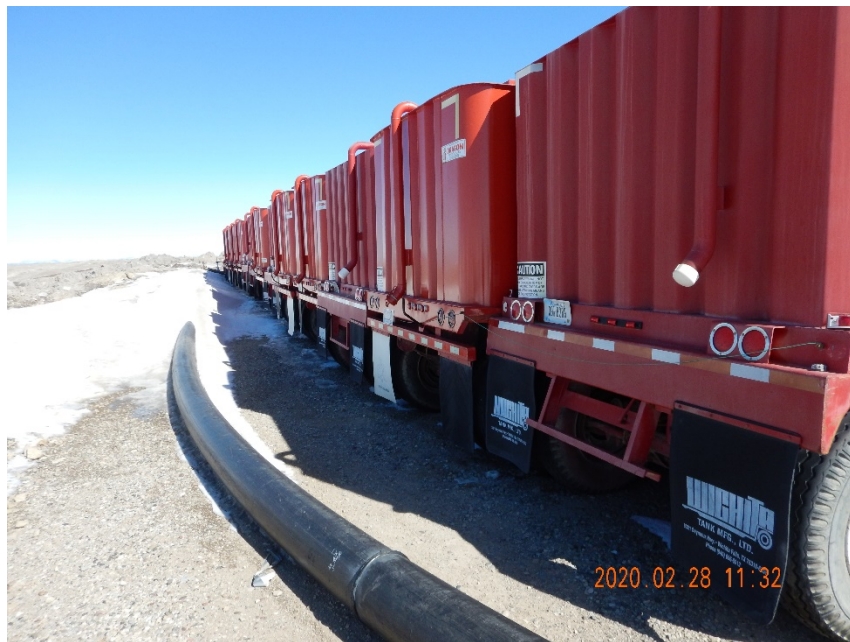
Photo #39 – View of frac tanks from southwest. Note absence of secondary containment device.
