Inspection Photos
Location Name: SG E34 496 Pad
Inspection Date: February 28, 2020

COLORADO
Oil & Gas Conservation
Commission
Department of Natural Resources

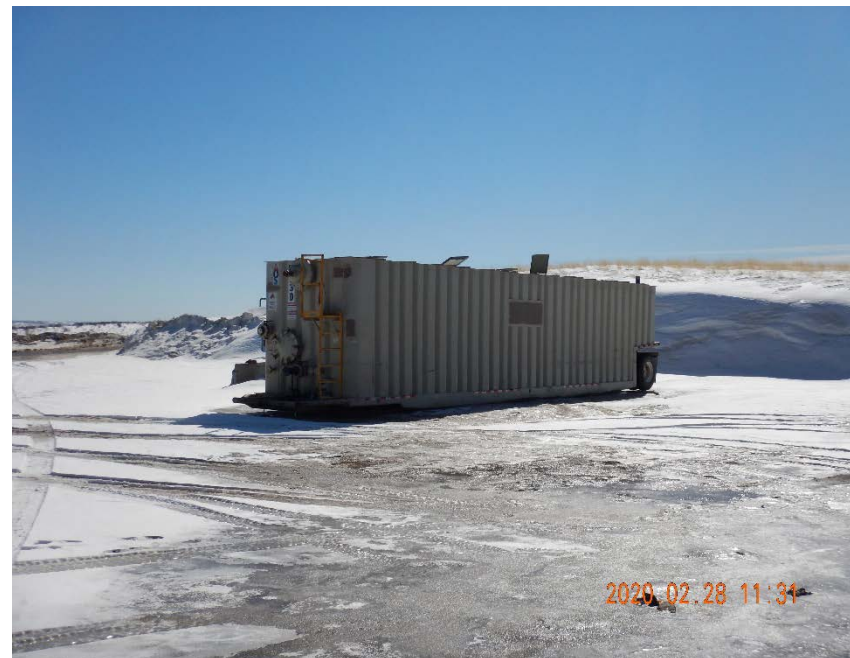
Photo #40 - Additional frac tank located on south side of pad also lacked secondary containment device on inspection date.

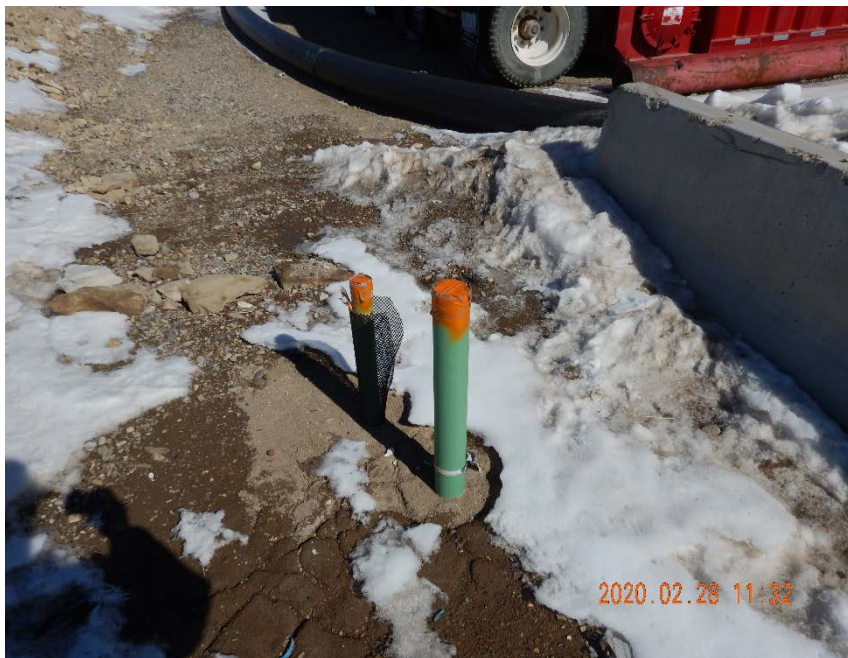
Photo #41 – Marked, uncapped flowline risers located southwest of frac tanks.

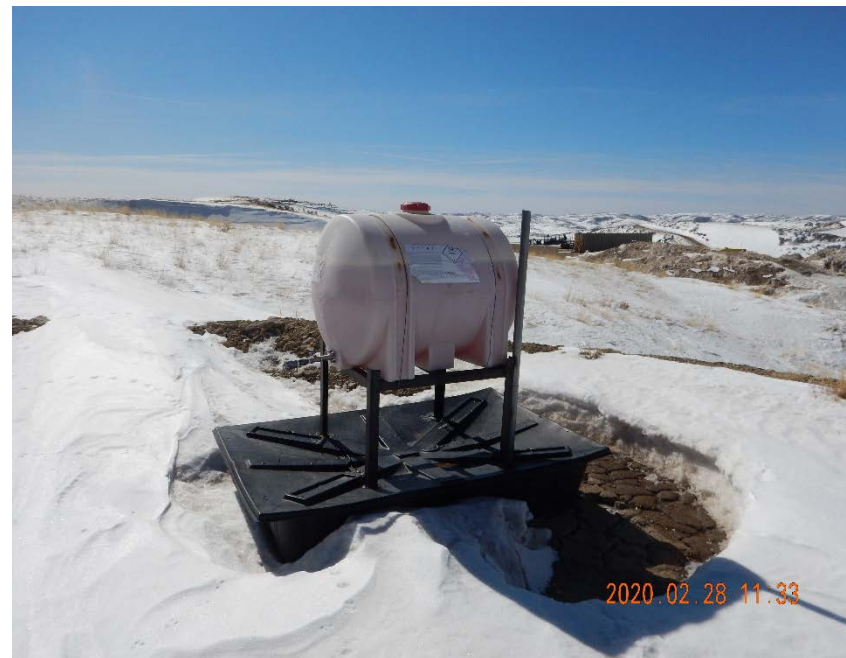
Photo #42 – Chemical storage day tank with secondary containment device located in southwest corner of pad. Note that tank label is faded and damaged.

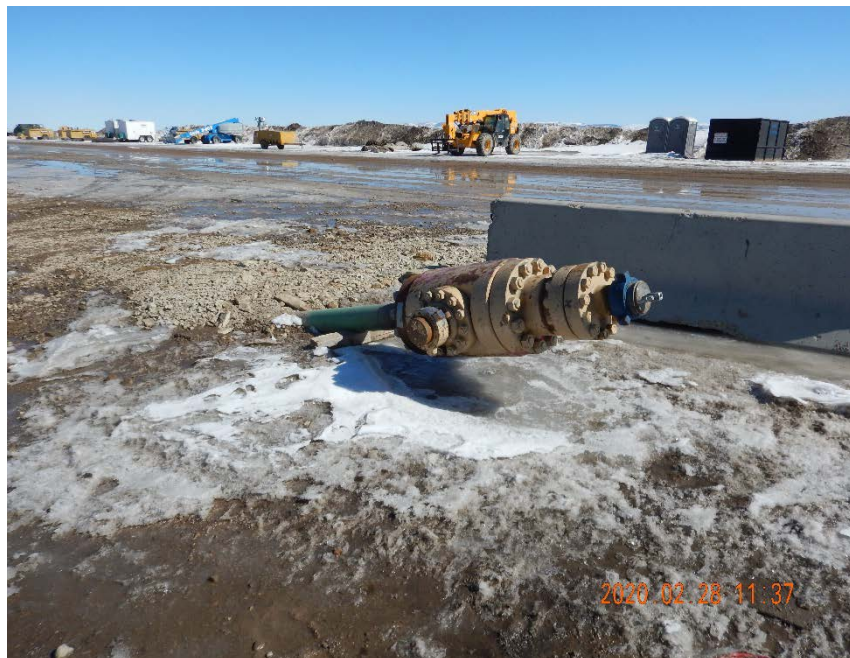
Photo #43 – Unmarked, angled flowline daylights southeast of wellheads.

COGCC suggests that operator should label and/or mark flowline to increase visibility.

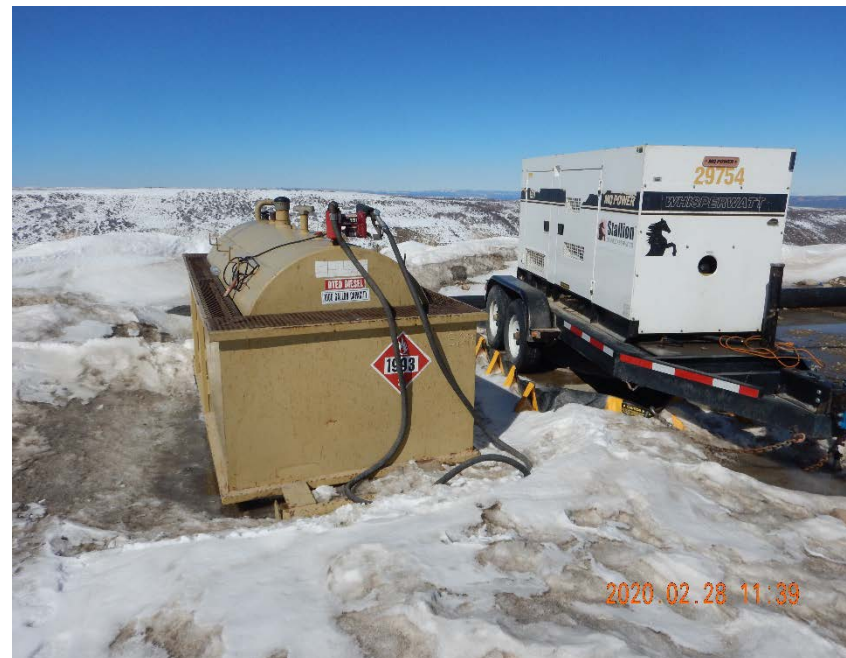
Photo #44 – 1000 gallon dyed diesel AST inside of secondary containment device located in northwest corner of pad along with generator.
