Inspection Photos
Operator: Williford Resources
API#: 067-06557
Date: 3/4/2020

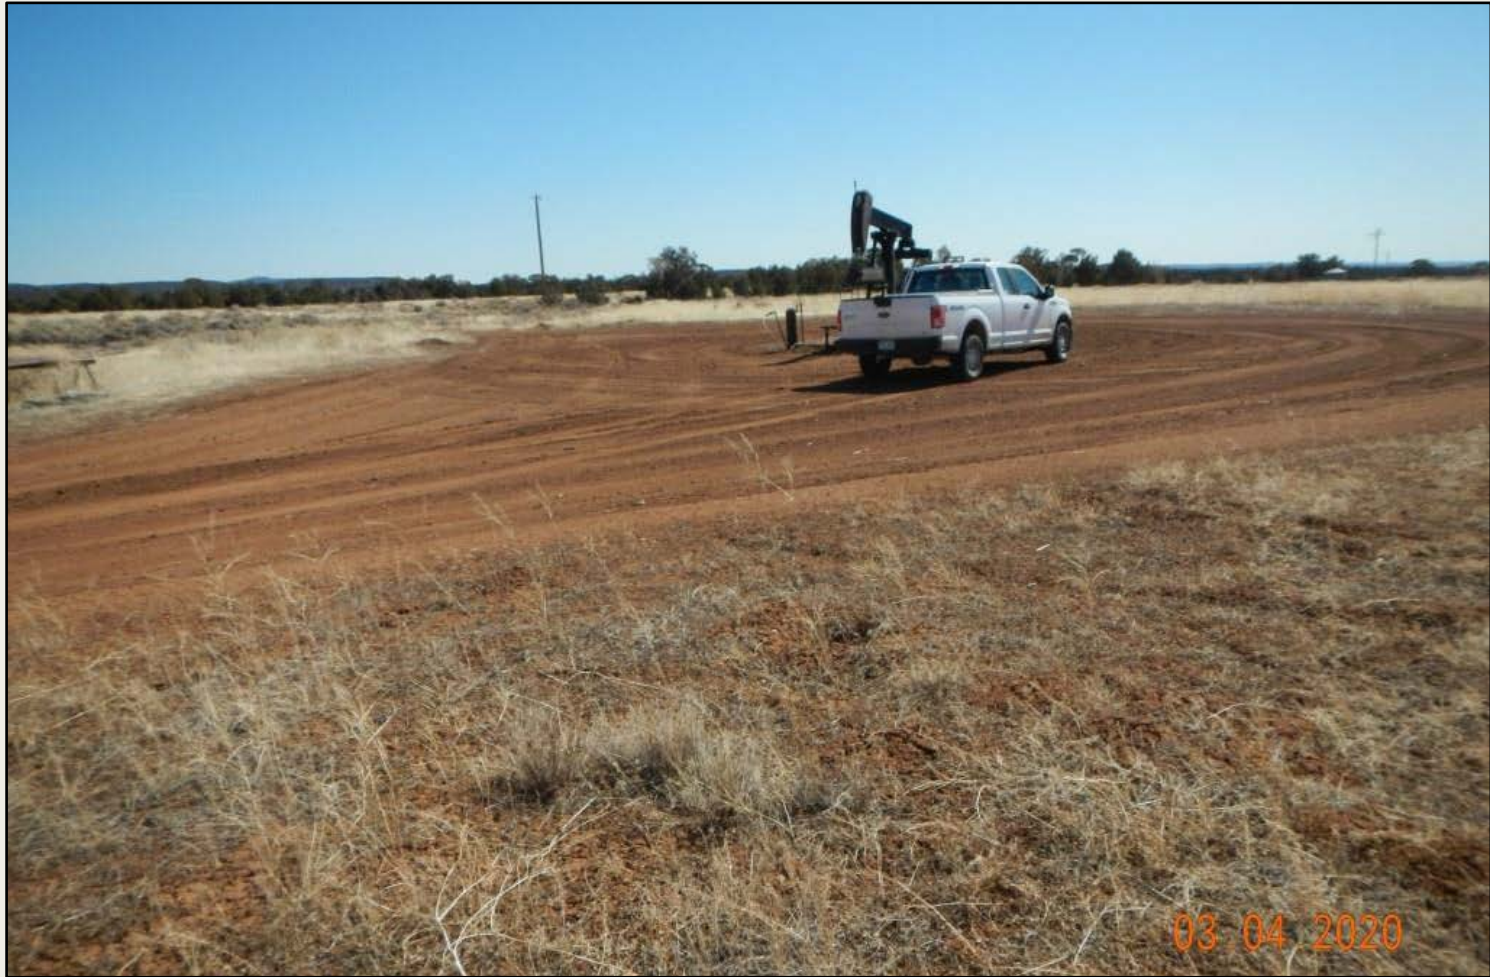
Photo 1. View of the project area from the northwestern corner facing center.

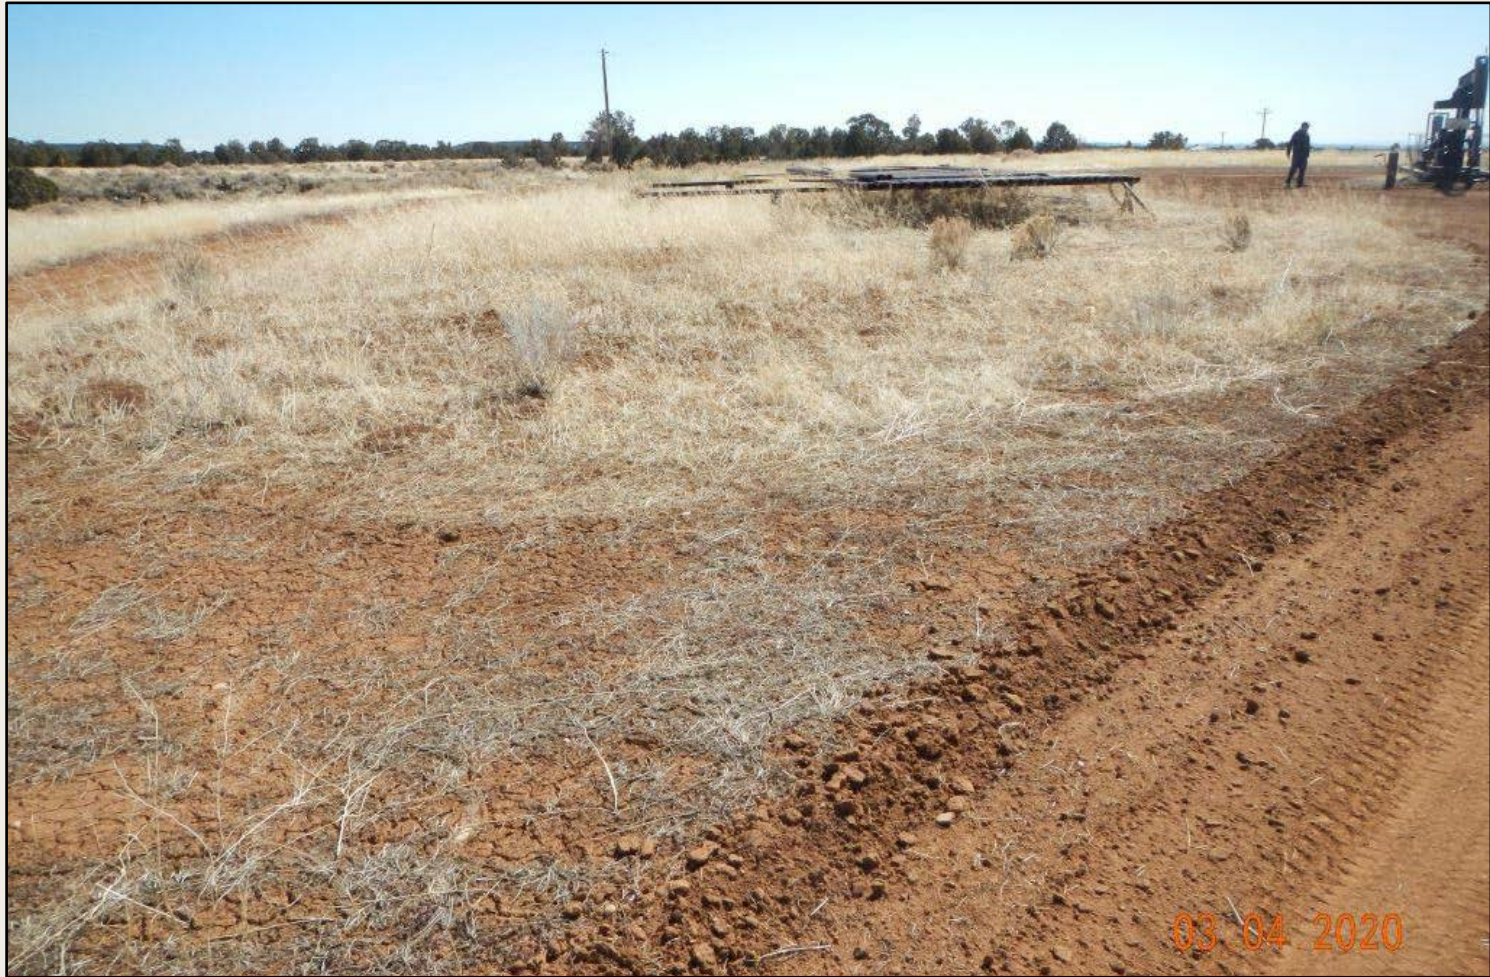
Photo 2. View of tubing stored within the central project area, needs to be removed.

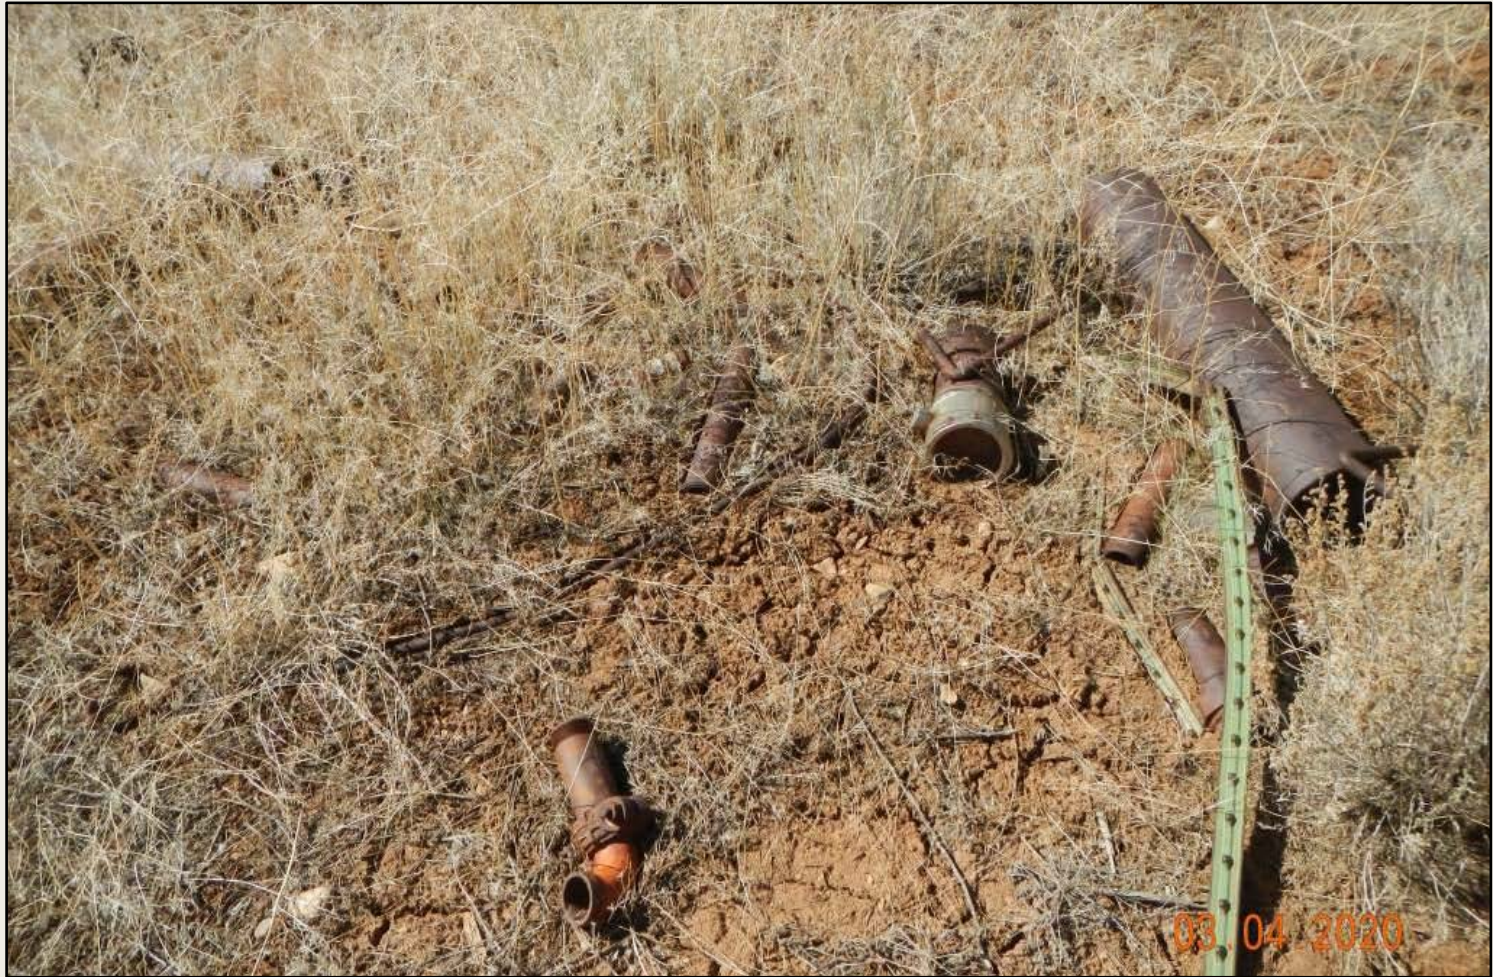
Photo 3. View of debris scattered around the outer edges of the project area.

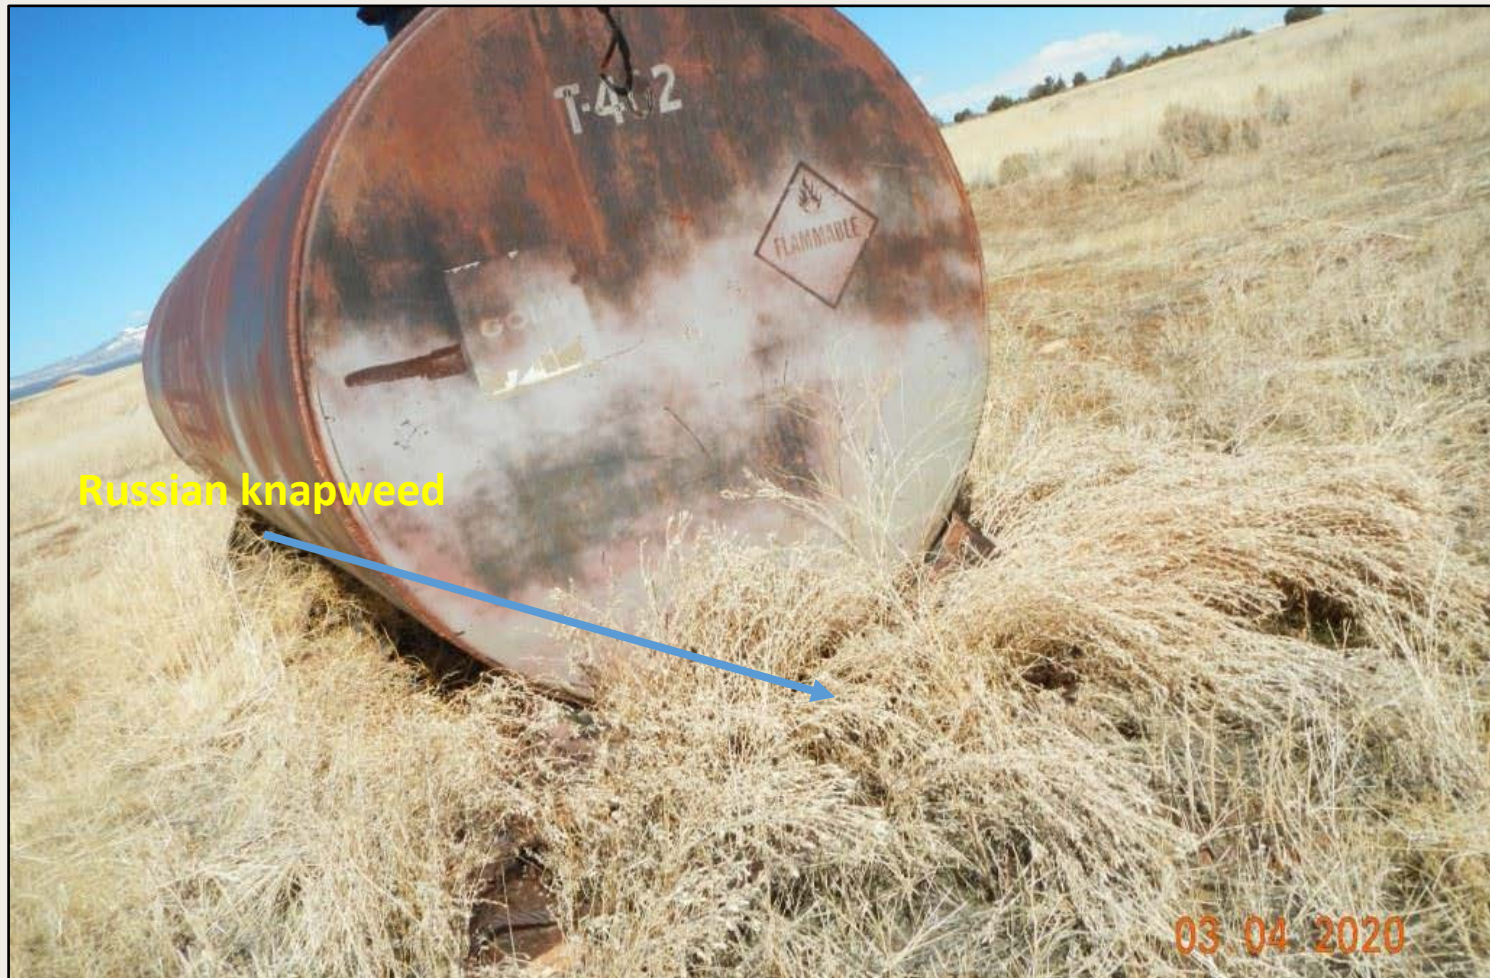
Photo 4. View of unused tank that needs to be removed and Russian knapweed that needs treatment northeast of the project area.

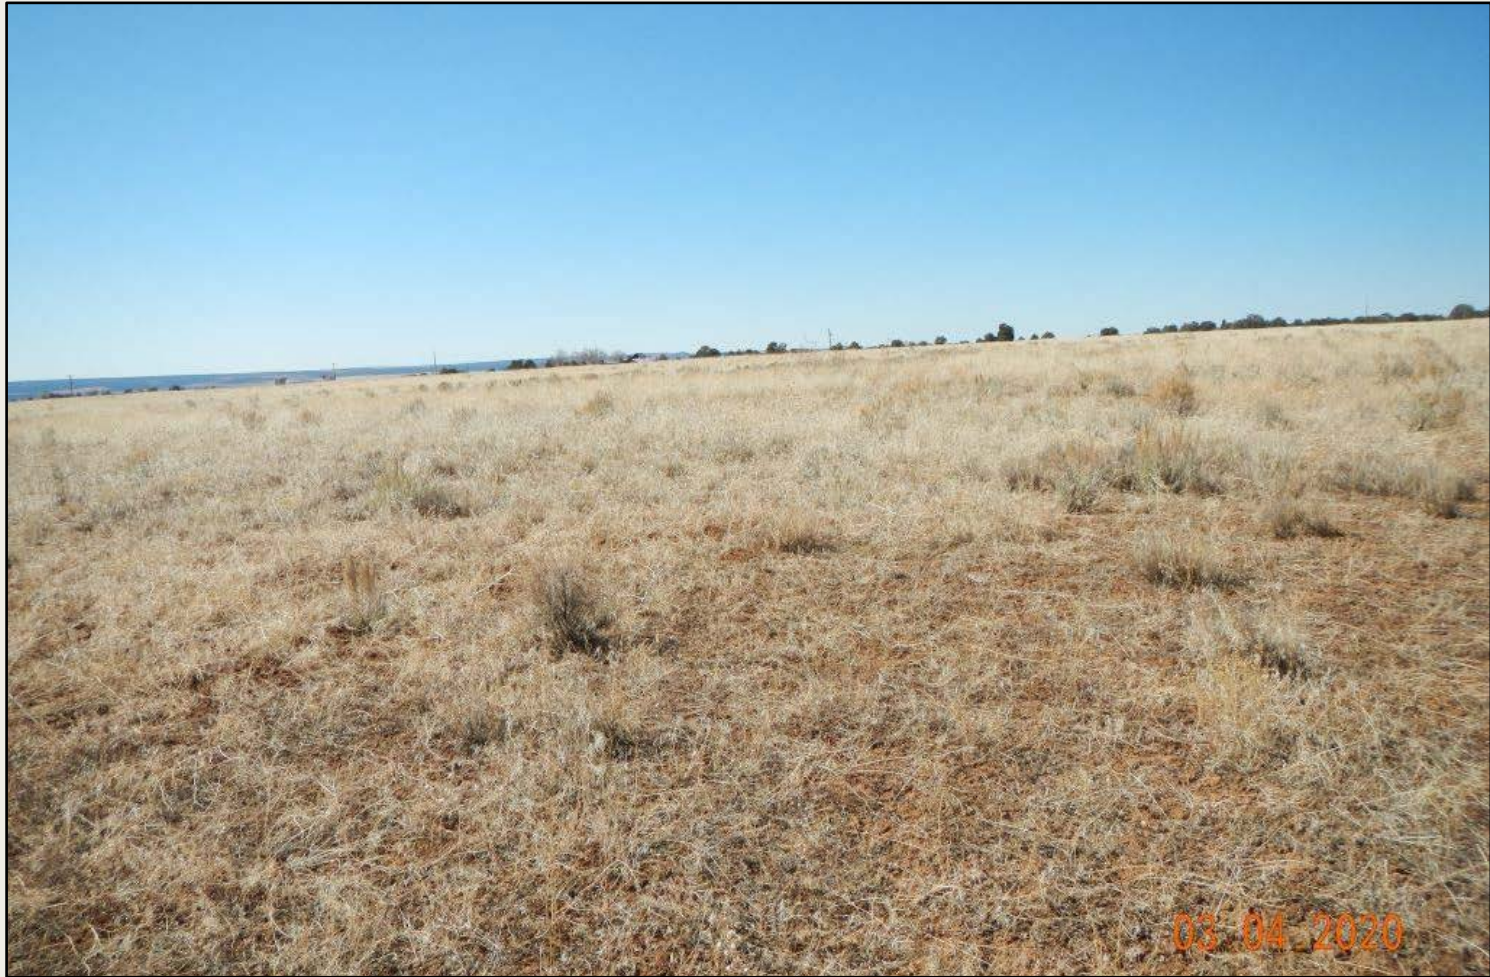
Photo 5. View of reference area vegetation west of the project area, largely comprised of sagebrush shrubland, in a dormant vegetative condition.
