Inspection Photos
Location Name: Ballantine 34-9 #32-2
API: 05-067-08075

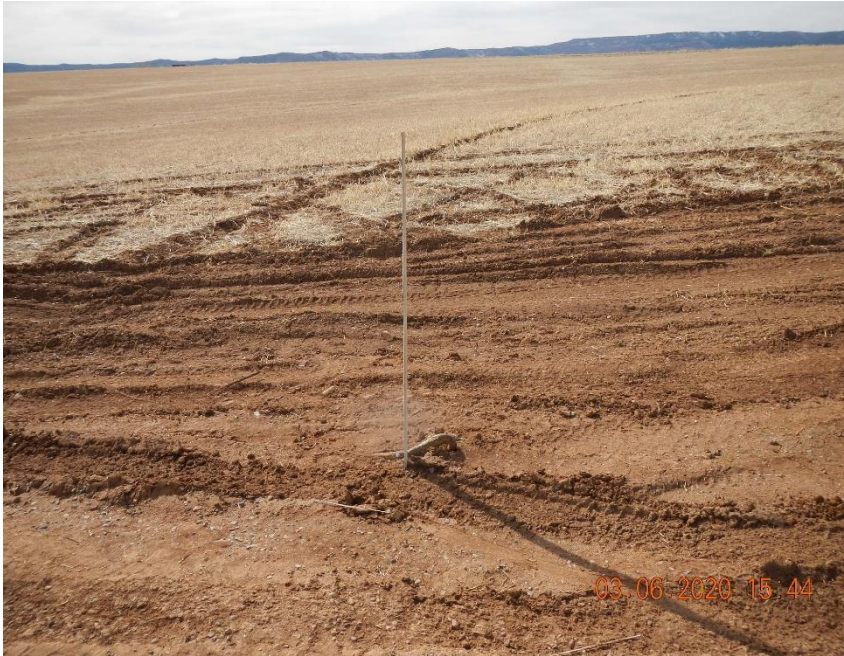
**Carsonite marker near rig anchor by entrance to location.
Corrective action from previous inspection.**

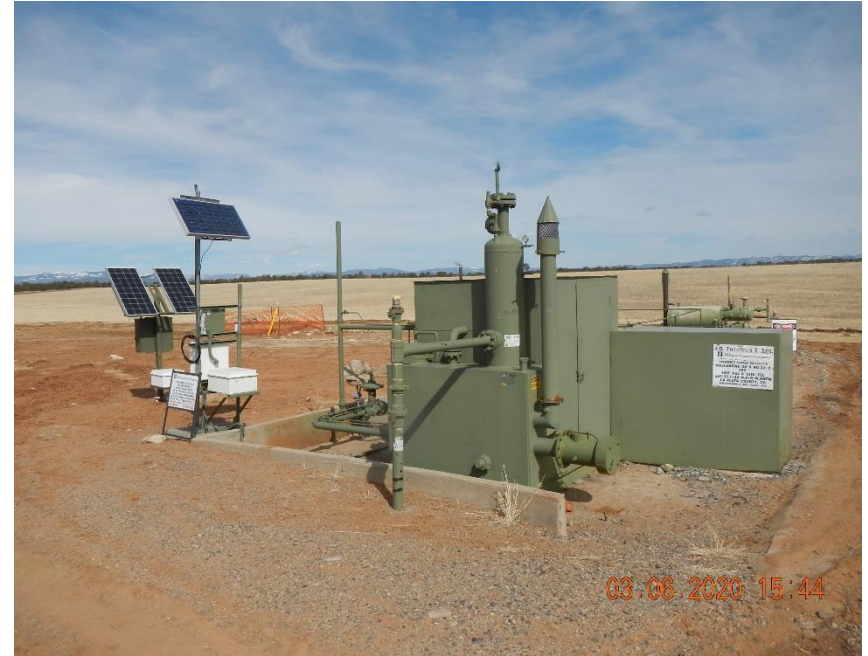
Ballantine 34-9 #32-2 production equipment.

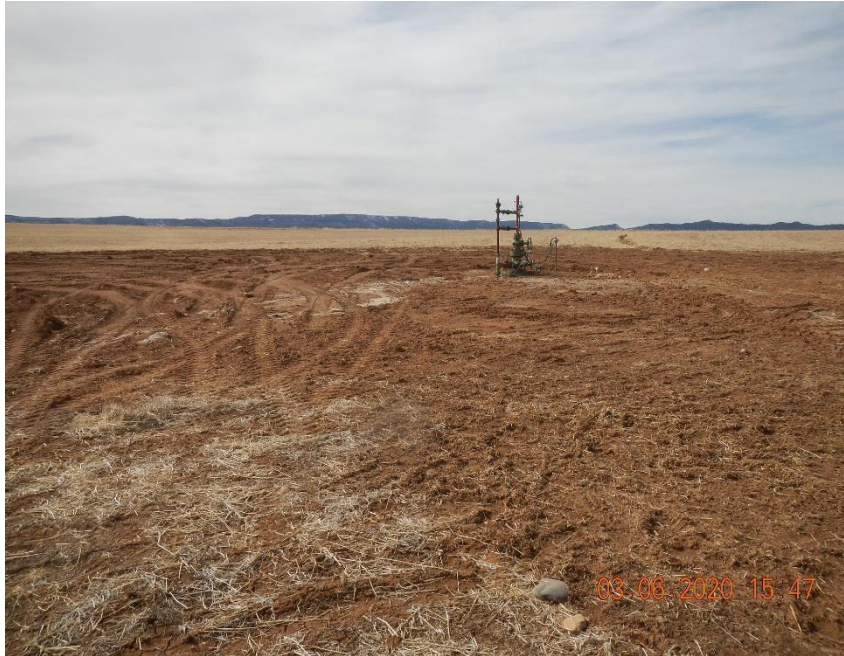
Ballantine 34-9 #32-2 well head. Photo taken from near PA Red Willow well.

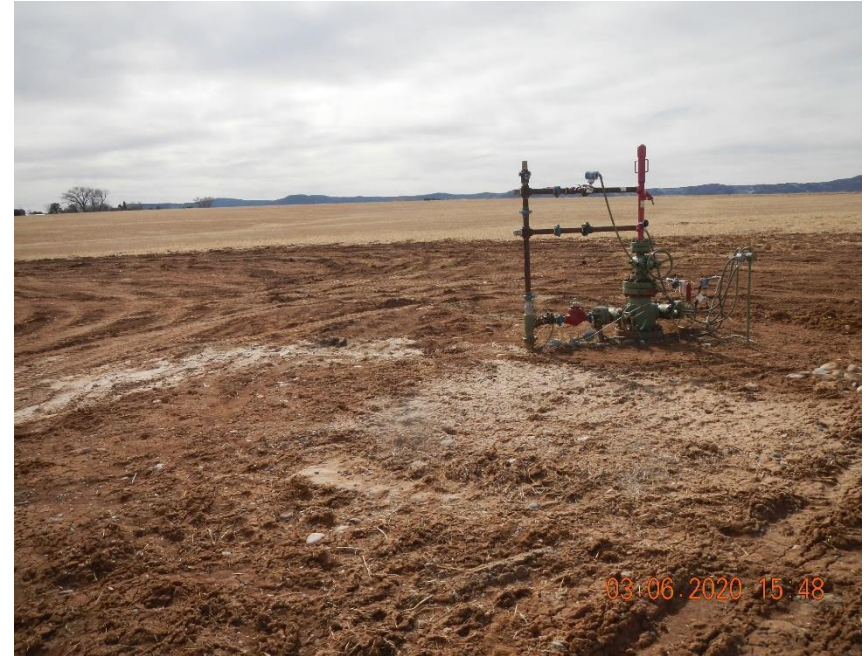
Discolored soil begins adjacent to Hilcorp well.

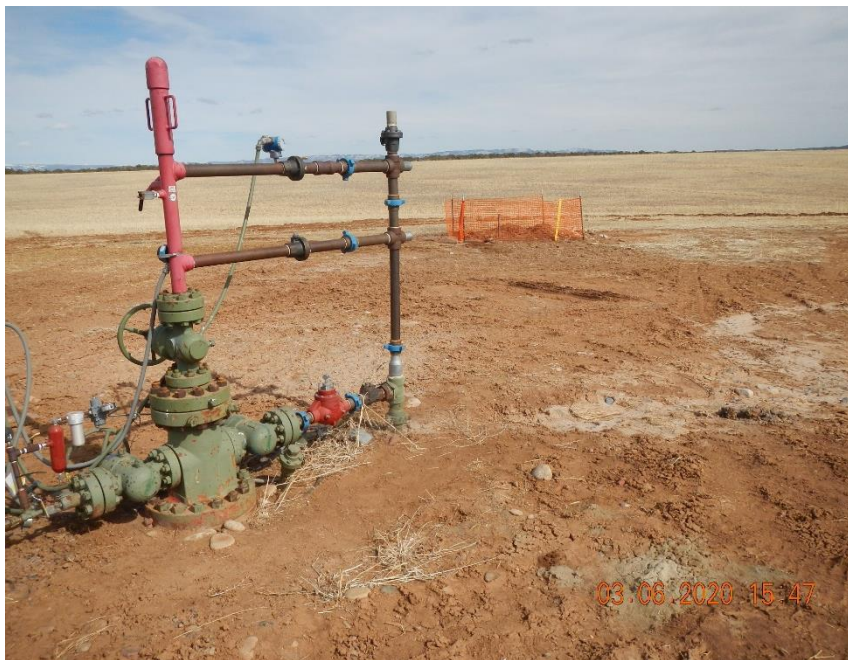
Ballantine 34-9 #32-2 well head. Excavation for PA well in the background. Hilcorp well is uphill from Red Willow well head location.

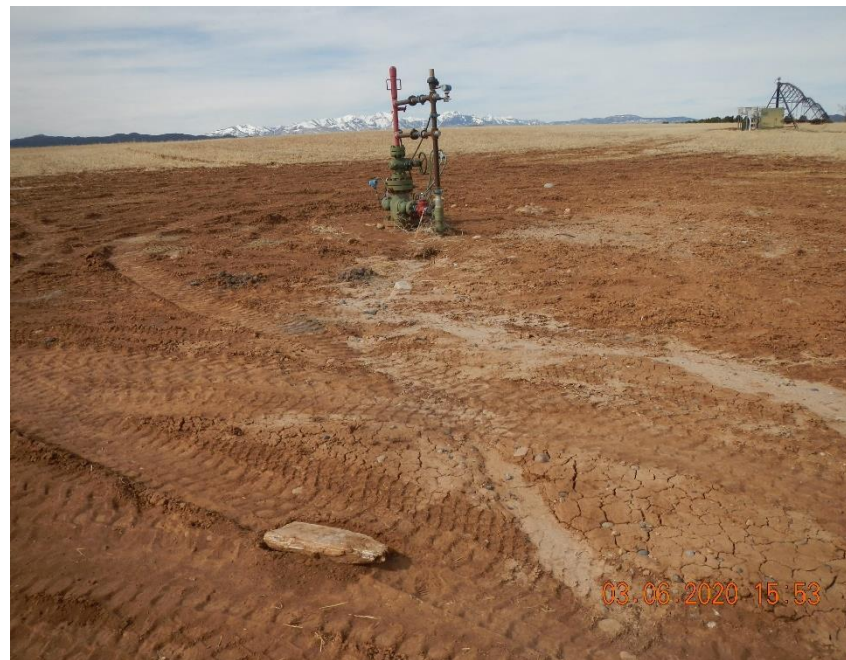
Drainage pattern with discolored soil extending SE from well head.
