Inspection Photos
Location Name: RWF 21-18
Location ID: 335569
Inspection Date: March 6, 2020

COLORADO
Oil & Gas Conservation
Commission
Department of Natural Resources

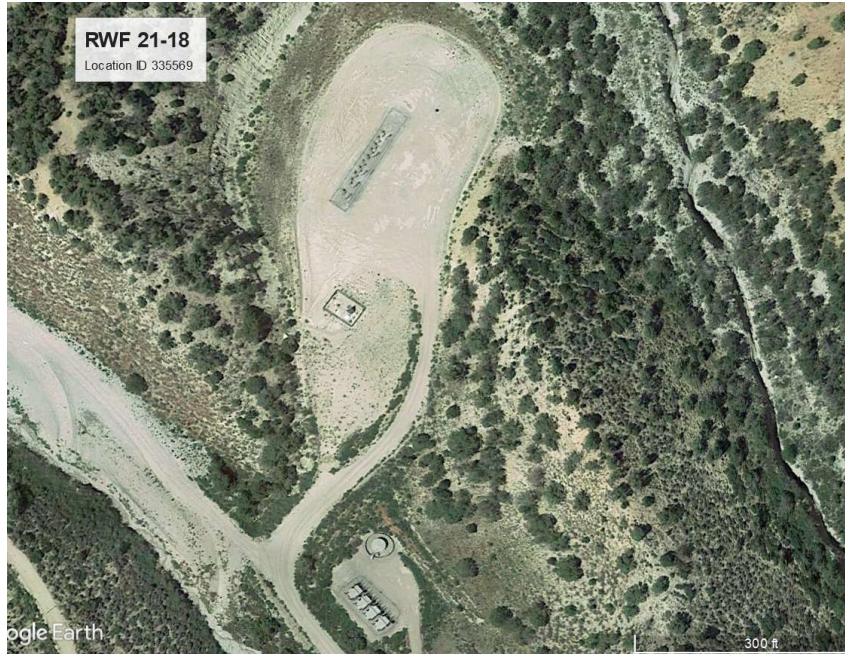
Aerial view of the location.

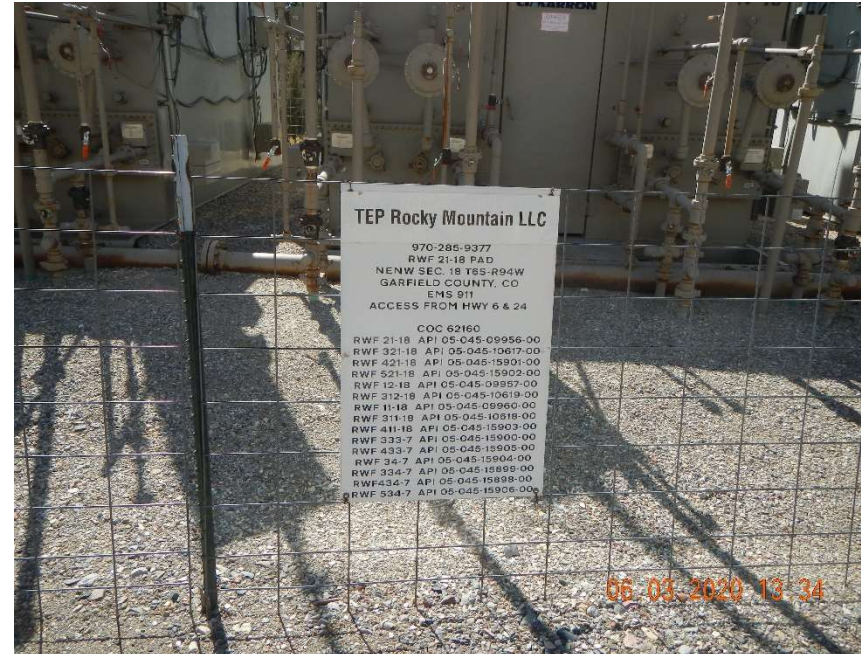
Location sign.

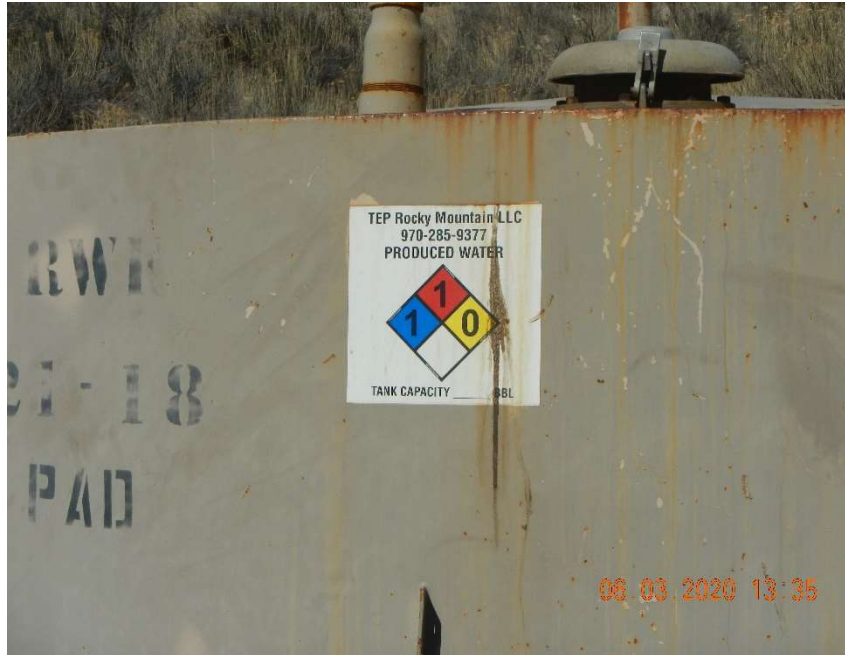
Produced Water steel AST missing capacity label.

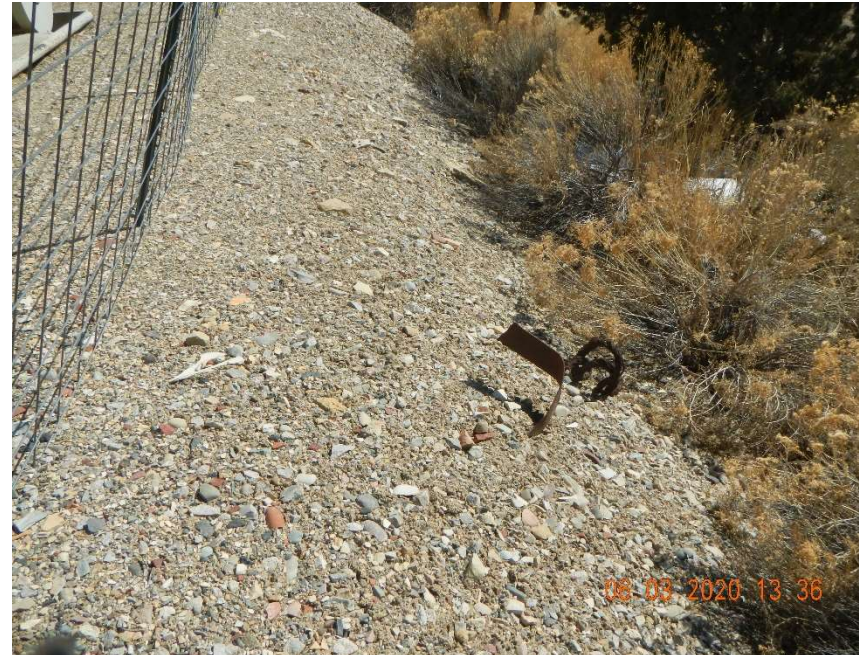
Trash and debris located around the separators.

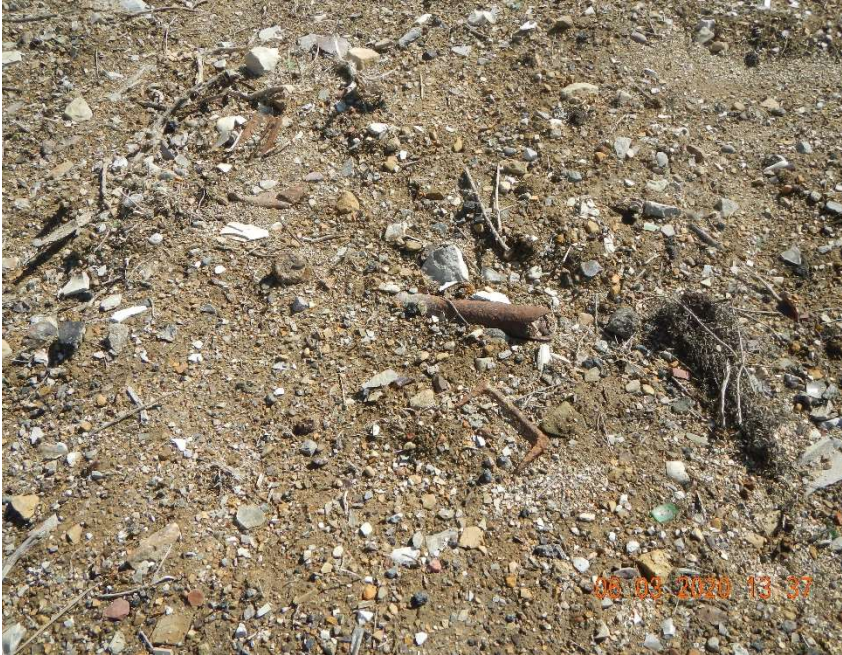
Trash and debris located around the separators.

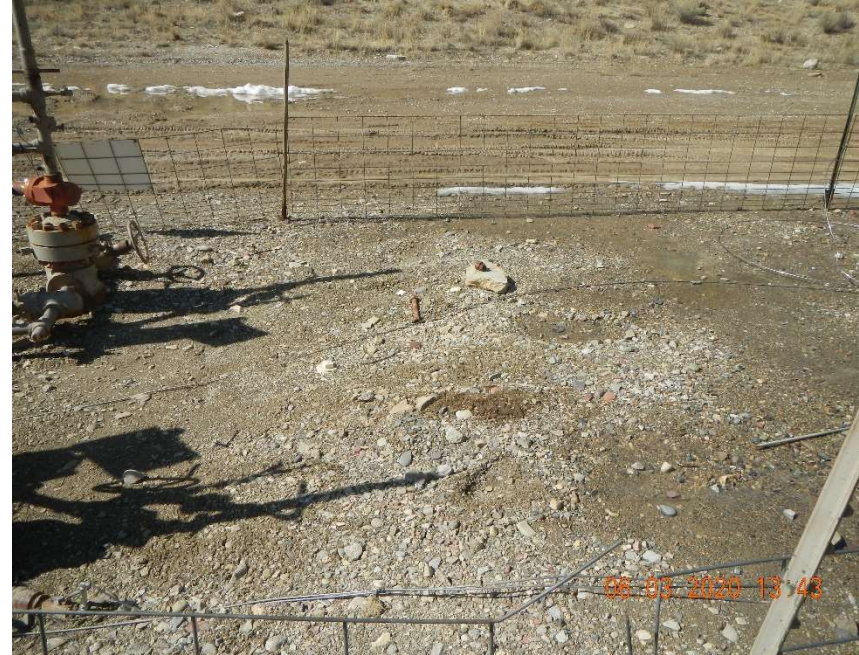
Trash and debris located around the wellheads.

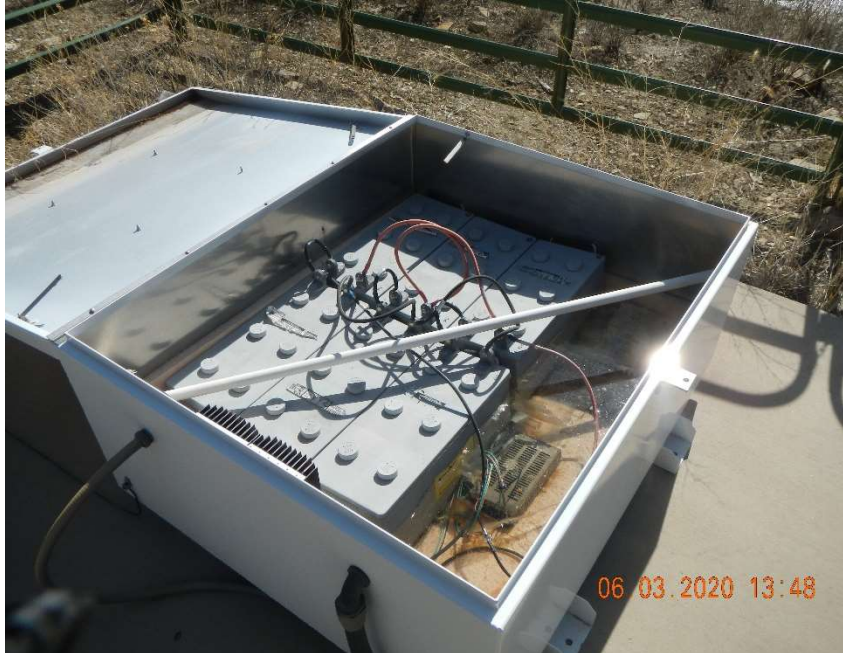
Unused equipment located on the southwest corner of the well pad.

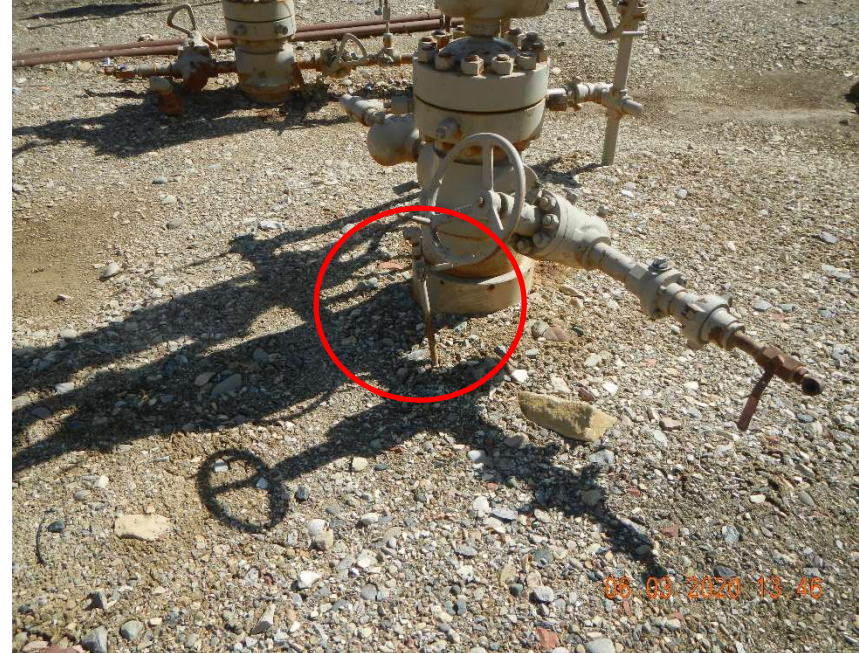
1-inch riser adjacent to RWF 312-18 wellhead.

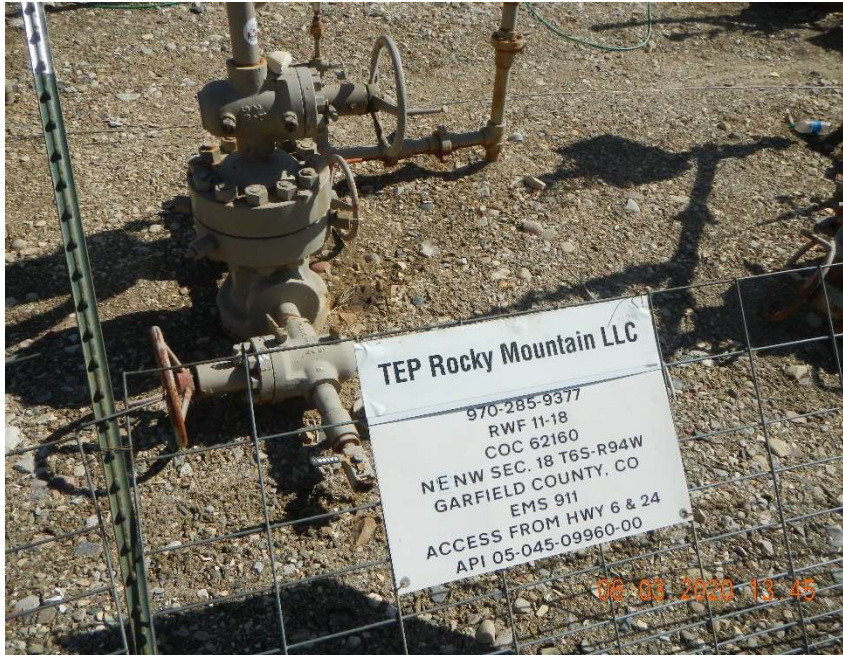
Localized accumulation of oily waste around wellhead.

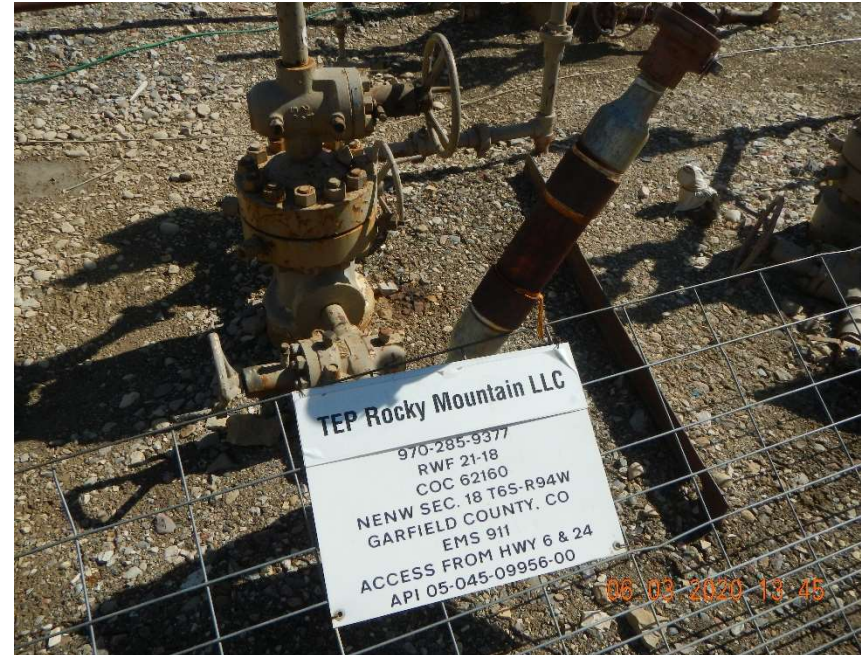
Localized accumulation of oily waste around wellhead.

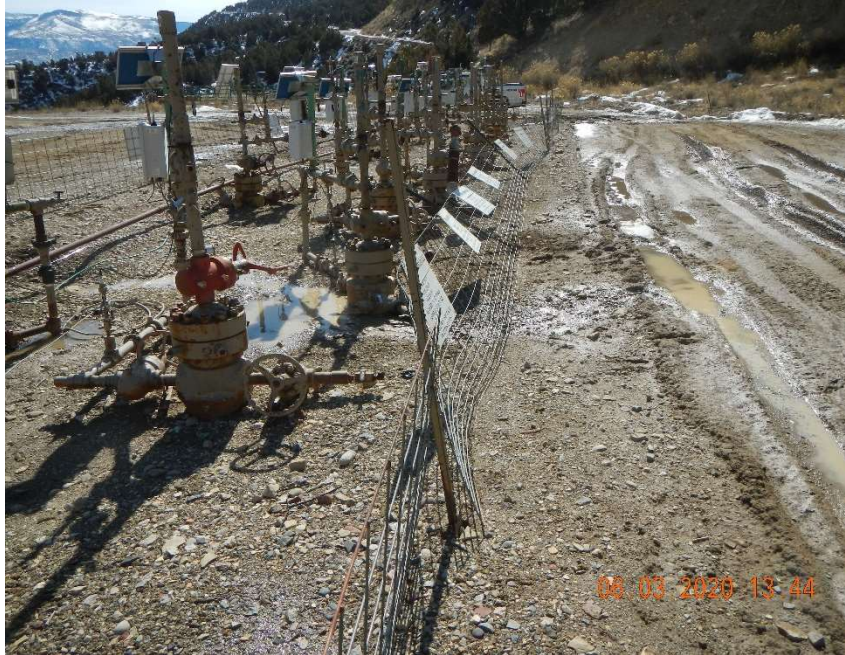
Wildlife fencing around wellheads in disrepair, vehicle tracking on location and fluids pooling around wellheads.

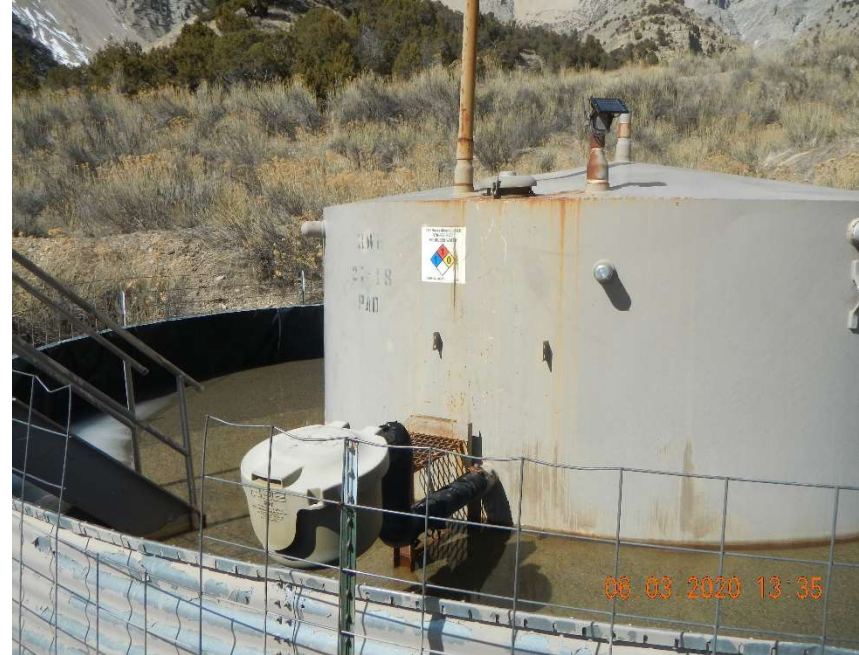
Localized accumulations of precipitation inside secondary containment area.

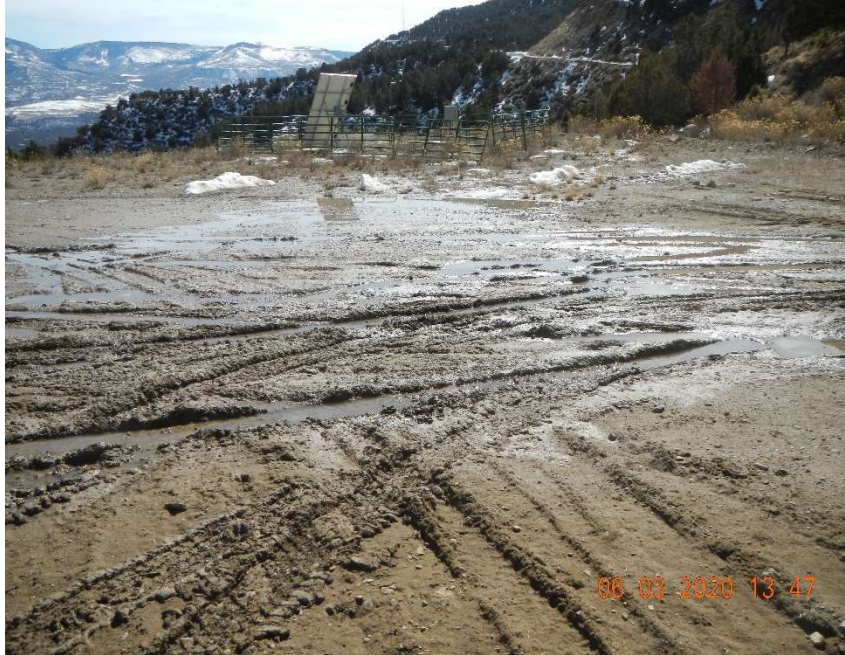
Vehicle tracking on location.

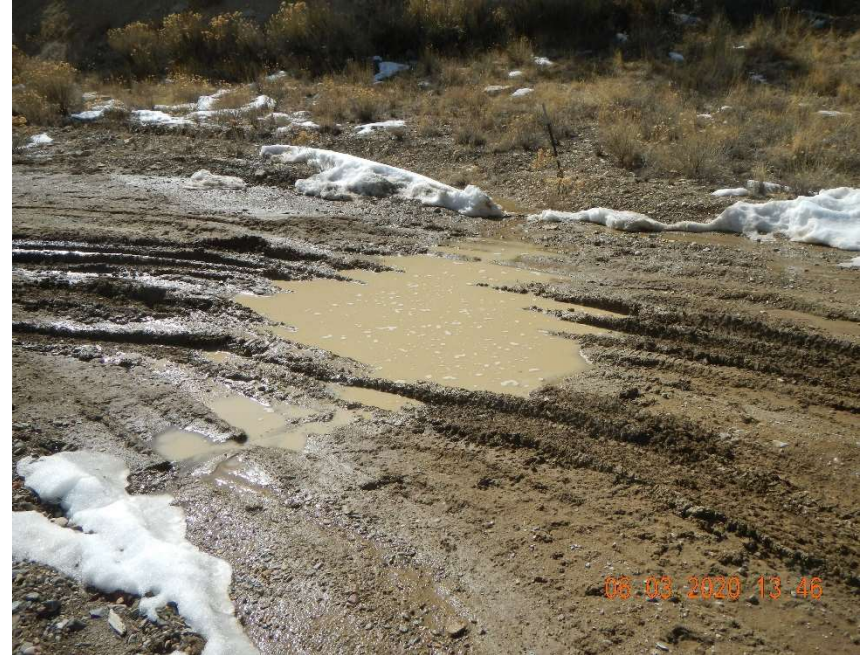
Vehicle tracking on location.
