Inspection Photos
Operator: BP America
API#: 067-05157
Date: 3/10/2020

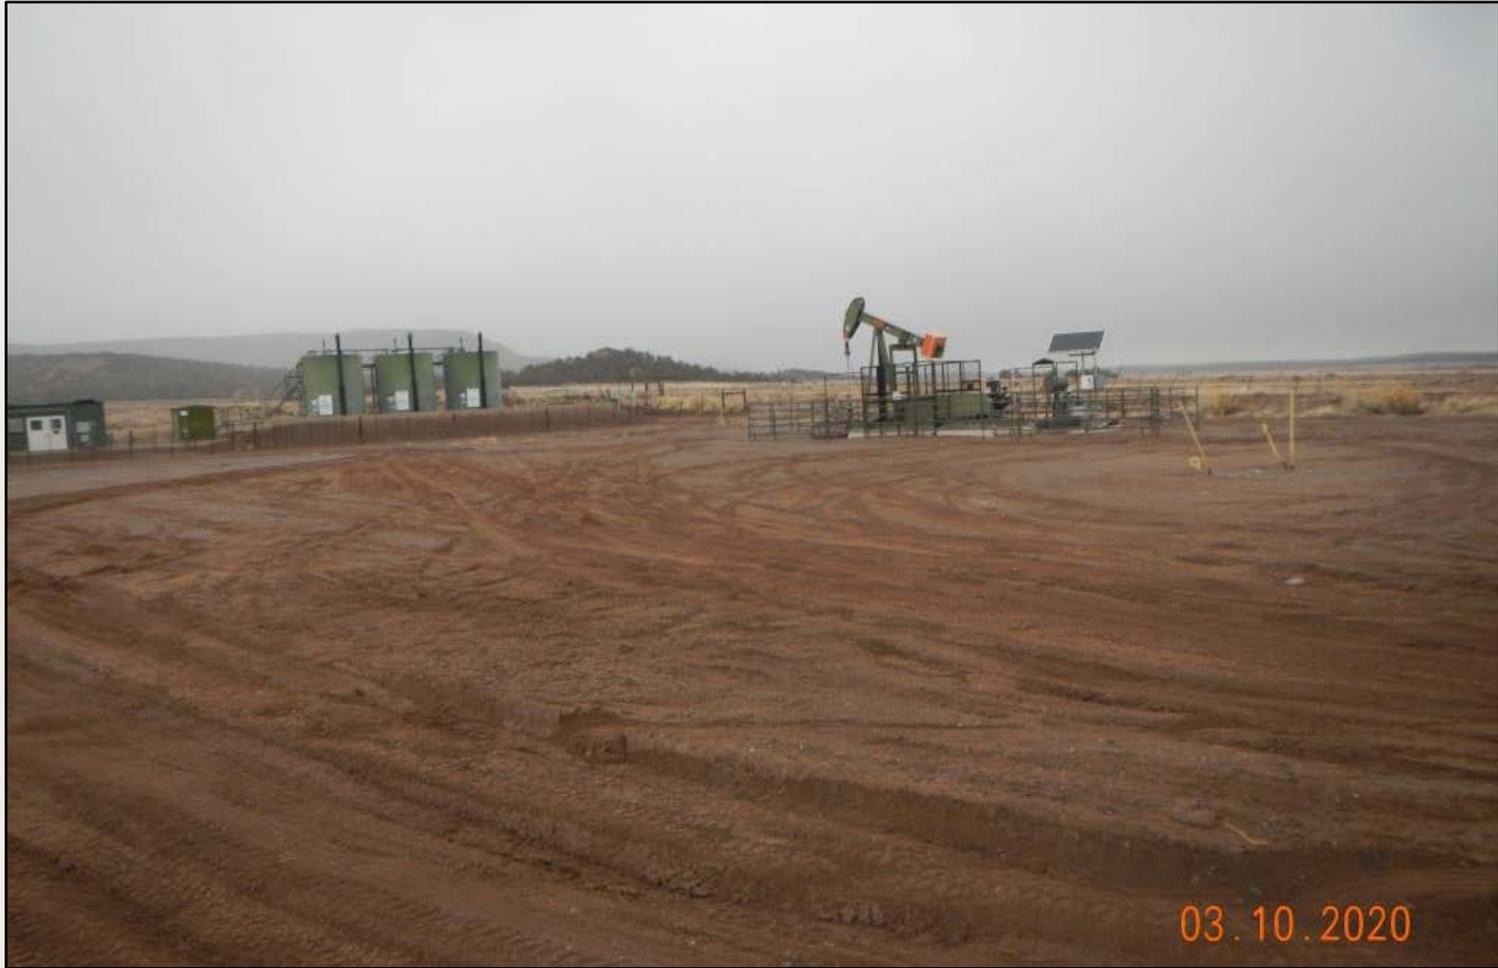
Photo 1. View of the project area from the well pad entrance facing center.

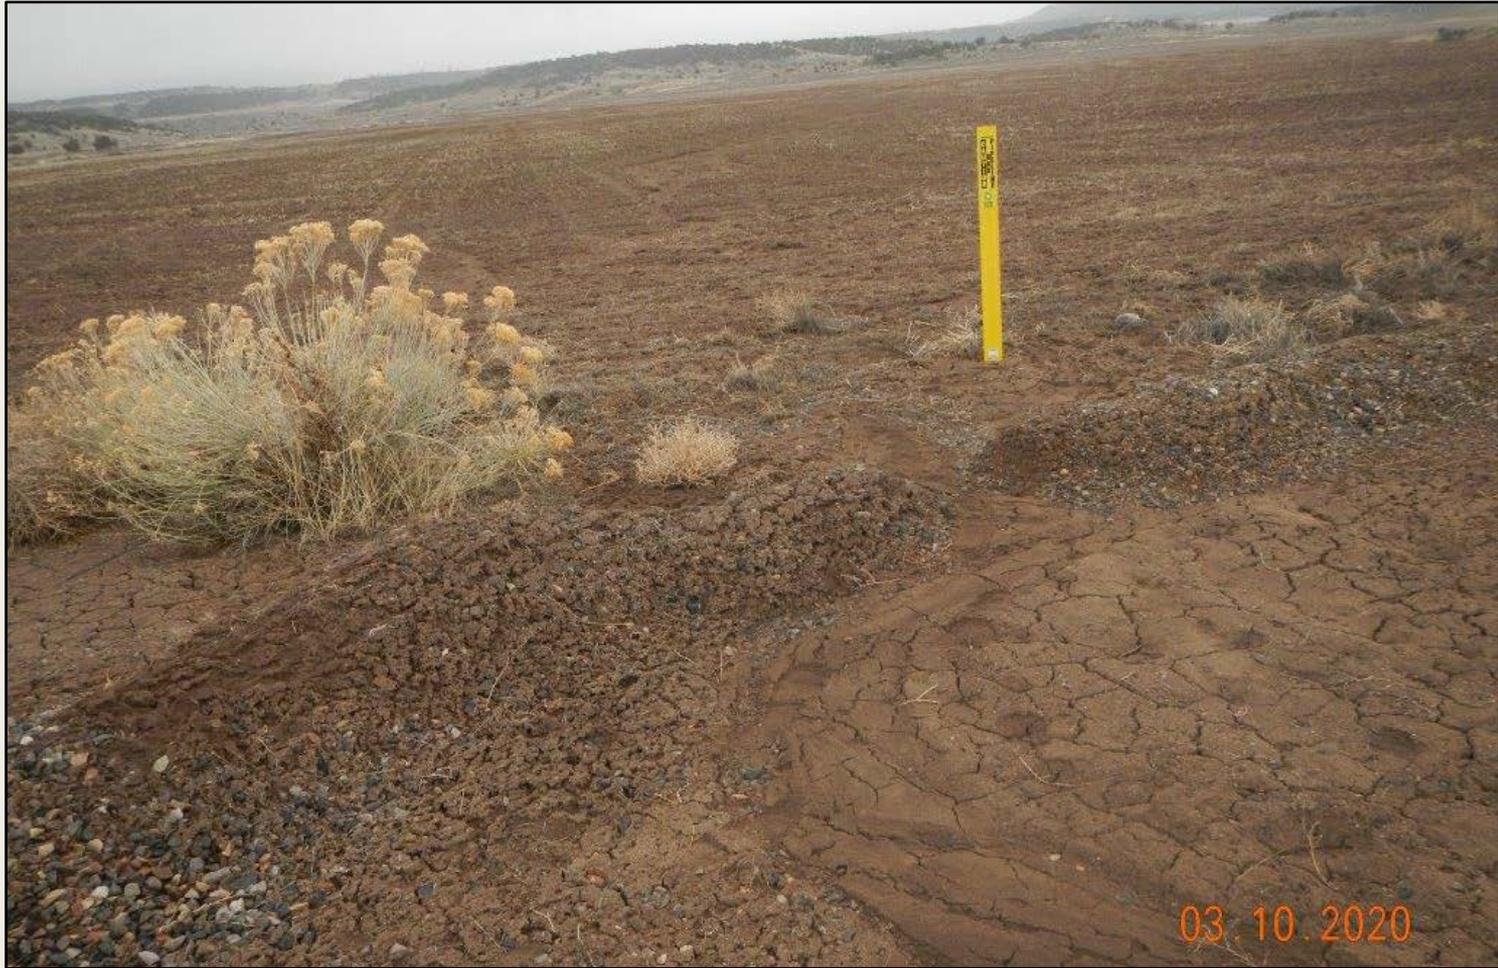
Photo 2. View of erosional channeling and failed berm within the southeastern project area.

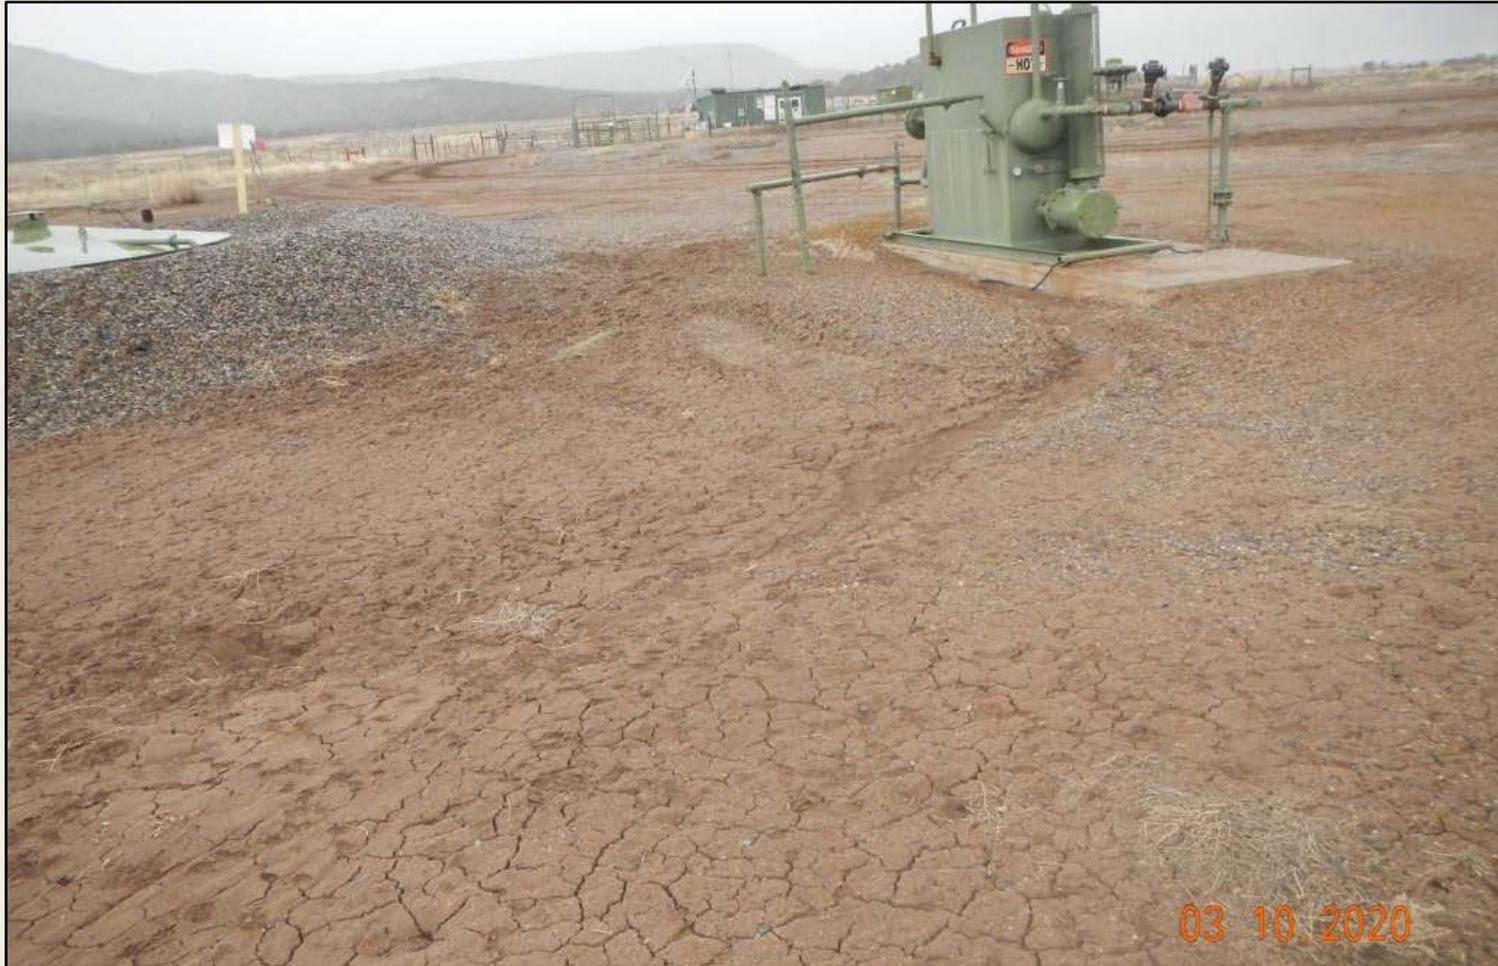
Photo 3. View of area where stormwater flows around facilities creating erosive channel.

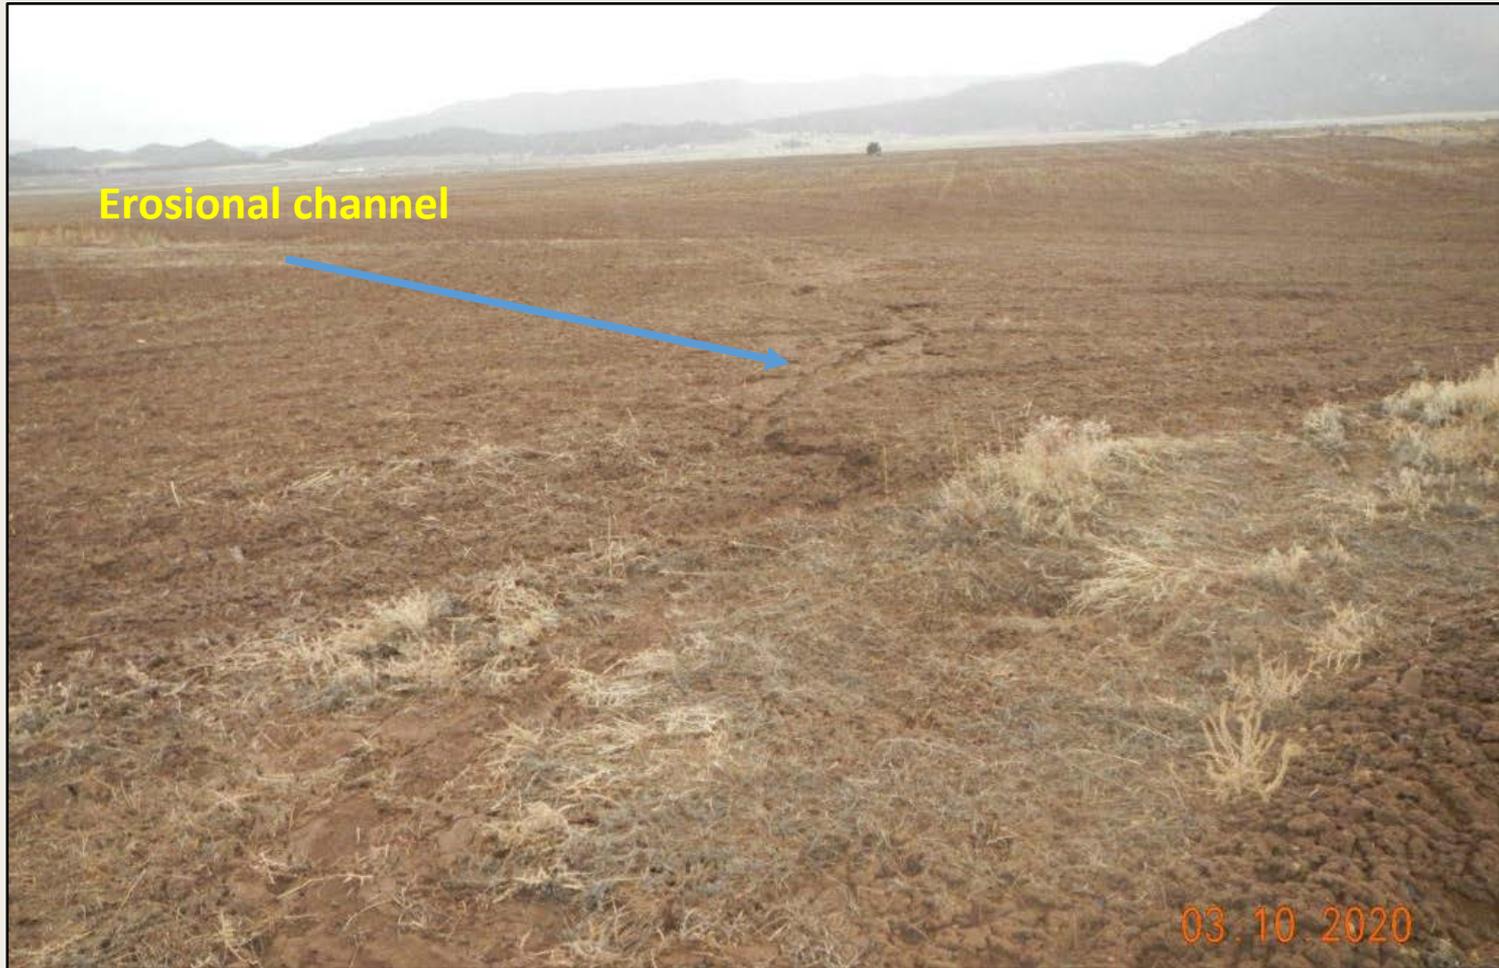
Photo 4. View of another erosional channel flowing southeast, off of the project area into adjacent crop field (reference area) not vegetated at this time.
