Inspection Photos
Operator: BP America
API#: 067-05115
Date: 3/10/2020

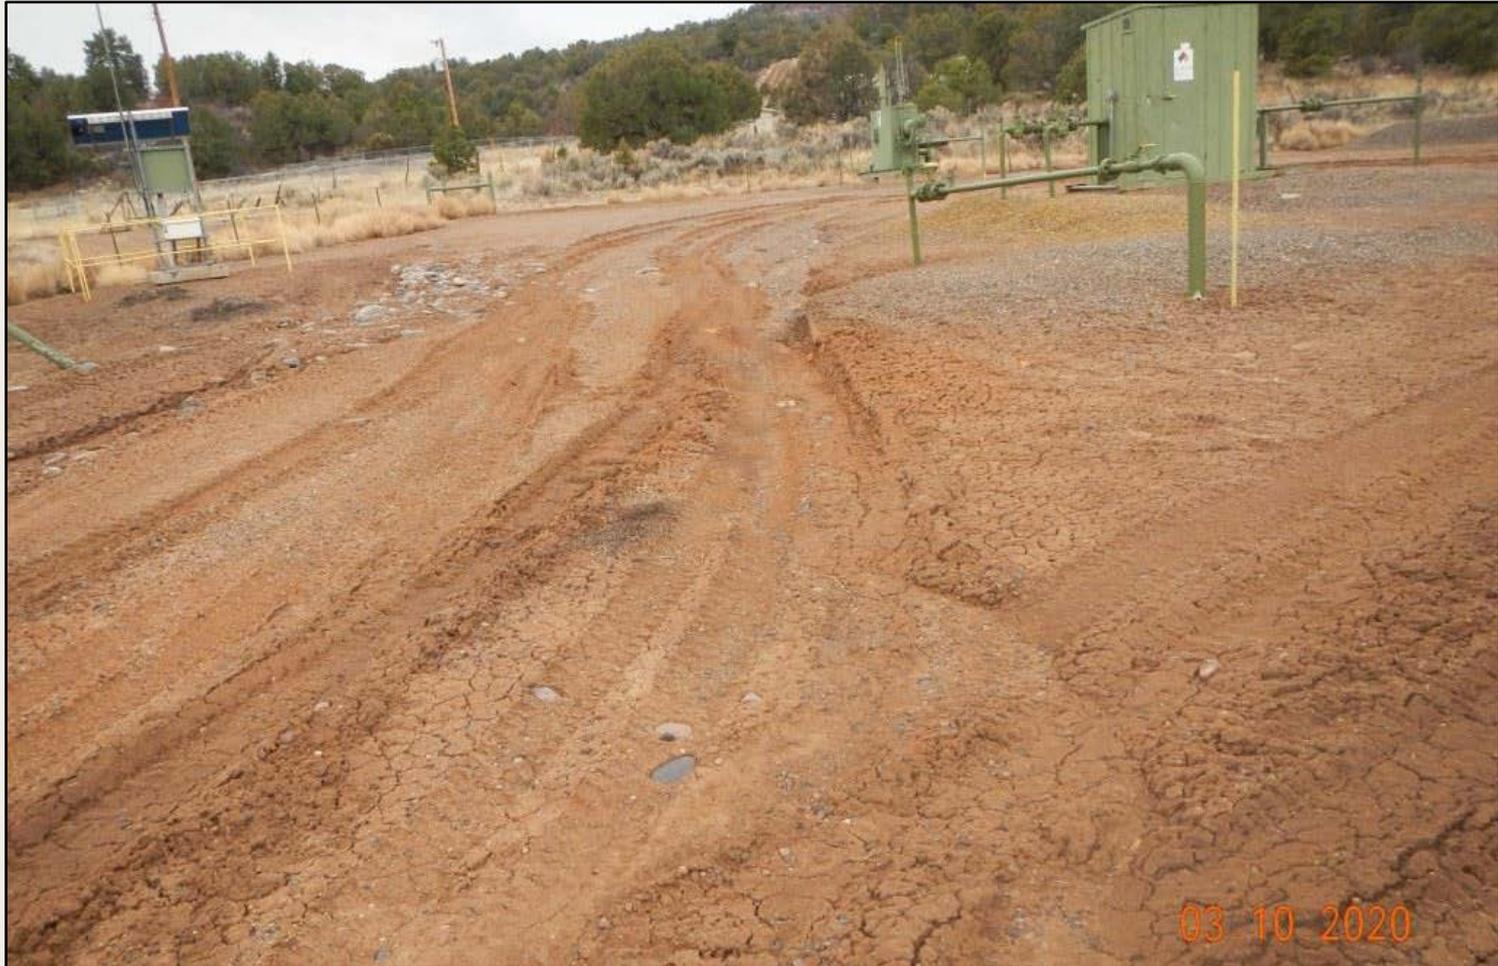
Photo 1. View of the southern project area from the southeastern entrance facing center.

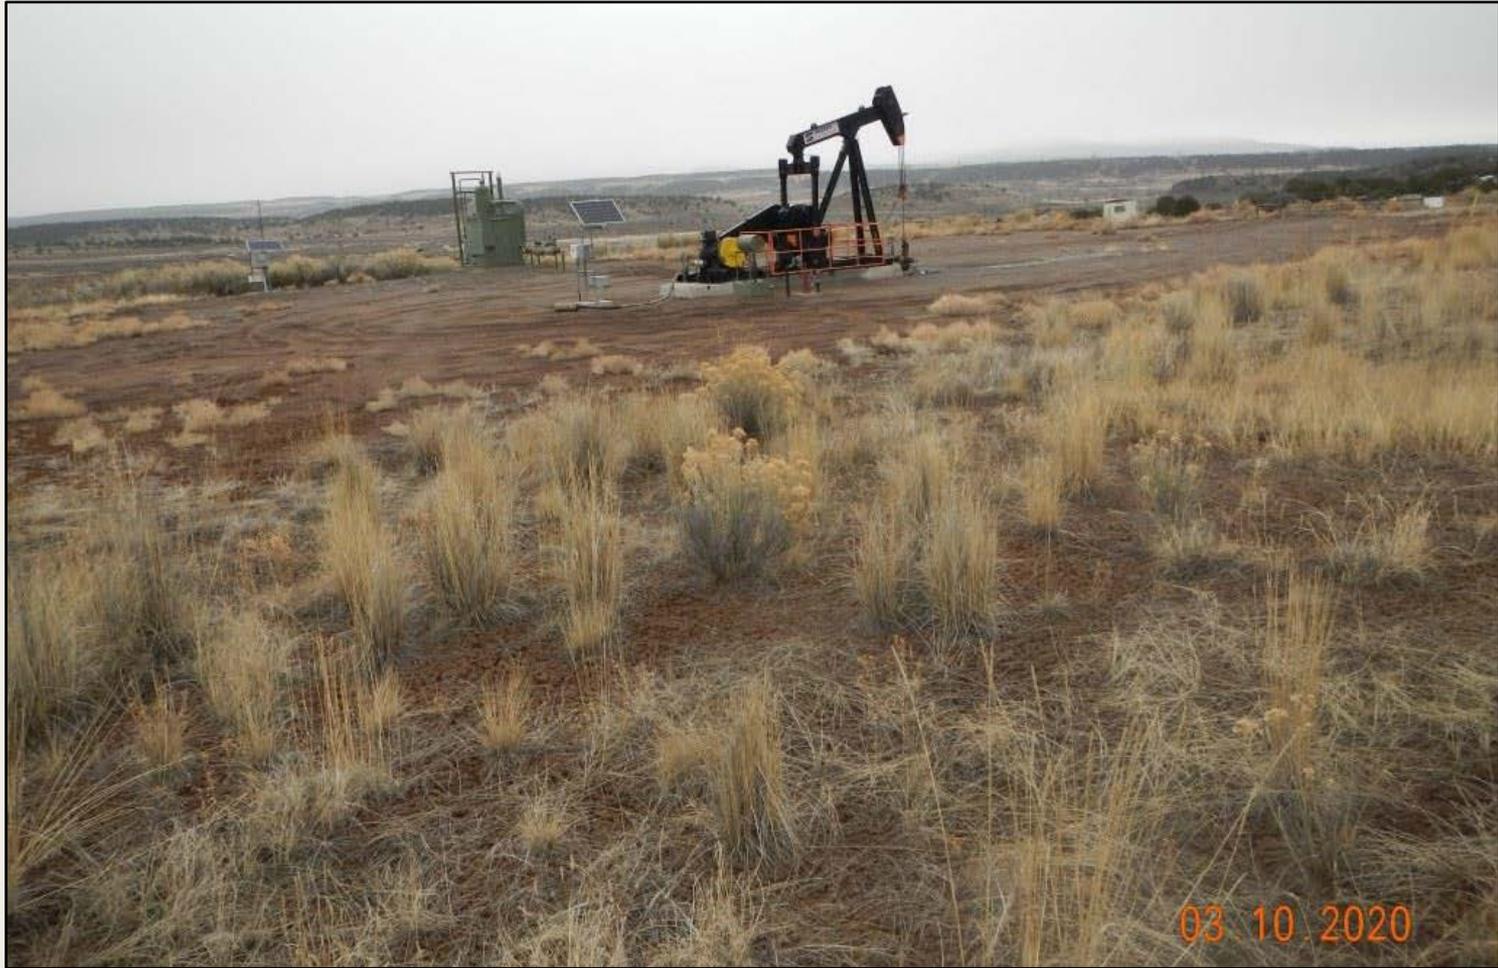
Photo 2. View of the northern project area from the western edge facing center.

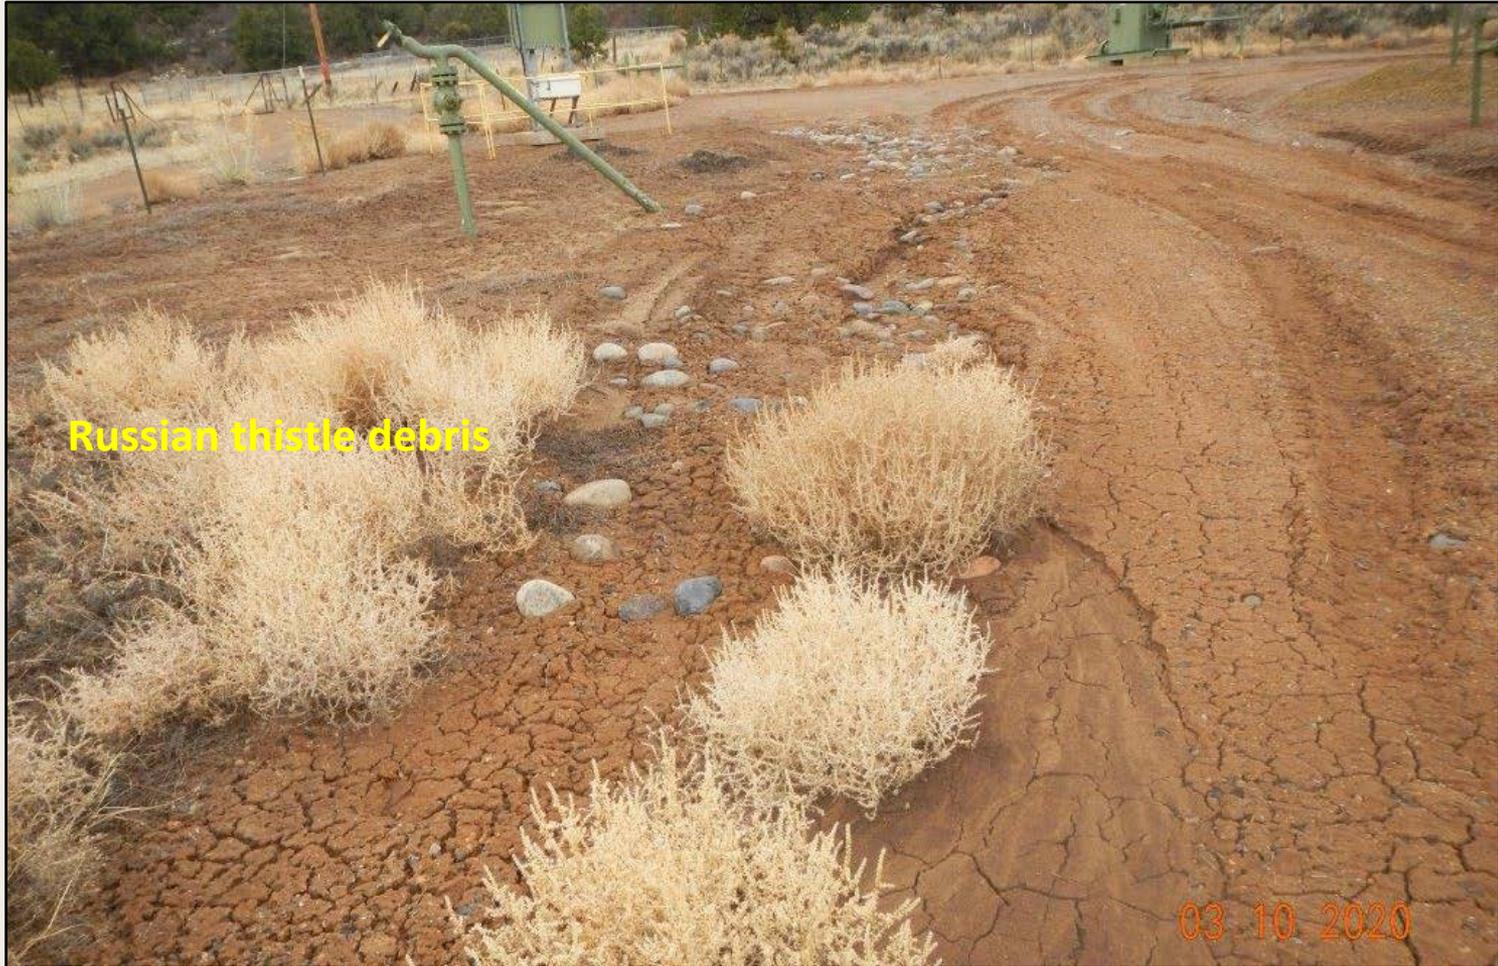
Photo 3. View of erosional rilling near flowing down the access road in the southeastern project area. Russian thistle debris needs to be removed.

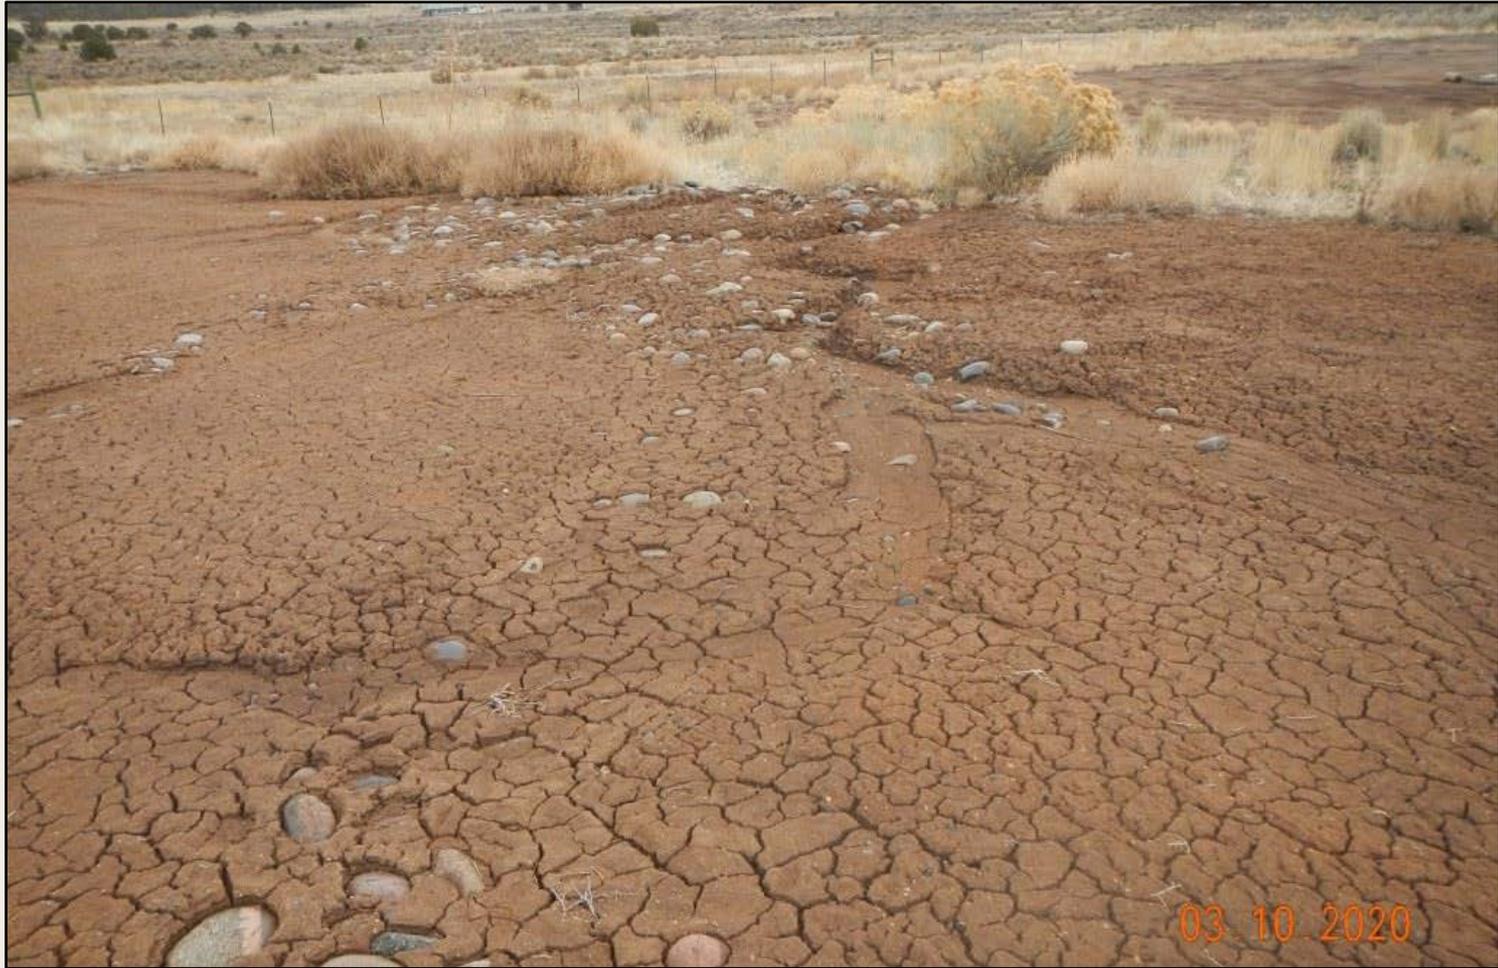
Photo 4. View of more erosional channeling running off the north end of the southern working area. Cobble placed within the project area is not functioning to stabilize erosion here.

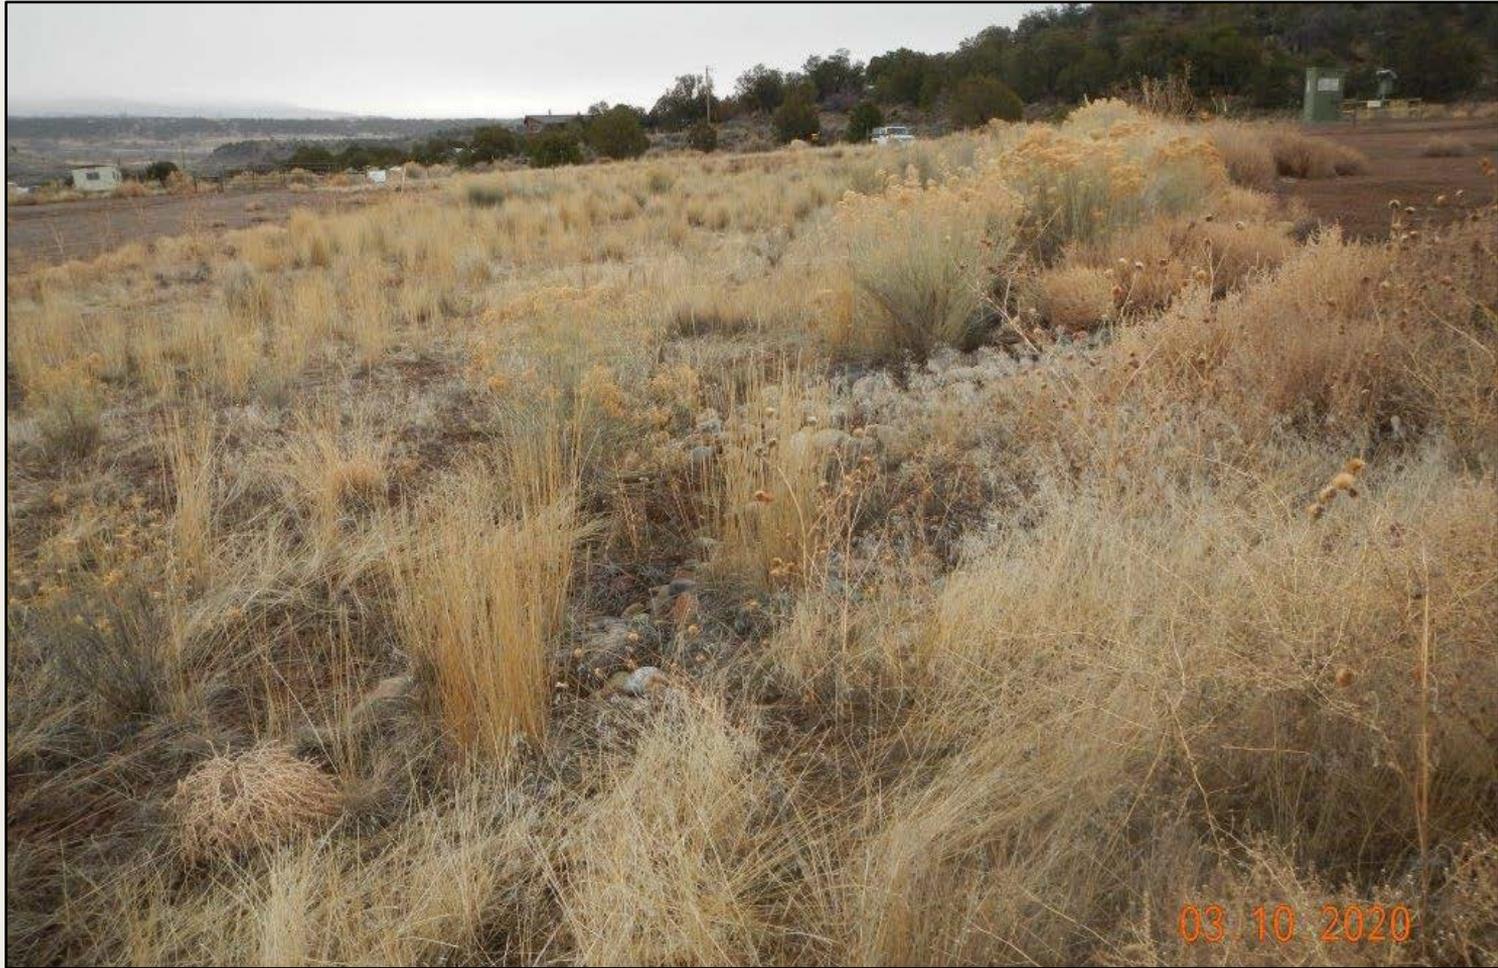
Photo 5. View of the fill slope dividing the northern and southern working areas. Revegetation is progressing largely with rubber rabbitbrush, intermediate wheatgrass, and western wheatgrass, although weedy in portions with cheatgrass and Russian thistle.

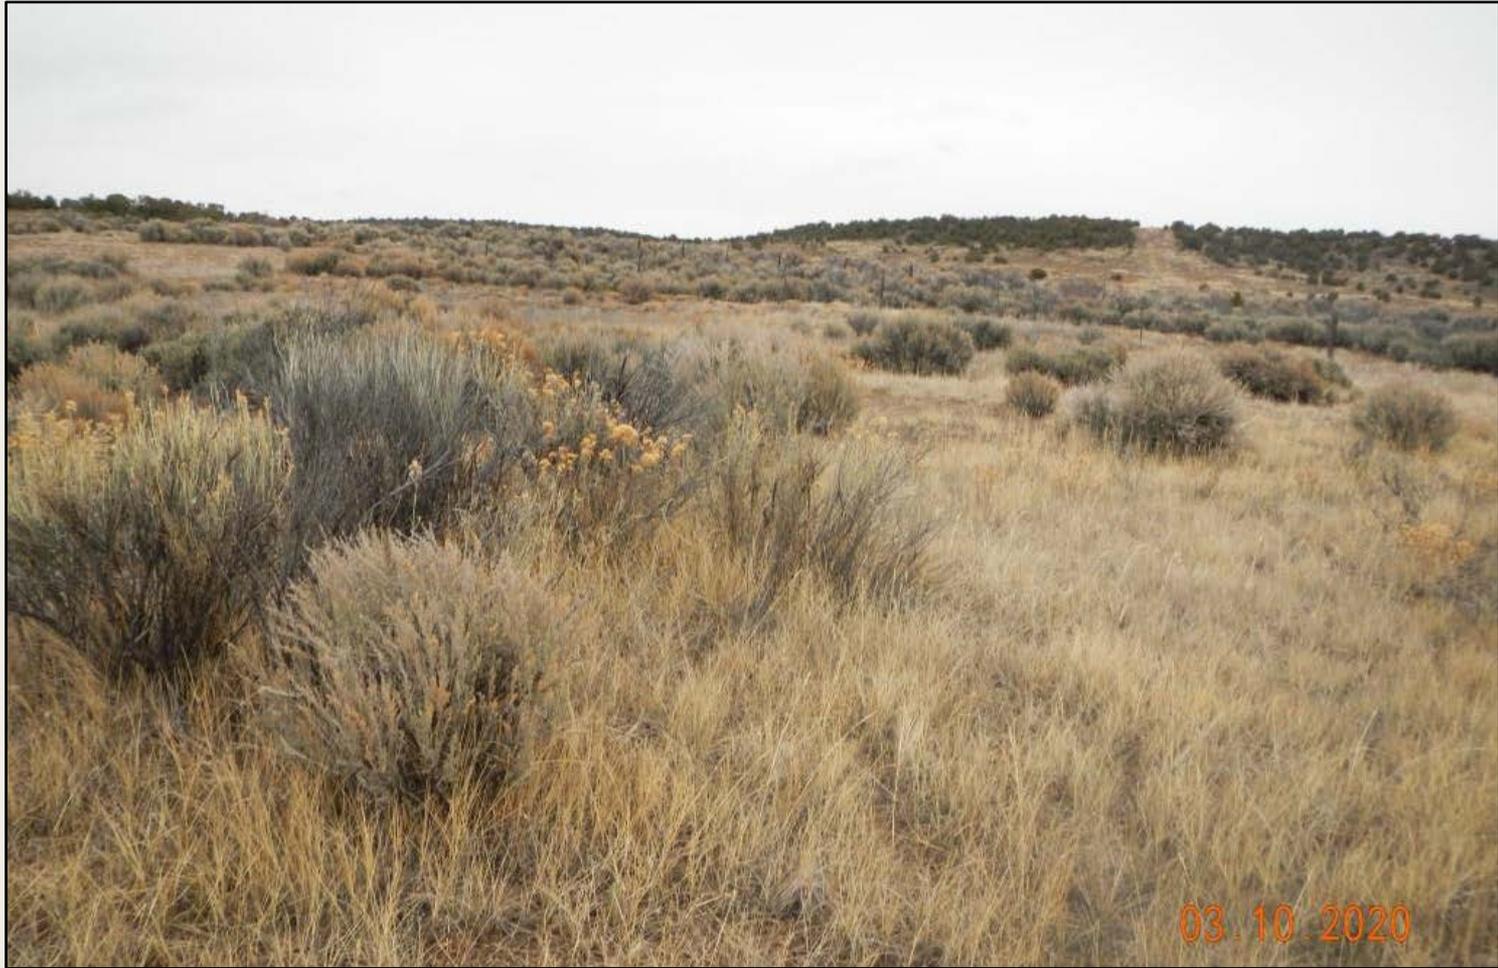
Photo 6. View of reference area vegetation comprised of sagebrush shrubland with grassy understory, dominated by thickspike wheatgrass, and James galleta.
