Inspection Photos
Operator: BP America
API#: 067-07868
Date: 3/10/2020

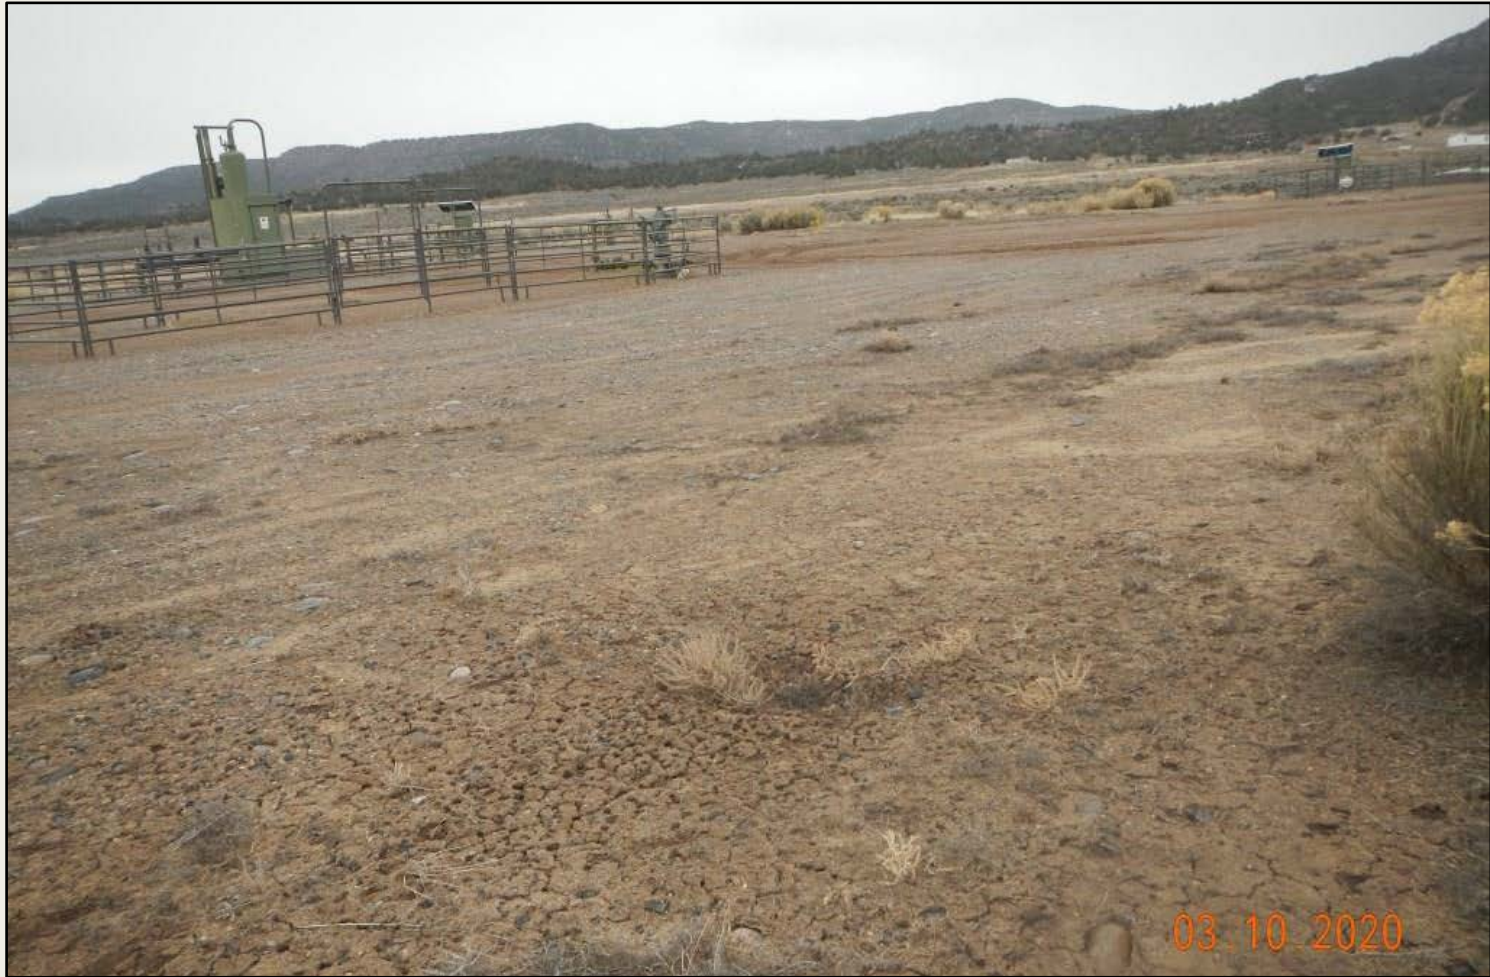
Photo 1. View of the project area from the northeastern corner facing center.

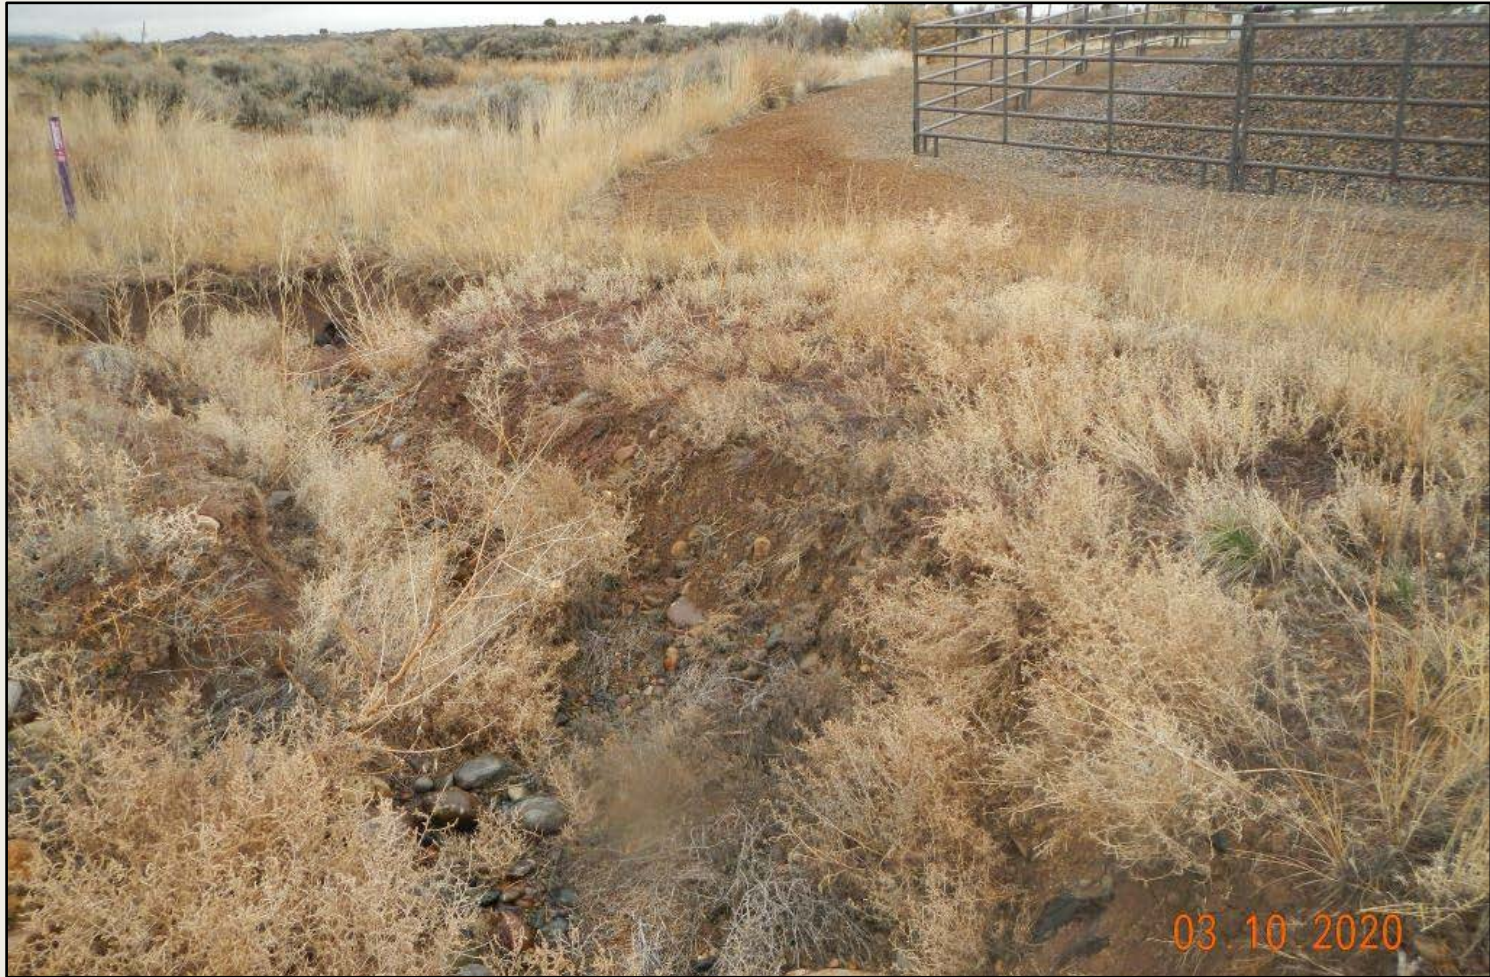
Photo 2. View of area adjacent to the southwestern corner of the working area where erosion continues. Cobble BMP placed in channel was not sufficient to stabilize this area and is largely washed downstream.

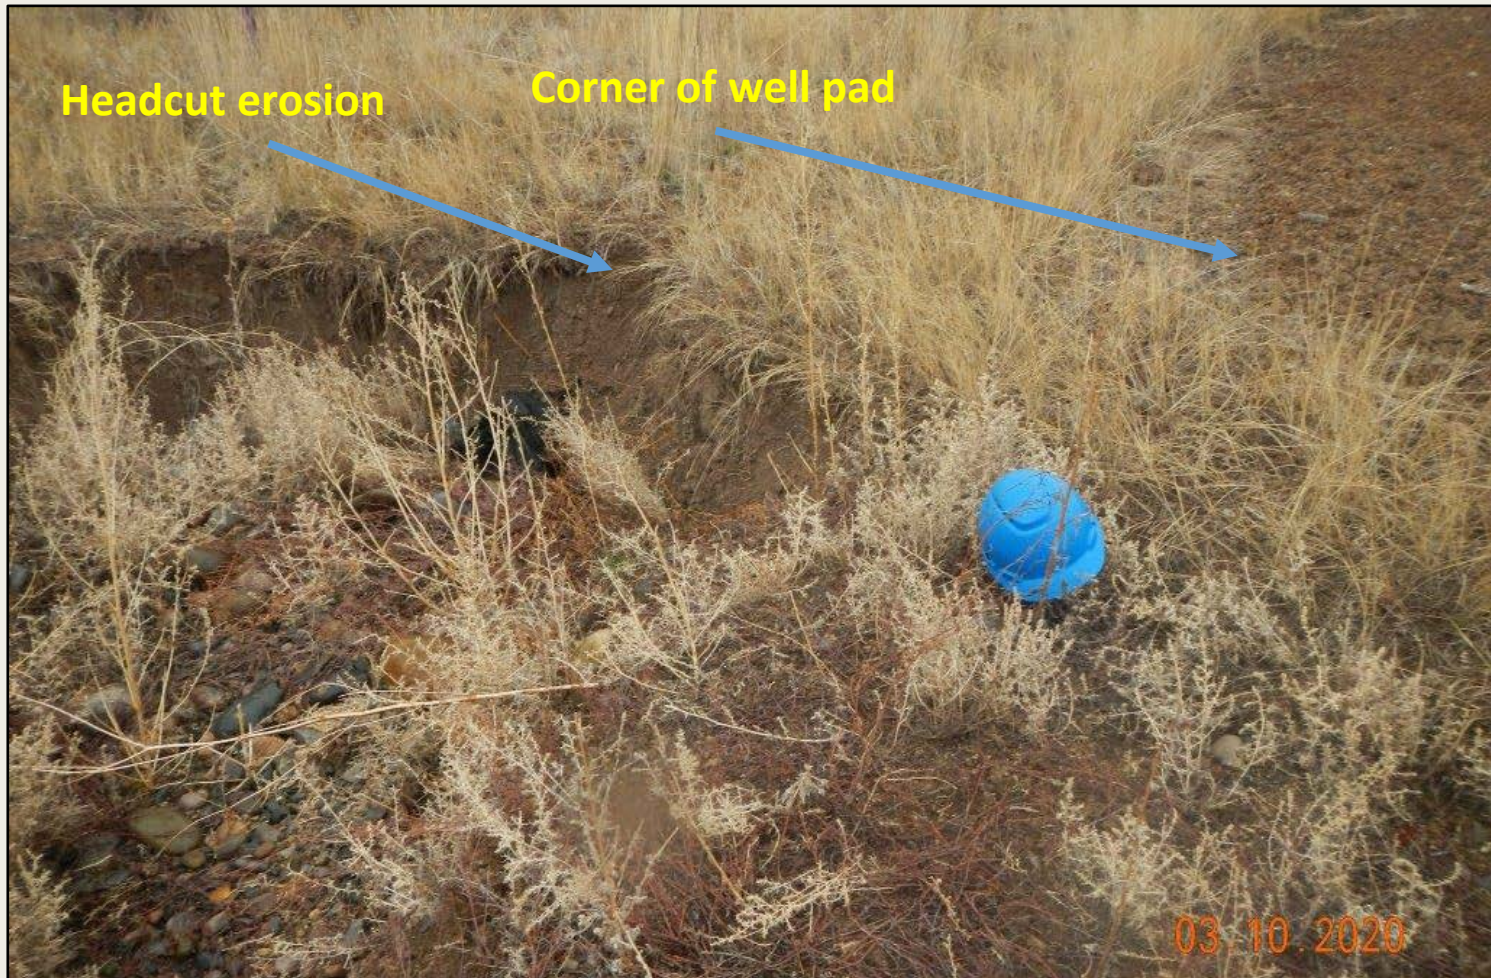
Photo 3. View of headcut erosion adjacent to the southwestern corner of the well pad. Hard hat in place for scale

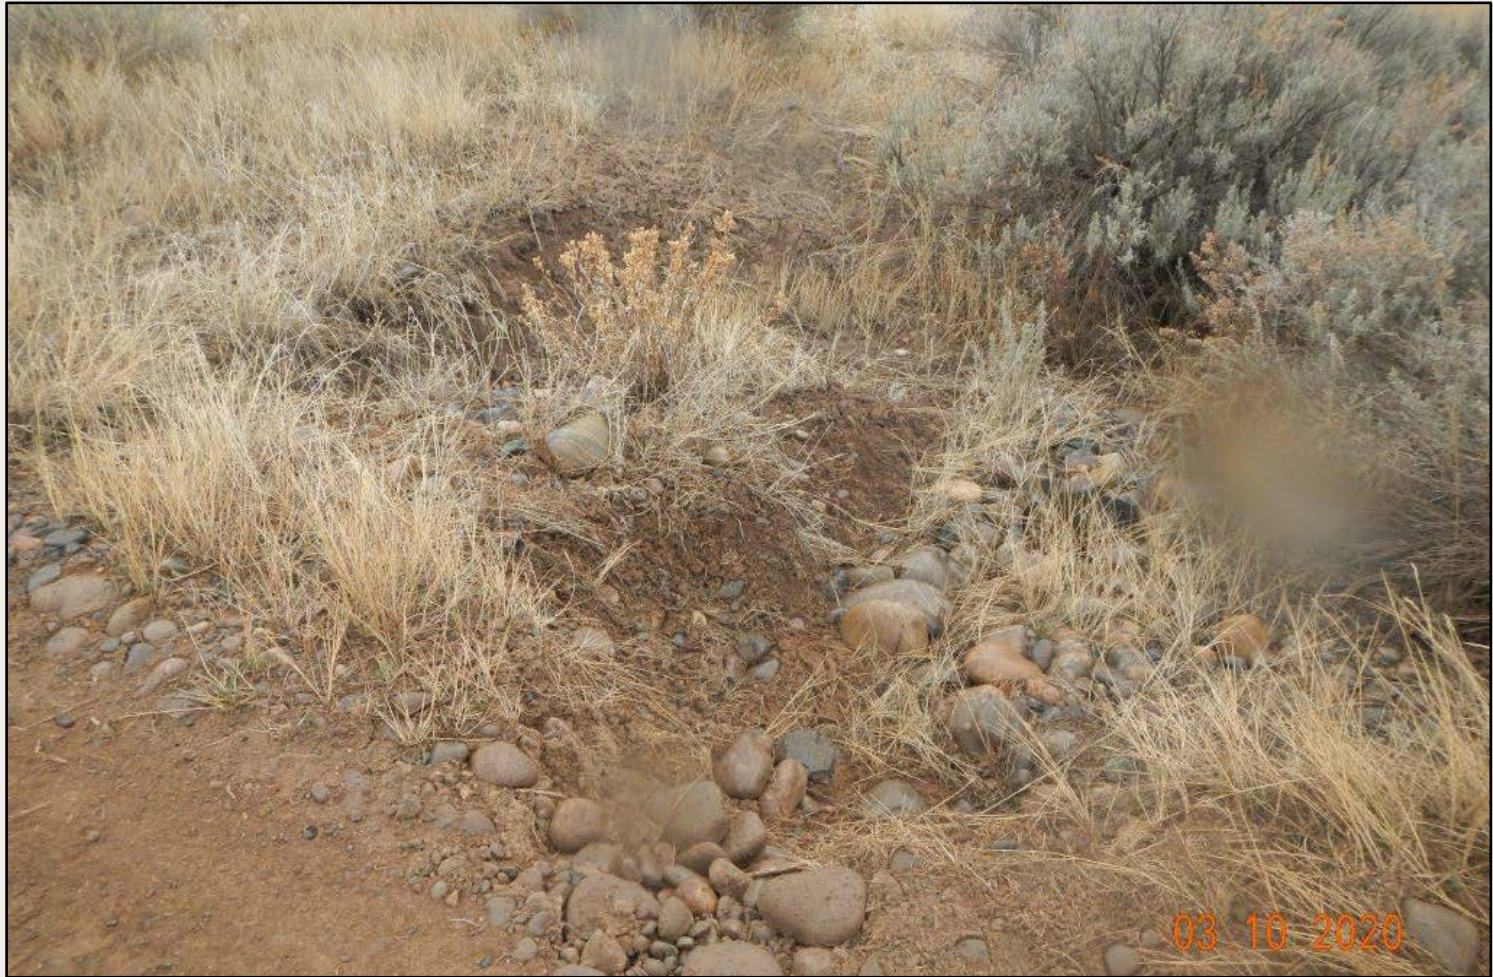
Photo 4. View of additional headcut erosion observed at well pad entrance where stormwater flows over the access road.

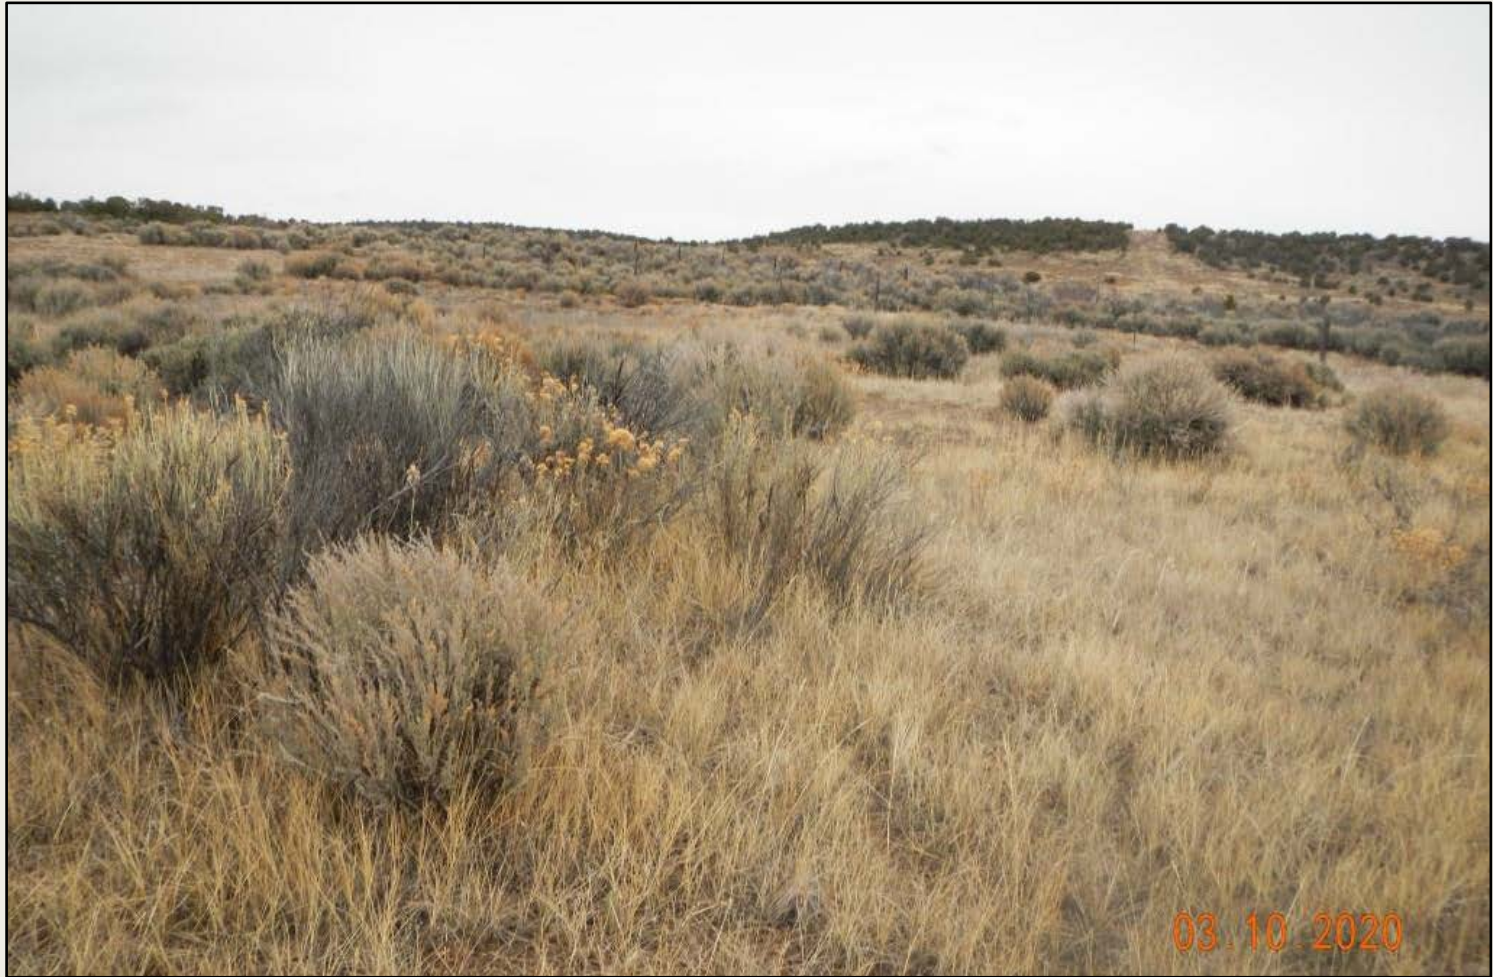
Photo 5. View of reference area vegetation comprised of sagebrush shrubland with grassy understory, dominated by thickspike wheatgrass, and James galleta.
