Inspection Photos

API: 071-09034

Operator: EVERGREEN NATURAL RESOURCES

Inspection Date: 3/9/2020

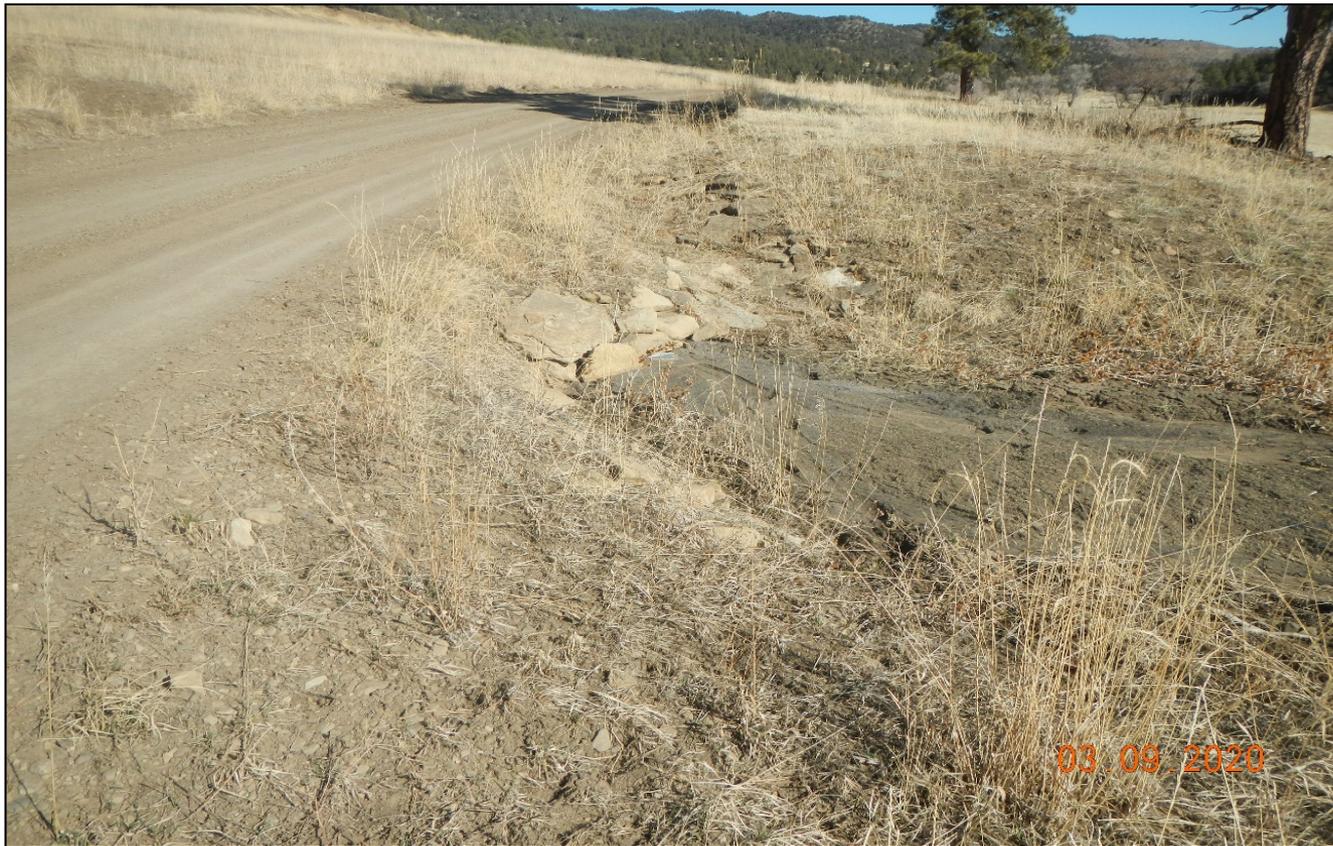
Photo 1. The culvert outlet has filled in with sediment at Lat/Long:37.05764,-104.81458.

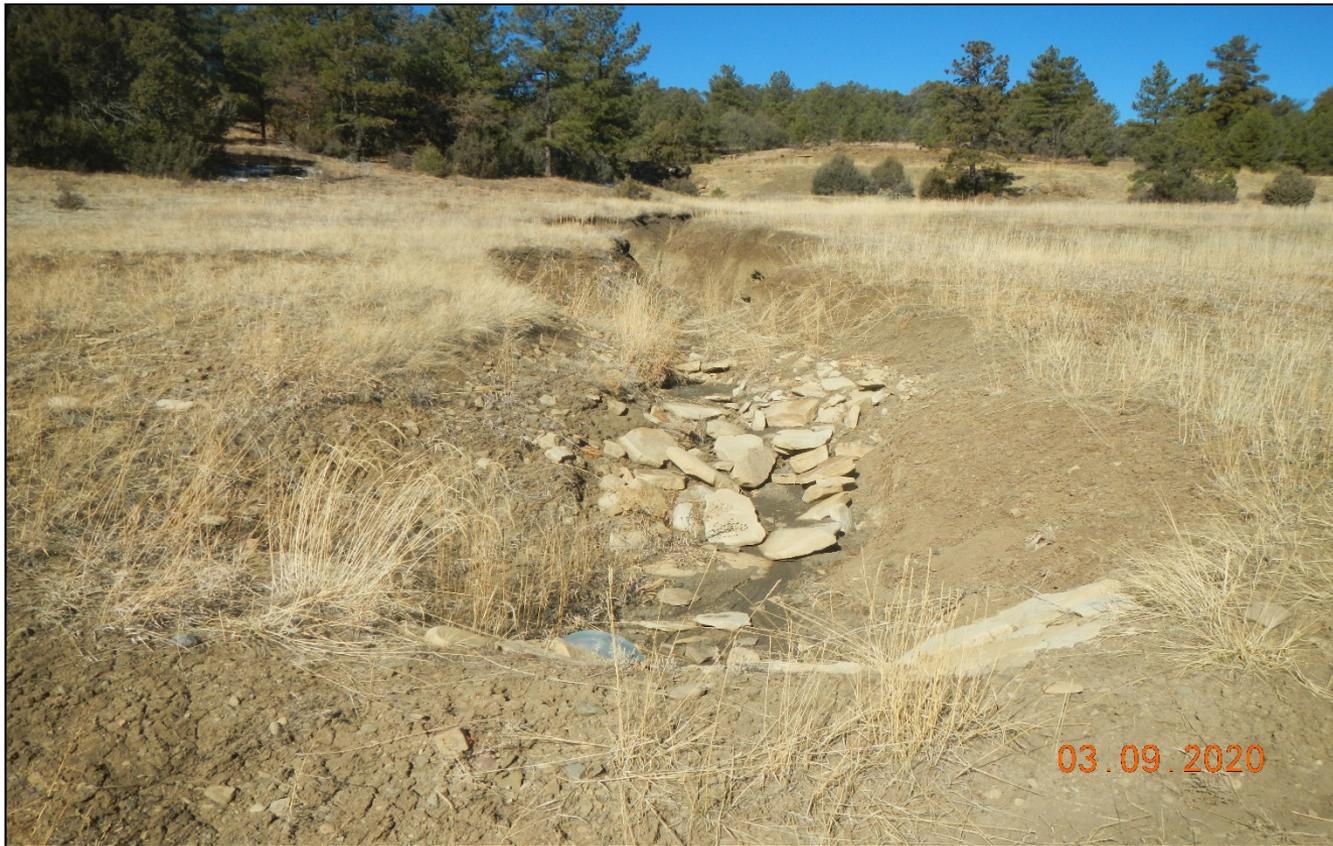
Photo 2. Facing west at the culvert inlet at Lat/Long:37.05764,-104.81458.

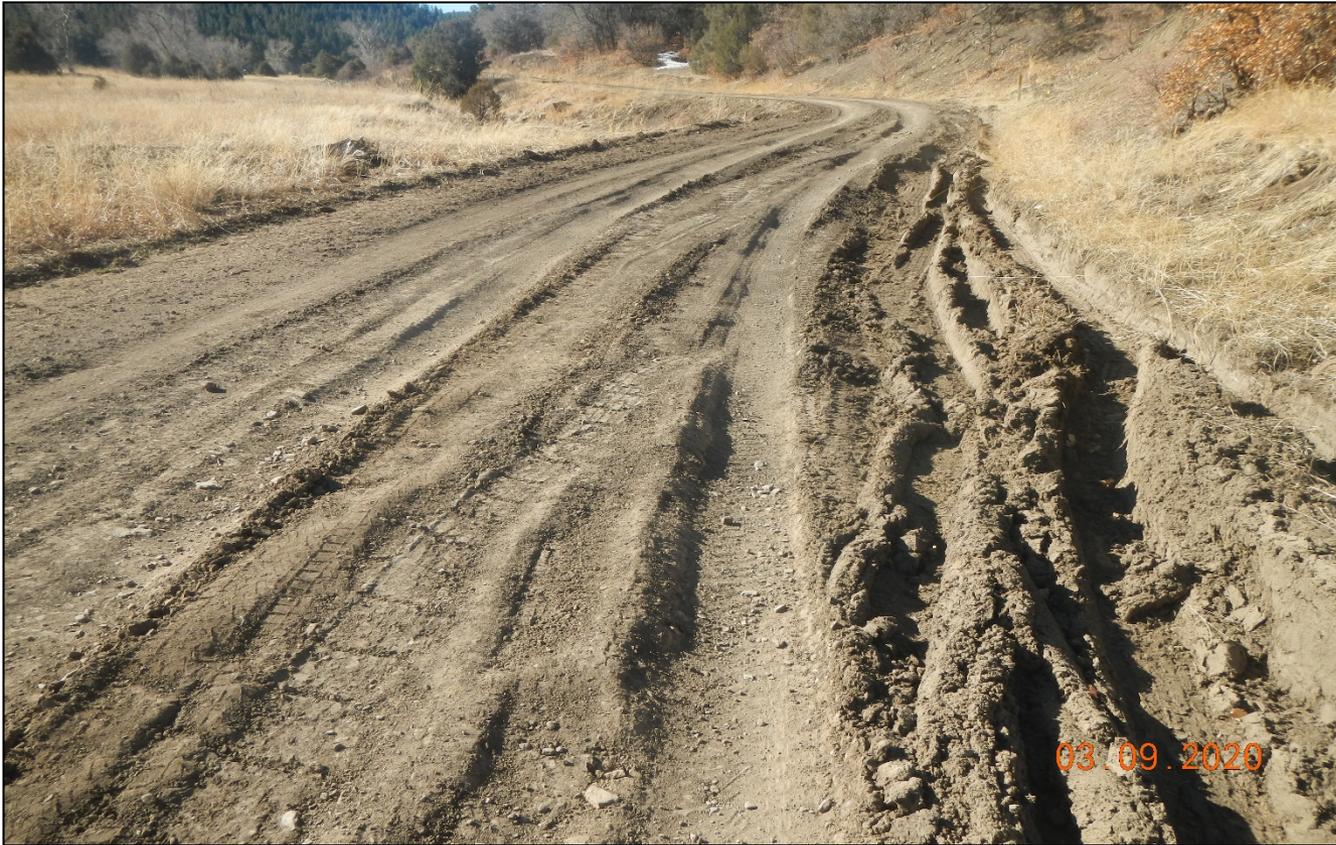
Photo 3. There is vehicle rutting along the main access road near the location.

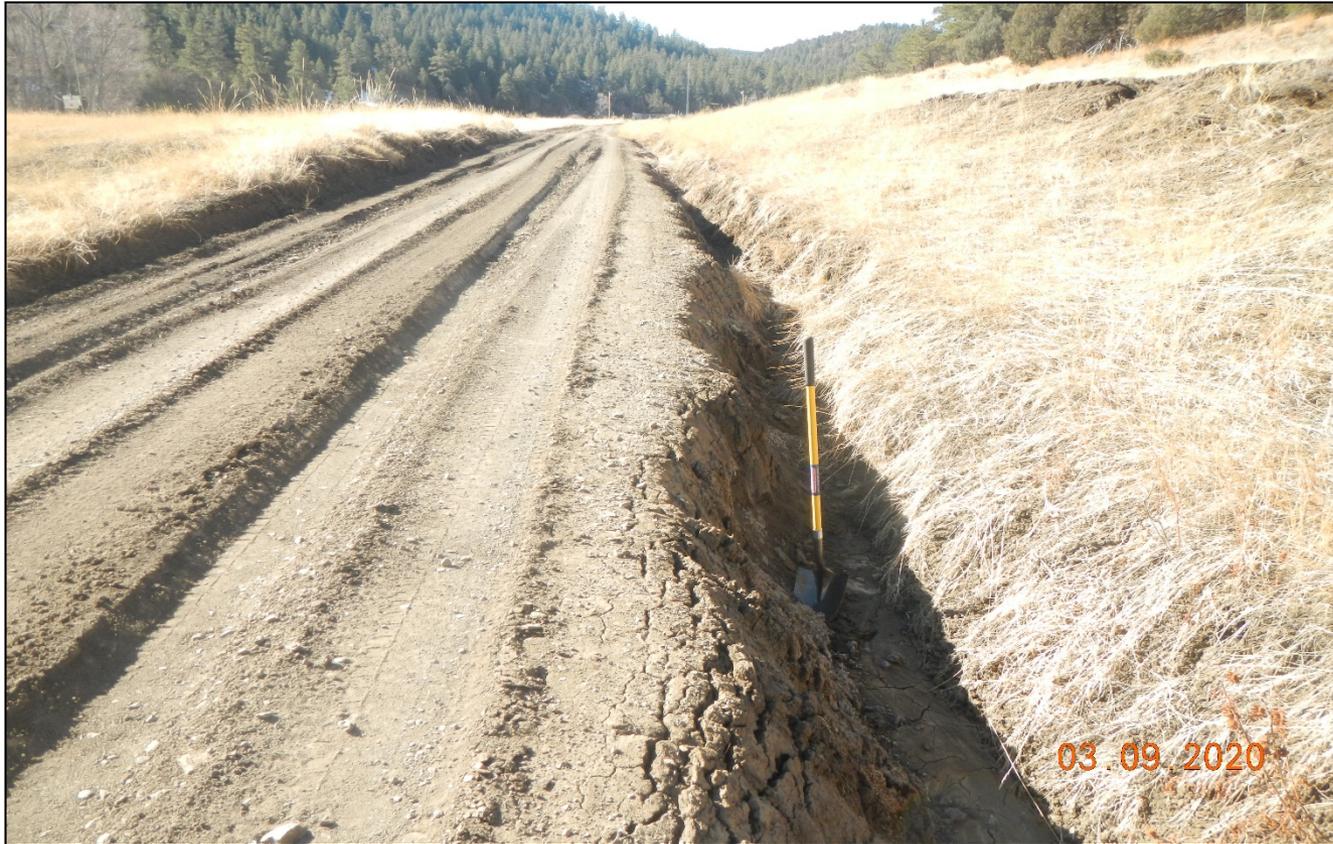
Photo 4. The sides of the main road has eroded a deep channel at Lat/Long:37.041830,-104.81016.

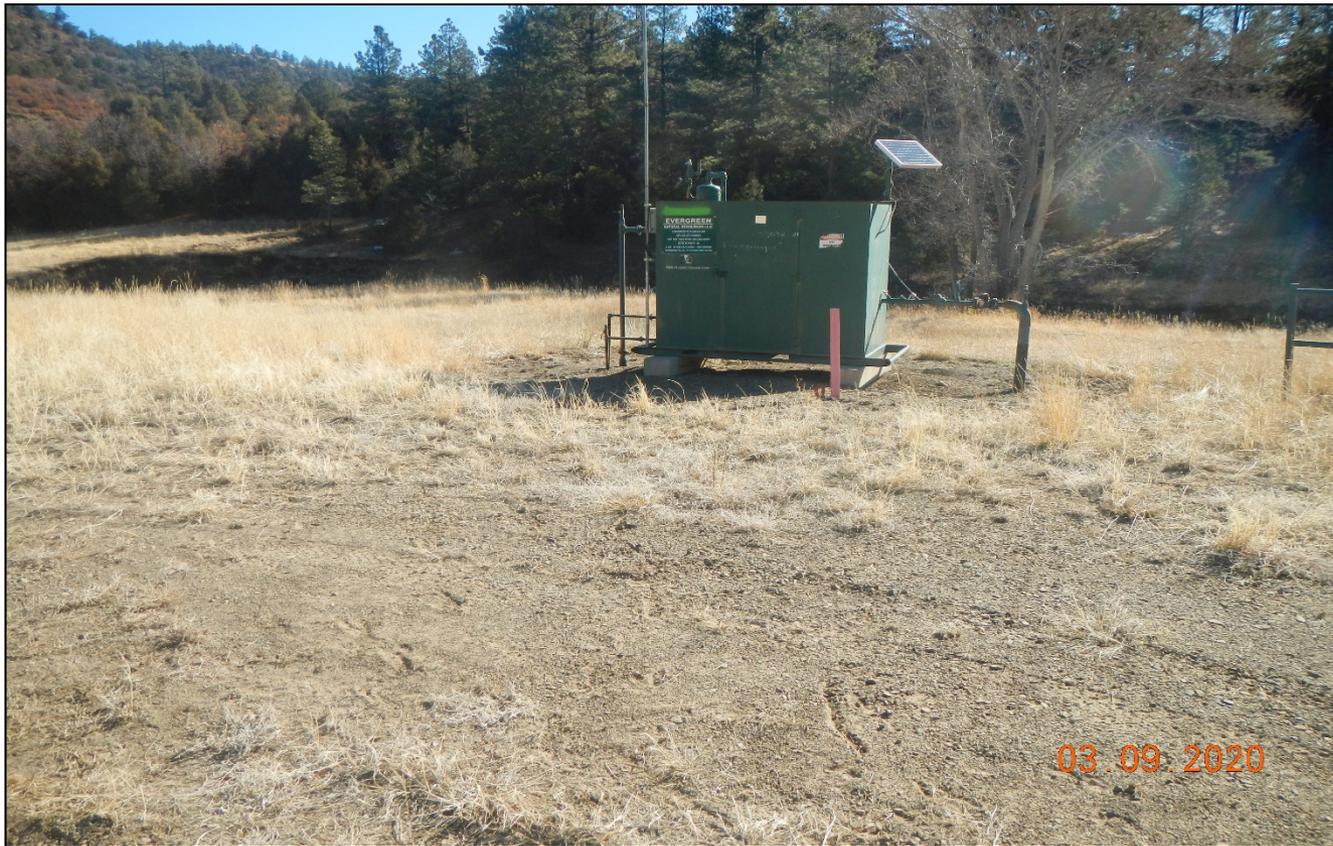
Photo 5. Facing toward the location.
