Inspection Photos

API: 071-09301

Operator: TIMBER CREEK OPERATING

Inspection Date: 3/12/2020

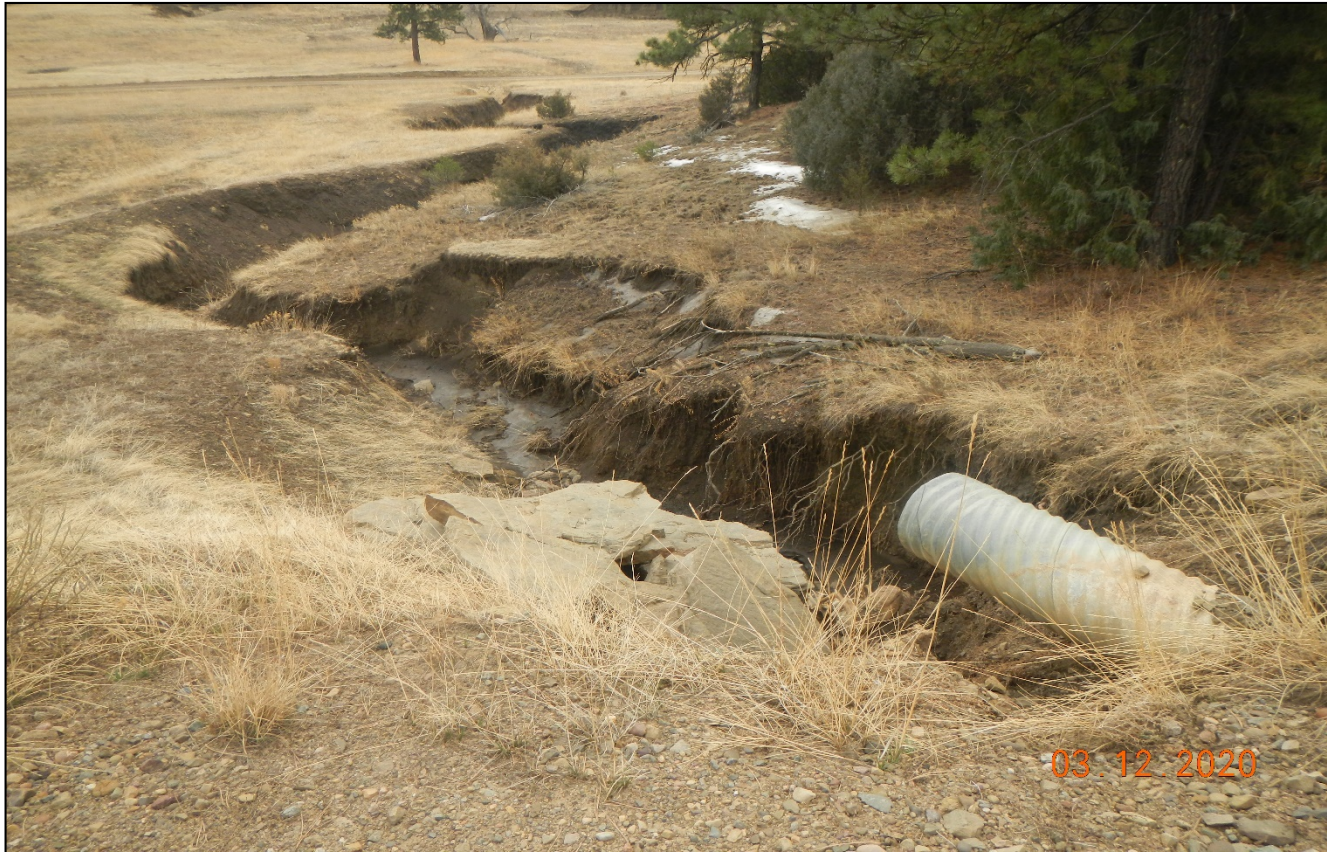
Photo 1. There is erosion occurring at this culvert outlet along the main road at Lat/Long:37.05979,-104.81561. No culvert outlet BMP to prevent erosion. Stormwater is being directed to this area from the road.

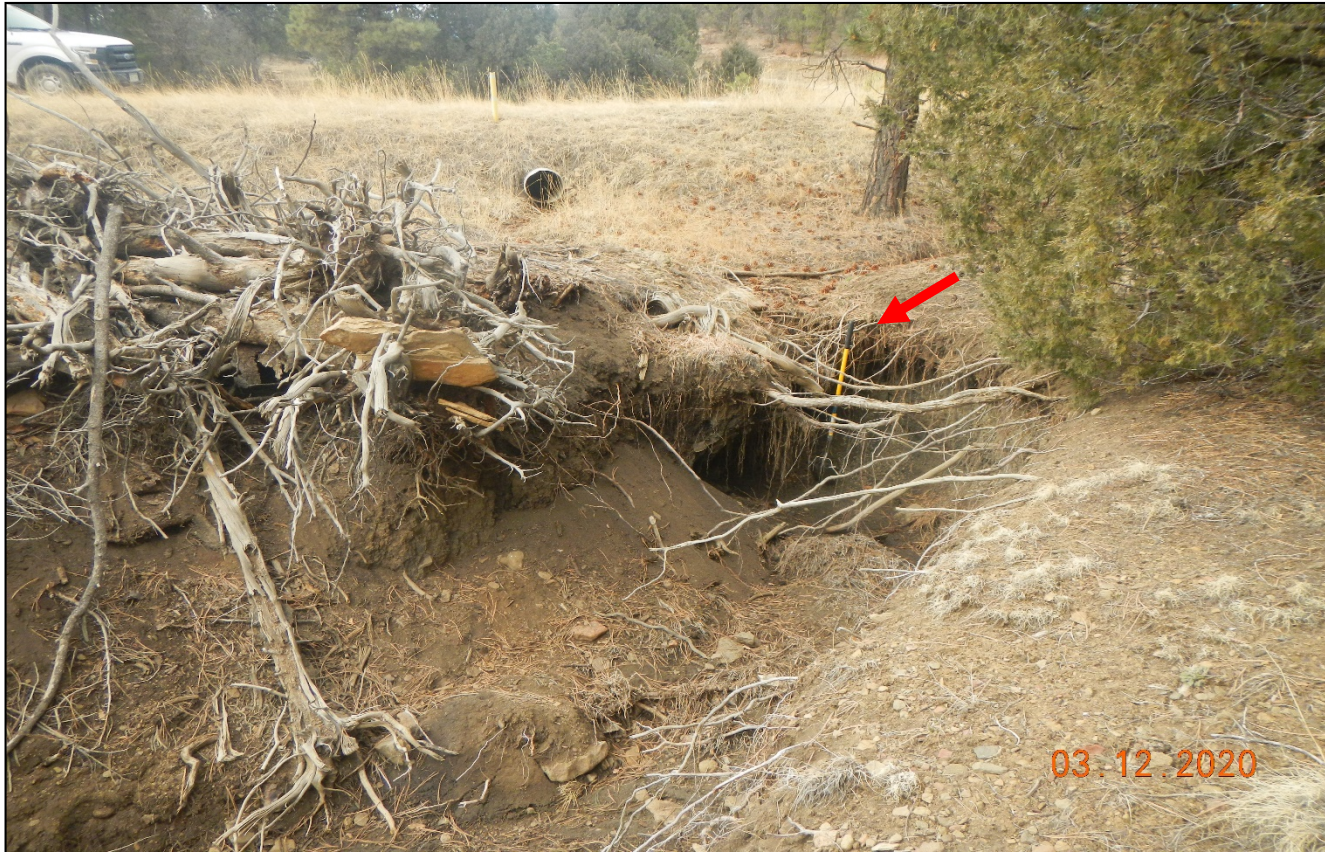
Photo 2. Further up the road there is erosion occurring from the culvert outlet along the main road at Lat/Long:37.05963,-104.81659. No culvert outlet BMP to prevent erosion. Red arrow points to 4.5 foot shovel placed in erosion gully.

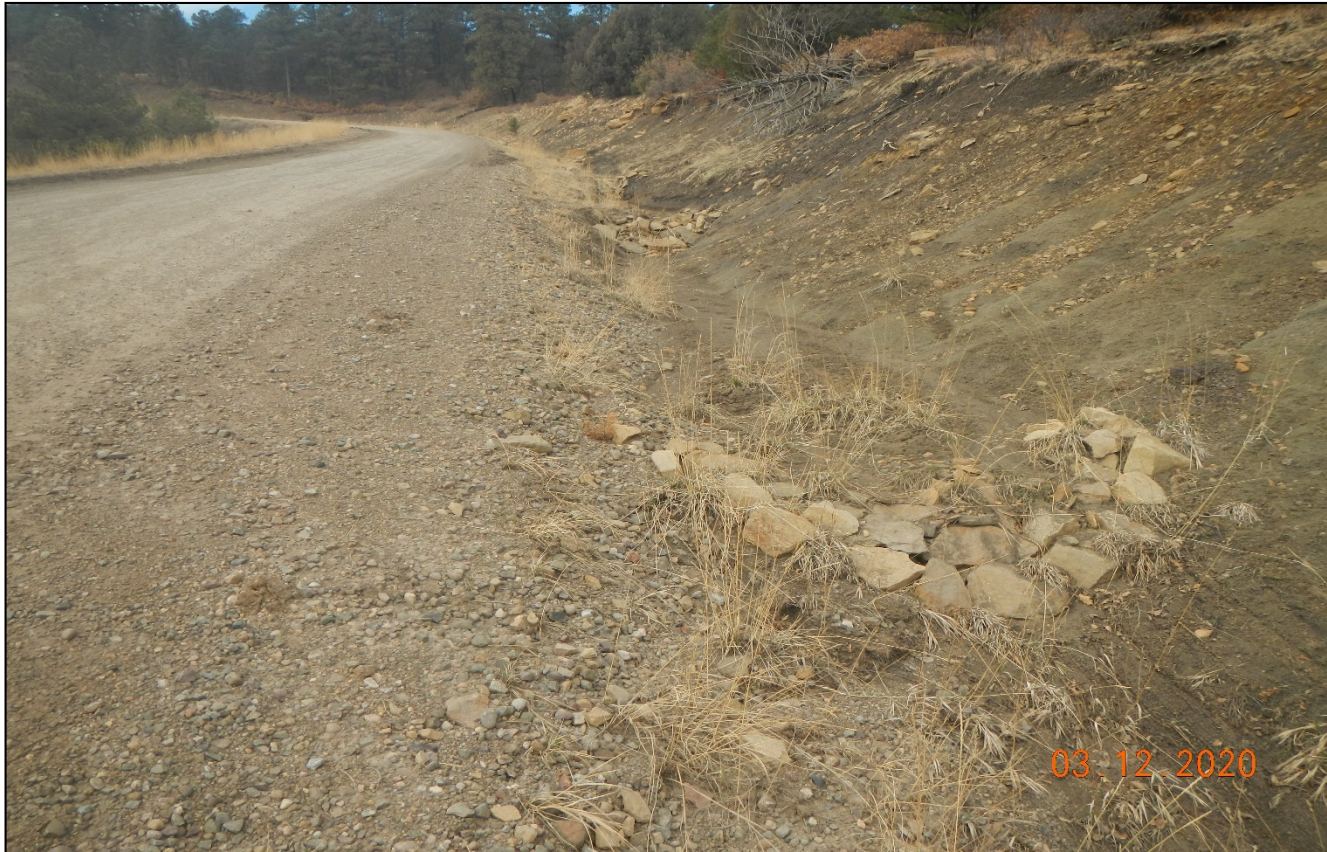
Photo 3. Erosion is occurring on the side of the road and rock check damns have filled up with sediment at Lat/Long:37.0586,-104.81750.

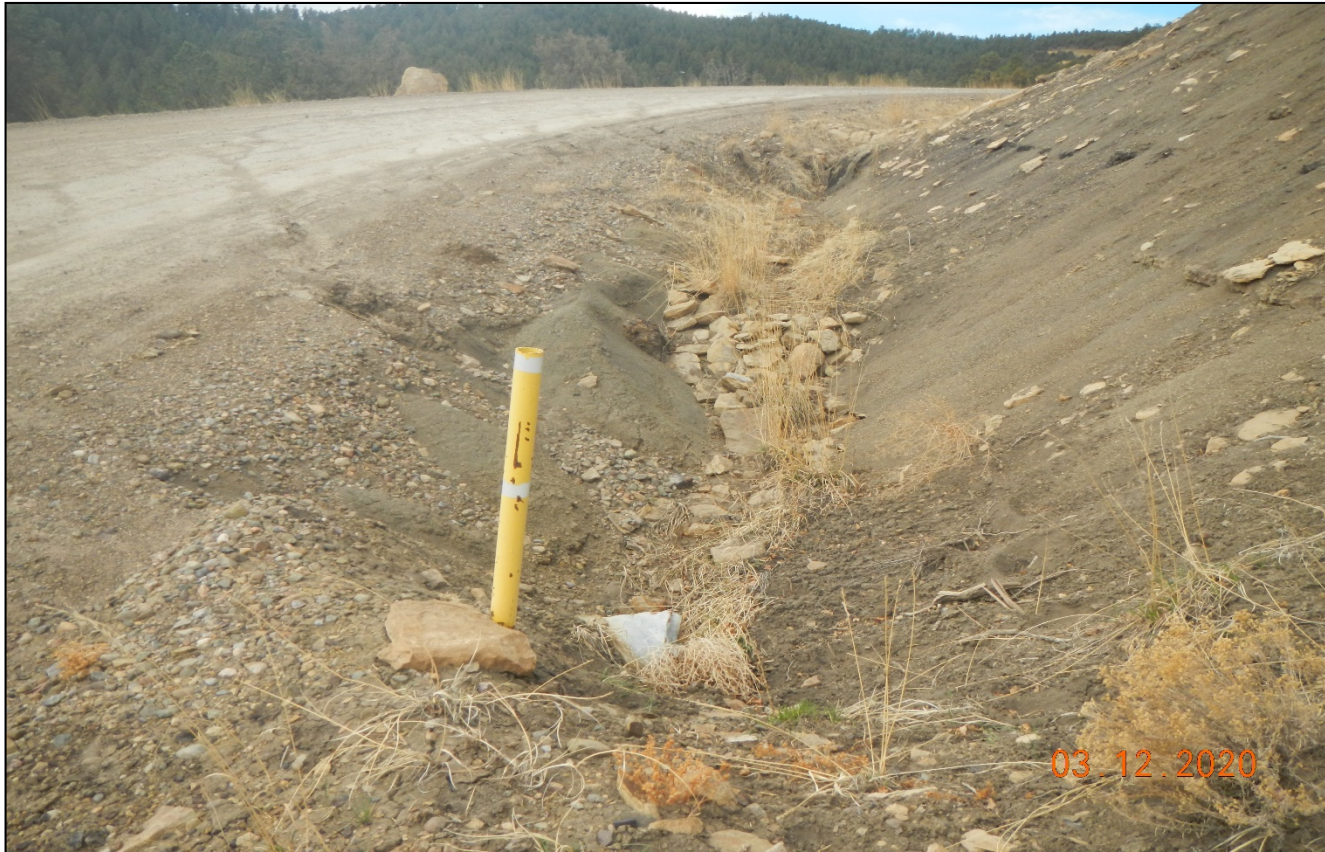
Photo 4. Erosion is occurring on the side of the road and this culvert has filled in with sediment at Lat/Long:37.0586,-104.81750.

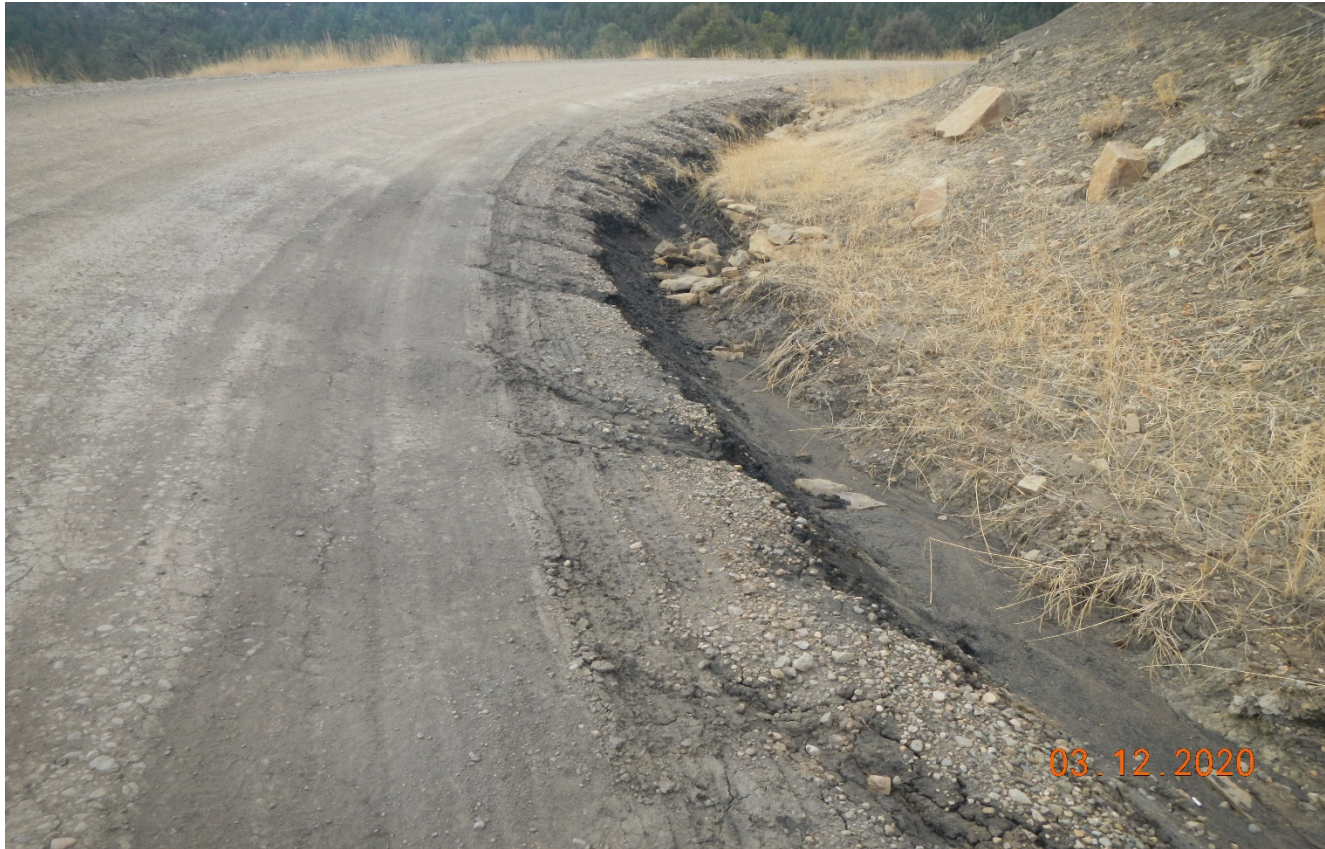
Photo 5. There is erosion occurring along the main road and no BMP's are installed to prevent erosion.

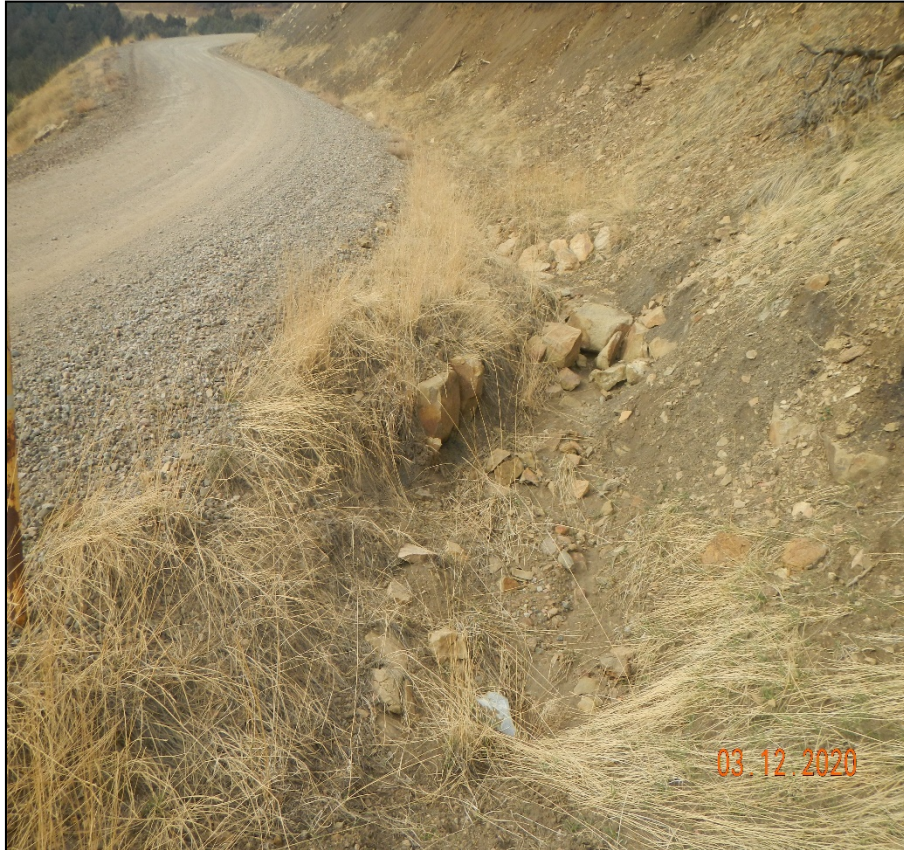
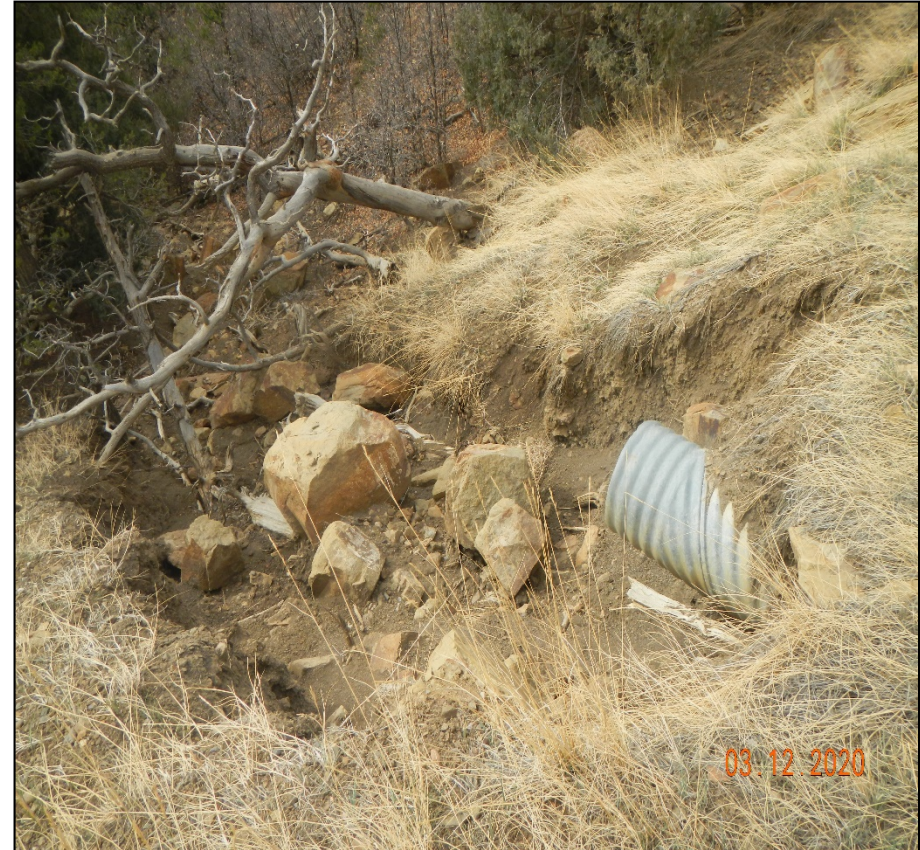
Photo 6. The above photos of the culvert inlet and outlet were taken at Lat/Long:37.05354,-104.82491. The inlet culvert has filled in with sediment and the outlet culvert is causing erosion.

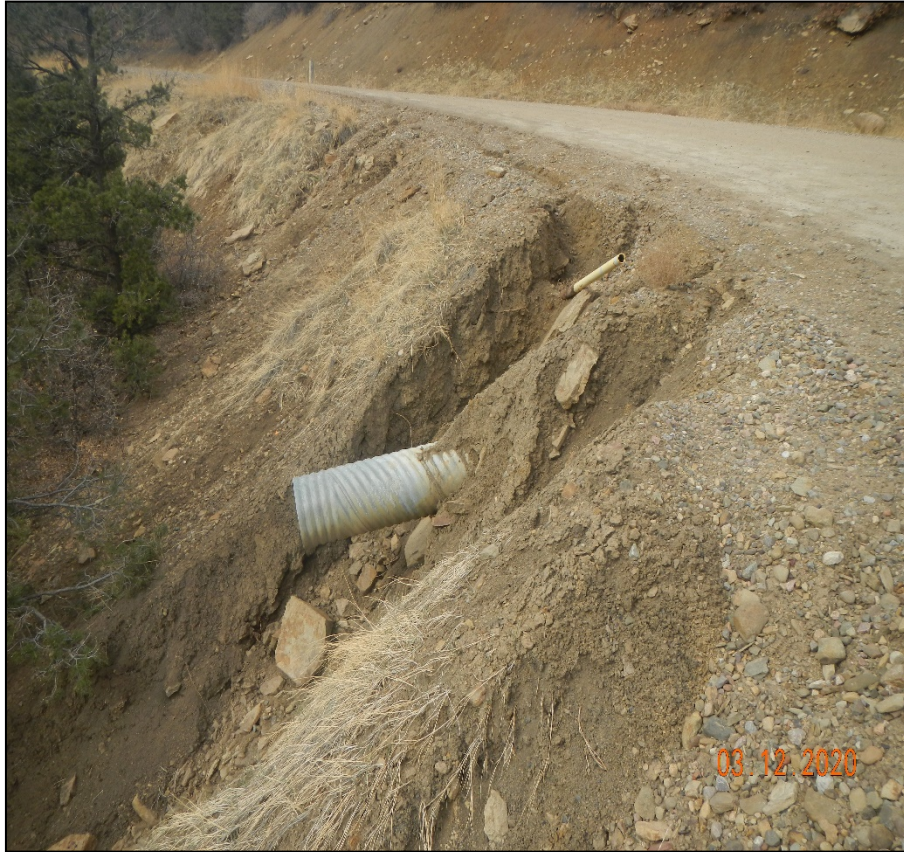
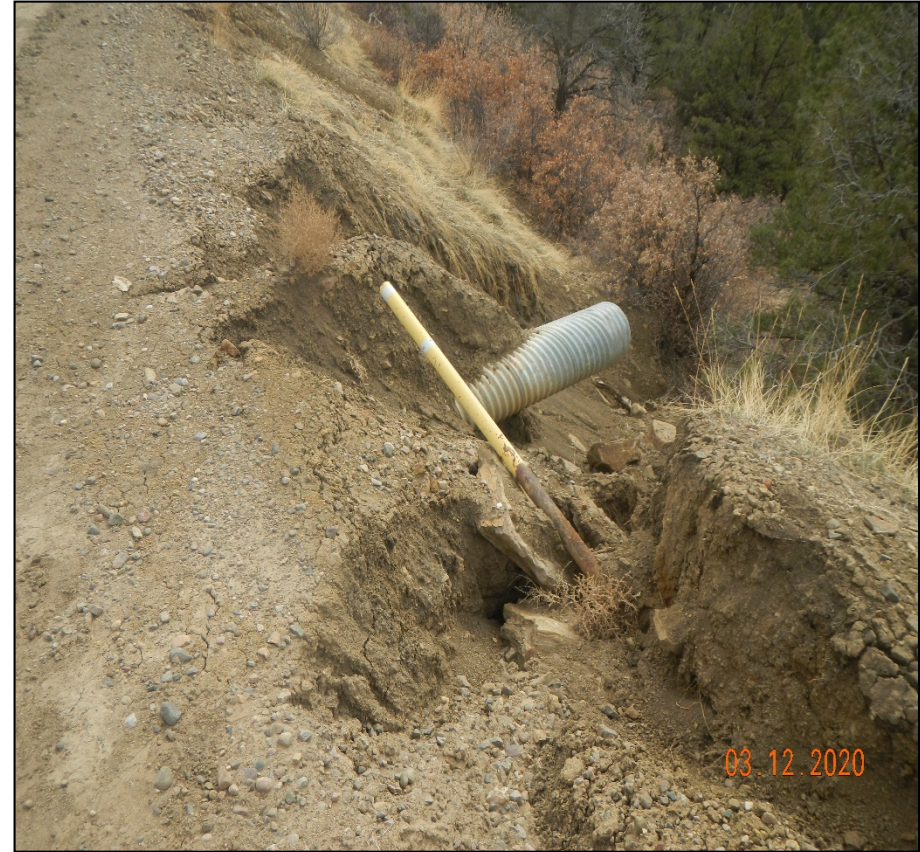
Photo 7. Photo 5. Stormwater runoff from the road is causing erosion near this culvert at Lat/Long:37.05297,-104.82619. There is no outlet protection installed at the culvert outlet.

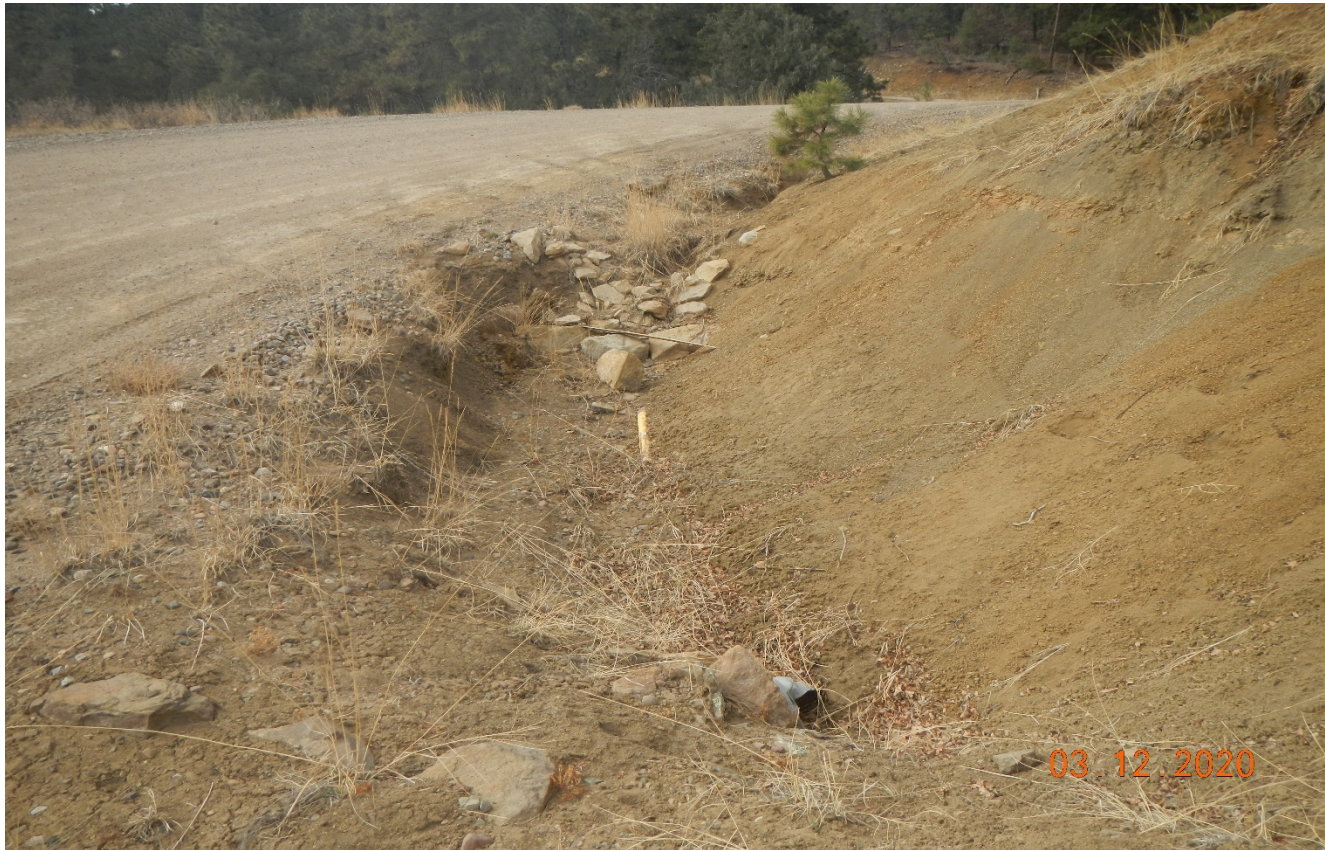
Photo 8. This culvert along the main road has filled in with sediment.

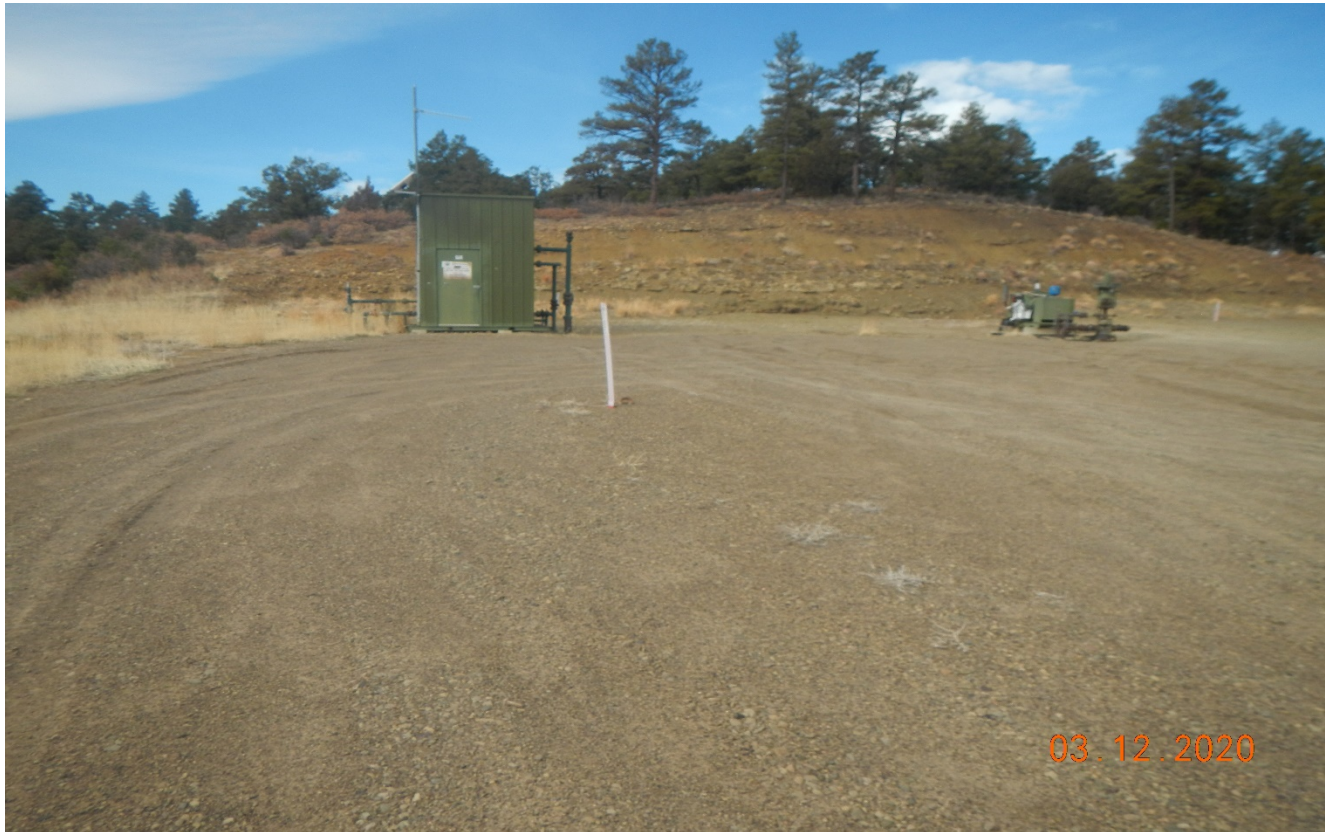
Photo 9. Facing toward the location. Well sign is posted at the meter house.
