Final Reclamation Inspection

March 12, 2020

Operator: PETROSHARE CORPORATION- 10454

Location Name: RMPCO-EVERETT-UPRR #1

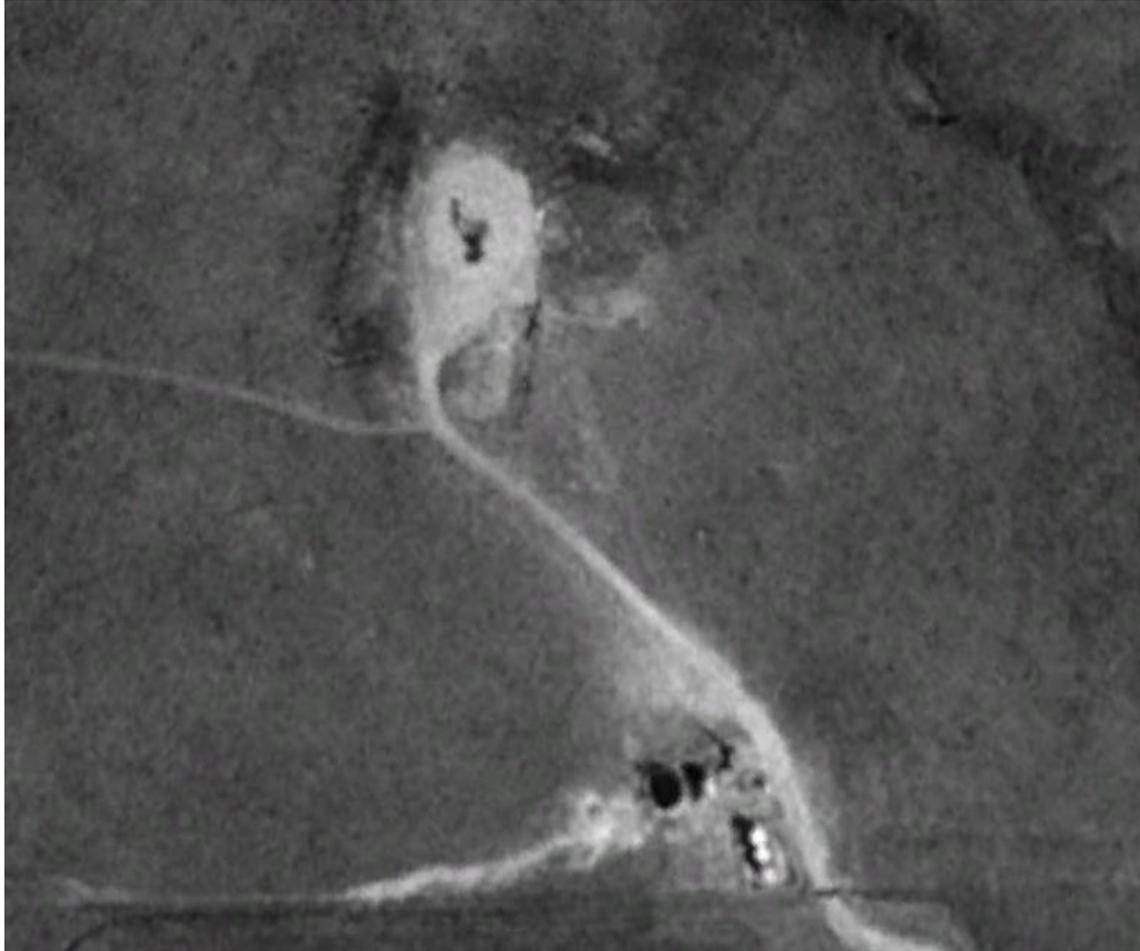
Photo 1. Google Earth aerial imagery taken 9/29/1999 illustrating well and battery location during operations.

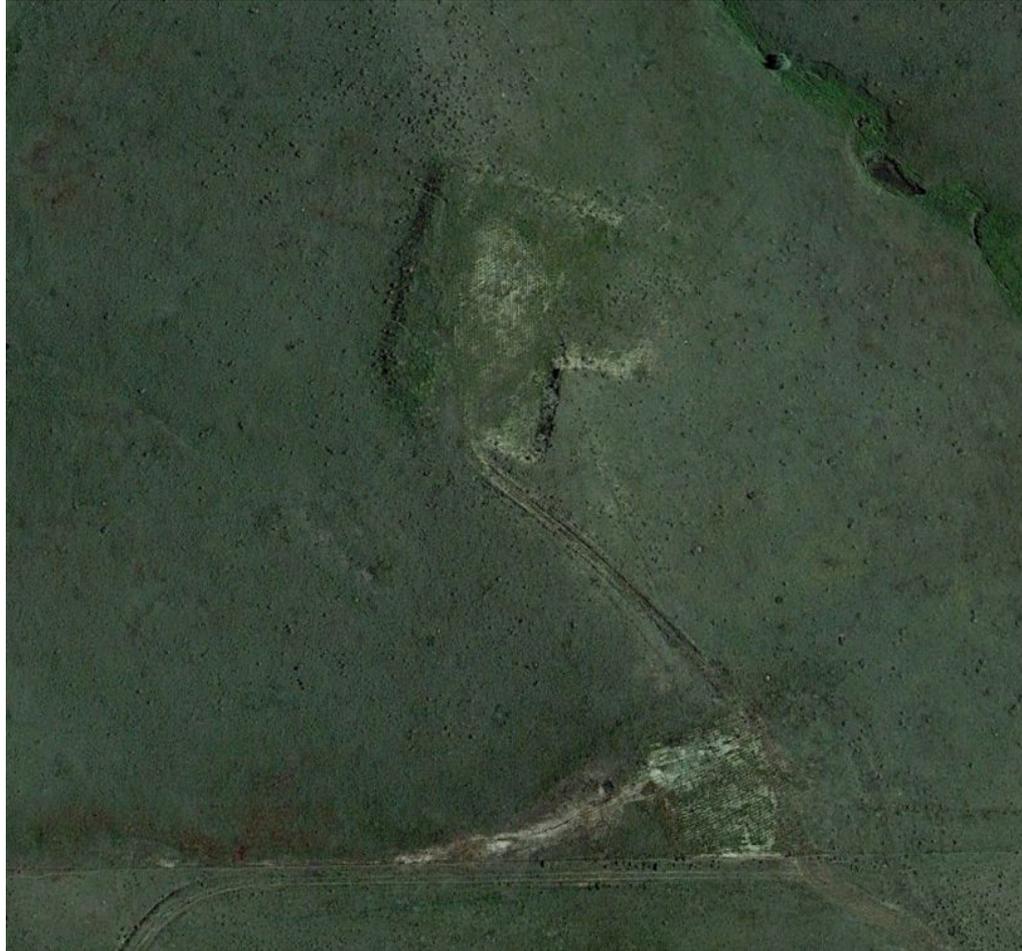
Photo 2. Google Earth aerial imagery taken 6/15/2010 illustrating well and battery location after the location was plugged in 2003. Both the well and battery locations do not meet Rule 1004 standards.

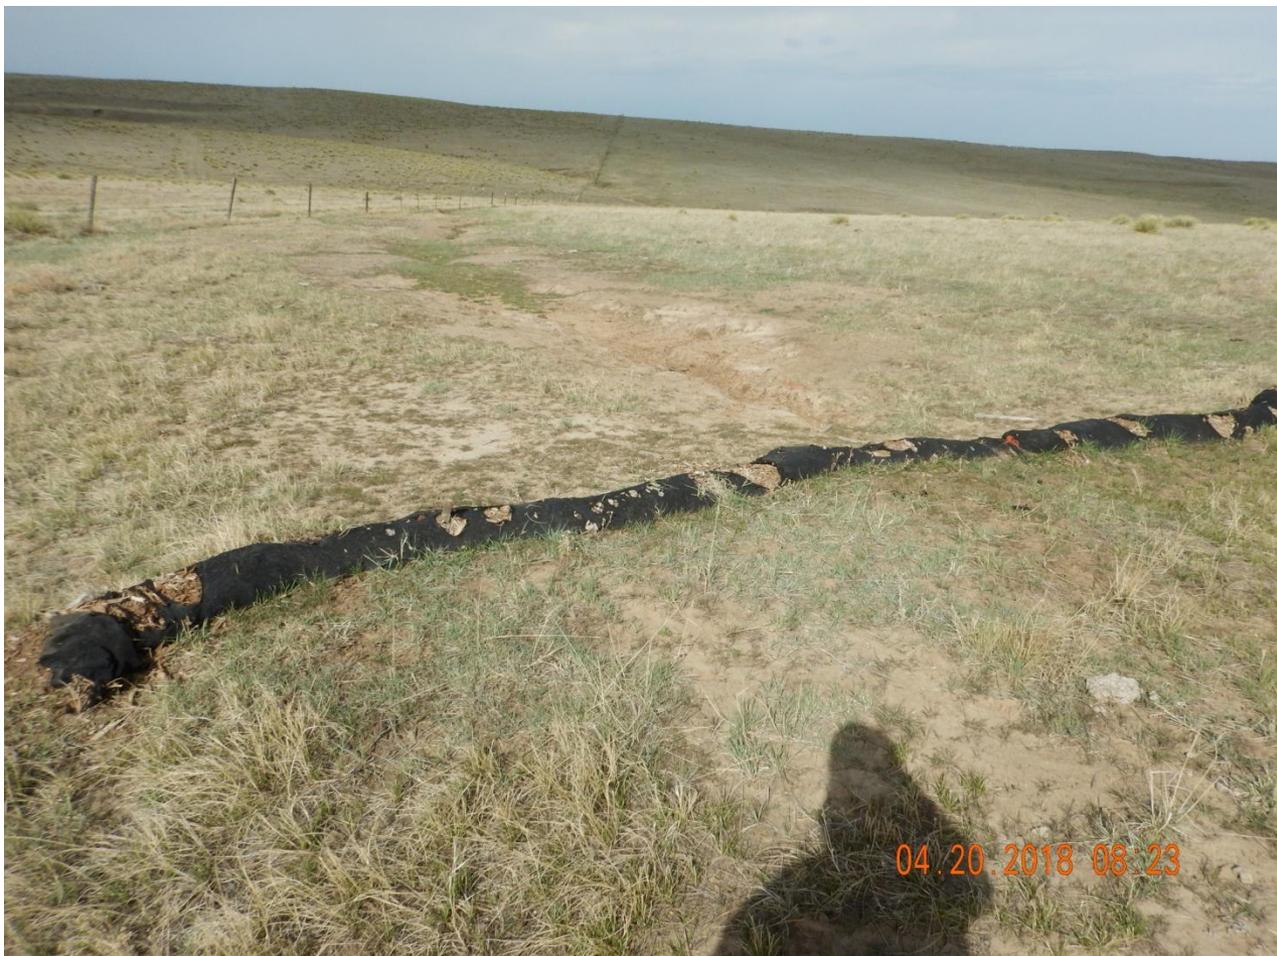
Photo 3. Photo taken from the western battery location on 4/20/2018, facing West. Gully erosion is evident and BMP is in disrepair. Operator has failed to complete final reclamation activities.

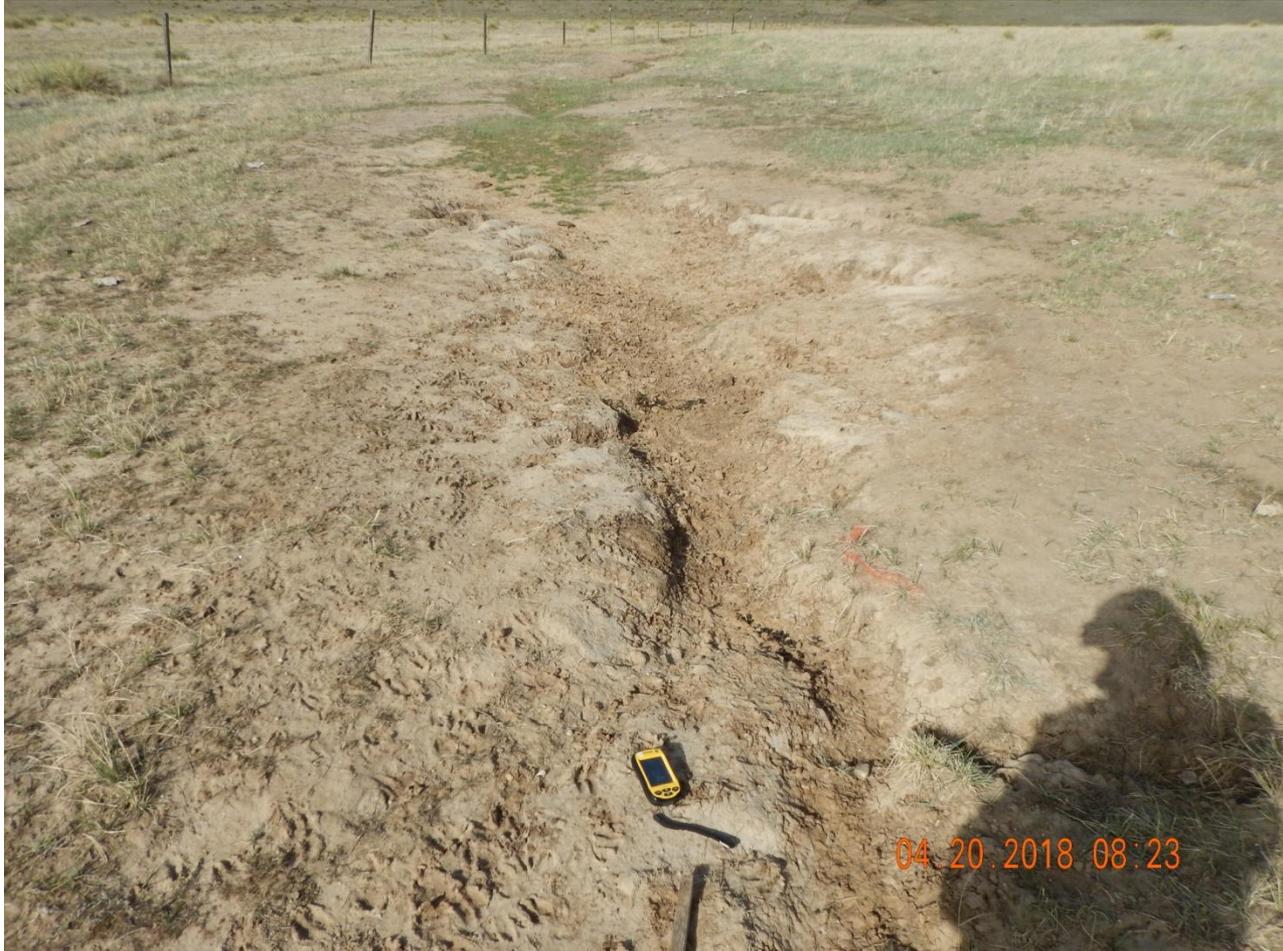
Photo 4. Photo taken from the gully erosion along the western battery location on 4/20/2018, facing West. Erosion continues west, off location.

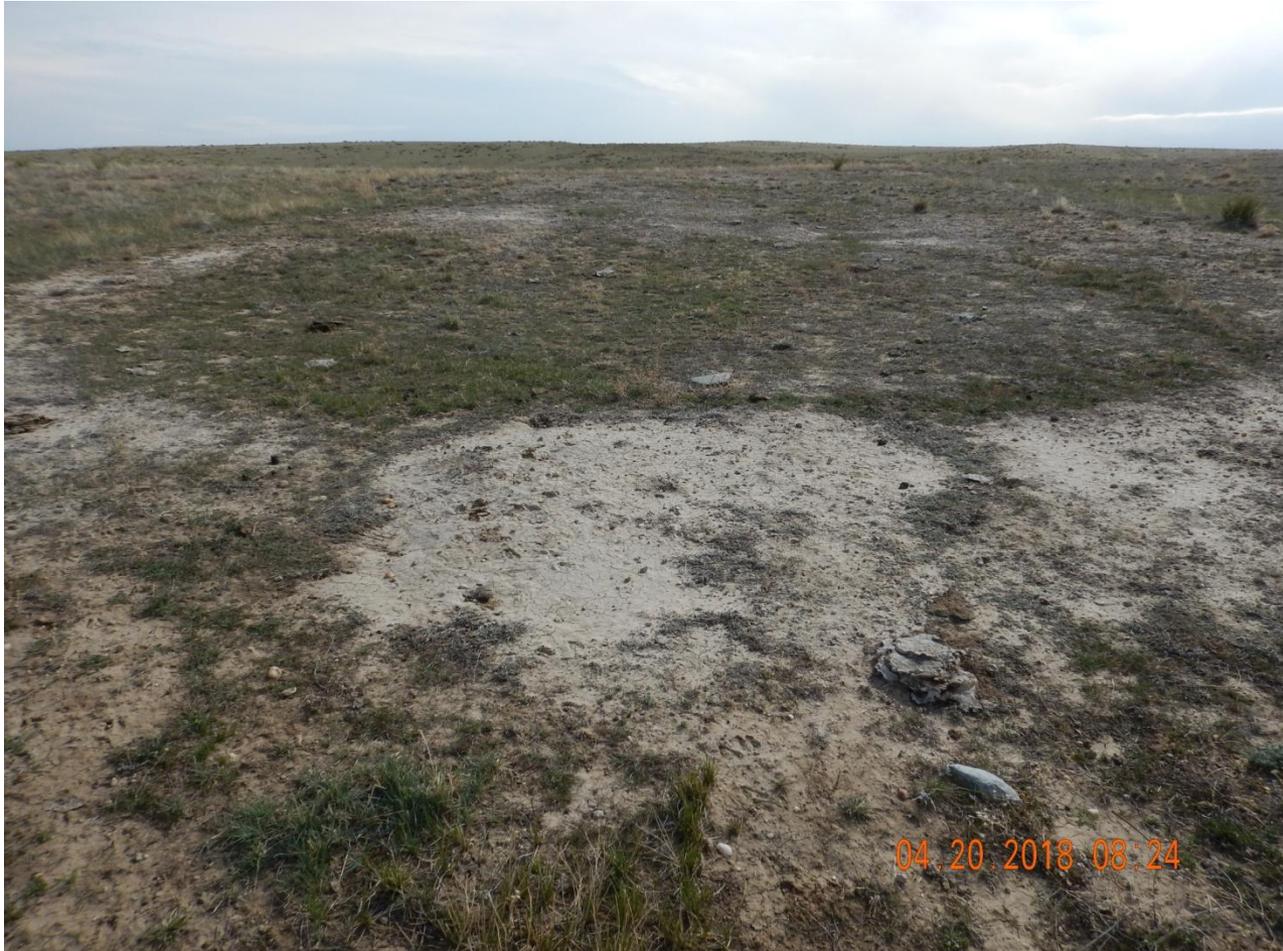
Photo 5. Photo taken from the western battery location on 4/20/2018, facing East. Vegetation at the battery location is not reflective of reference area vegetative level and does not meet Rule 1004 standards. Operator has failed to complete final reclamation activities.

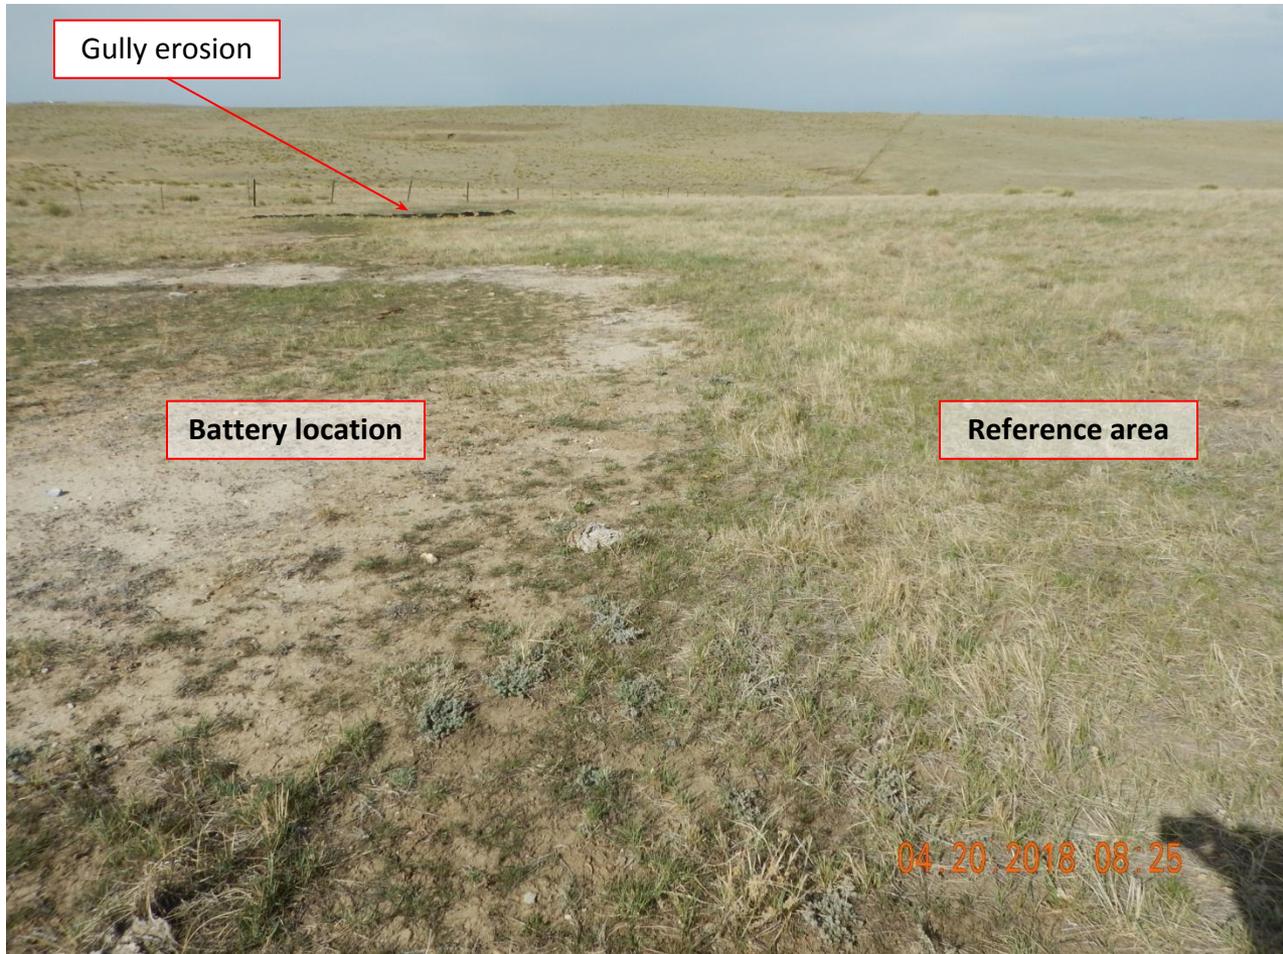
Photo 6. Photo taken from the northern battery location on 4/20/2018, facing West. See comments under Photo 3.

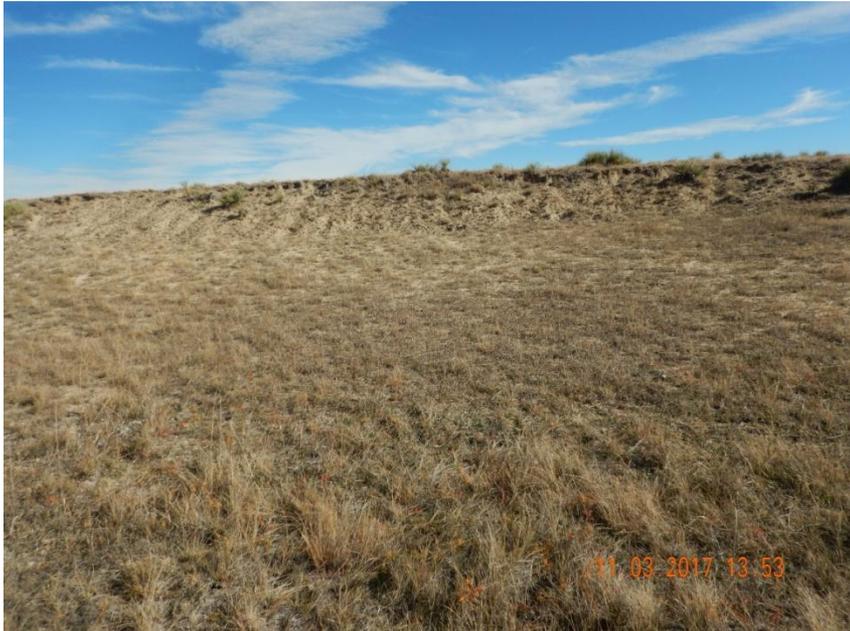
Photo 7. Photo taken of the eastern well location on November 3, 2017, facing East. Operator has not reclaimed the location per Rule 1004 standards. The location has not been contoured to match the surrounding landscape. Rill erosion evident along the eastern cut slope.

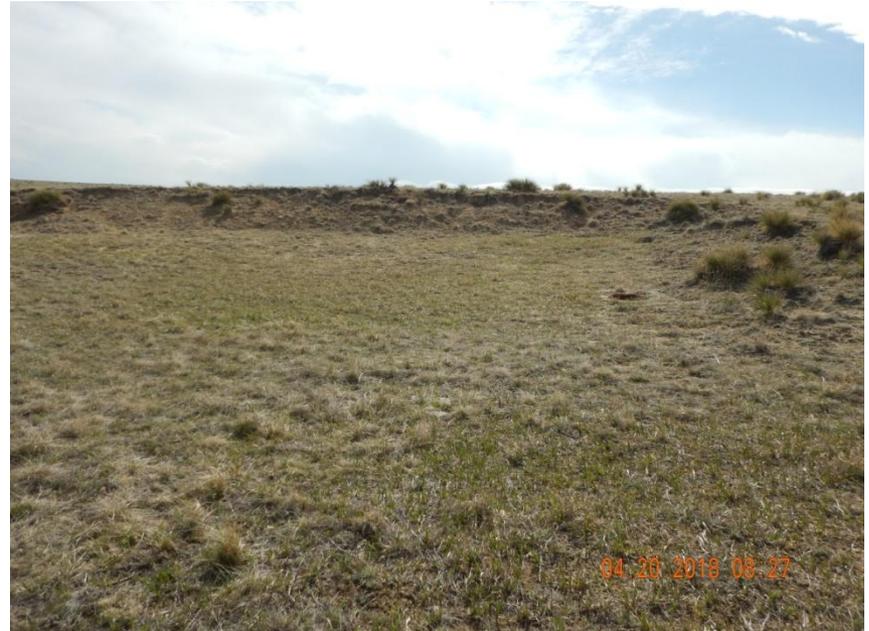
Photo 8. Photo taken of the eastern well location on April 20, 2018, facing East. Operator has failed to complete final reclamation activities.

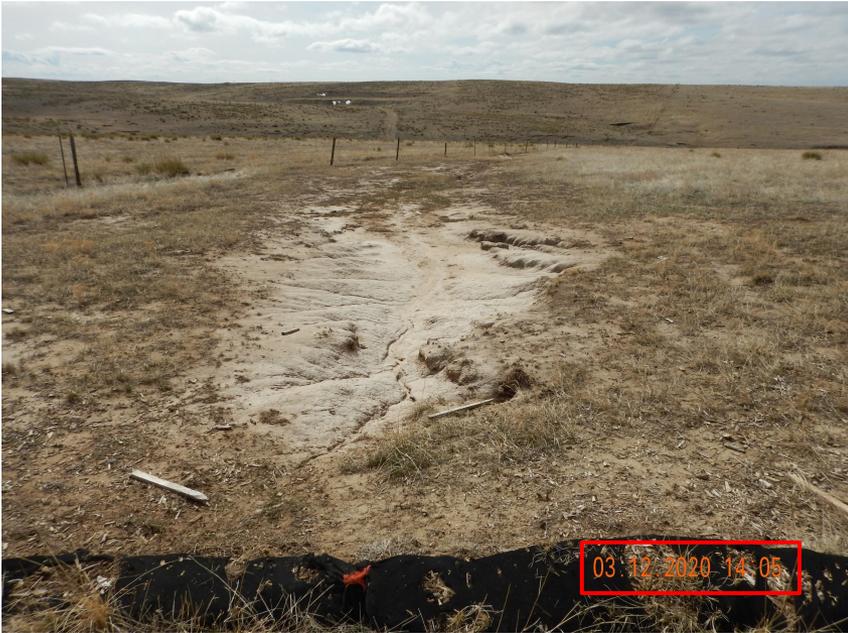
Photo 9. Photo taken from the western battery location on 3/12/2020, facing West. Photo illustrates Operator has failed to conduct any of previous corrective actions- refer to Photos 3-6.

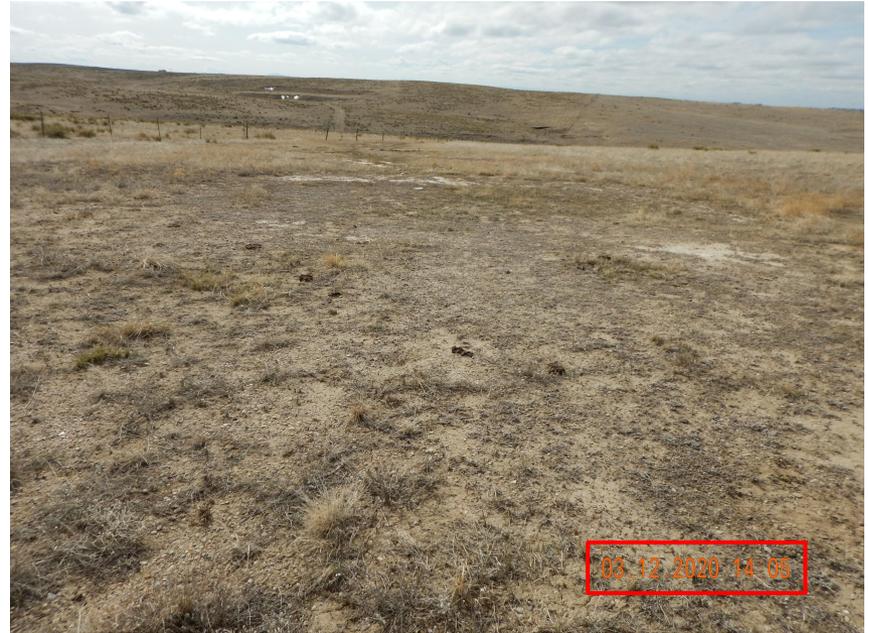
Photo 10. Photo taken from the western battery location on 3/12/2020, facing West. See comments under Photo 9.

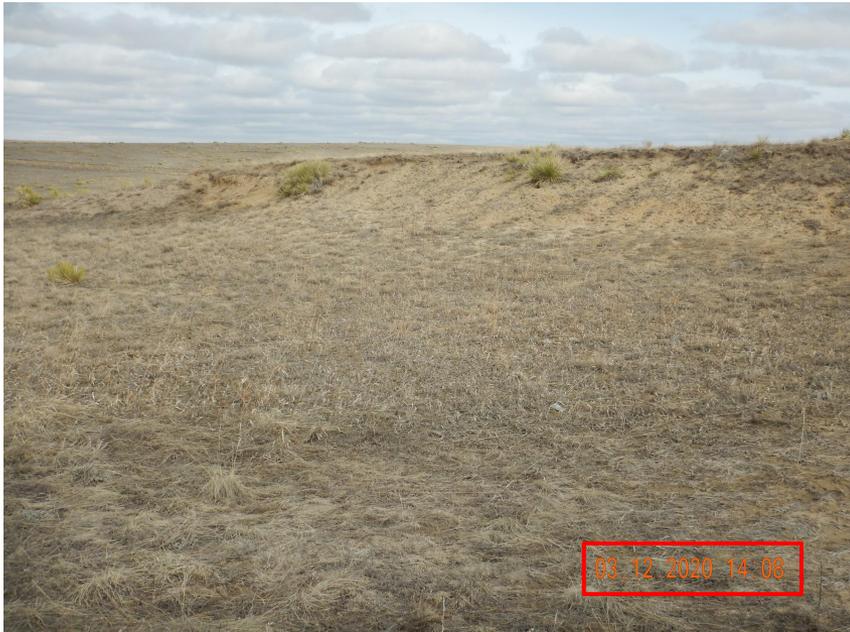
Photo 11. Photo taken of the eastern well location on 3/12/2020, facing Northeast. Photo illustrates Operator has failed to conduct any of previous corrective actions- refer to Photos 7-8.

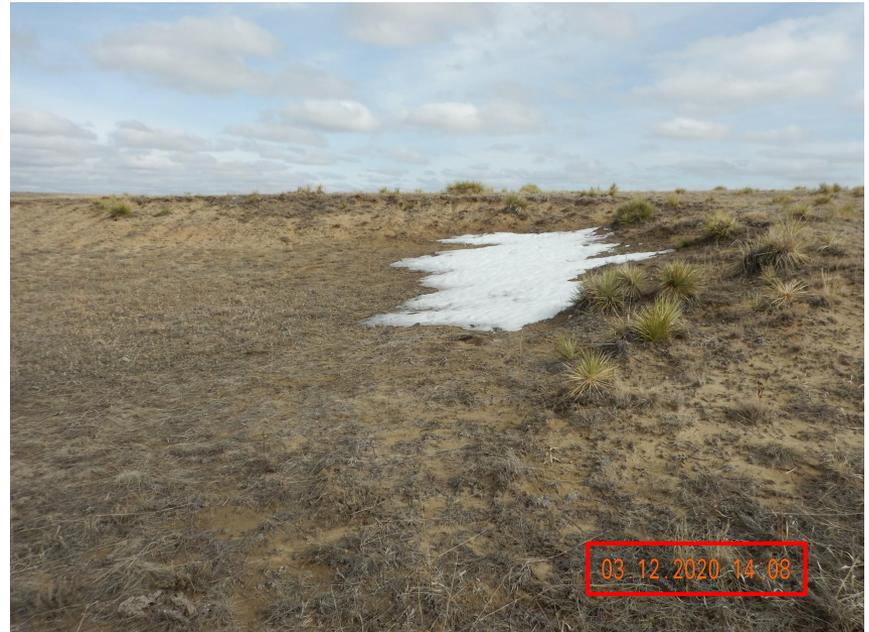
Photo 12. Photo taken of the southeastern well location on 3/12/2020, facing East. See comments under Photo 11.
