Inspection Photos  
Spill Fac ID 473059  
Inspection Date: 3/10/2020  
All Photos taken by Kris Neidel

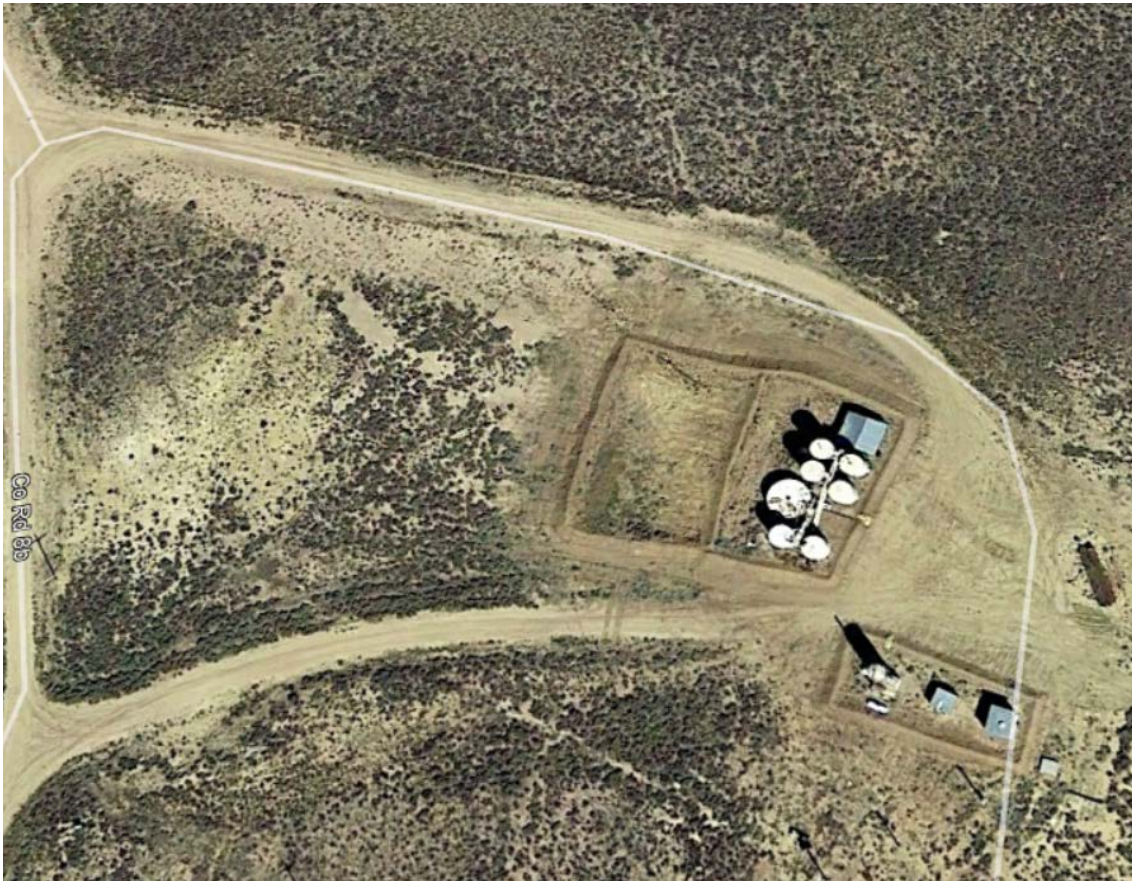
Aerial Photo, provided to give context to photos. Berm west of tanks separates the tank battery from lower level secondary containment.

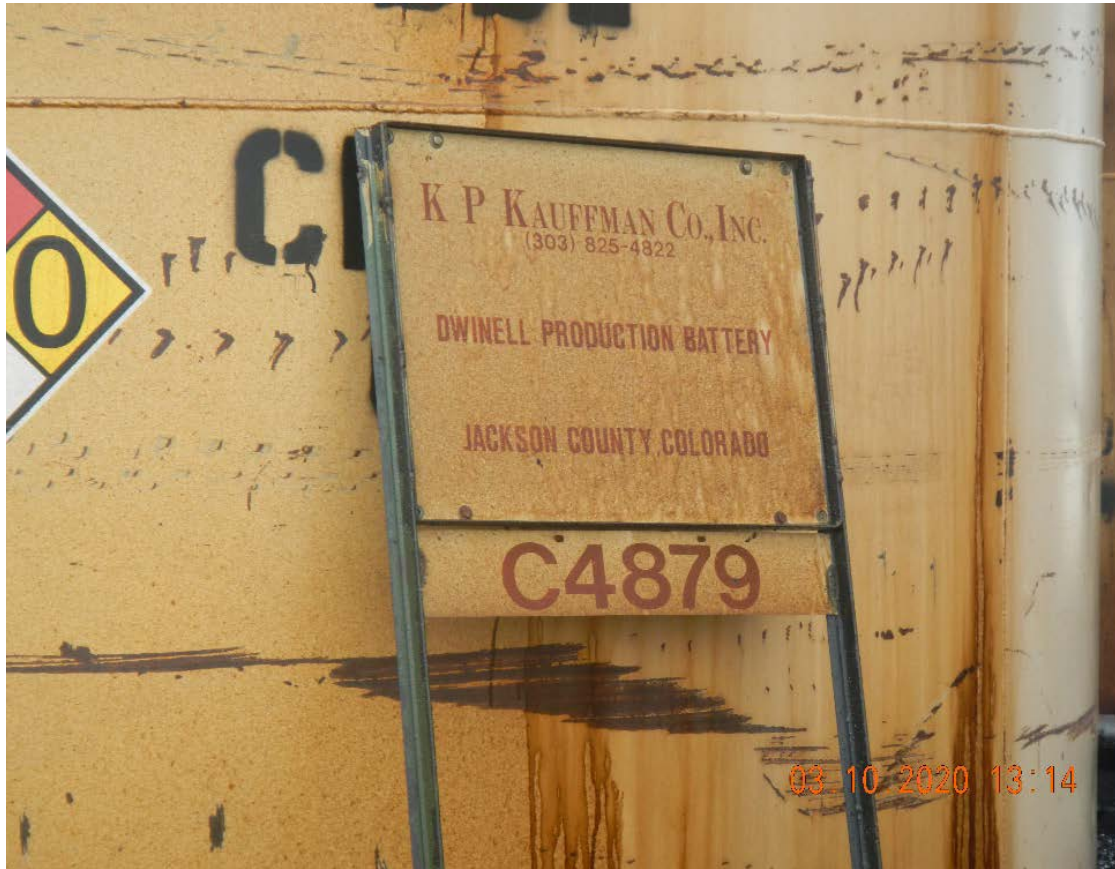
Photo #1 tank battery sign. Hydrocarbon impacts on sign.

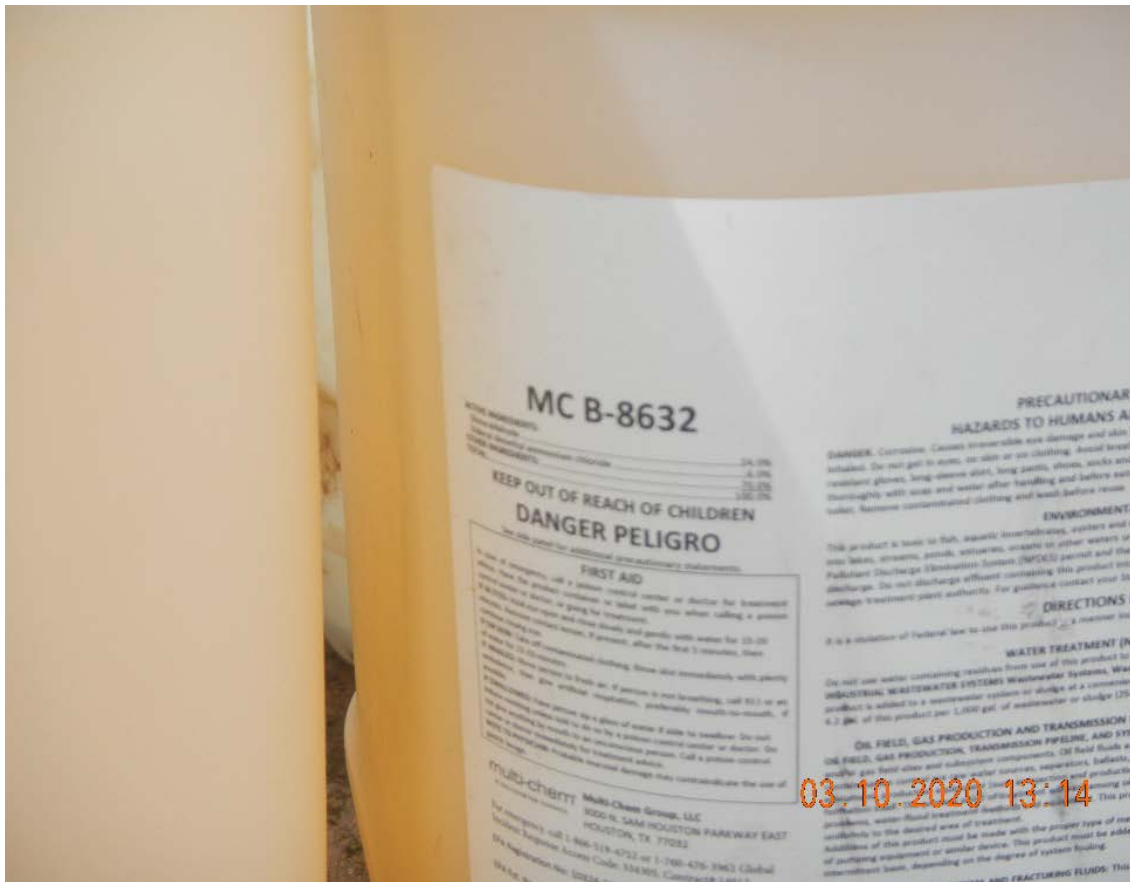
Photo #2 Chemicals at tank battery.

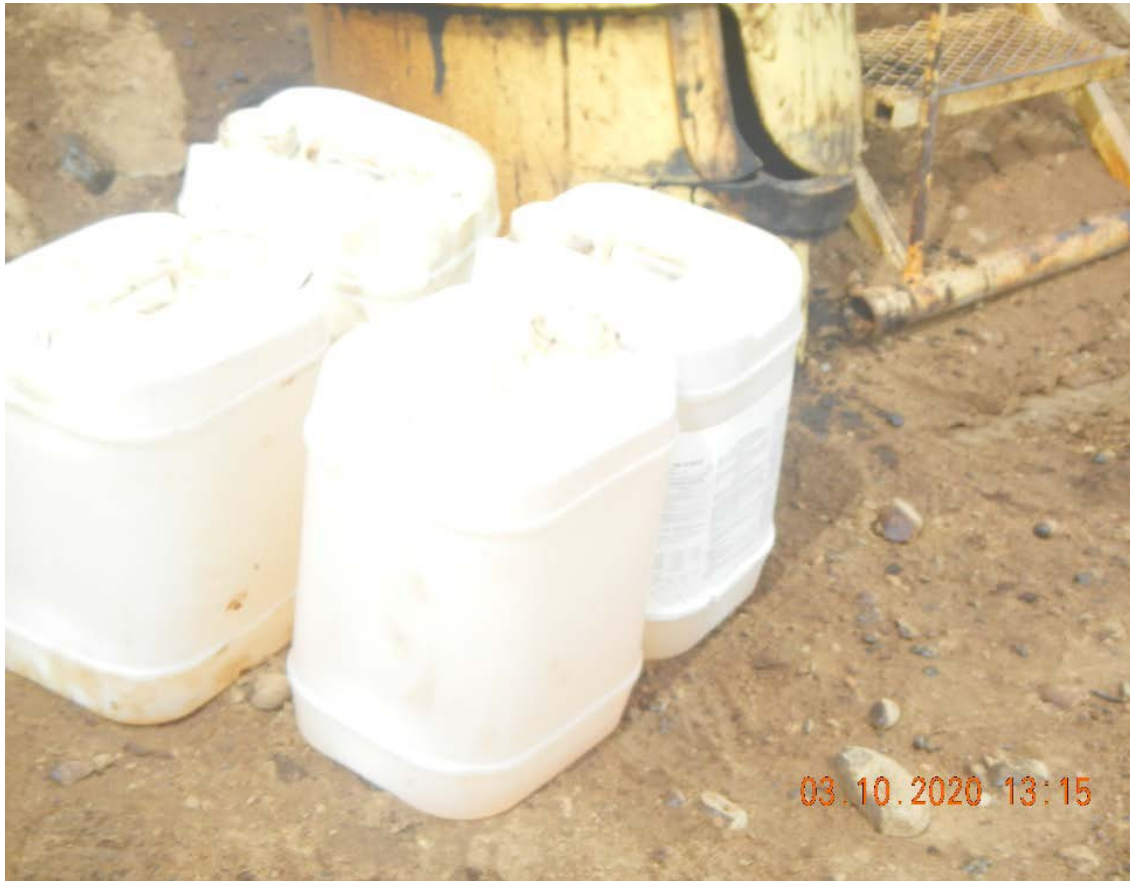
Photo #3 Chemicals at tank battery

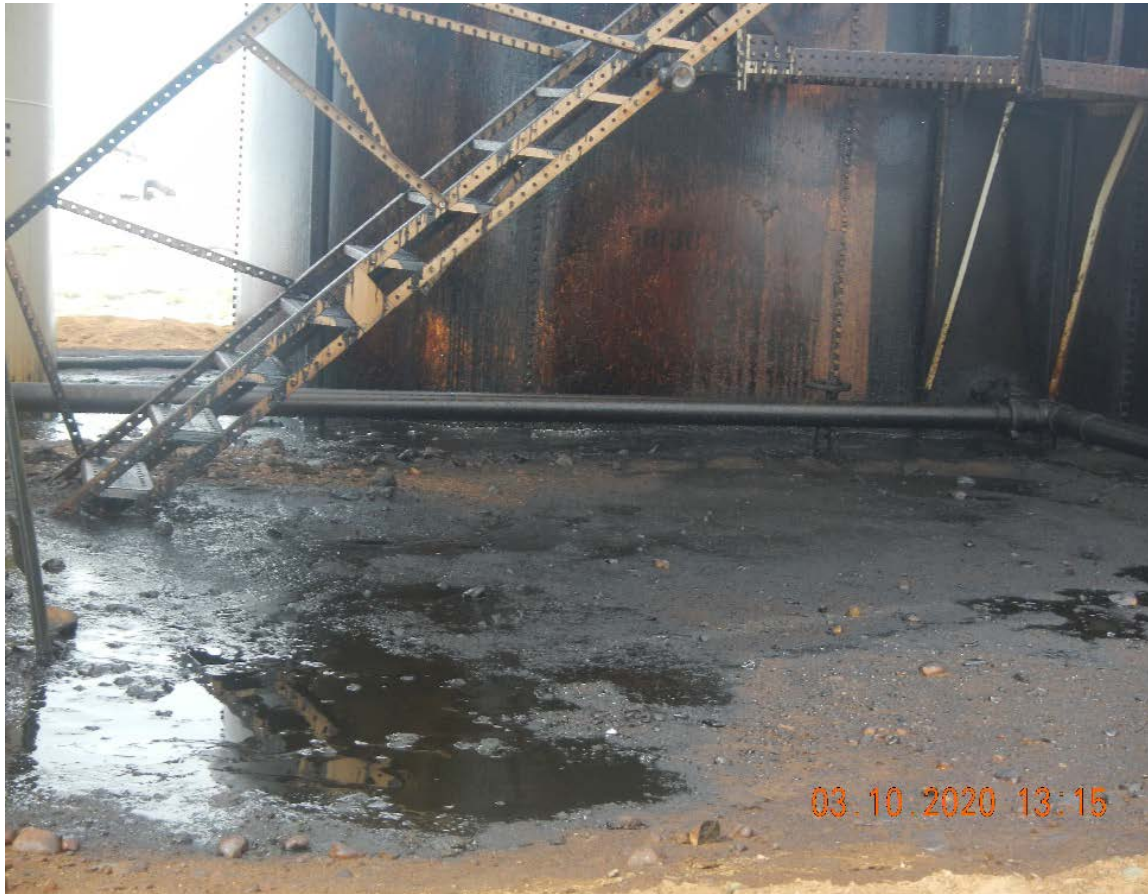
Photo #4 upper portion of tank battery. Note: staining on tank  
this tank overtopped.

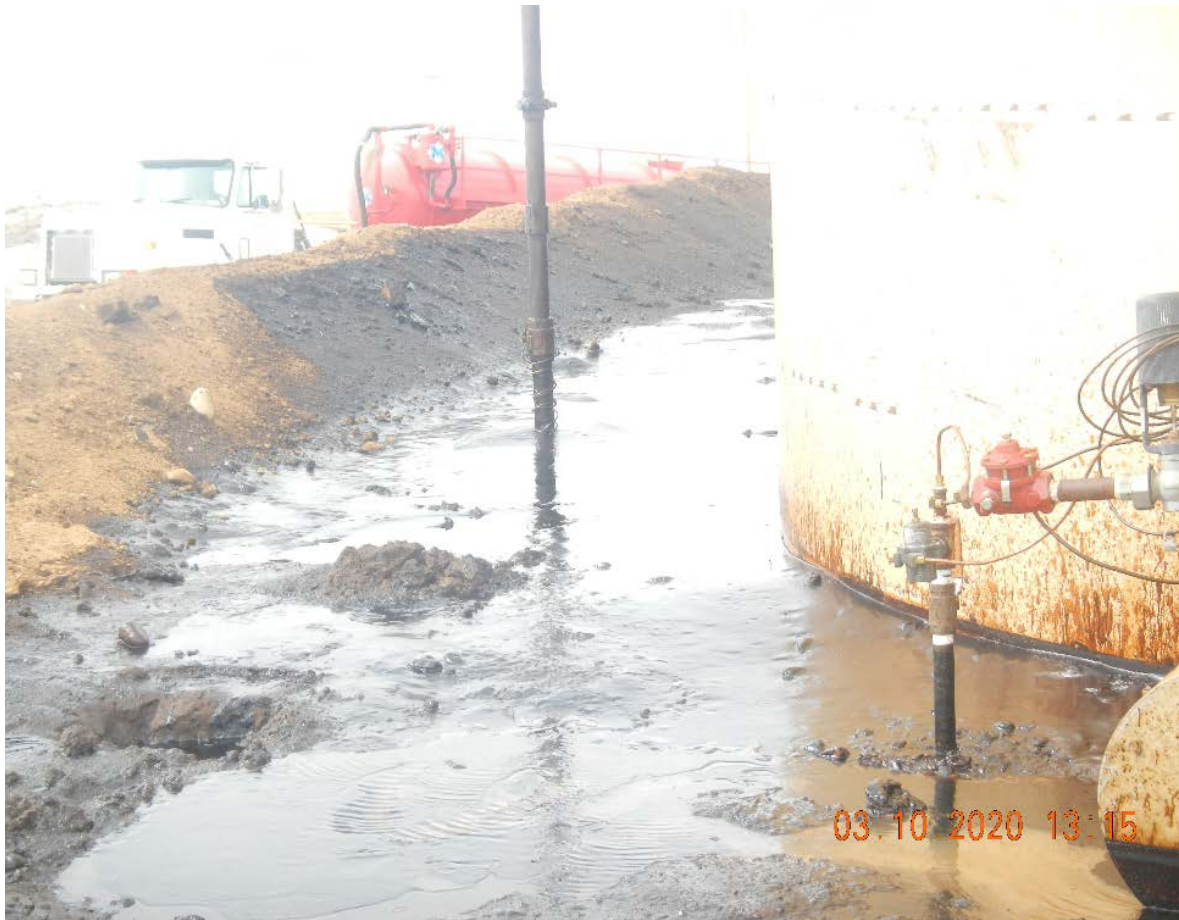
Photo #5 photo taken looking west. Tank in photo is the south end of the tank battery.

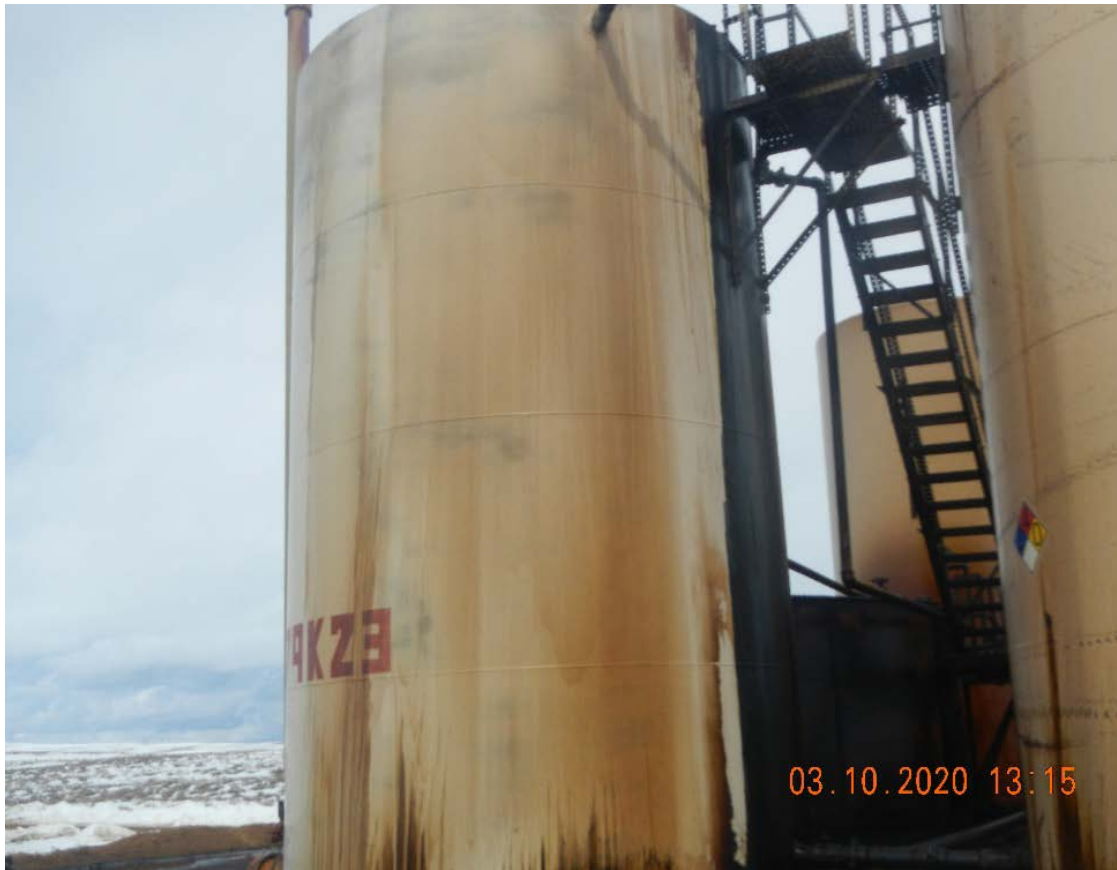
Photo #6 looking north. Tank overtopped.

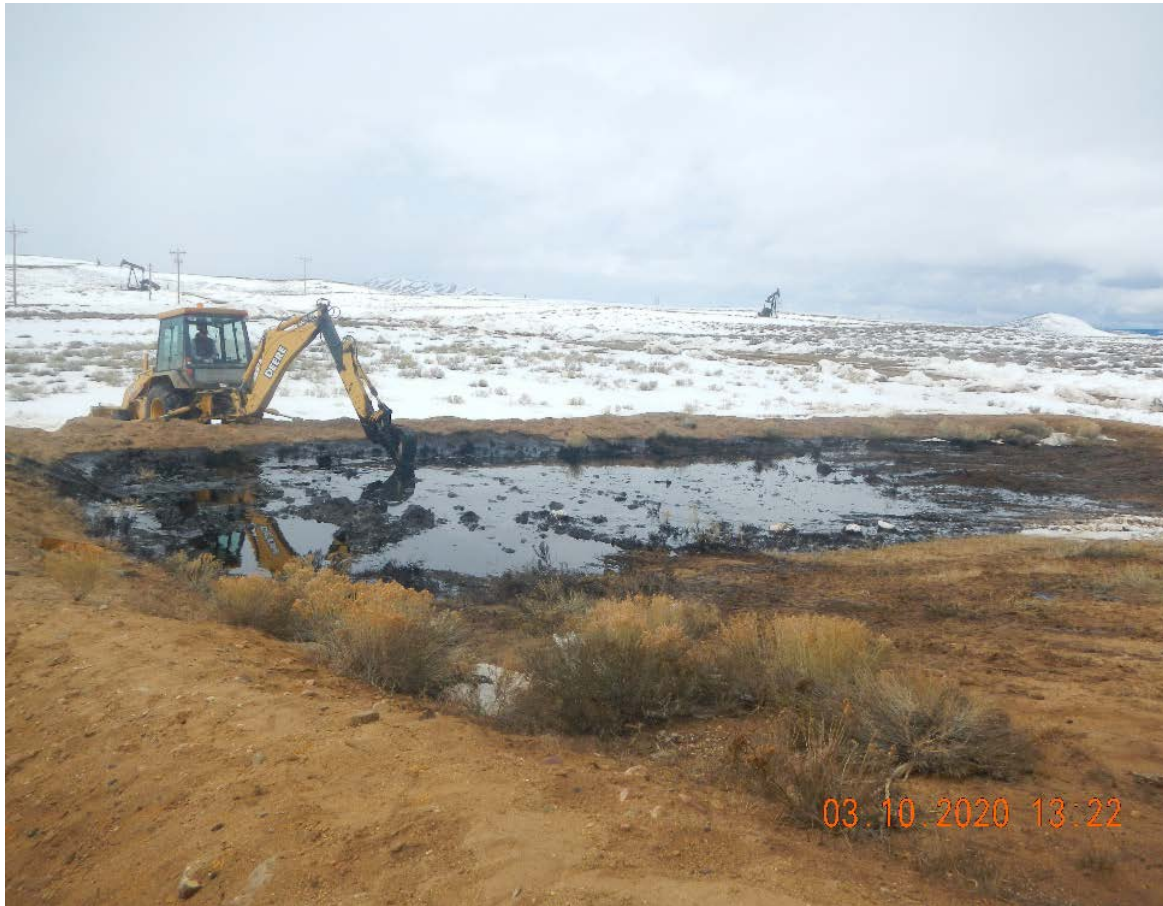
Photo #7 Pooled Oil in the lower level secondary containment.

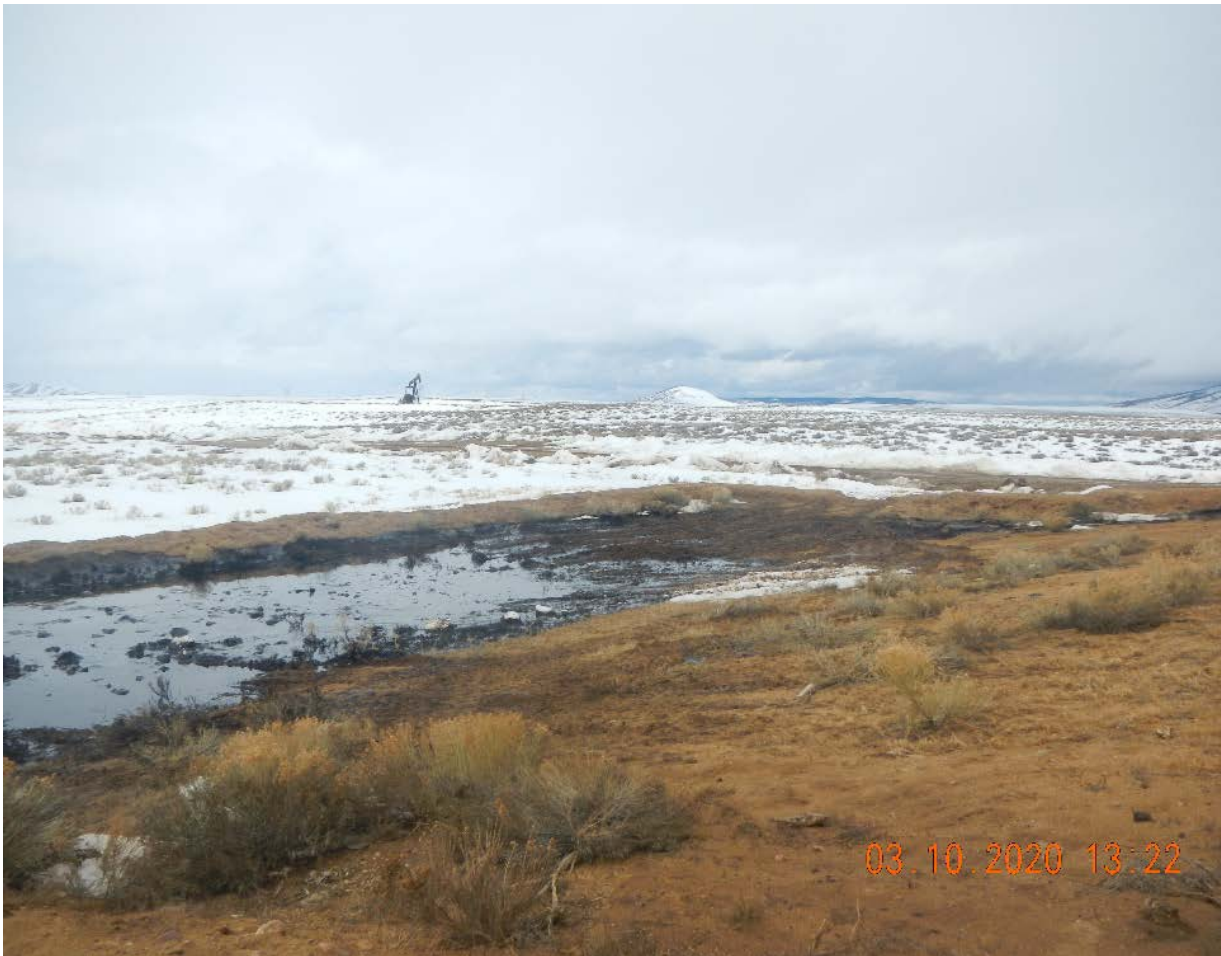
Photo #8 looking northwest at lower level of secondary containment. It is hard to see in this photo, soils were surface scraped to push oil to the south-west corner for vacing.

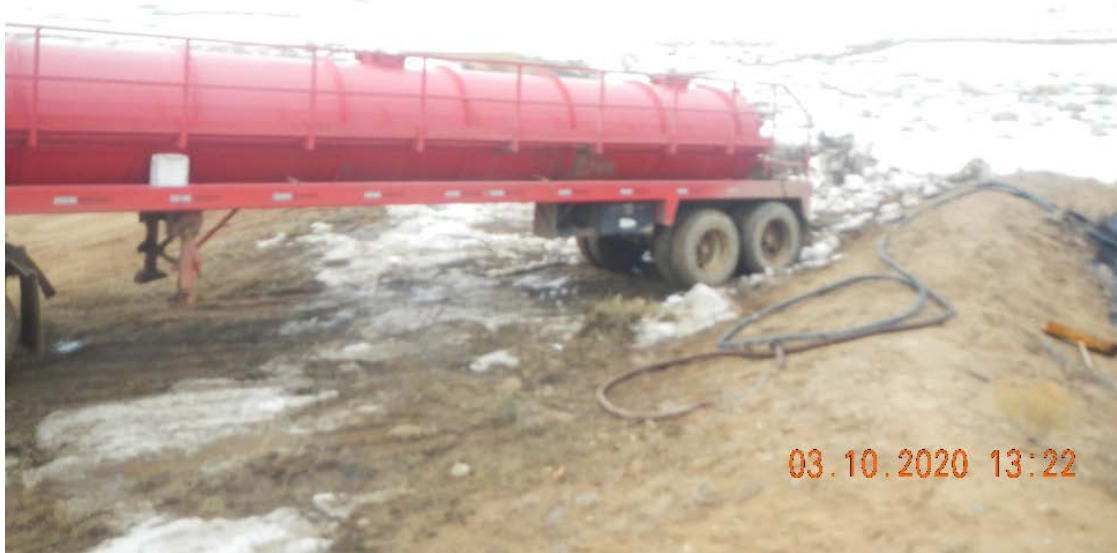
Photo #9 Water truck vacing up oil/water.

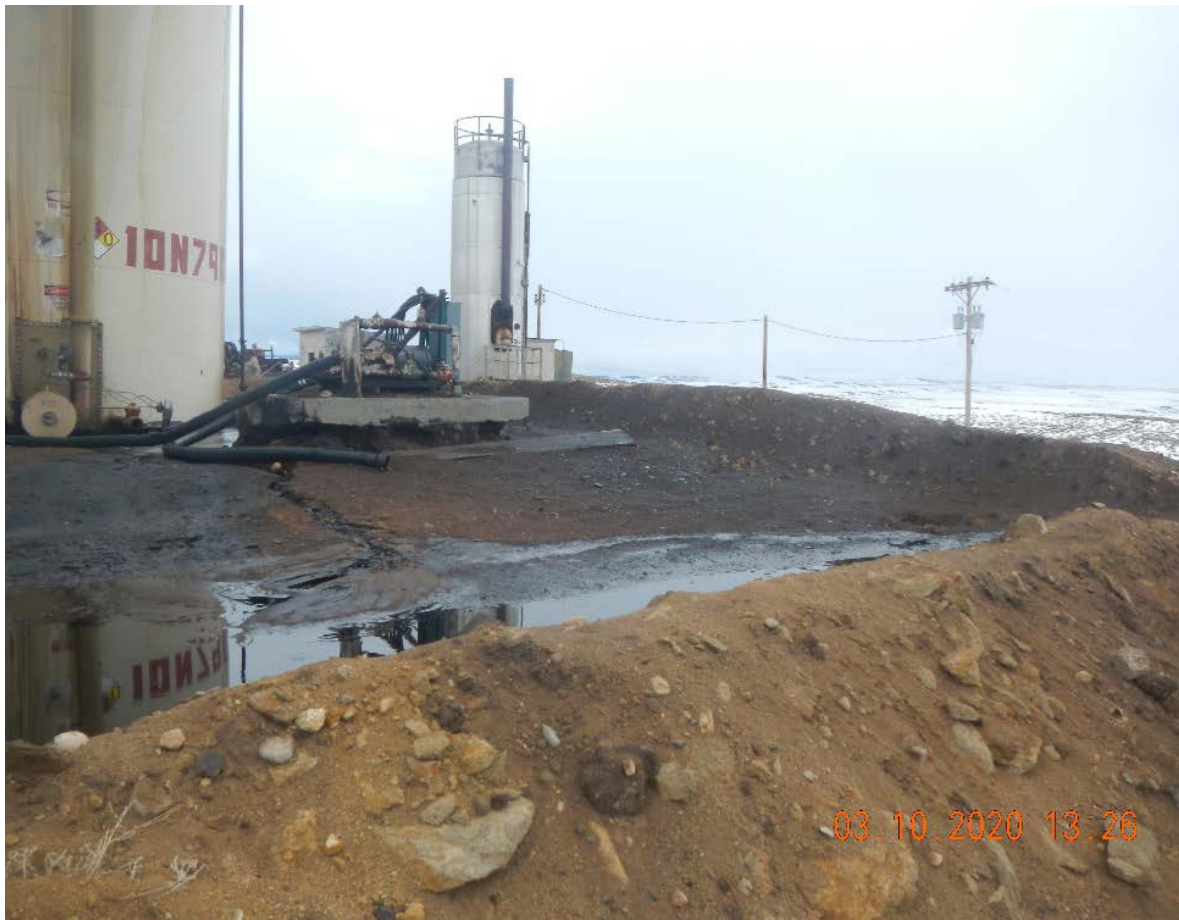
Photo #10 camera is sanding in lower level secondary containment. Looking southeast.

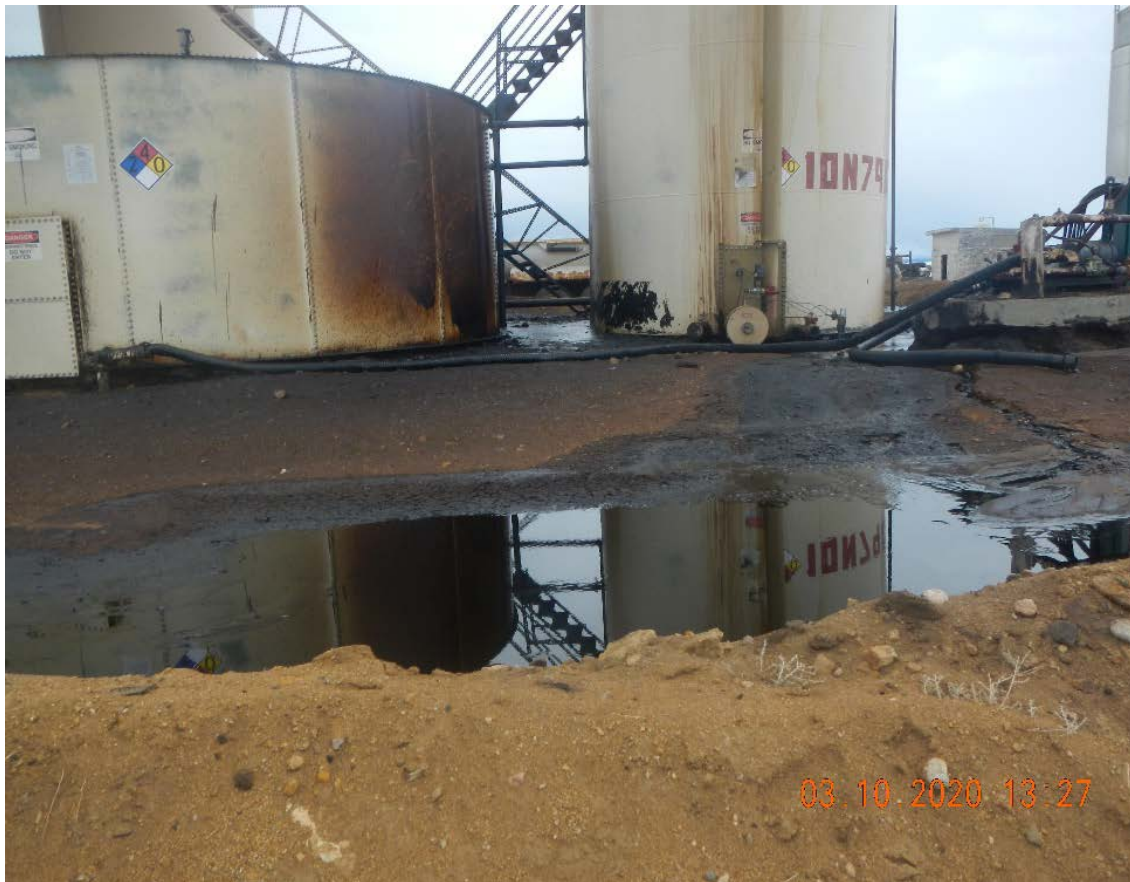
Photo #11 Camera is inside of lower level secondary containment, looking at tank battery level.

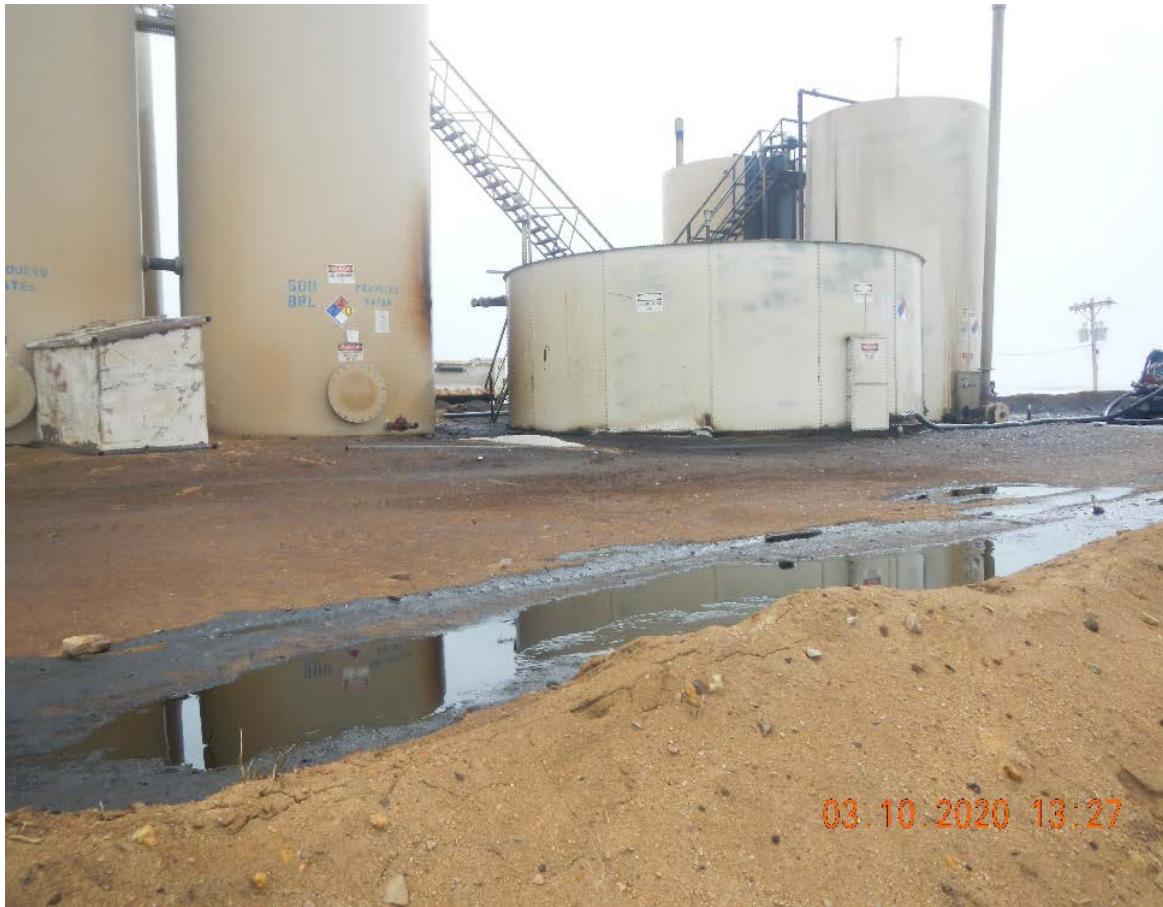
Photo #12 Camera is inside of lower level secondary containment, looking at tank battery level.

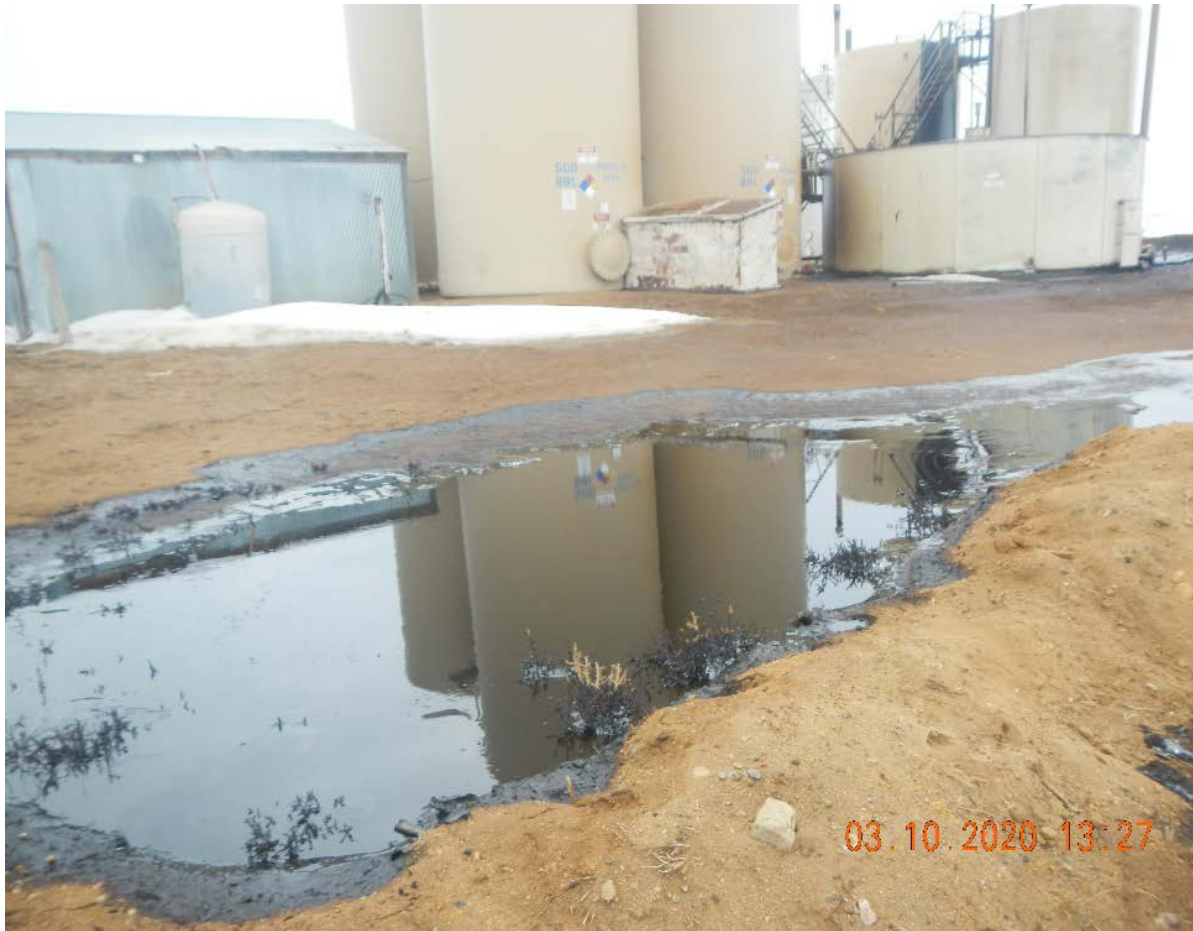
Photo #13 Pooled oil from tank battery level. This is where oil transferred to the lower level of the secondary containment, note black soil at lower right of photo.

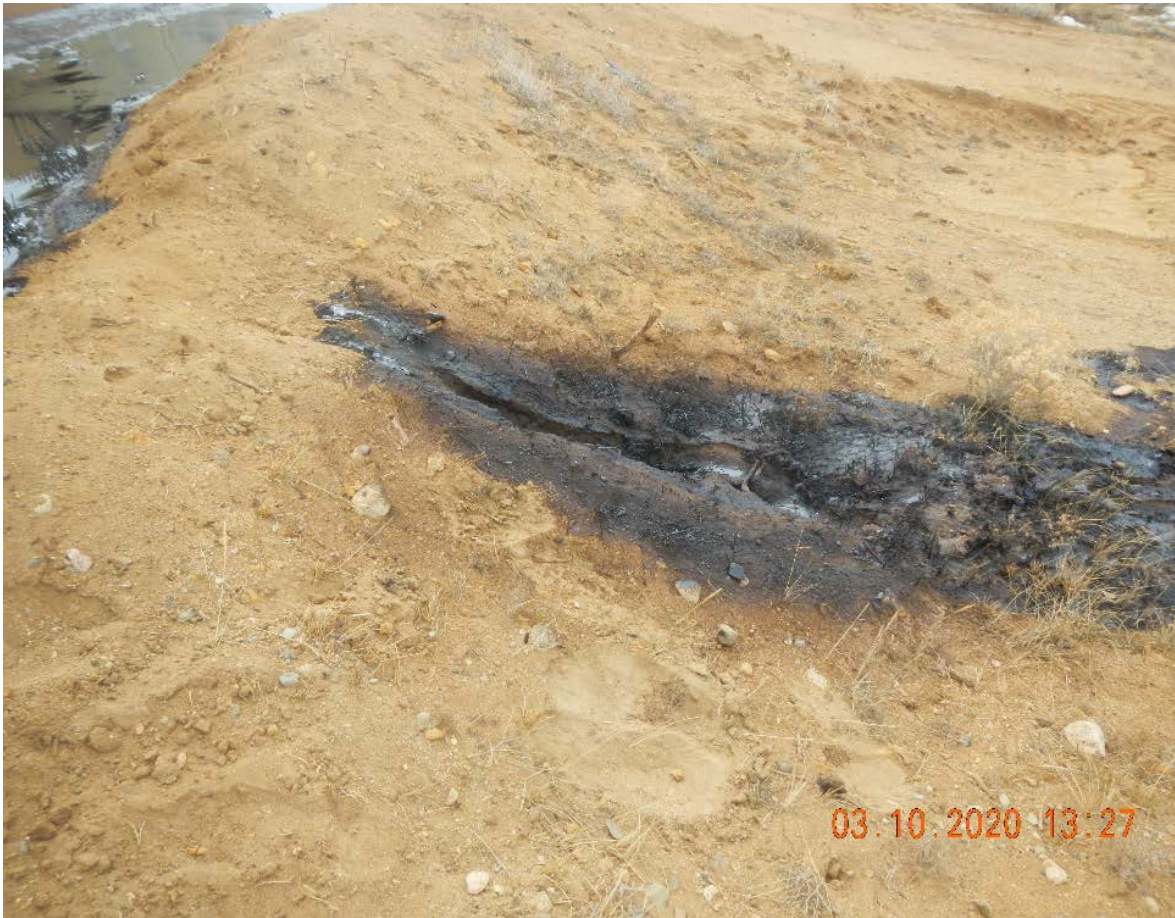
Photo #14 Area where spill flowed from upper tank battery to lower level secondary containment.

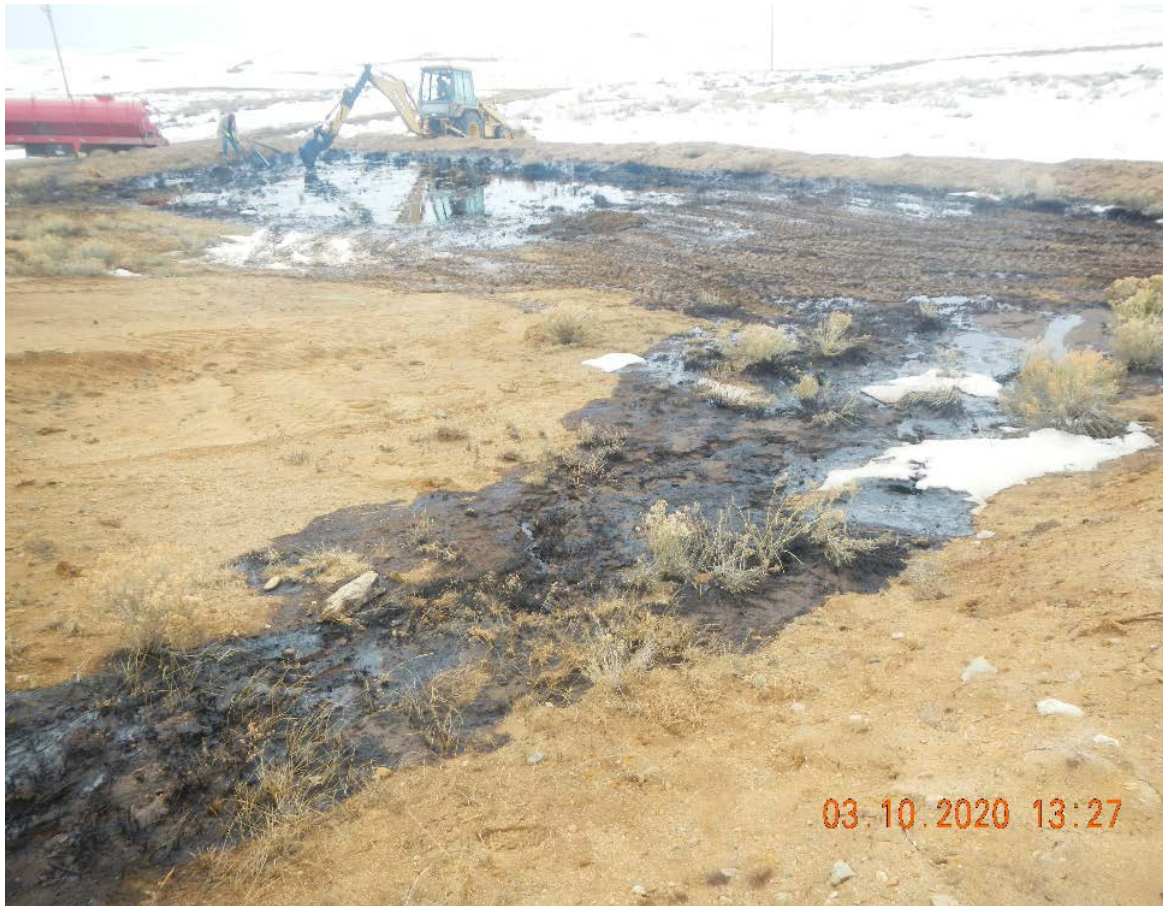
Photo #15 spill flowed from left of photo to western berm of the lower level secondary containment. Spilled fluid was pushed to the southwest side of the containment area for vacing.

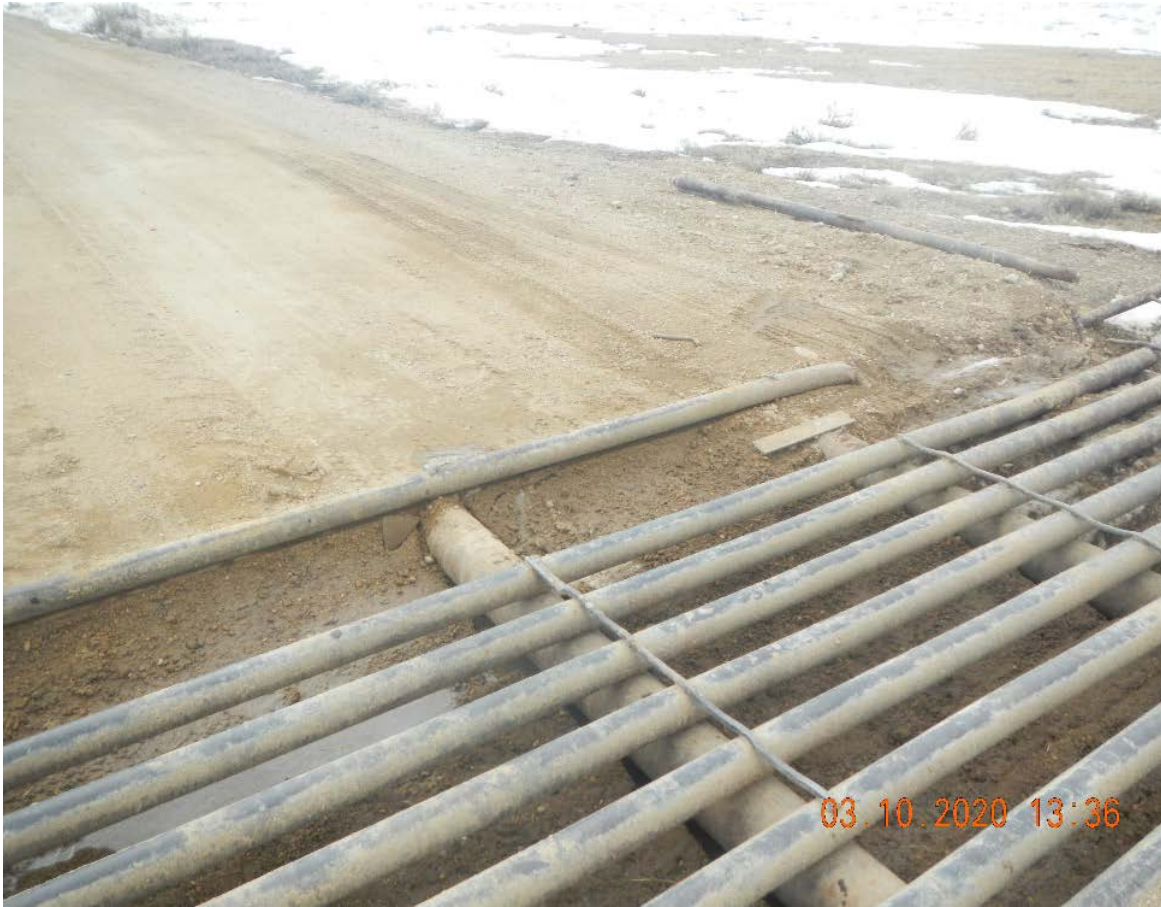
Photo #16 cattle guard on county Rd 8. COGCC notified KPK staff and Jackson County Road and Bridge. R&B was headed out from the shop to mark the cattle guard for safety prior to repair.
