Inspection Photos

API: 071-09051

Operator: WAPITI OPERATING LLC

Inspection Date: 3/17/2020

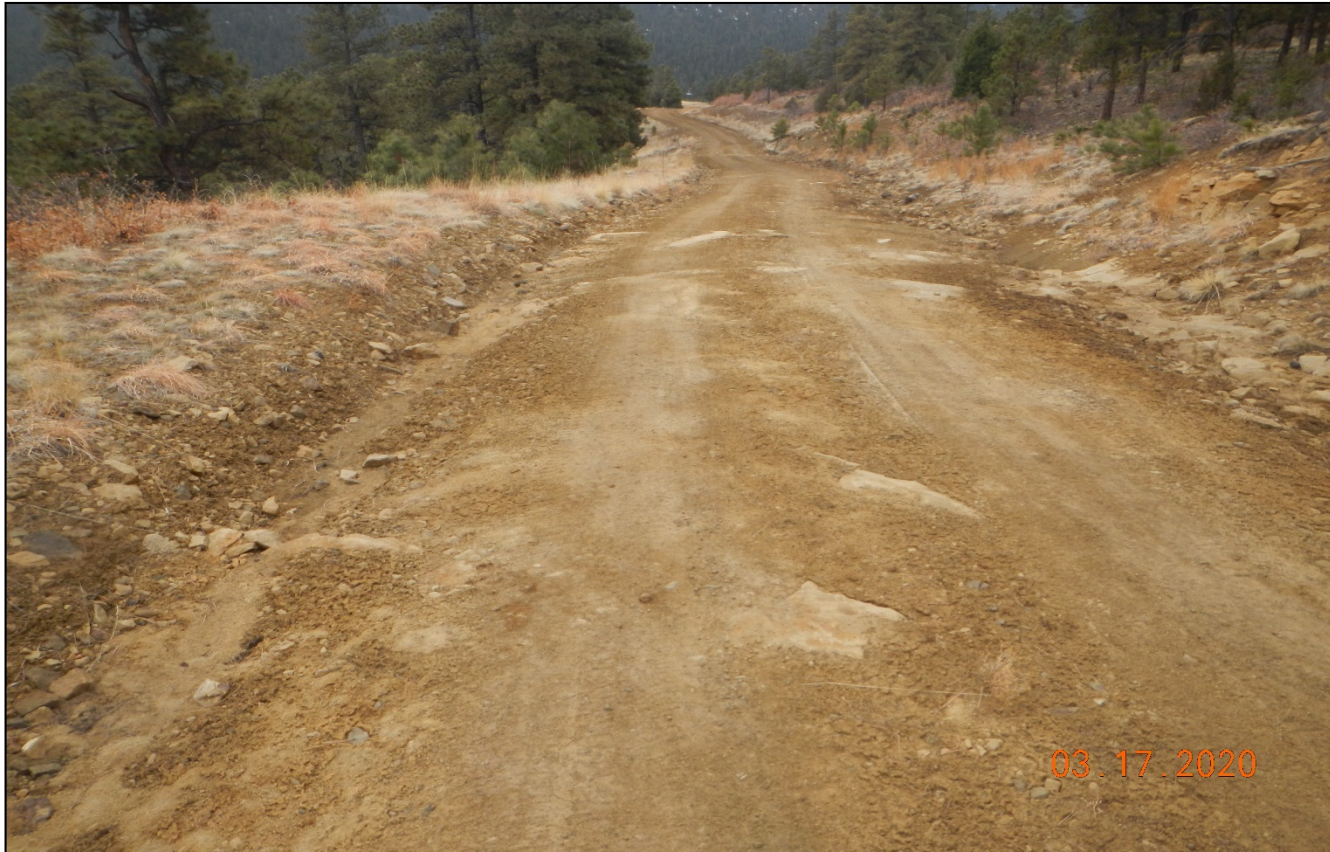
Photo 1. Facing south along the access road. The road has been graded.

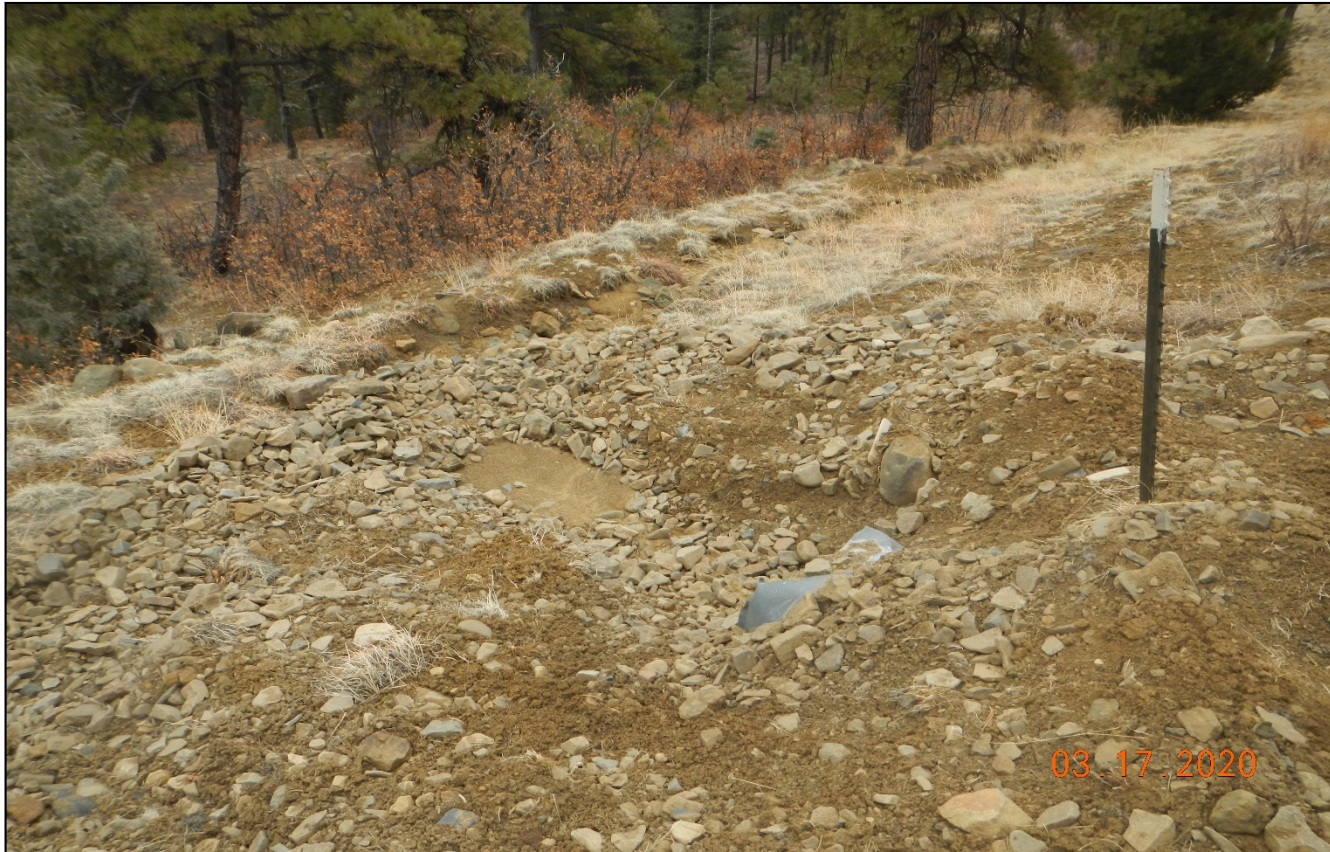
Photo 2. It appears rock rip/rap was placed at the culvert outlet and is capturing sediment. This may need to be cleaned at and enlarged.

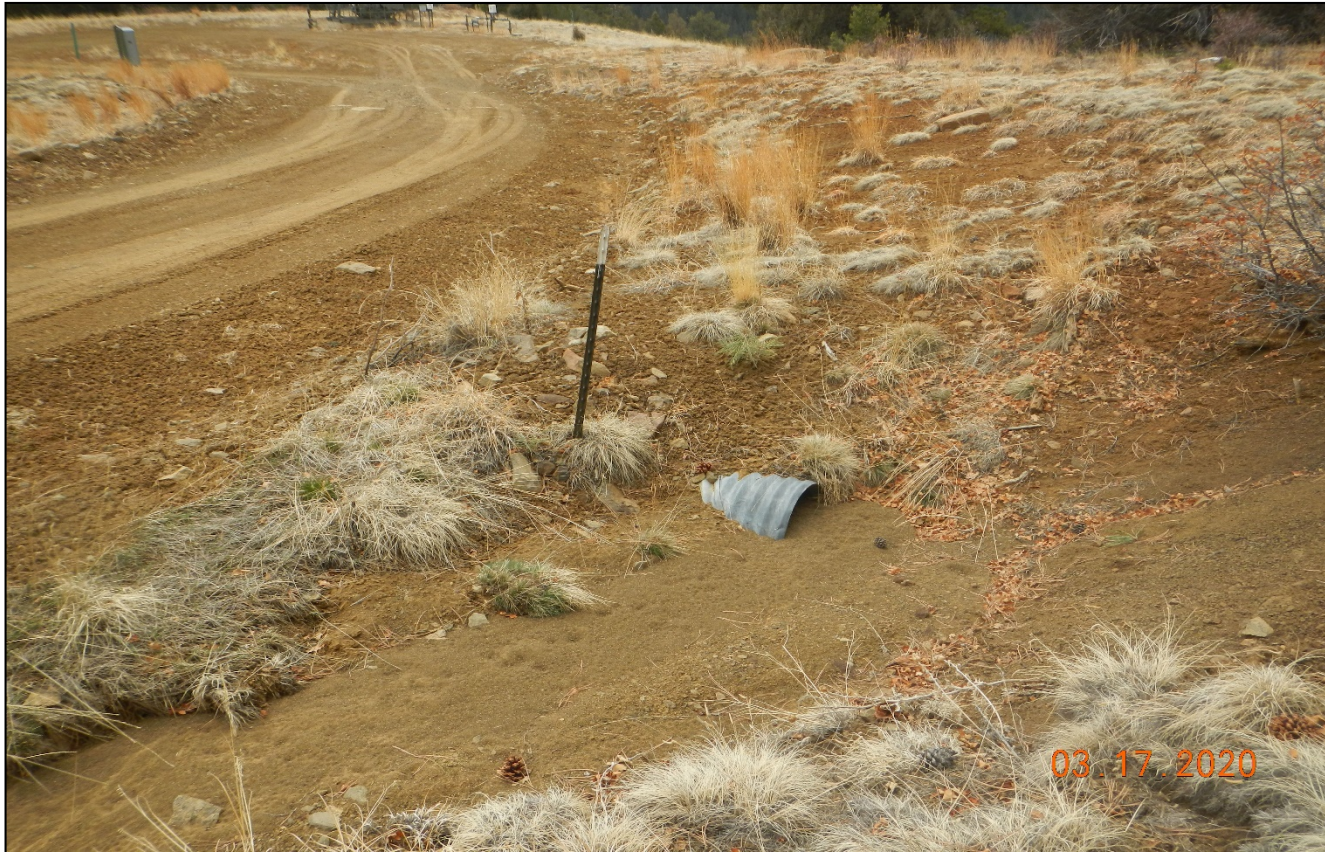
Photo 3. The culvert inlet is filling in with sediment and needs to be cleaned out. BMP's may need to be installed up hill from the culvert to prevent sediment accumulation at culvert inlet.

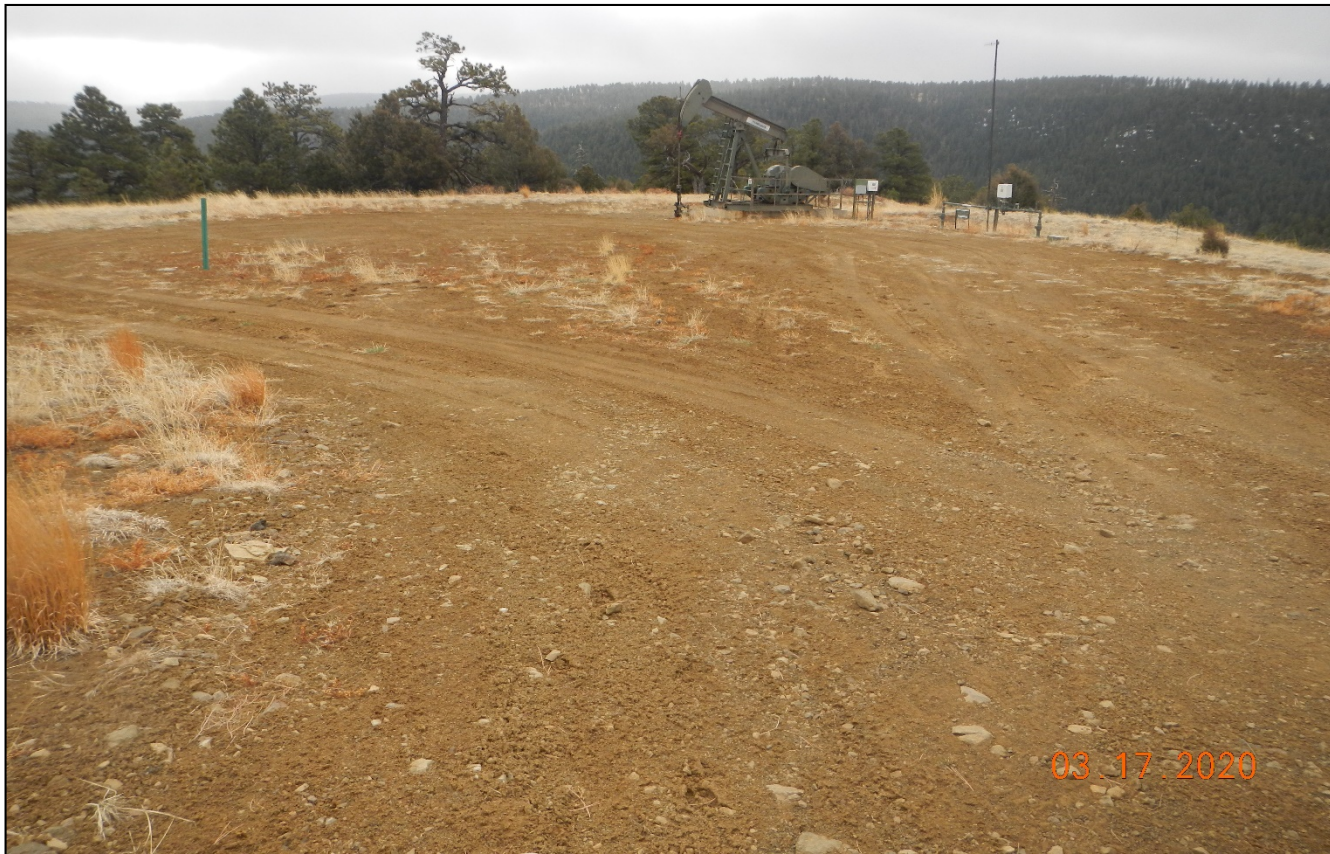
Photo 4. Facing southeast toward the location.
