Inspection Photos

API: 071-09108

Operator: TIMBER CREEK OPERATING

Inspection Date: 3/19/2020

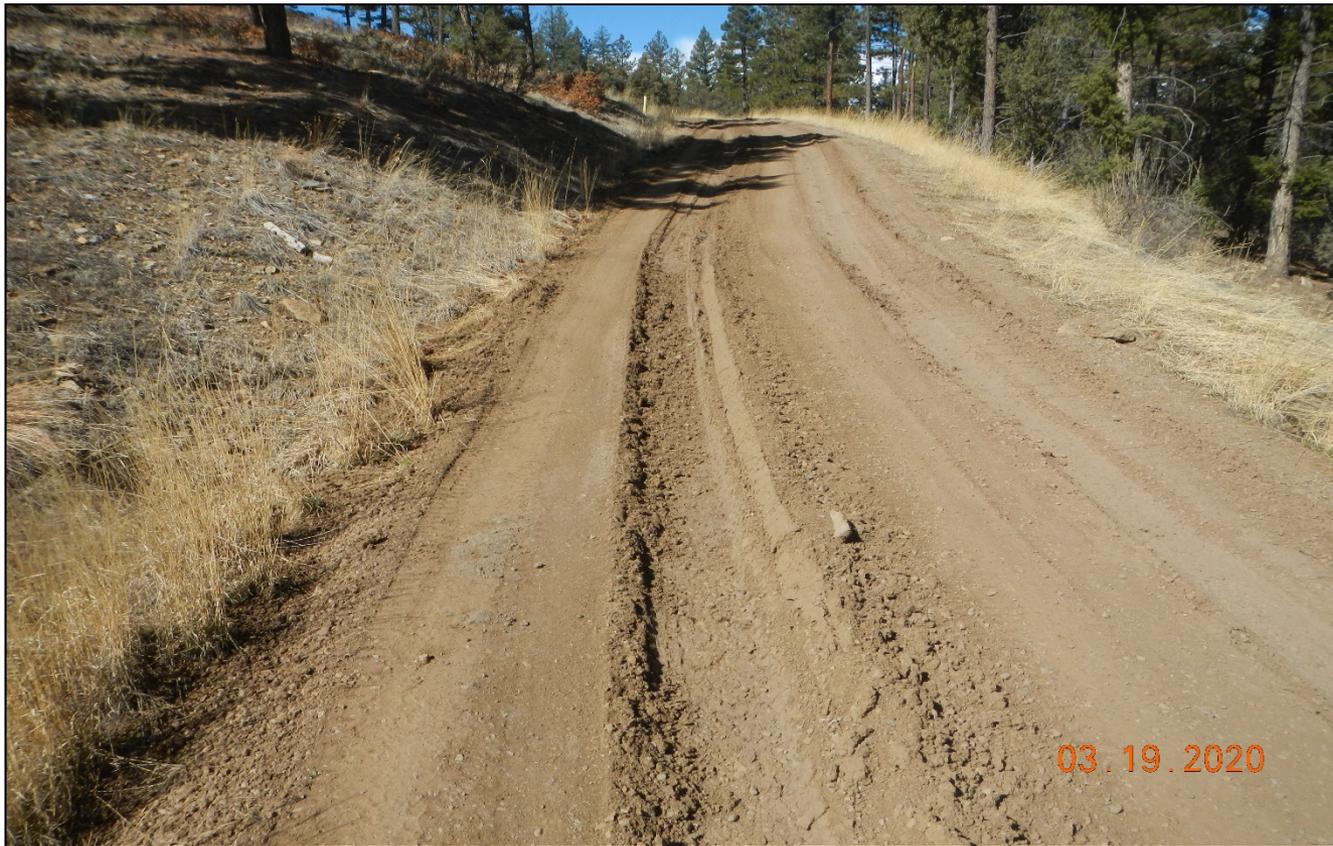
Photo 1. Facing southwest along the access road. There are vehicle ruts along the road. The road needs to be graded and maintained.

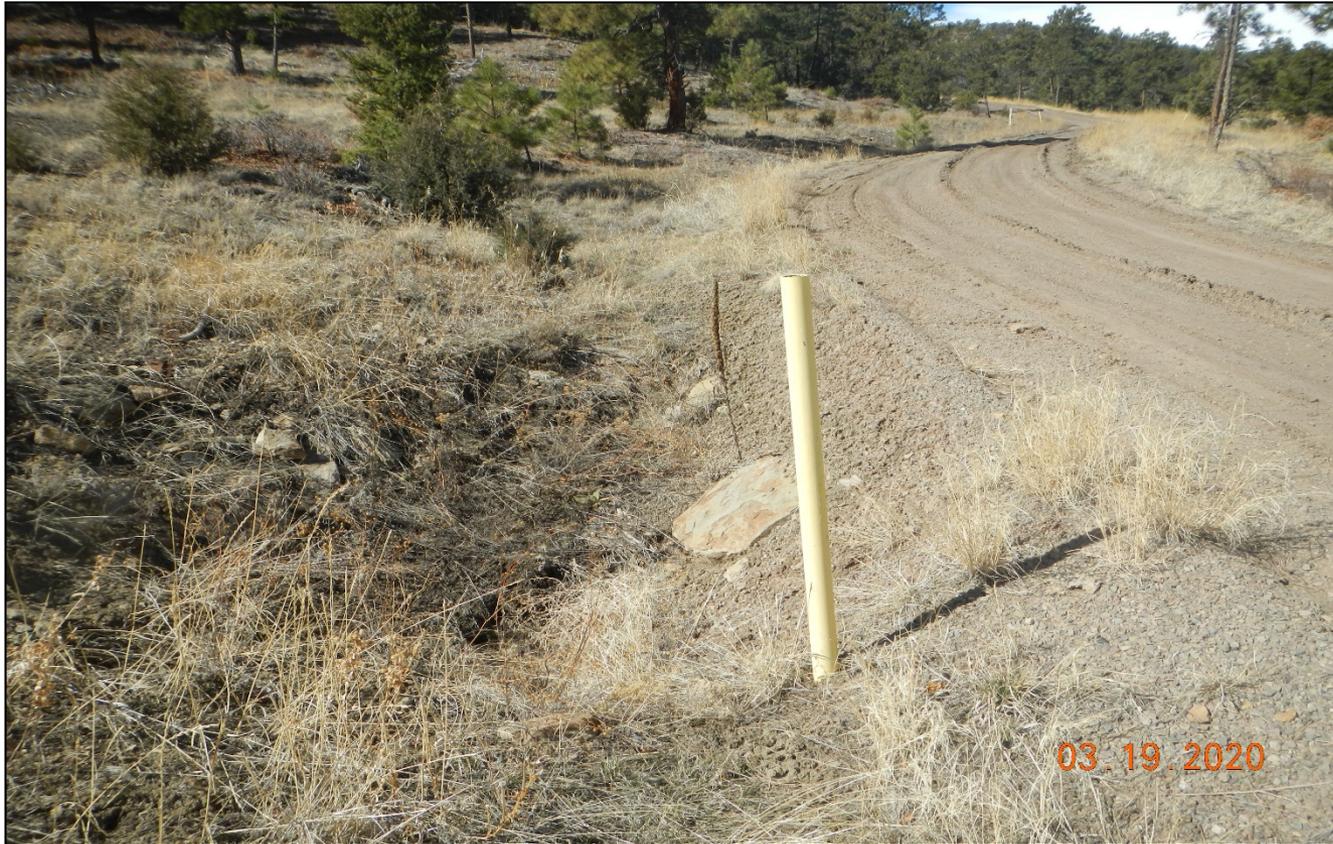
Photo 2. The culvert along the access road is filled in with sediment.

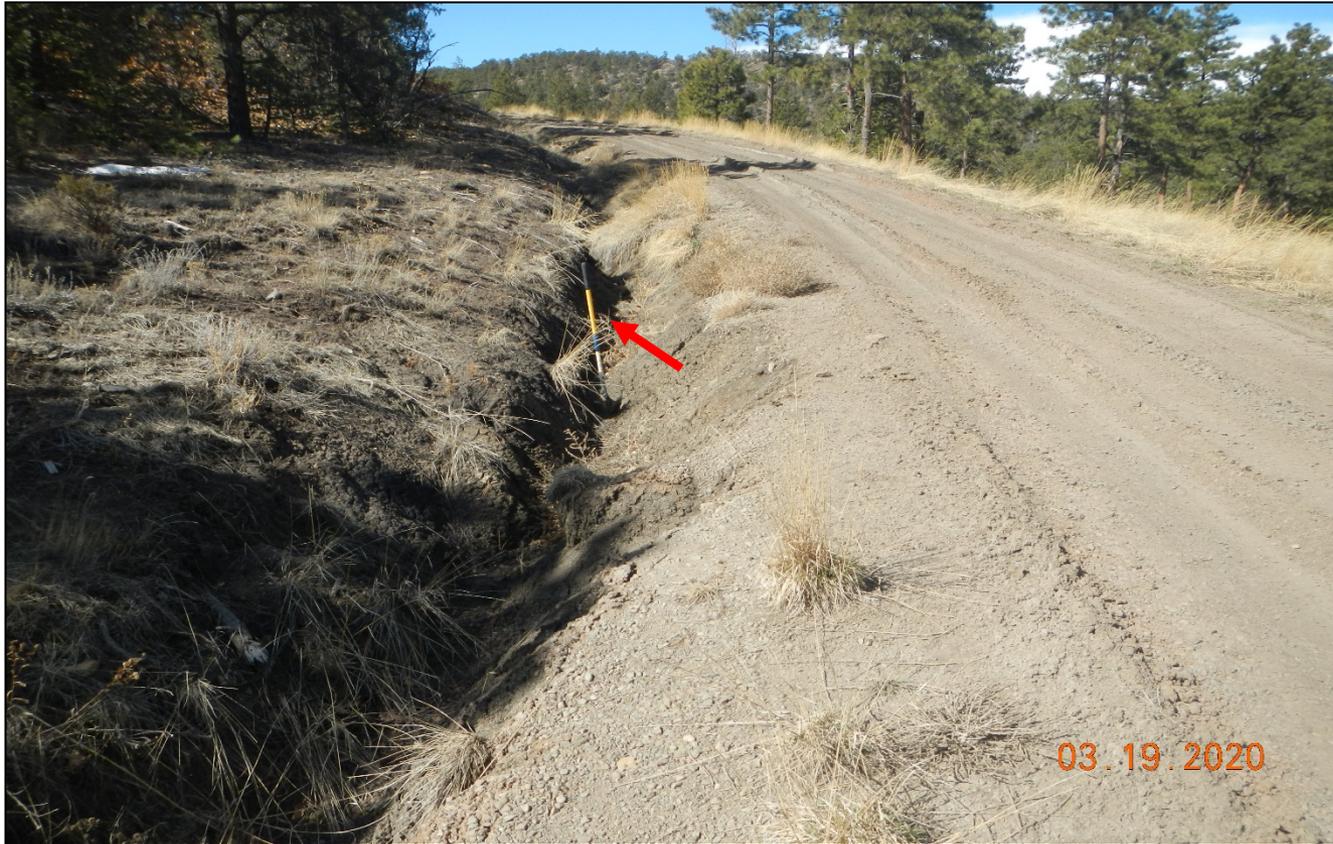
Photo 3. There is erosion occurring on the side of the access road that needs to be repaired and stabilized. Arrow points to 4.5 ft. shovel for scale.

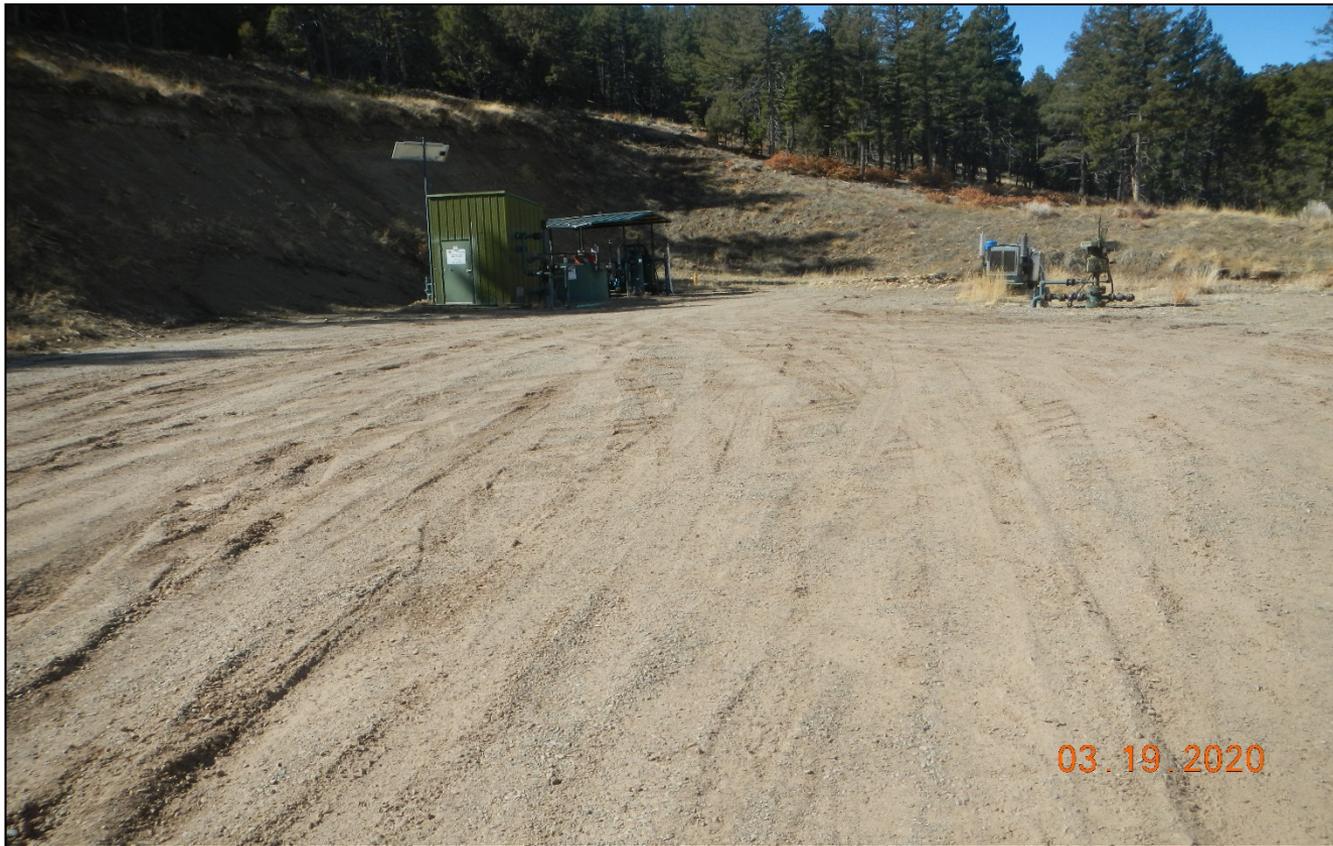
Photo 4. Facing southwest toward the location.

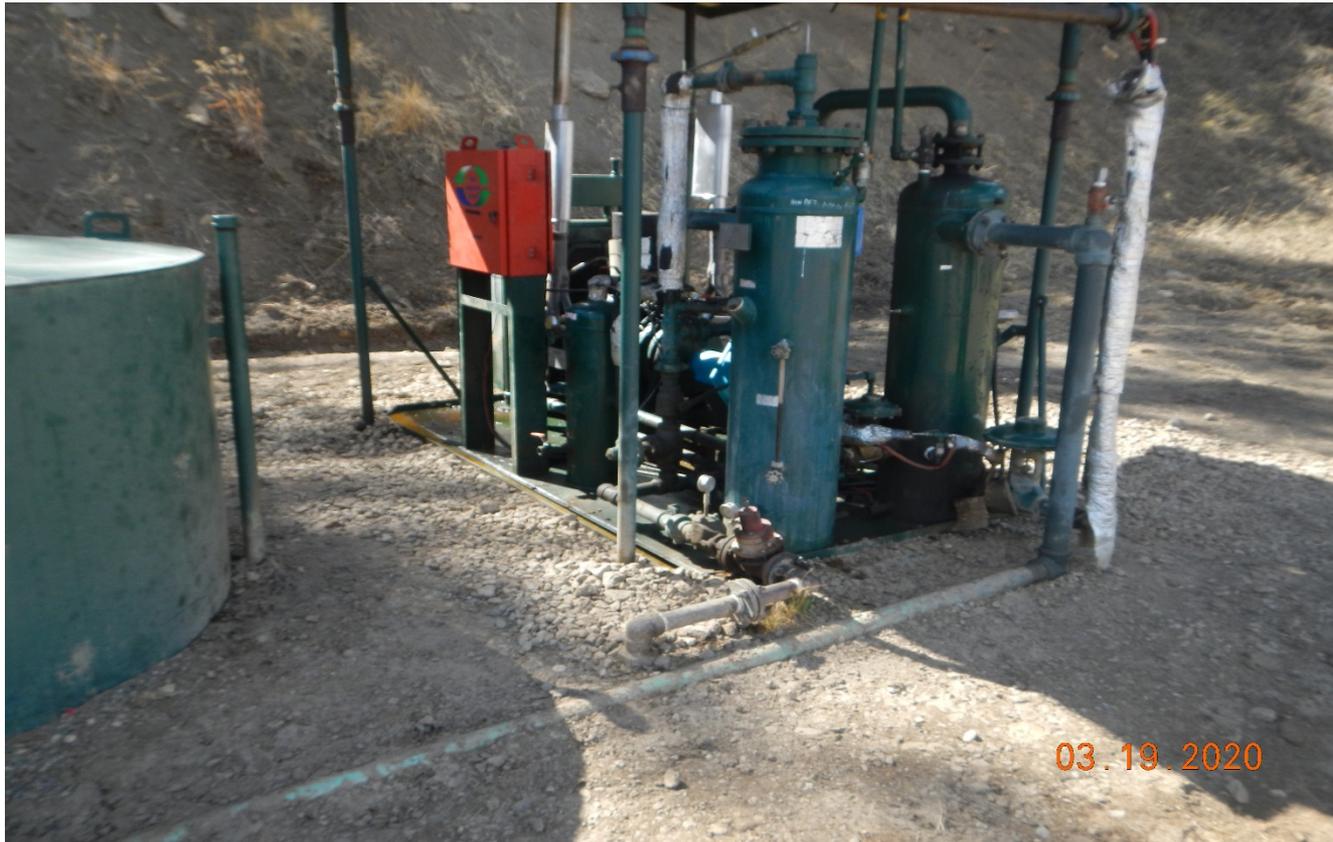
Photo 5. The oil on the engine skid has been cleaned up since previous inspection.

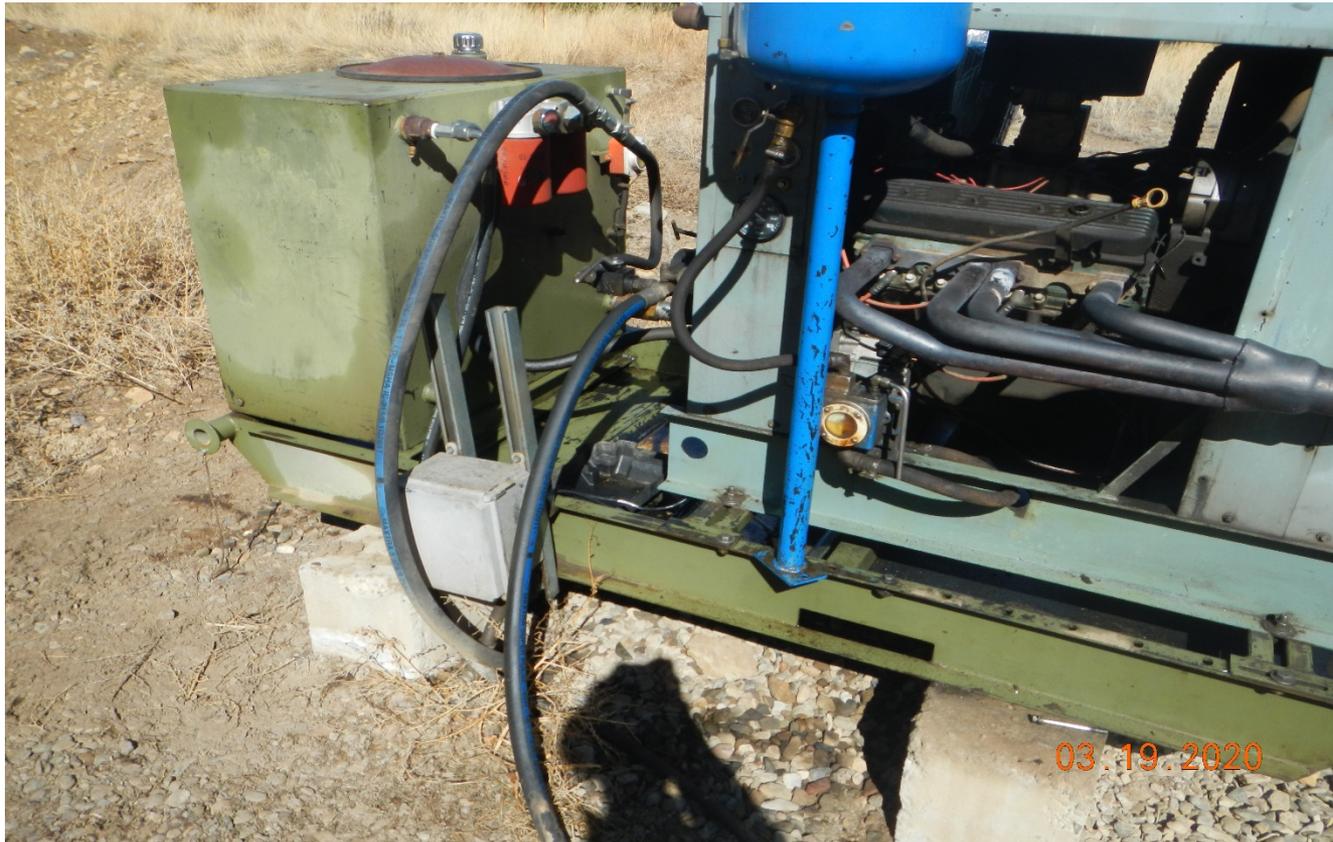
Photo 6. The oil on the engine skid has been cleaned up since previous inspection.

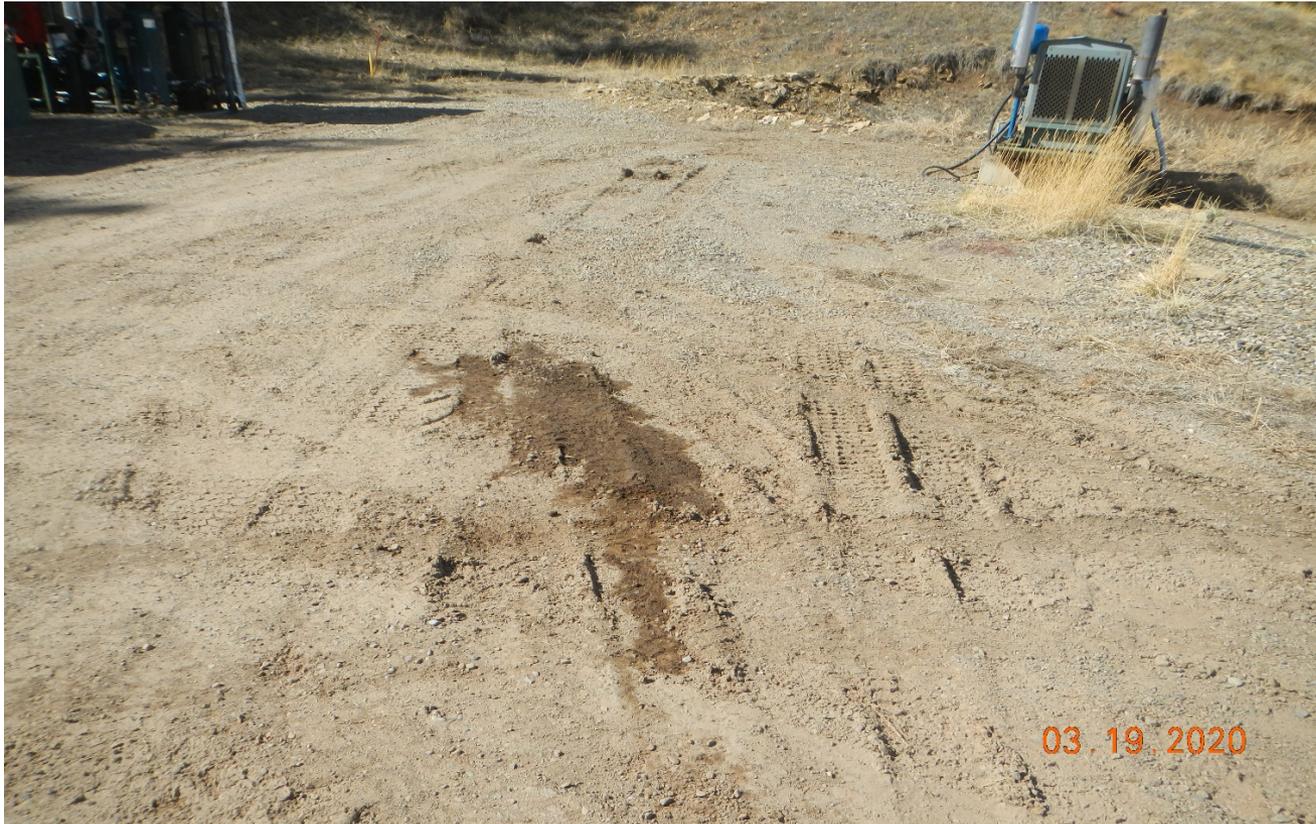
Photo 7. There is oil stained soil approximately 1'x3' area that needs to be cleaned up.
