Inspection Photos

API: 071-09853

Operator: TIMBER CREEK OPERATING

Inspection Date: 3/19/2020

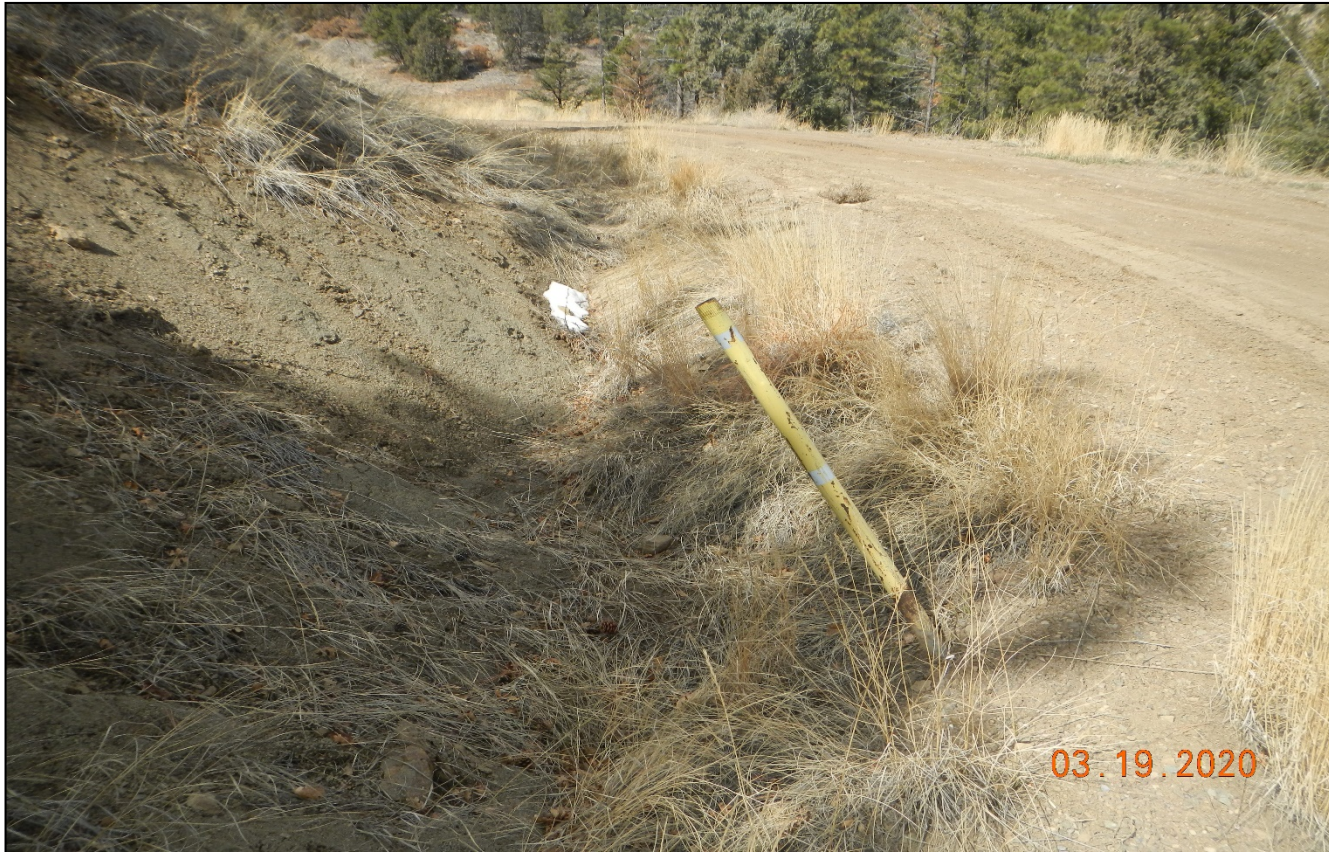
Photo 1. The culvert along the main lease road road is filled in with sediment.
Lat/Long:37.13931,-104.91829.

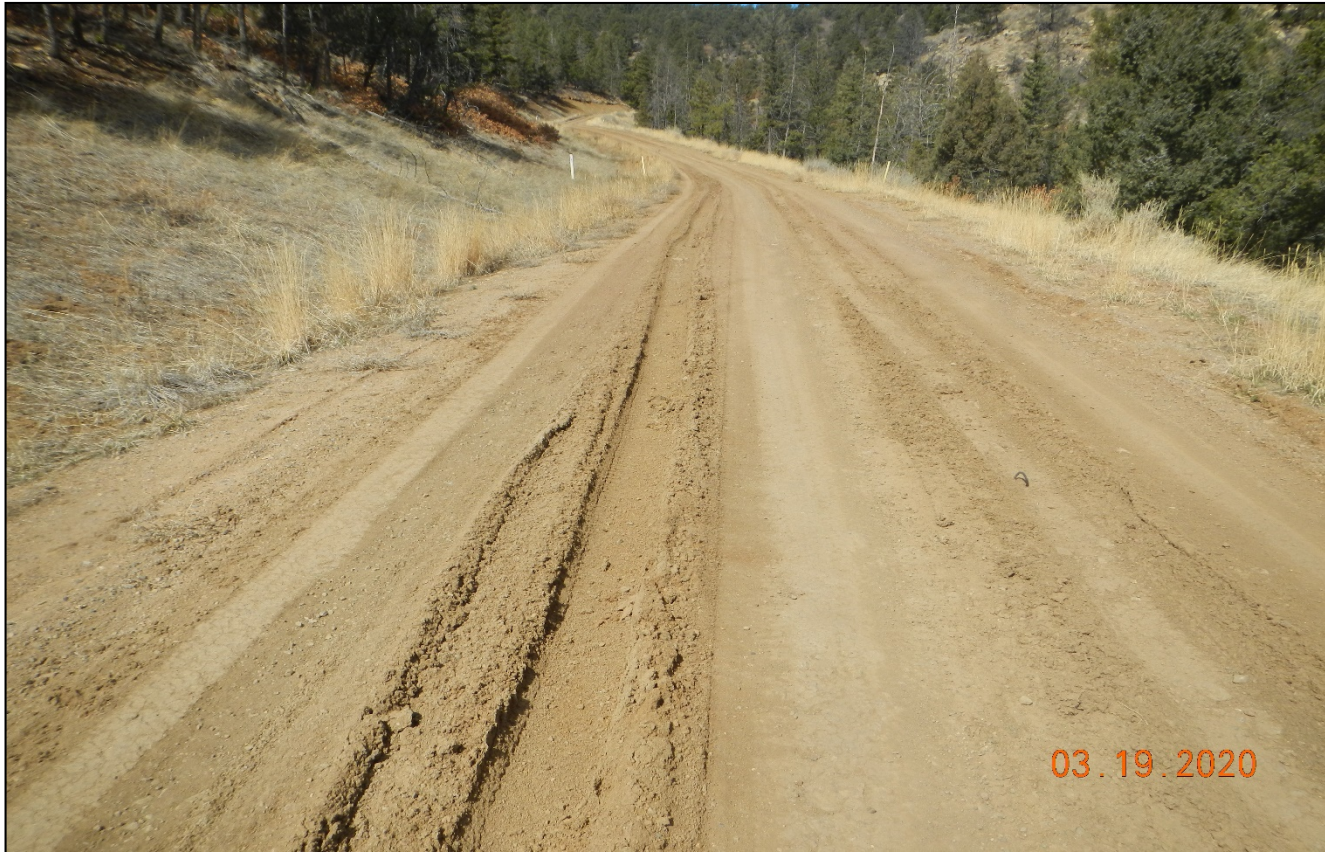
Photo 2. Facing northwest along the main lease road ascending the hill. There are vehicle ruts along the road. The road needs to be graded and maintained.

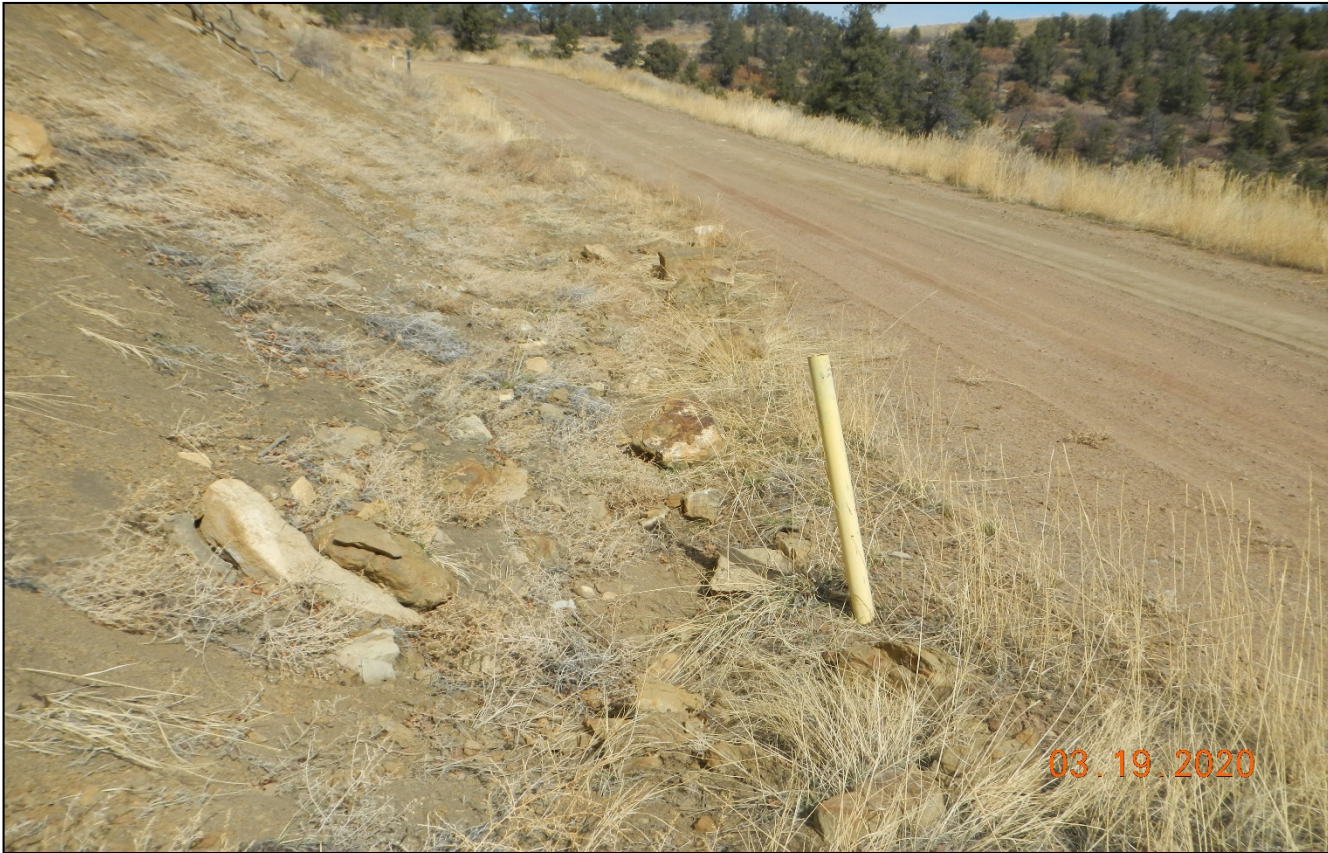
Photo 3. Another culvert along the main lease road is filled in with sediment.

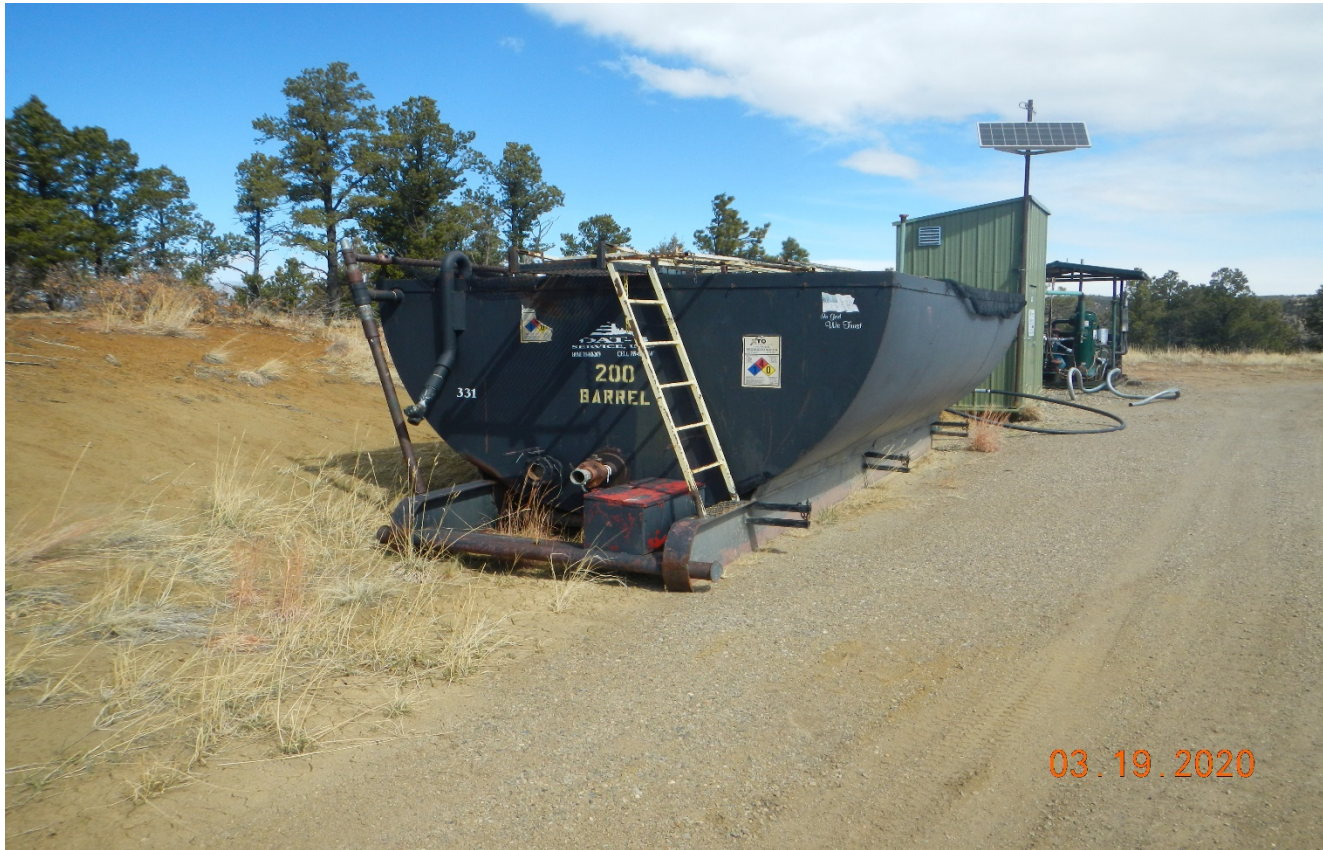
Photo 5. The 200 barrel open top tank does not have secondary containment installed.

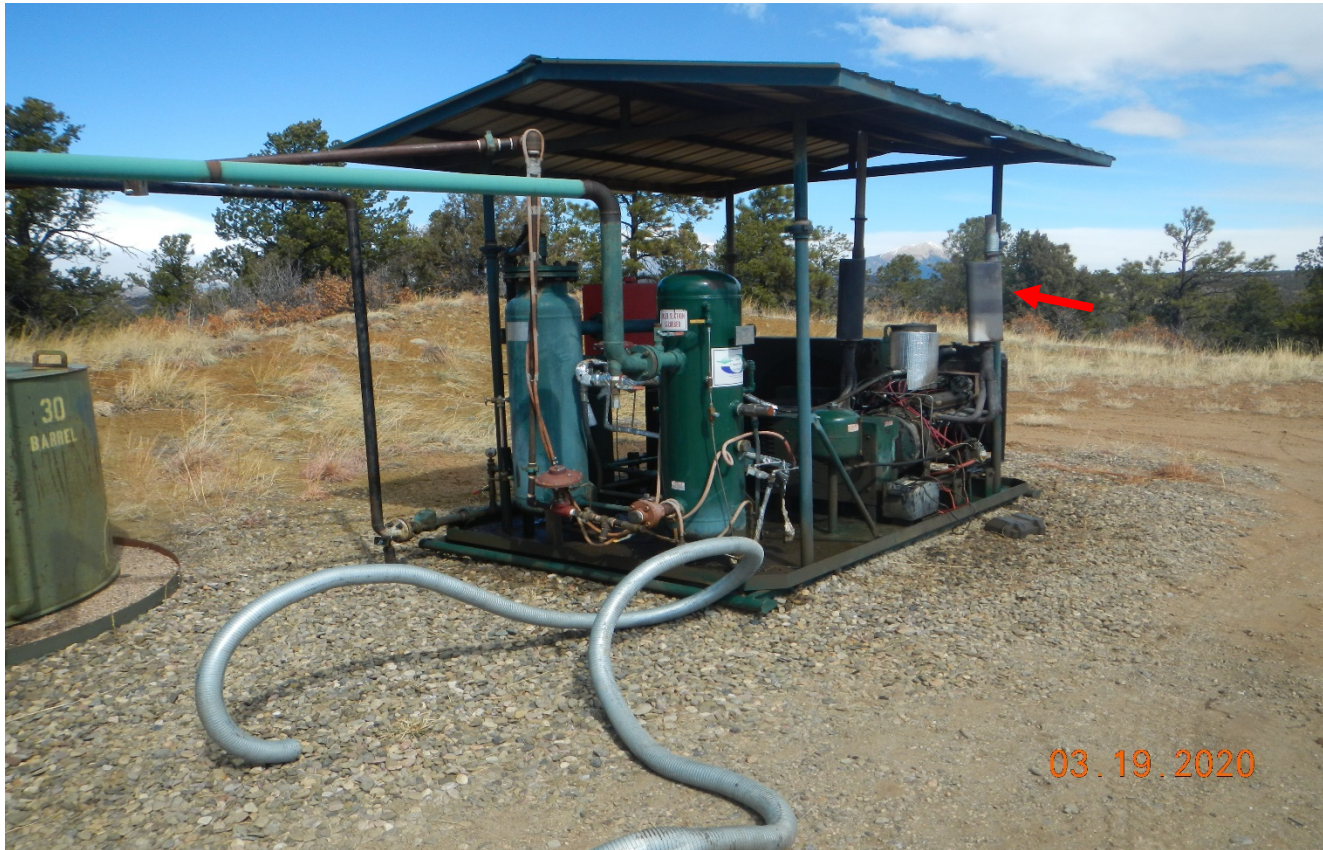
Photo 6. The exhaust pipe is laying on the ground at the compressor. The exhaust muffler is very loud. Maintenance is needed.
