Inspection Photos

API: 071-09236

Operator: TIMBER CREEK OPERATING

Inspection Date: 3/19/2020

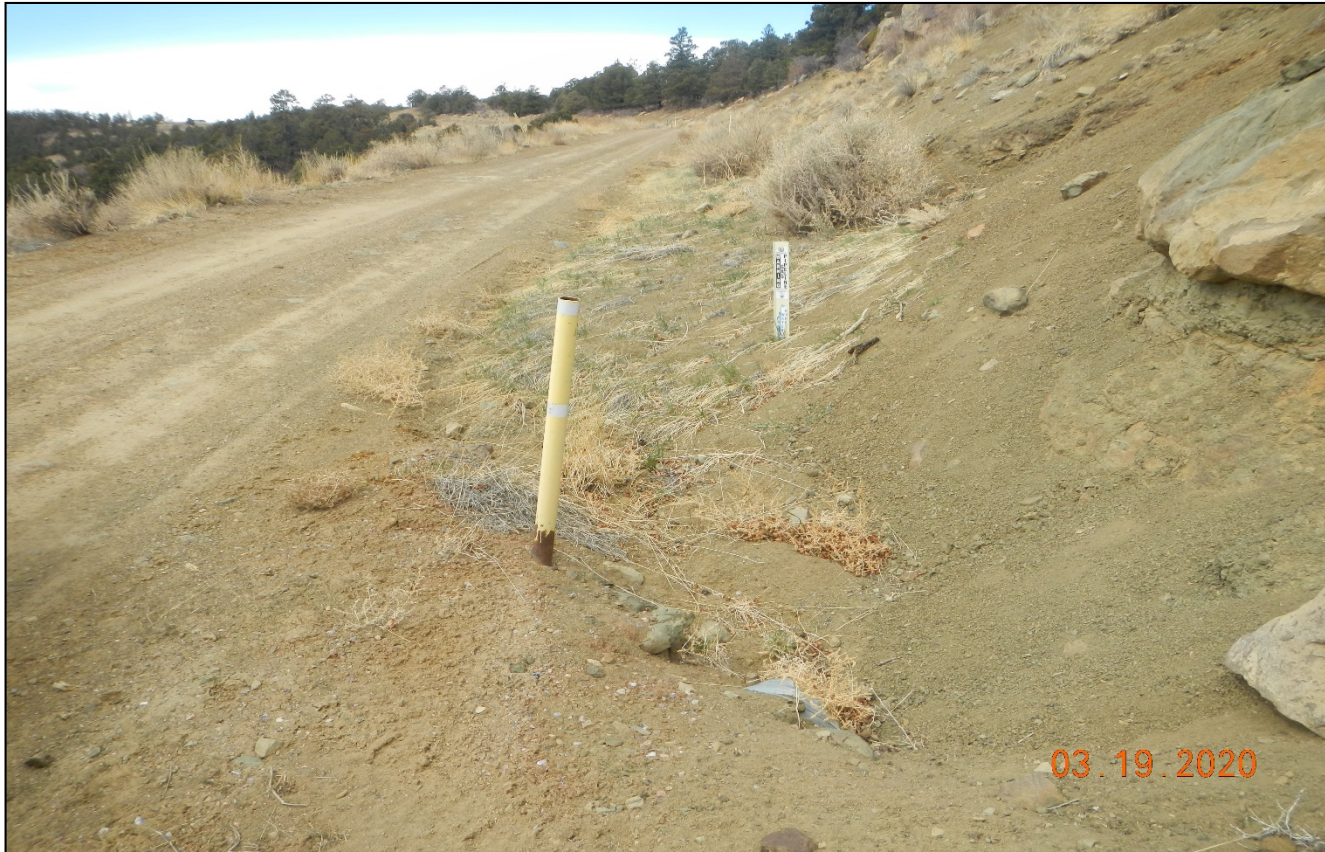
Photo 1. The culvert along the main lease road ascending the hill to the location is filled in with sediment.

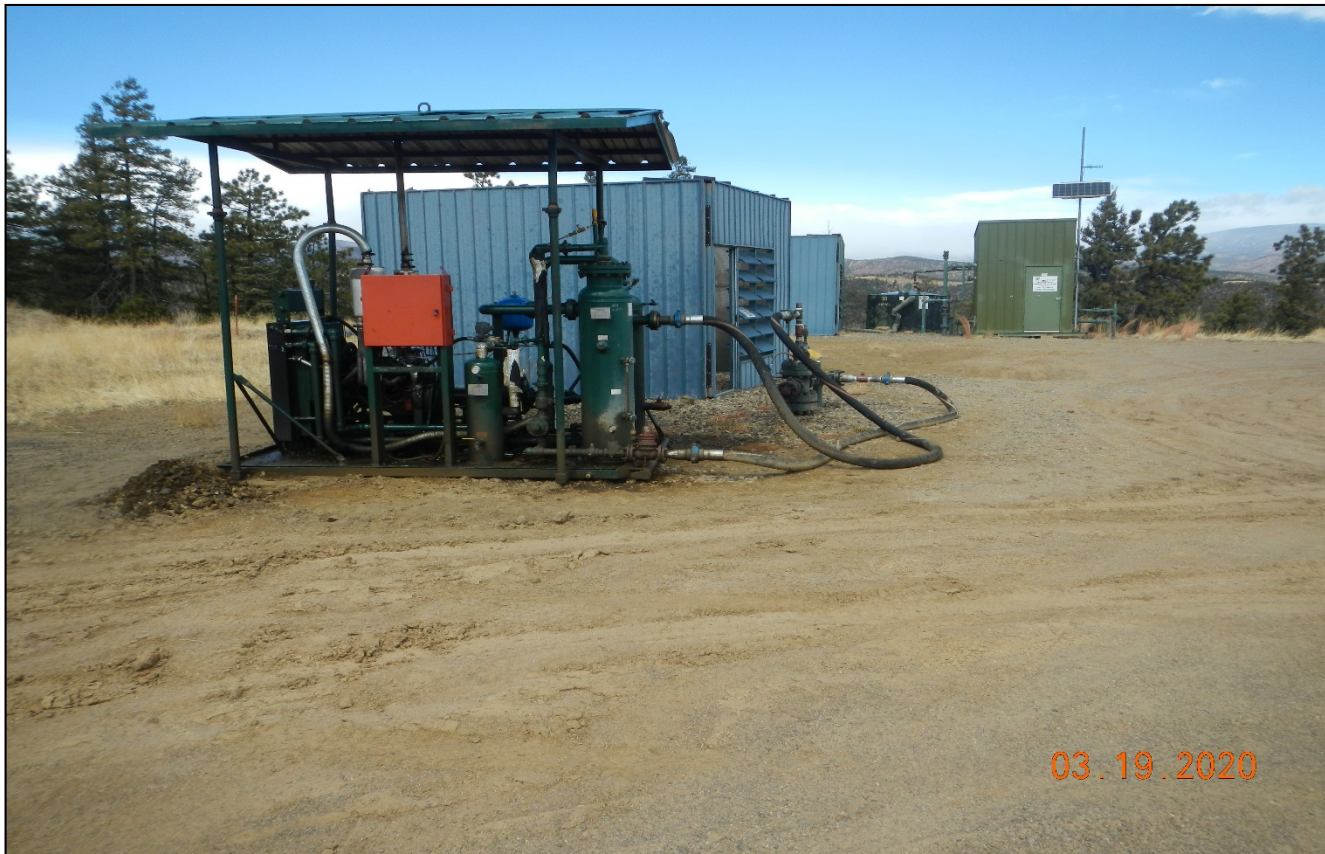
Photo 2. Facing northwest toward the location.

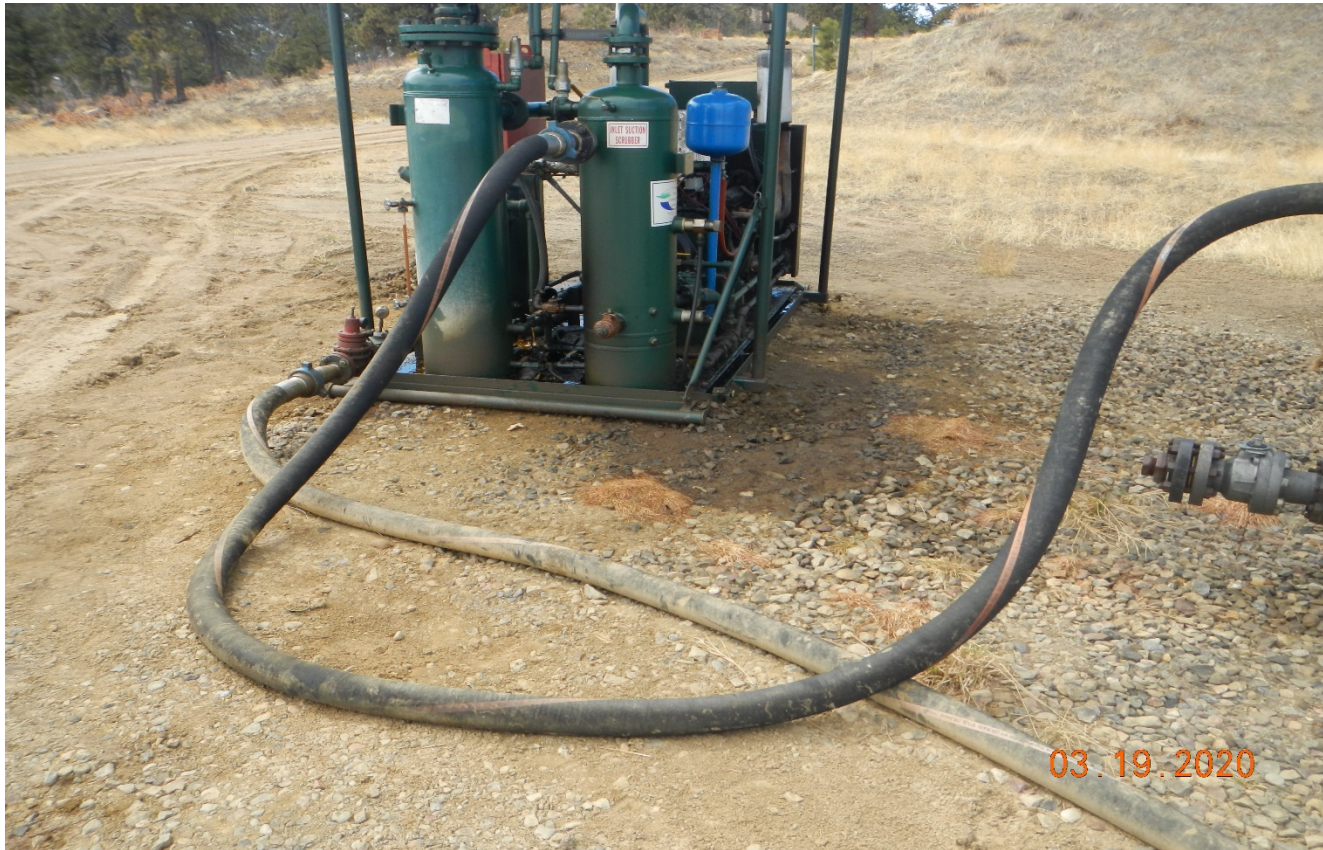
Photo 3. There is oil stained soil around the engine skid that needs to be cleaned up.

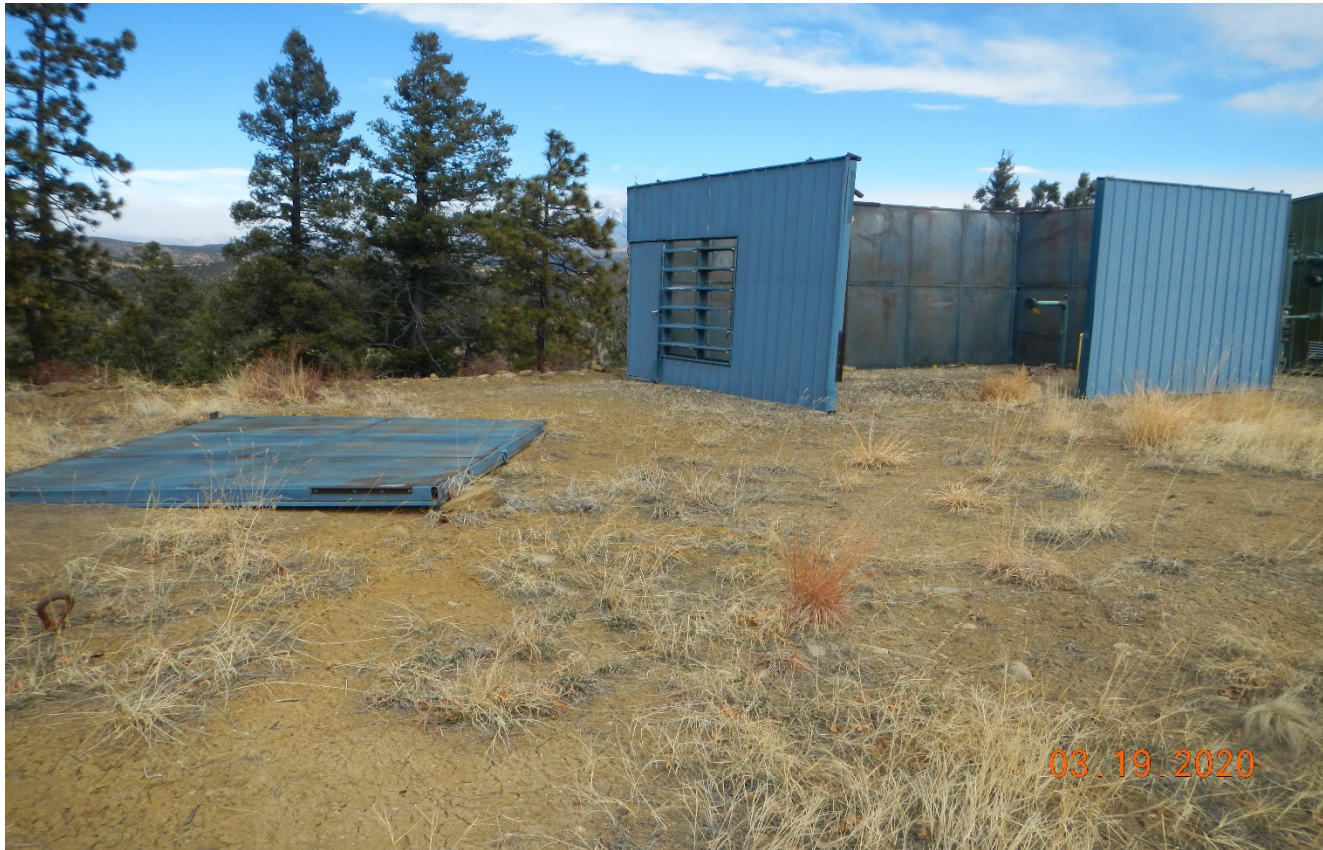
Photo 4. The sound wall is laying on the ground and the standing walls have no use. Unused equipment needs to be removed.

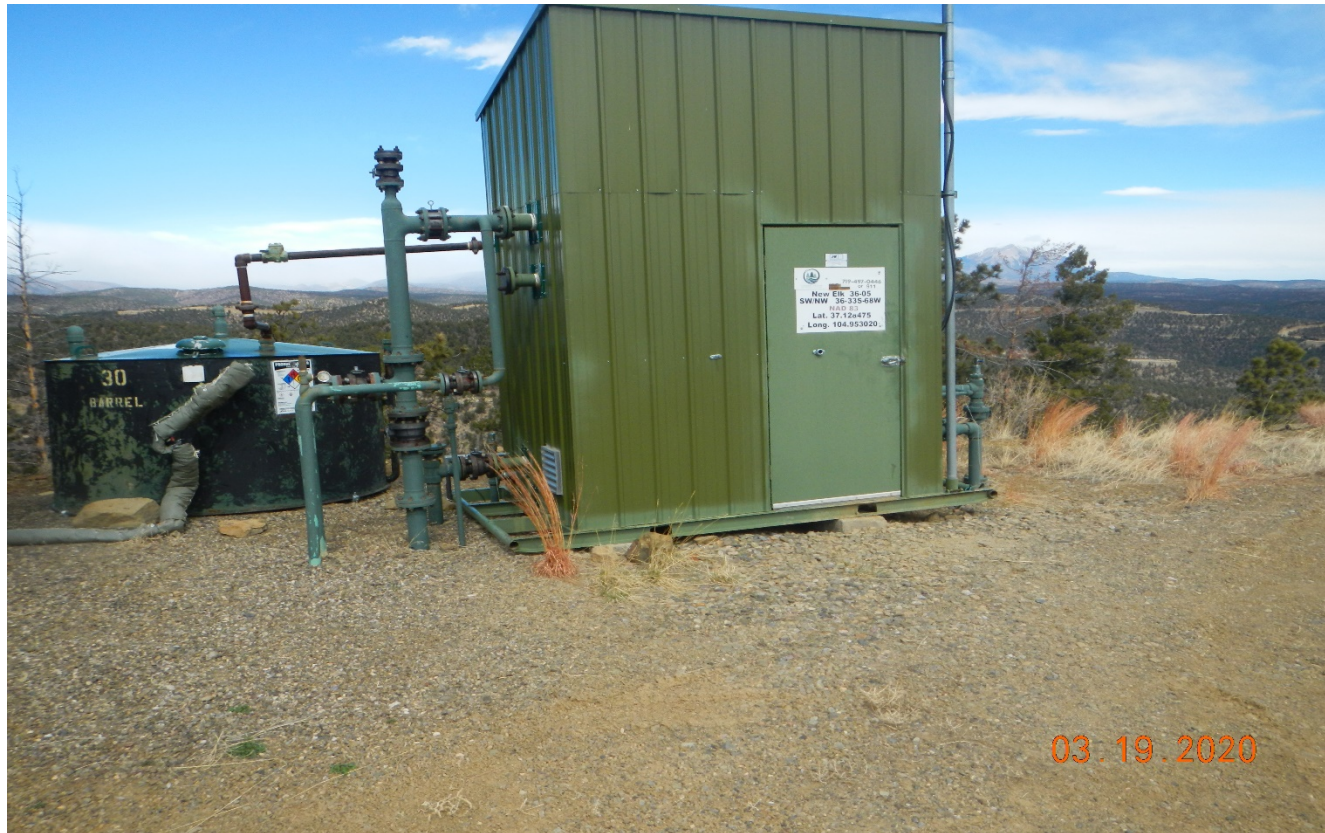
Photo 5. Well sign is posted at the meter shed.

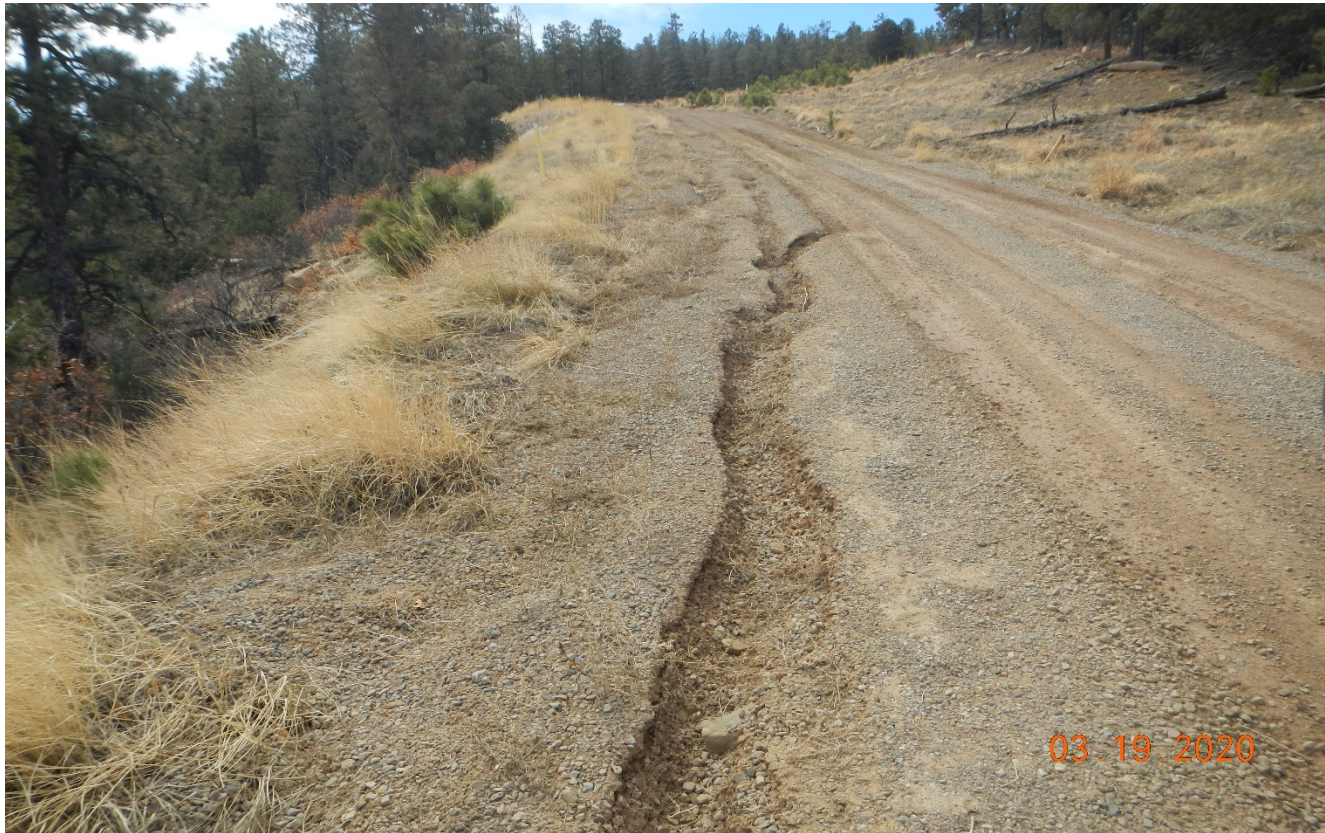
Photo 6. There is erosion occurring down the road as it ascends to the top of the hill. Approx. Lat/Long:37.12287,-104.95893.
