Inspection Photos

Operator: Hilcorp Energy
API#: 067-07798
Date: 3/18/2020

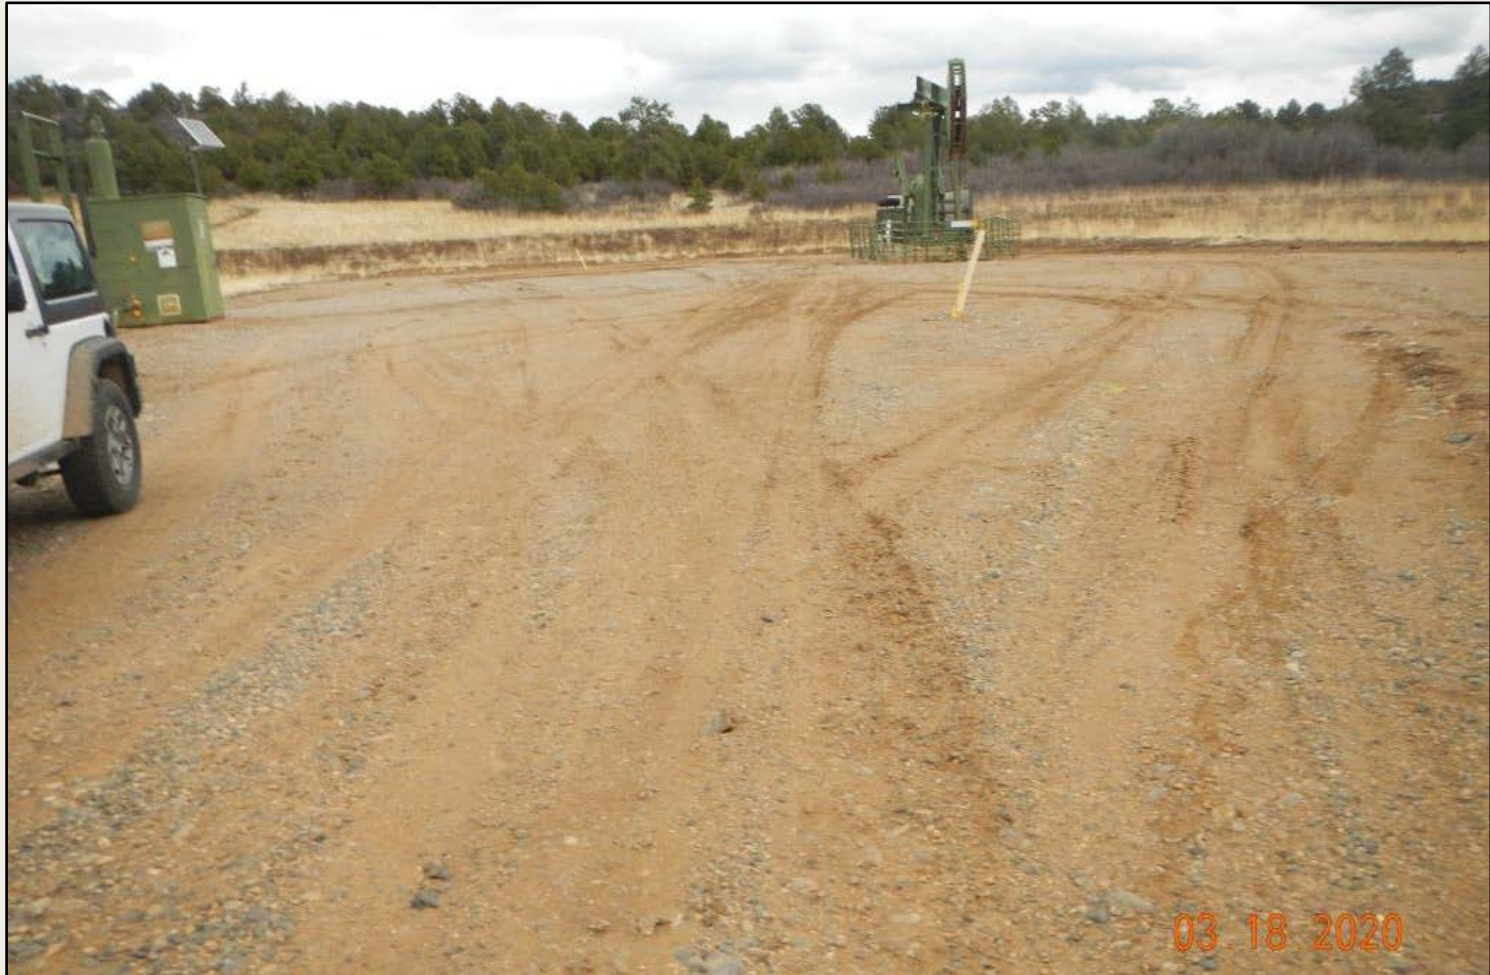
Photo 1. View of the project area from the northwestern corner entrance facing center.

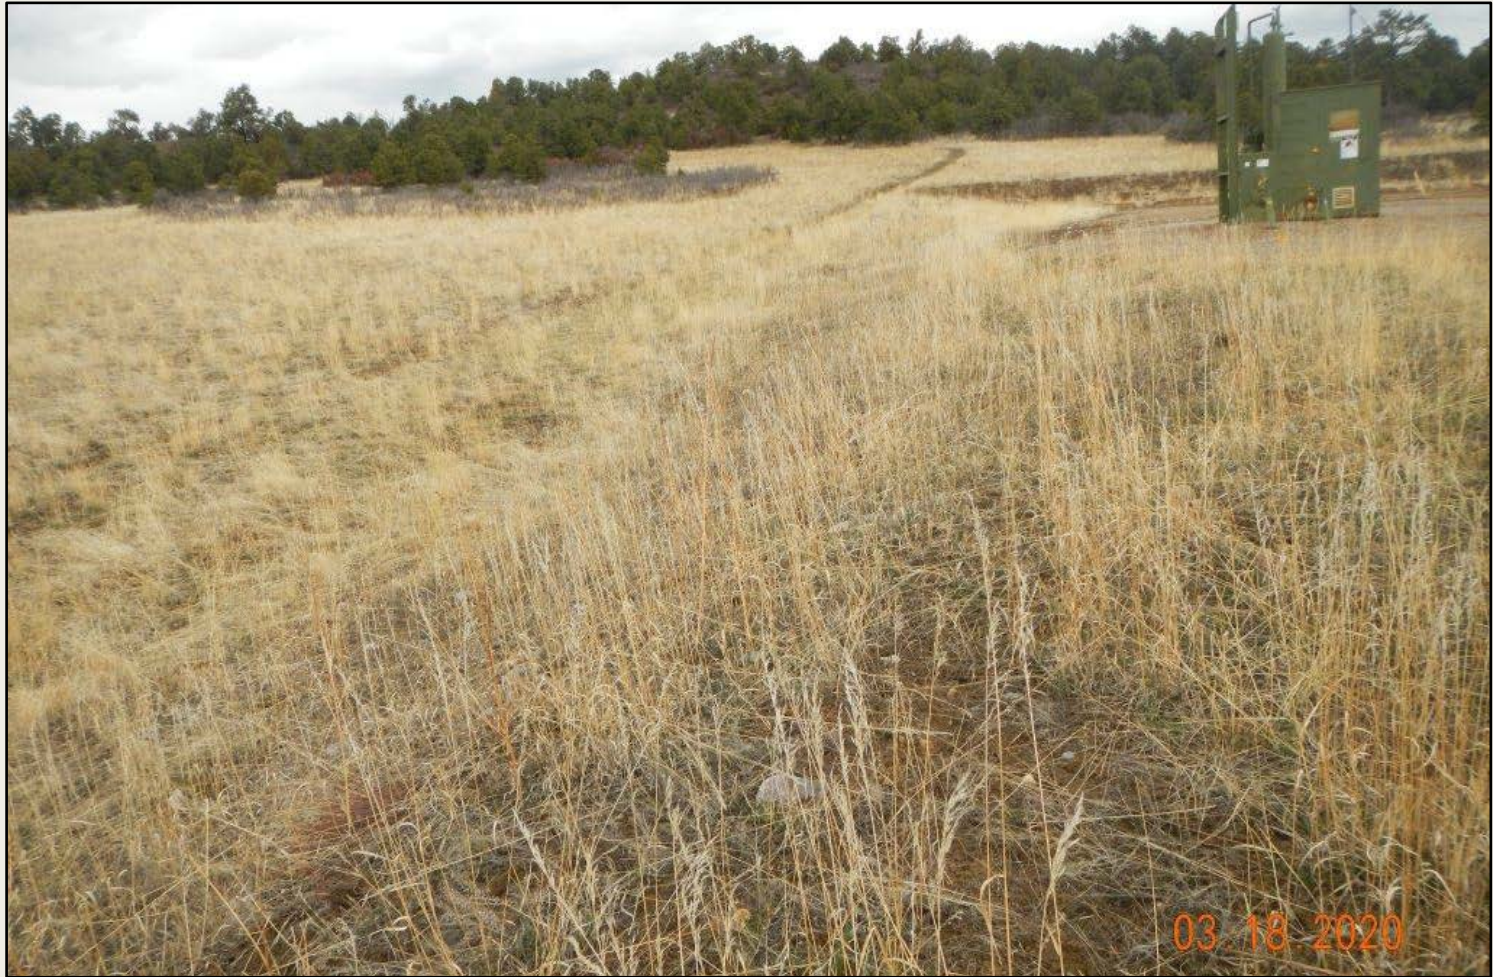
Photo 2. View of the northern project area from the northwestern corner facing eastward. Revegetation is progressing here, largely with smooth brome and mixed wheatgrasses.

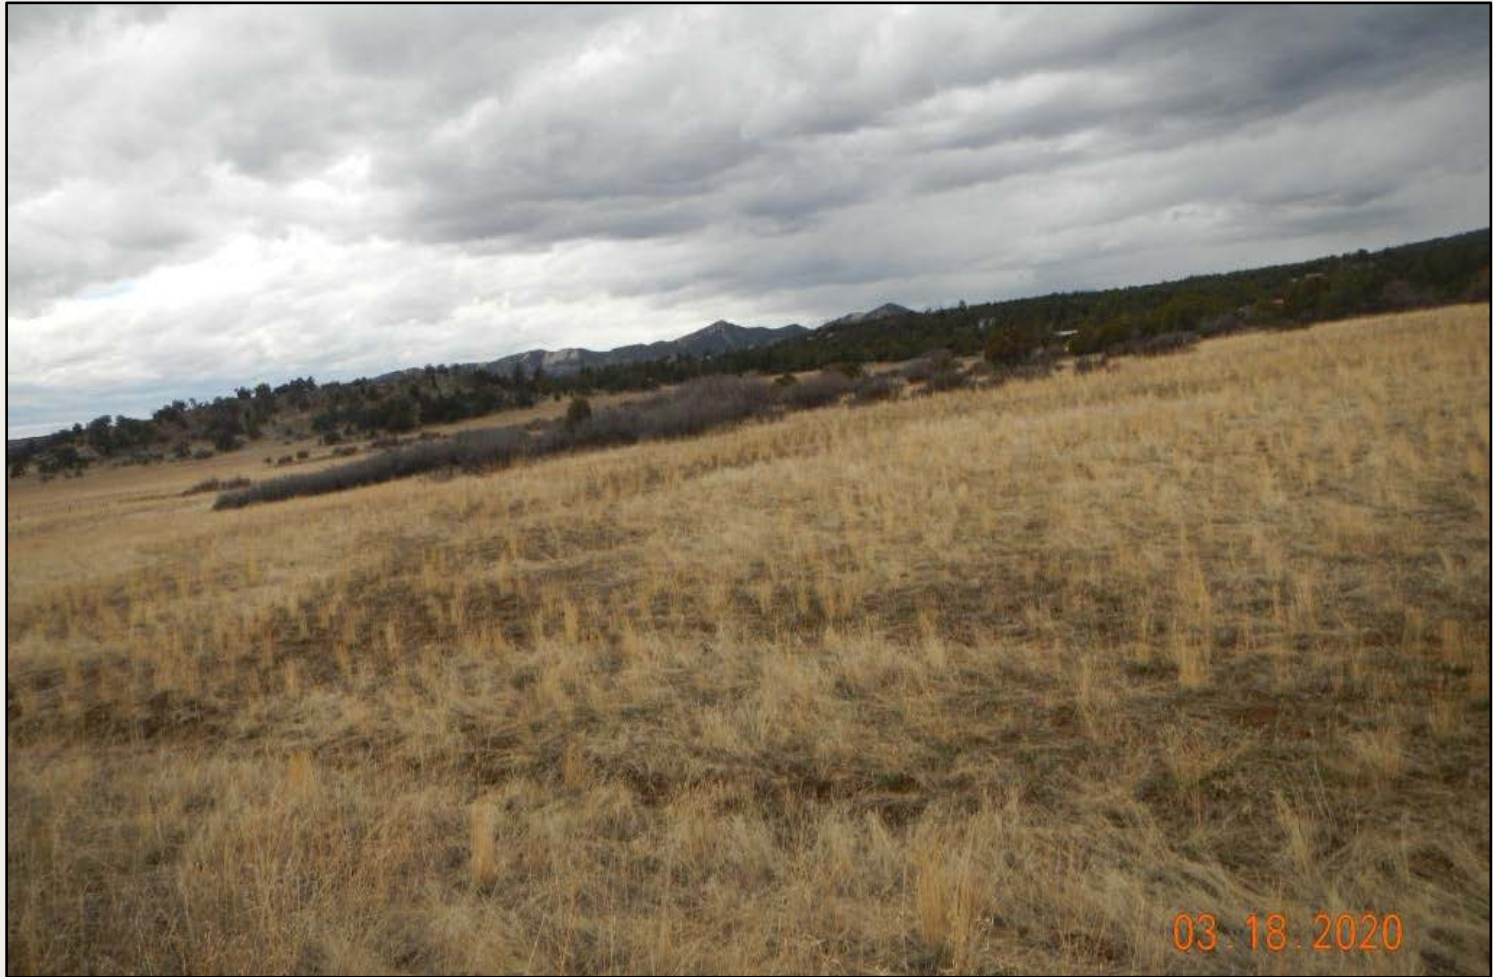
Photo 3. View of the surrounding reference area comprised of smooth brome dominated grass field with patches of gambel oak.
