Inspection Photos  
Operator: Hilcorp Energy  
API#: 067-06581  
Date: 3/18/2020

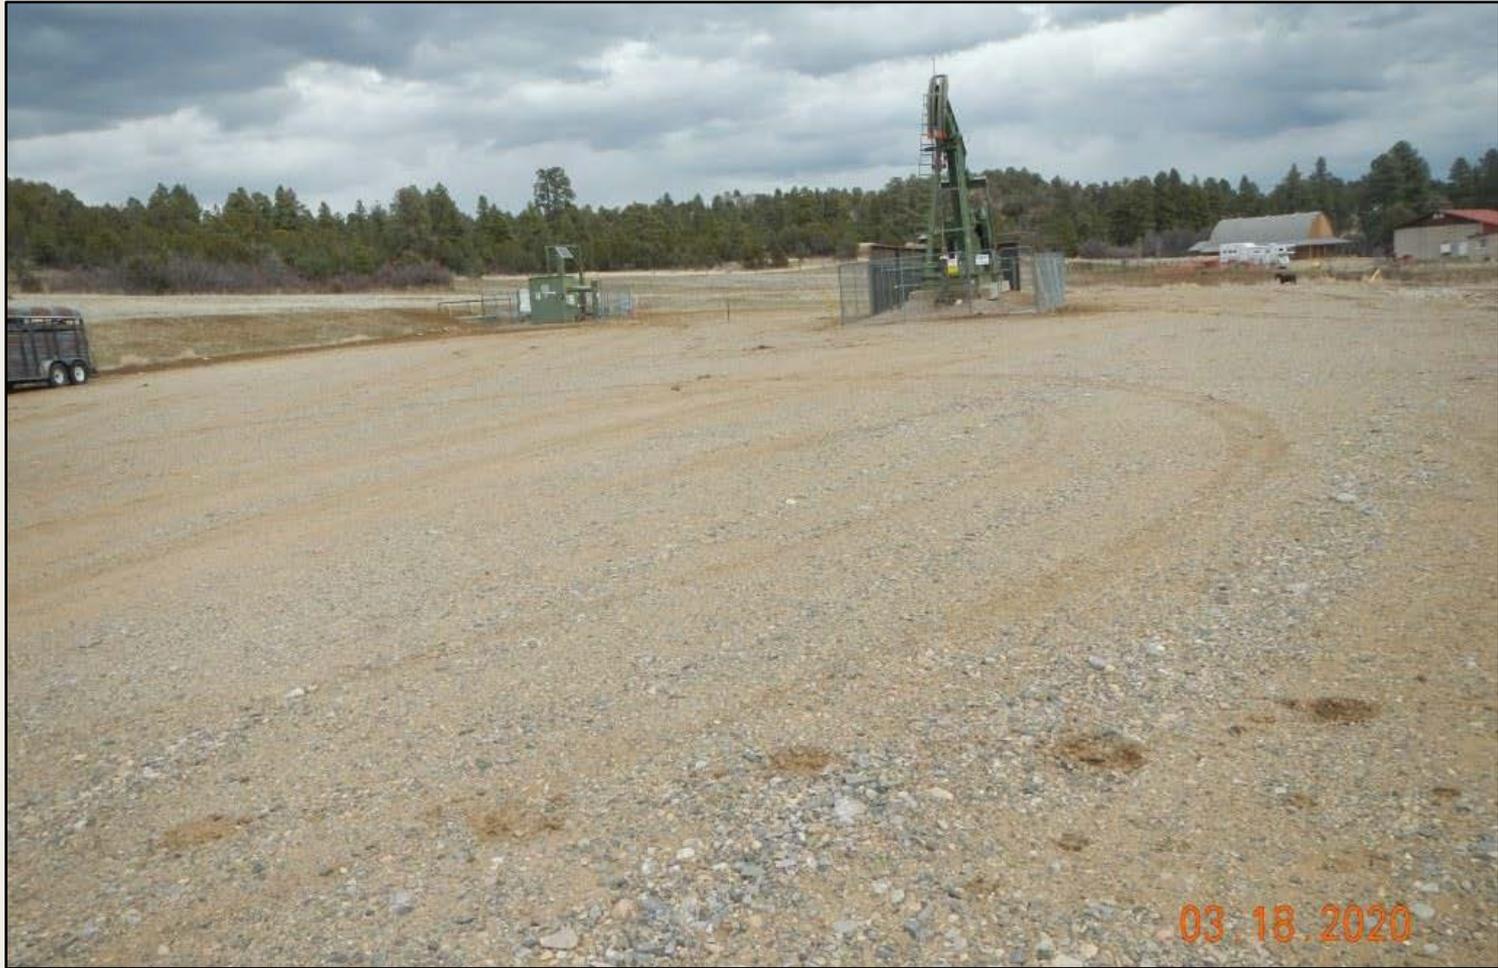
Photo 1. View of the project area from the well pad entrance facing center.

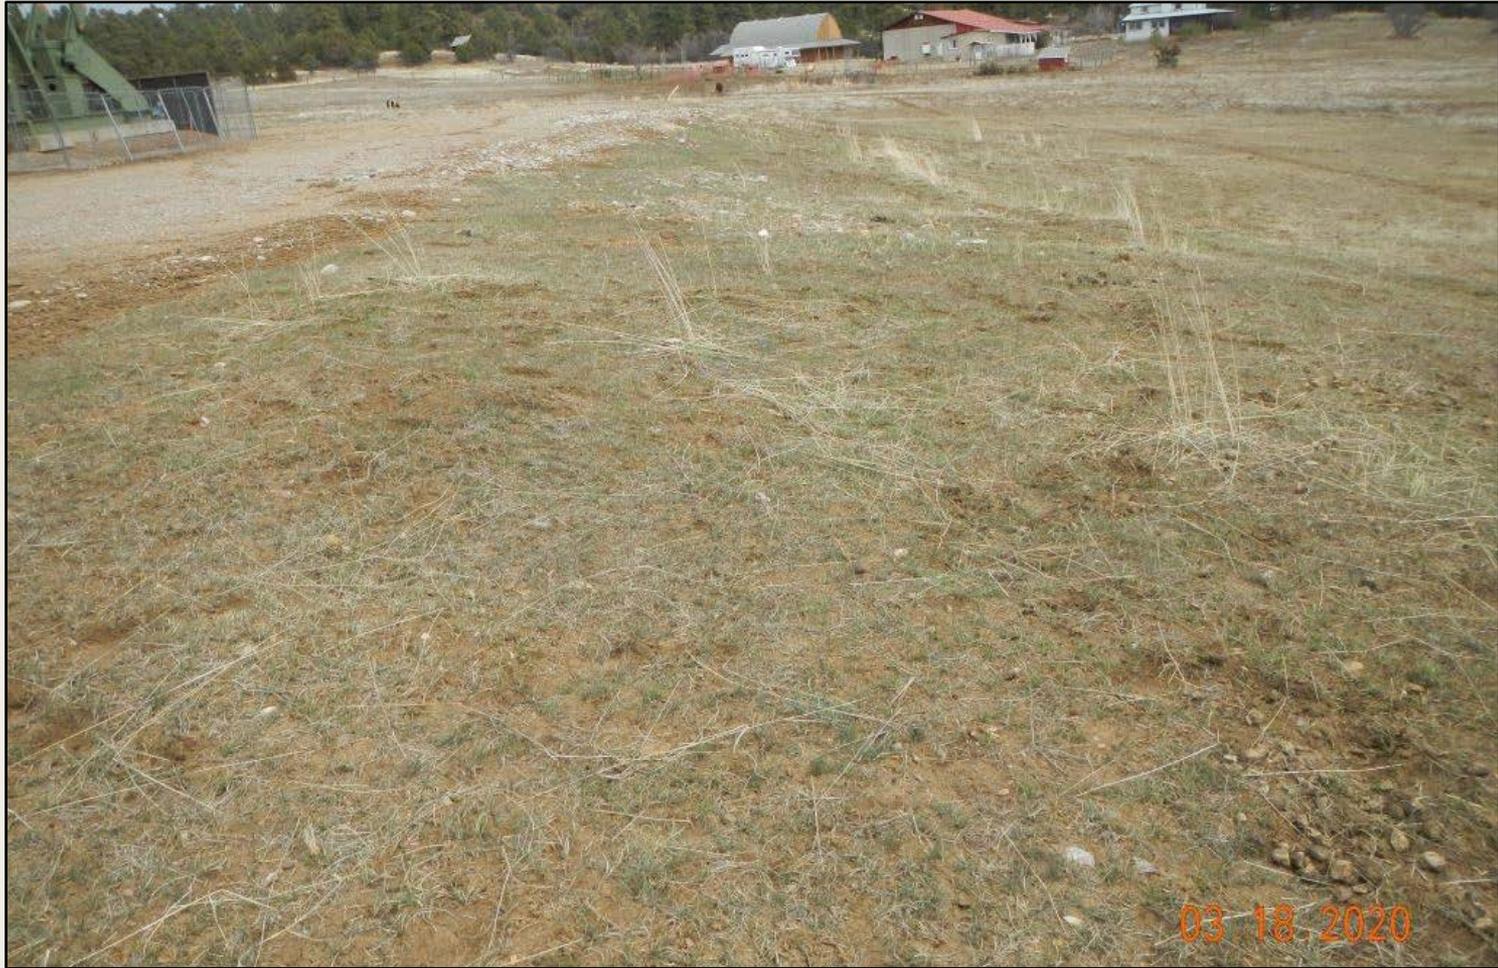
Photo 2. View of the southern project area from the southwestern corner facing eastward. Revegetation is progressing here in a grazed condition similar to reference area.

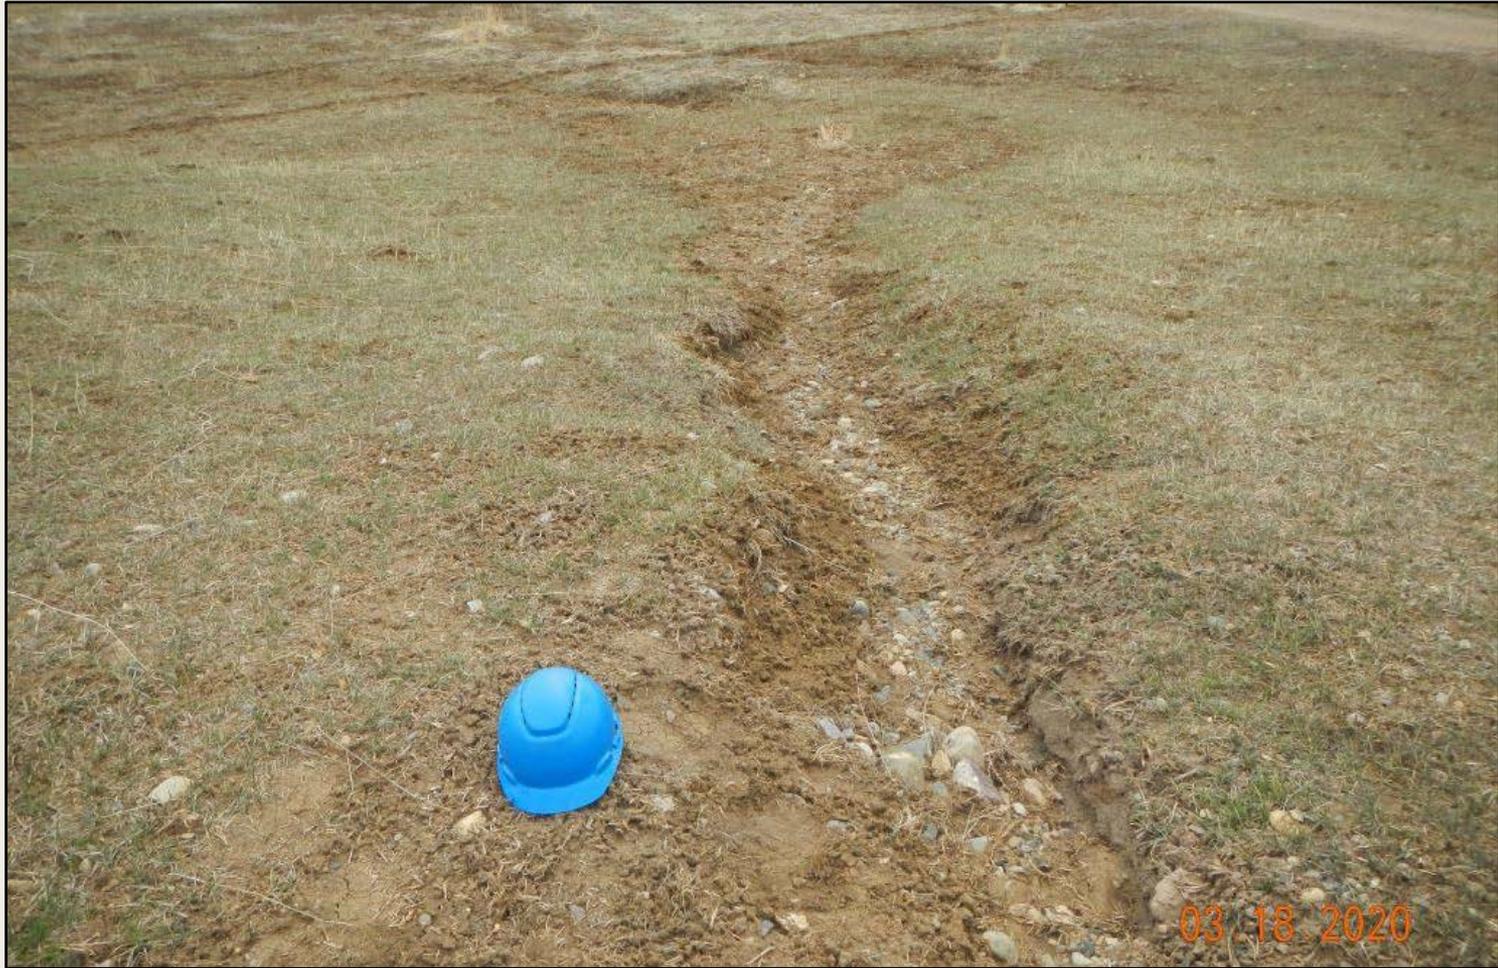
Photo 3. View of erosional channel approximately 2 feet wide and 1 foot deep, forming within the southwestern corner of the project area. Hard hat in place for scale reference.

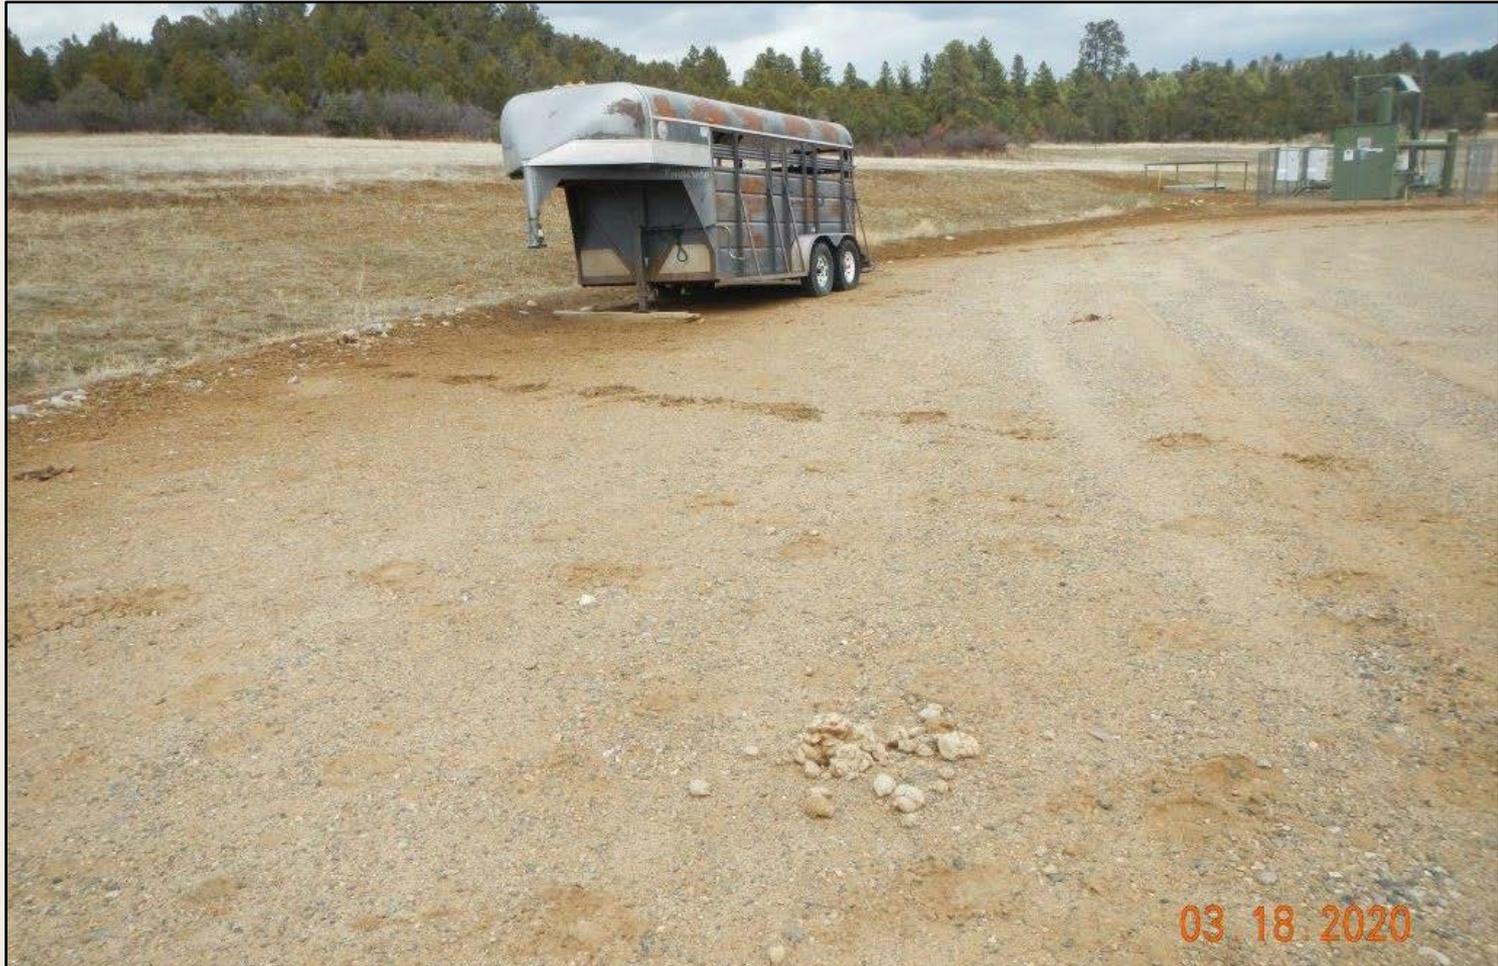
Photo 4. View of trailer parked on well pad, needs to be removed.

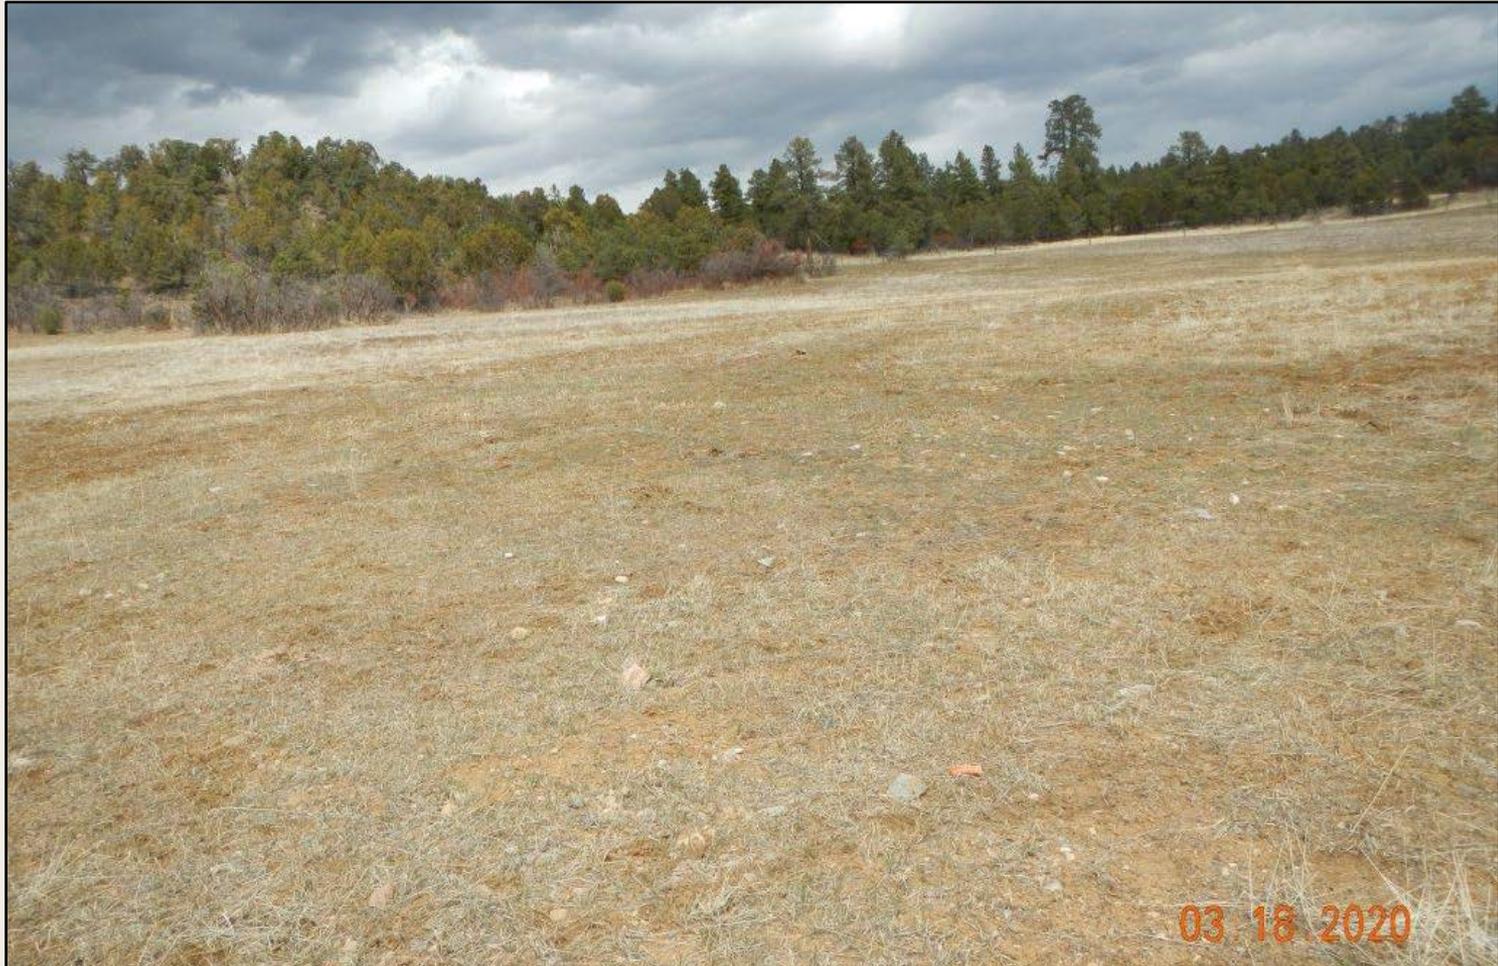
Photo 5. View of reference area, comprised of grass field in a grazed vegetative condition.
